X-ray CT Image = Microscope Image = Conductivity Test ?

# CONSISTENCY CHECK

Feb.12, 2021

Hayashi-REPIC

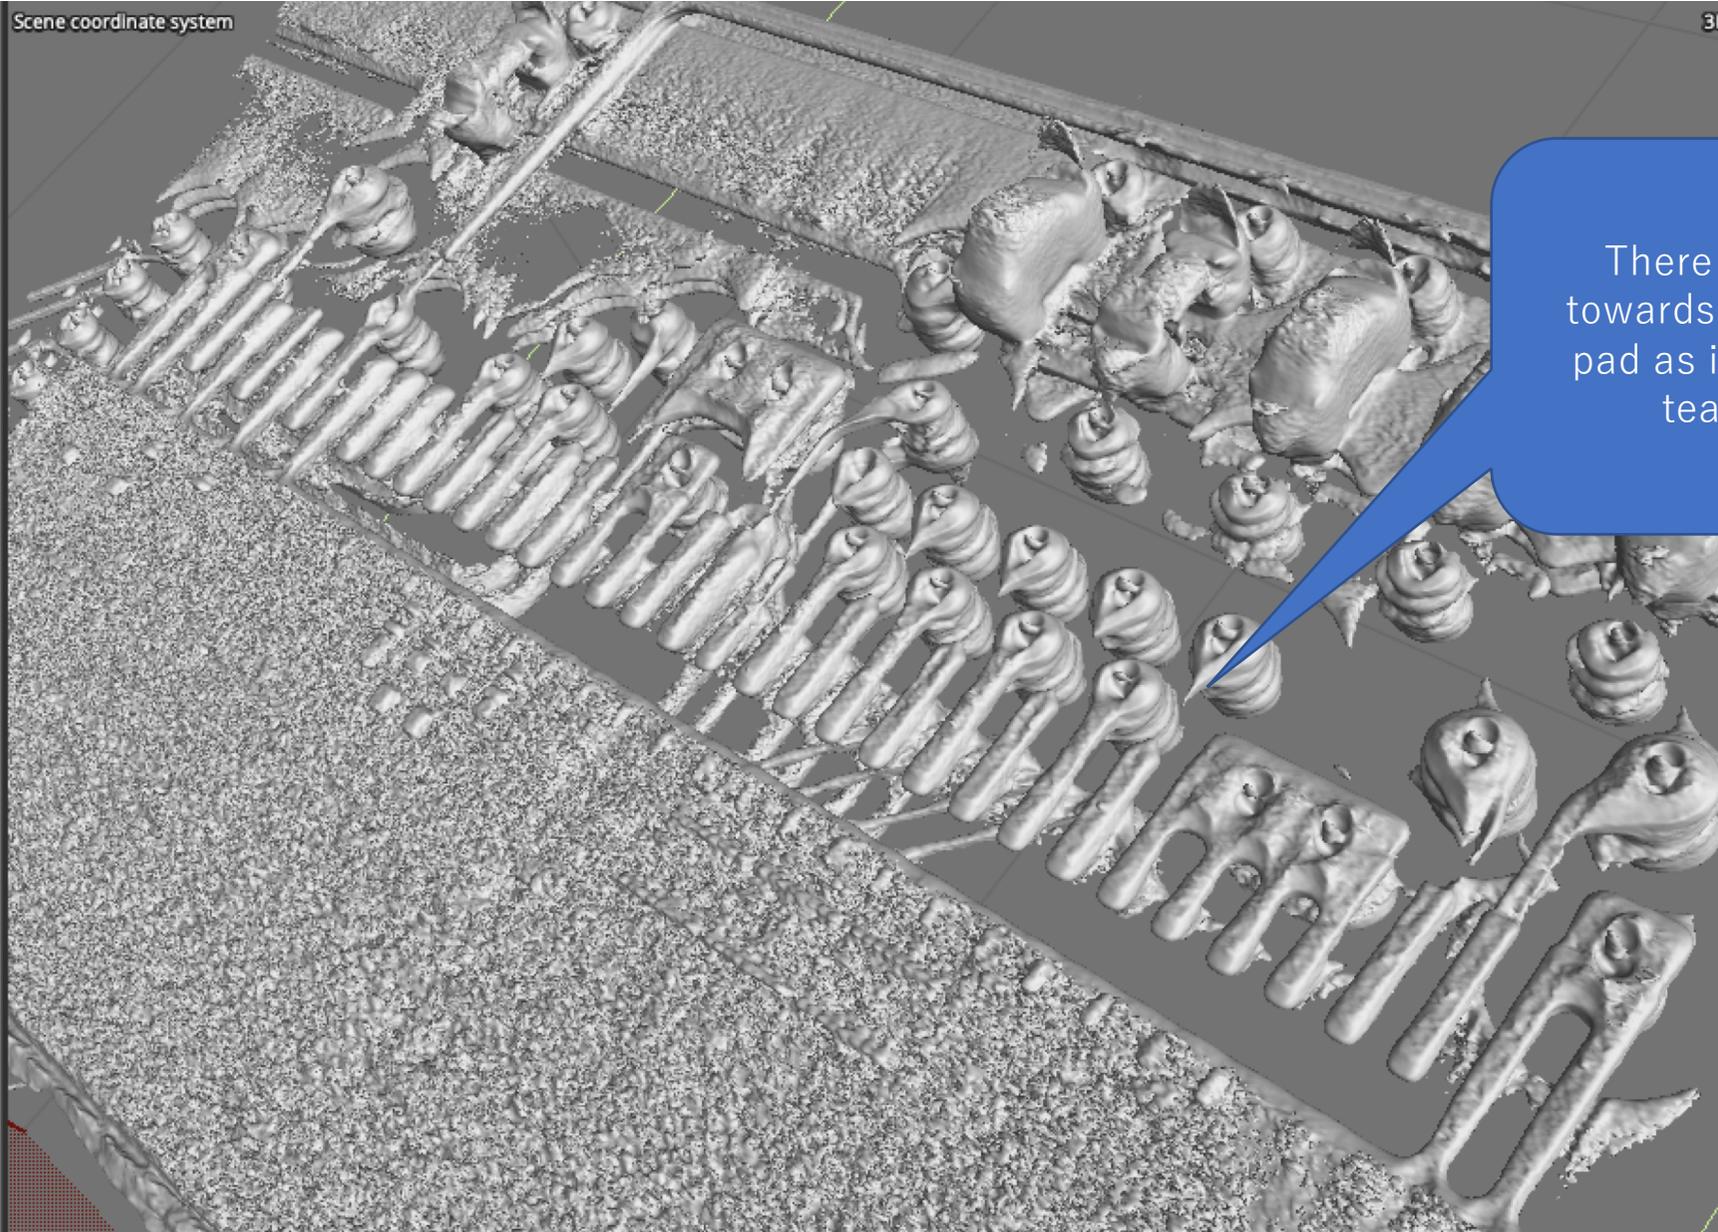
There are traces towards the bonding pad as if the path is torn off.

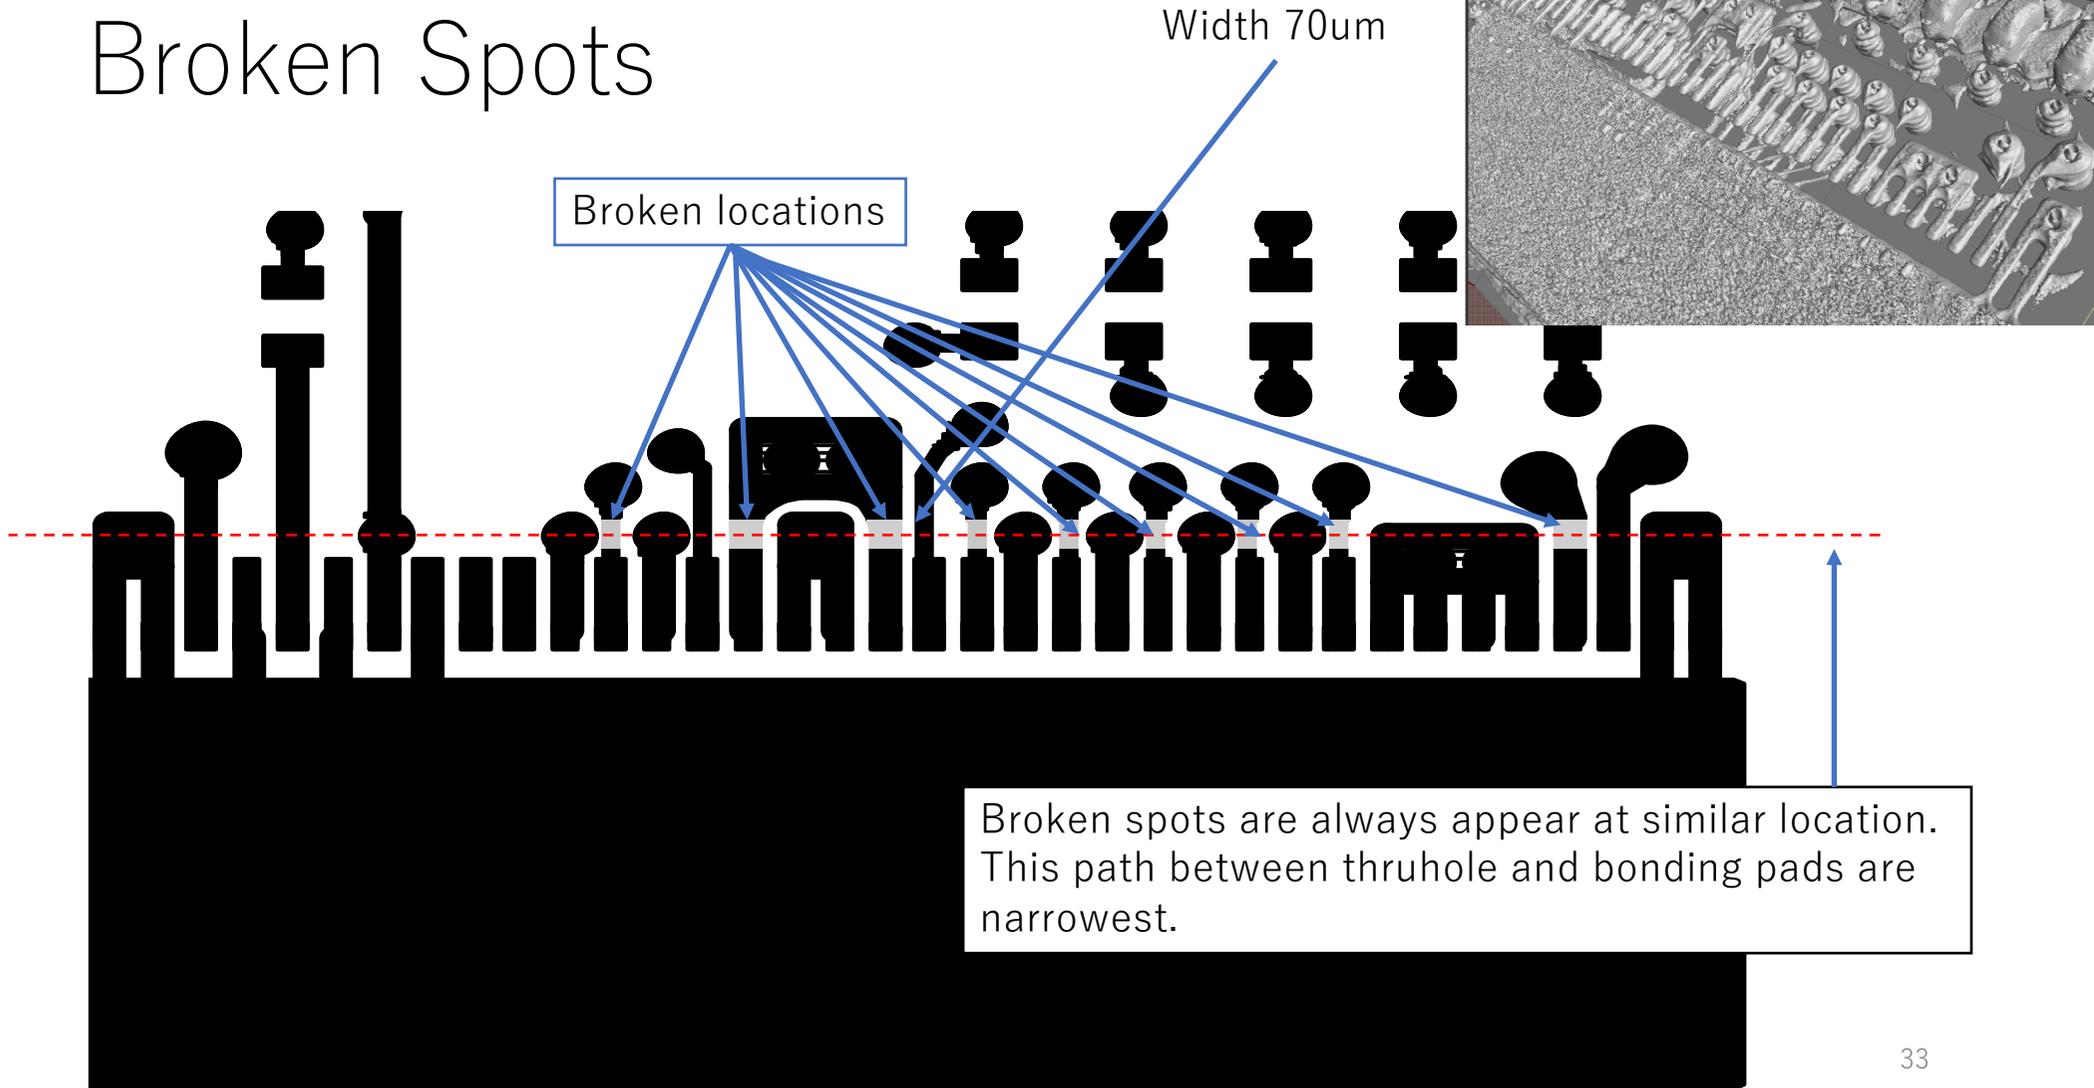
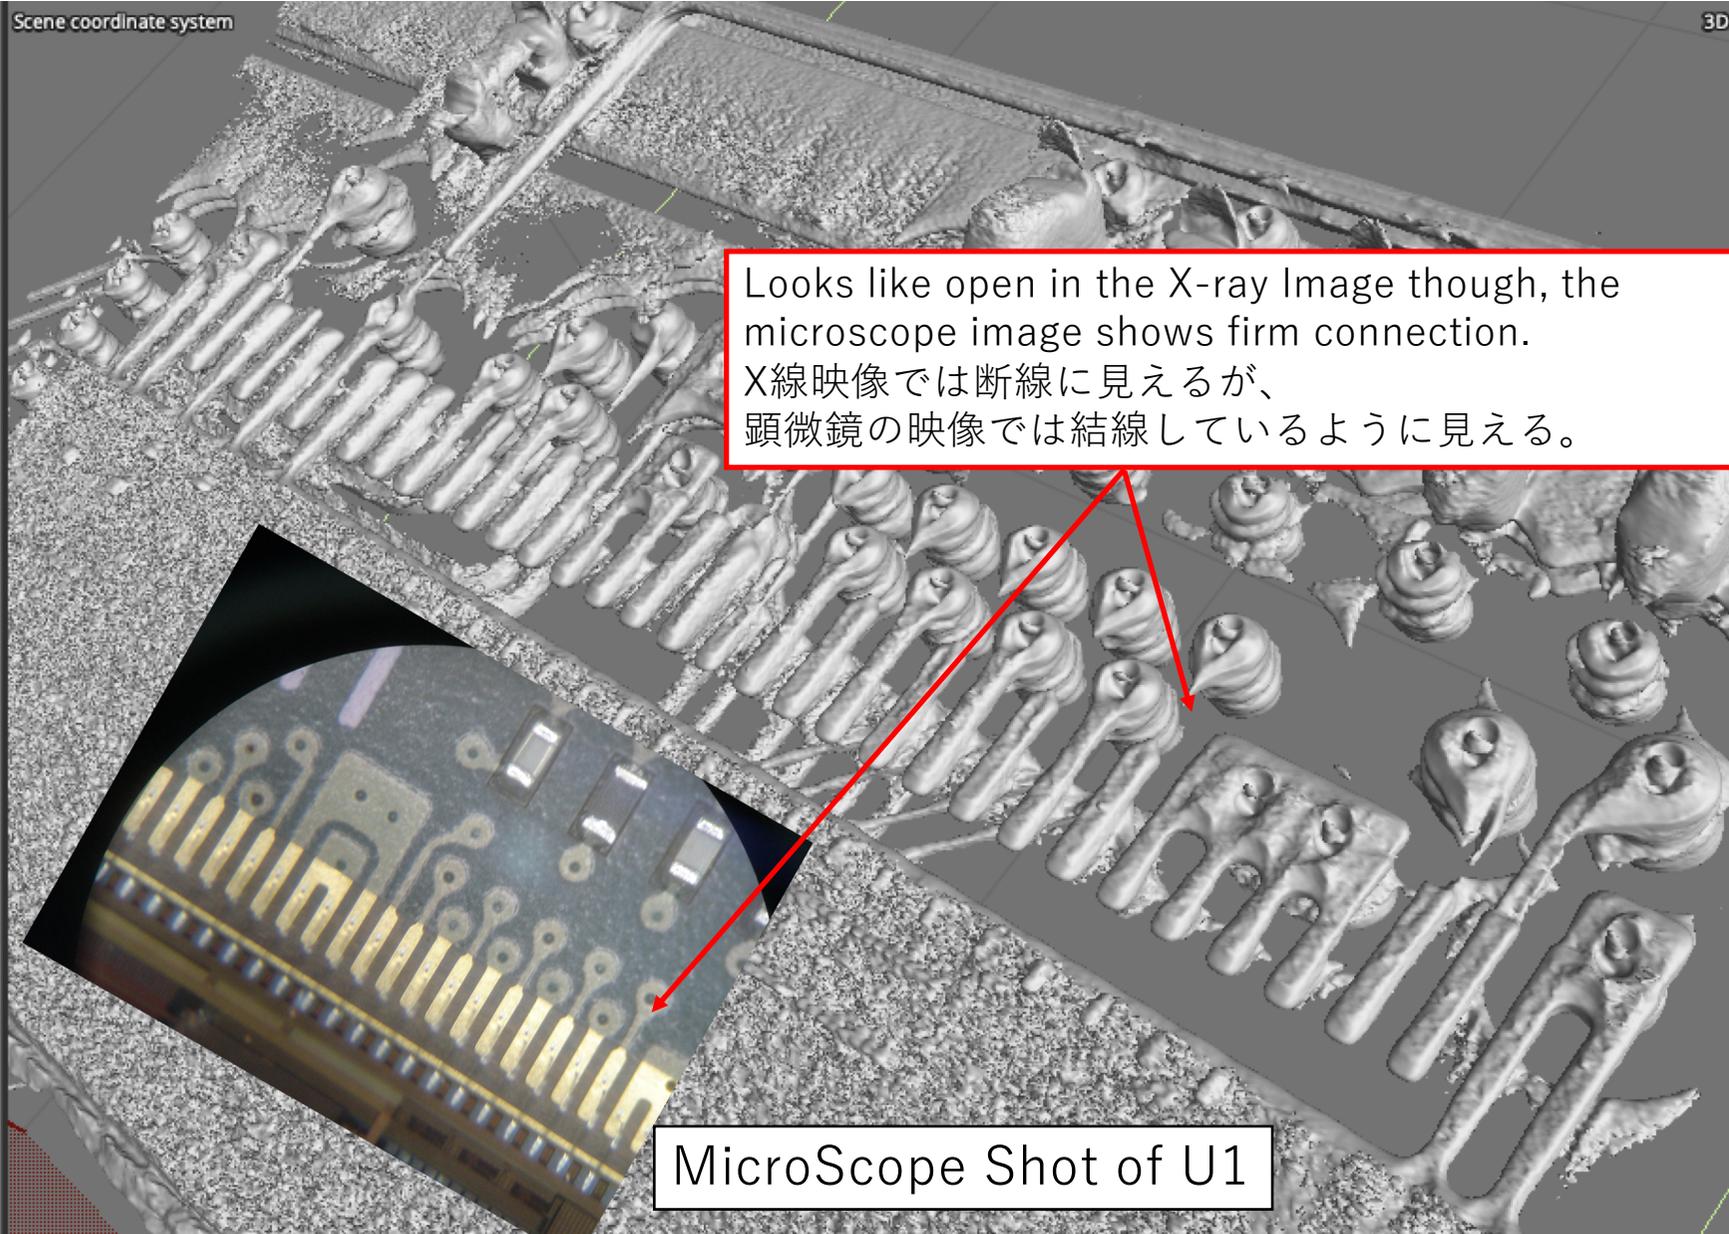
# Broken Spots

Looks like open in the X-ray Image though, the microscope image shows firm connection.  
X線映像では断線に見えるが、顕微鏡の映像では結線しているように見える。

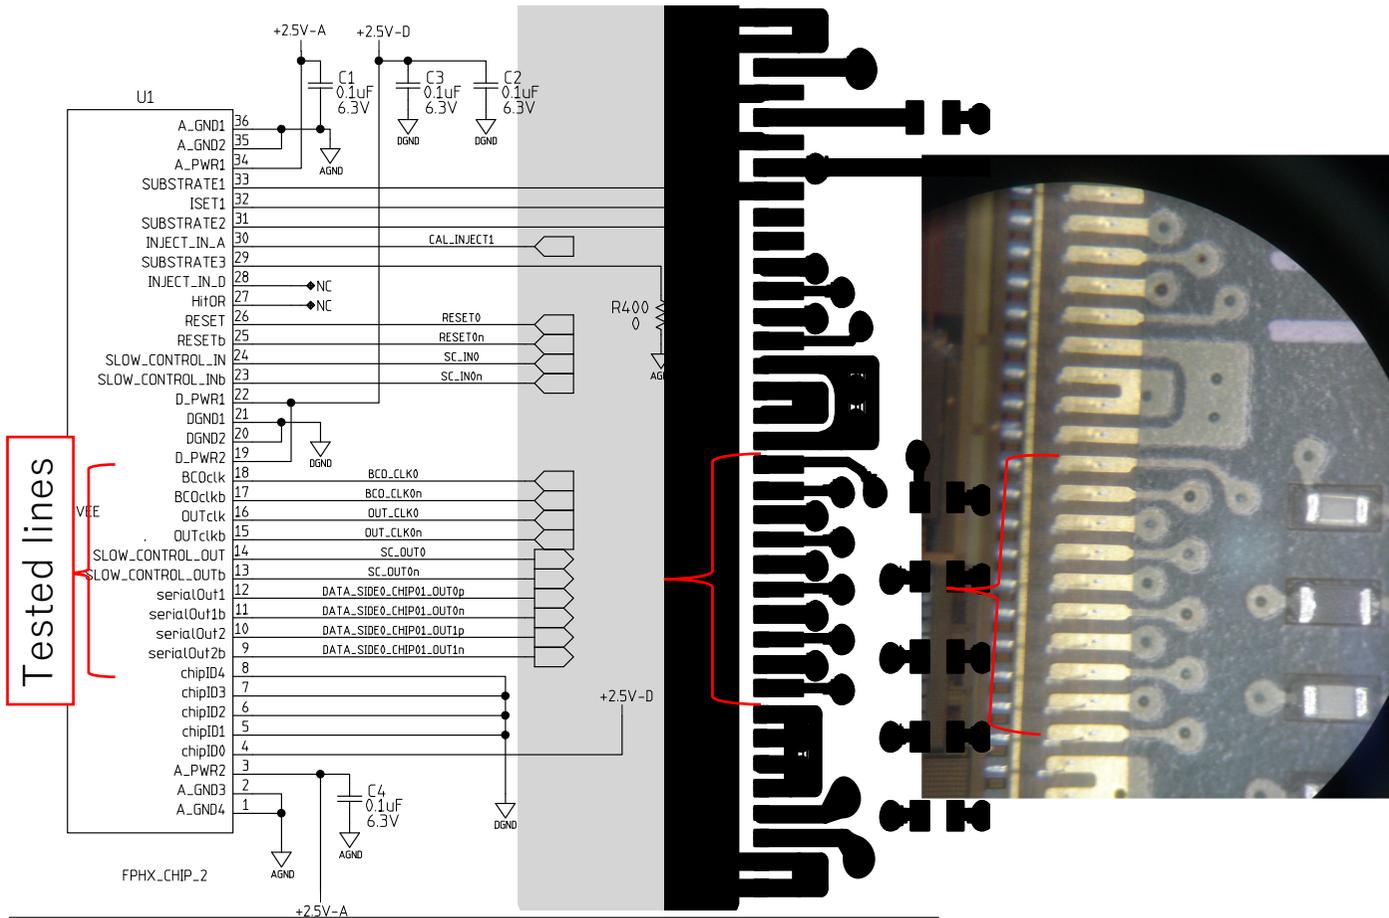
# Conductivity Test

Only outclk line is open as measured in Taiwan

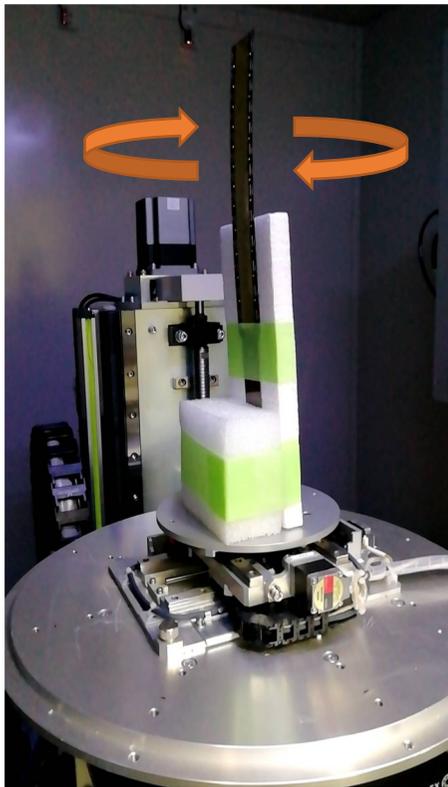
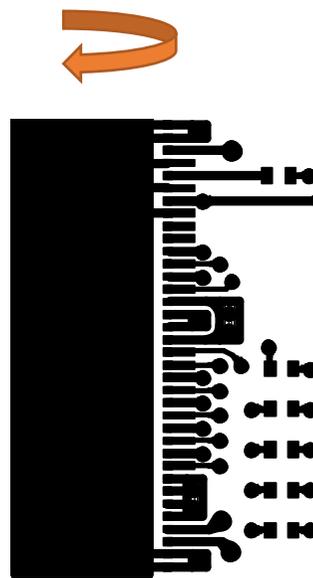
The reconstructed image can be different if we let the chip spin this orientation.
