<b>Document Title</b>	<b>Existing BABAR (sPHENIX) Solenoid - JLab Engineering Risk Assessment</b>
<b>Project</b>	EIC Experimental Equipment
<b>Purpose of document</b>	To collate information pertaining to the long term engineering robustness and suitability of using the existing BABAR (sPHENIX) solenoid as the EIC detector solenoid
<b>Version No.</b>	5.00
<b>Date</b>	<b>10.15.2020</b>
<b>Engineer</b>	R. Fair
<b>Reviewed by</b>	R. Rajput-Ghoshal

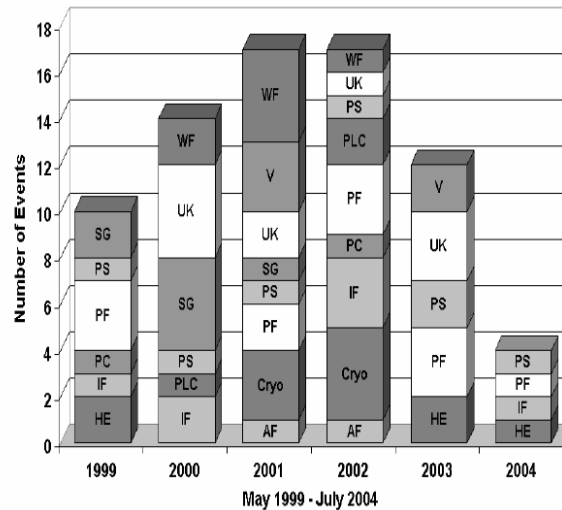
For the events labeled as ‘Unknown’ in Figure 1 below, either the event was not well documented or the cause of the event was not known at the time. If a hardwire quench detection interlock is tripped, it can be difficult to obtain information about what initiated the problem. However, if the cause were known, it would most certainly fit into one of the other categories. A fair number of the unknown events are thought to have been caused by electrical noise on the quench detector circuit.

Figure 1 – (a) Historical distribution of the failure modes for the BABAR superconducting magnet. The absolute number and relative percent of each failure mode is shown in the chart [5]; (b) Number of magnet interruption events per month between May 1999 and July 2004 of the BABAR experiment [5]

Figure 2 – Number and cause of magnet interruptions as a function of year for the BABAR experiment – significantly reduced after mitigations were implemented [5]

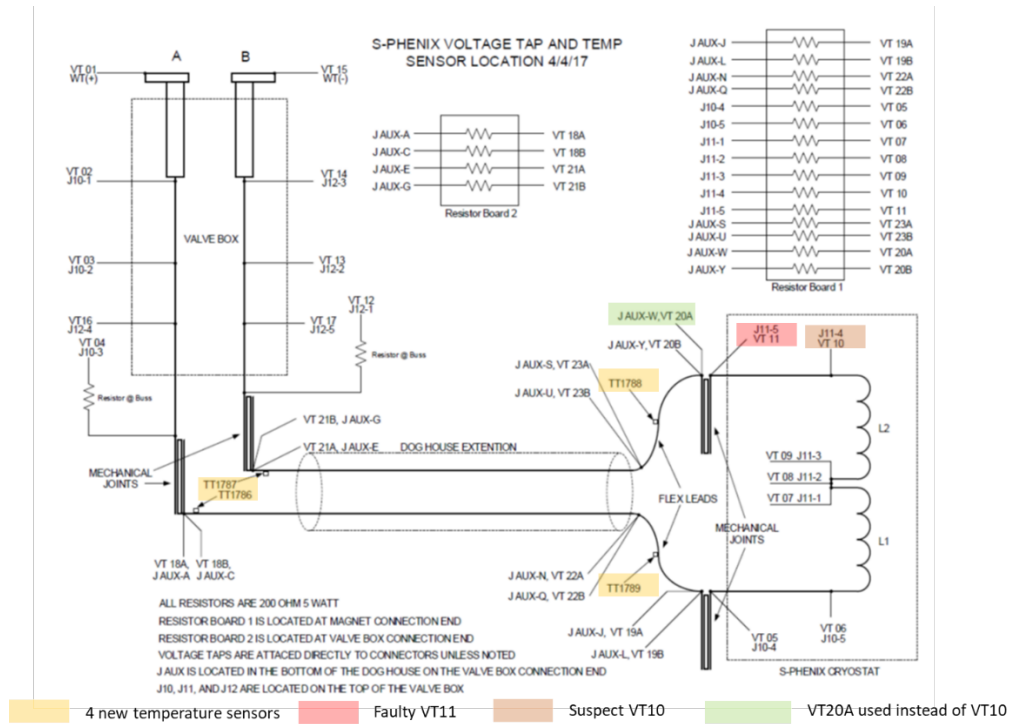
The high field test [7] was carried out after installation of a return flux steel box enclosing the superconducting magnet. Four new temperature sensors were added to the flexible portion of the magnet's current leads (superconducting bus bars) and at the bottom of the fixed portion of the current leads (superconducting bus bars). However, during testing it was determined that the boards the sensors were mounted to, were not in good thermal contact with the superconducting bus bars and therefore read higher than they should have. Before the cool down started, VT11 was found to be open-circuit. VT11 is one of the VTs connected to one end of the magnet – it was ignored and VT10 was used instead; VT10 is closer to the magnet coil winding.

Figure 3 – Locations of existing voltage taps and 4 new temperature sensors added for the full field test [7]

The magnet was ramped in stages: 10 A, 75 A, 500 A, 1000 A, 2000 A and nearly made it to 4040 A but then underwent a fast discharge due to VT10 becoming open circuit for a brief period of time. VT10 recovered shortly thereafter. VT9 and VT20A were subsequently used for quench detection/protection.

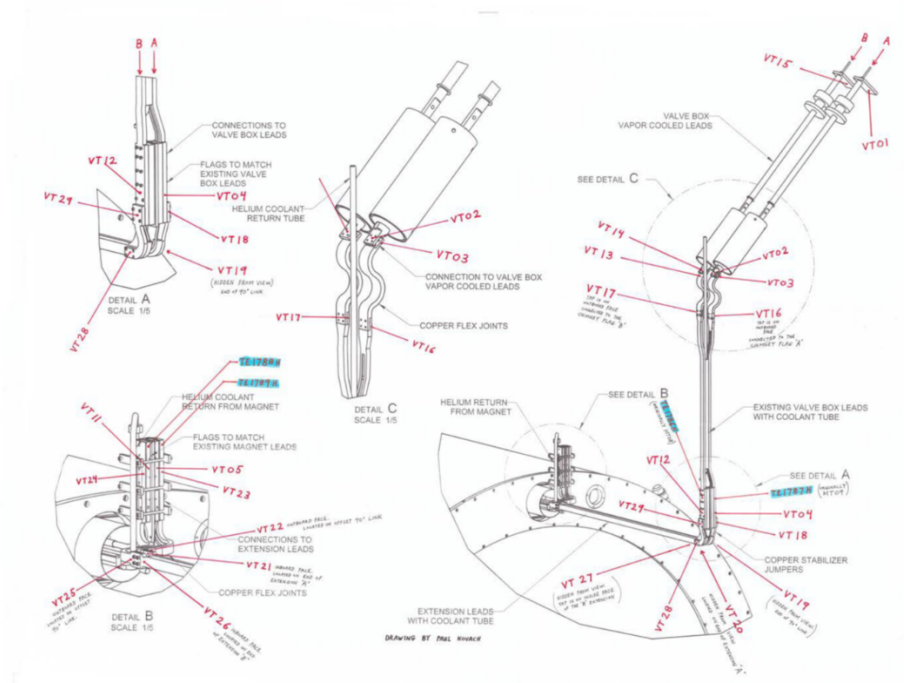
Figure 4 – Physical locations of existing voltage taps [8]

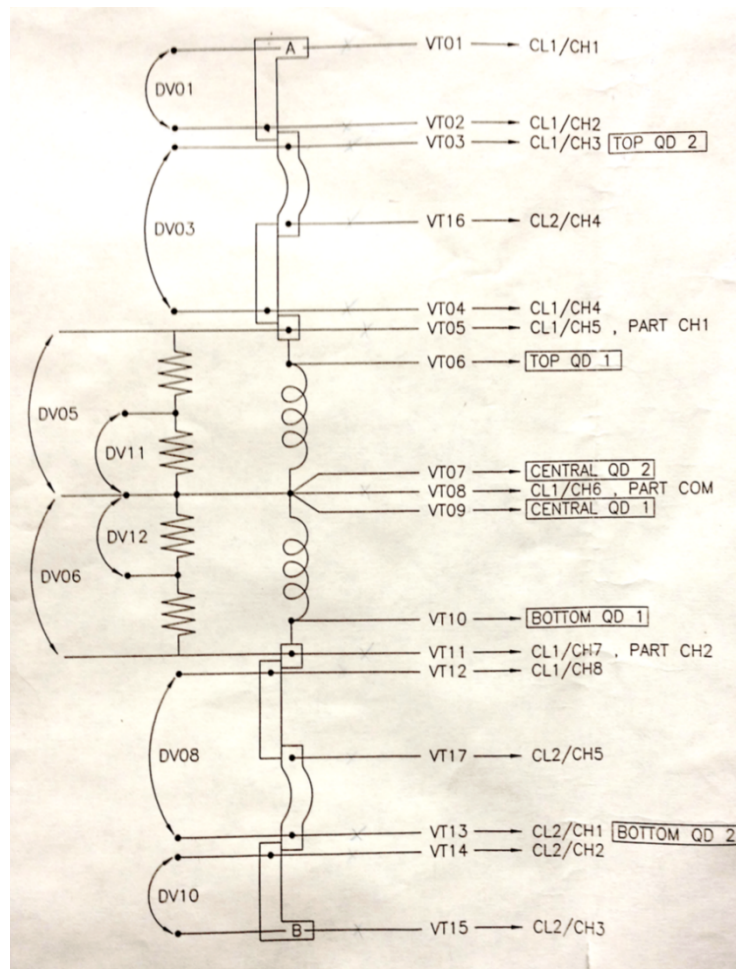
Figure 3 – The magnet itself is equipped with 17 voltage taps which, in pairs, measure the voltages of the inner and outer layers, the total magnet voltage, and sections of the leads. At some locations there are multiple taps for redundancy. [6]

- Recommendation: None
- ➔ At least one critical voltage tap has been lost and another one considered suspect. They have therefore been eliminated from the quench detection and protection system. There is a high likelihood that additional voltage taps could be lost or could malfunction in the future.

- Recommendations: Fit additional voltage taps and check all the others. This requires disassembly of the magnet, and unfortunately this could introduce another risk to the magnet, that of causing damage to the conductor or insulation during the soldering and fitting of new voltage taps. So this remedial action should be carefully planned before execution.

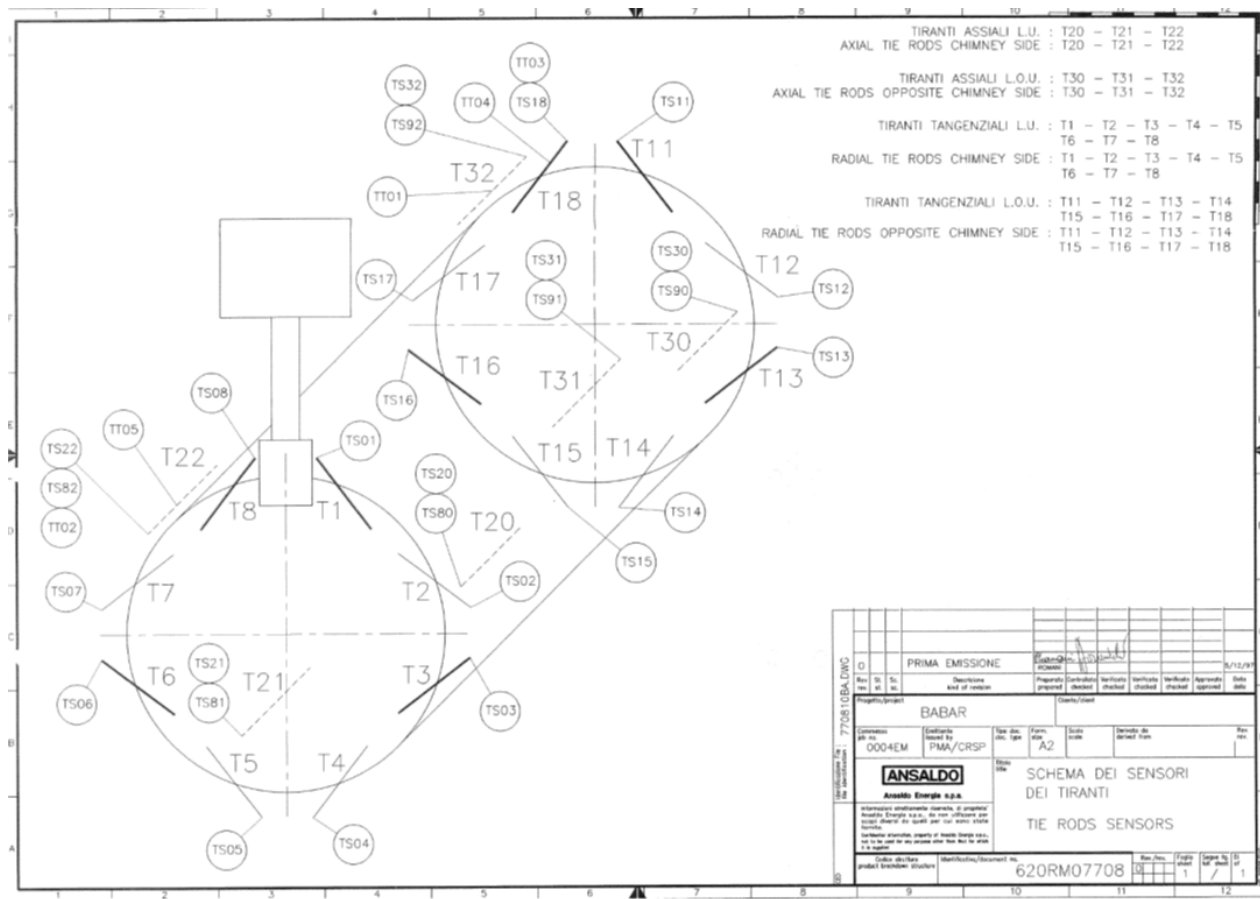
Figure 4 – There are 26 active strain gauges and 3 passive gauges for temperature compensation mounted at various locations within the magnet. [6]

- ➔ It is unlikely that the tie rods have been stressed beyond their elastic limit. However, the condition of the tie rods and spring washers remains as an unknown and therefore could pose some risk of damage for future operation.
- ➔ Several strain gauges (5) have been lost and at least one indicates a high reading and is subsequently ignored during magnet operation.
  - Recommendation: Fit new strain gauges. This will require disassembly of the magnet.
- ➔ There is also a question of whether any of these mechanical components have been overstressed during the transport from SLAC to BNL. However, there is no outward evidence of any deterioration of the internal mechanical support system at present.
