Ladder Production at BNL

Status

Milan Stojanovic, Rachid Nouicer

PB2-L003 South

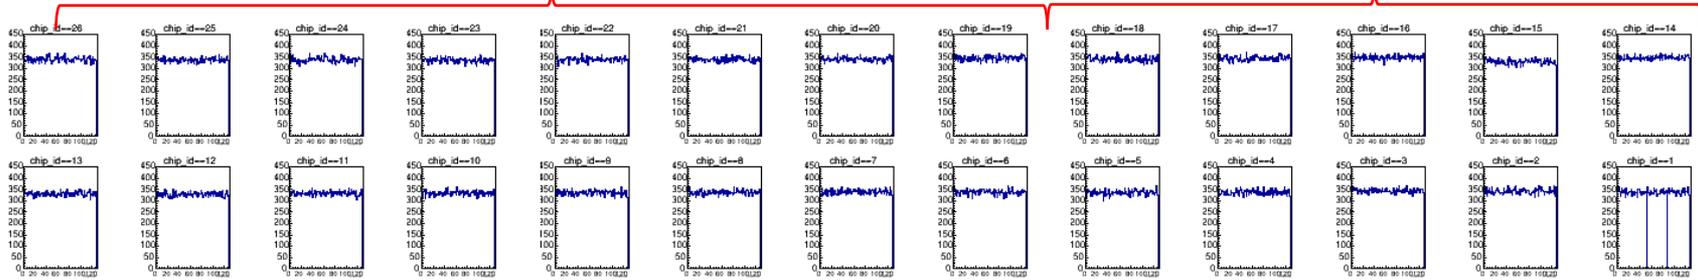
HDIs-Chips-Sensors

Acurrent = 160 nA

Bcurrent = 25 μ A

<-- very high!

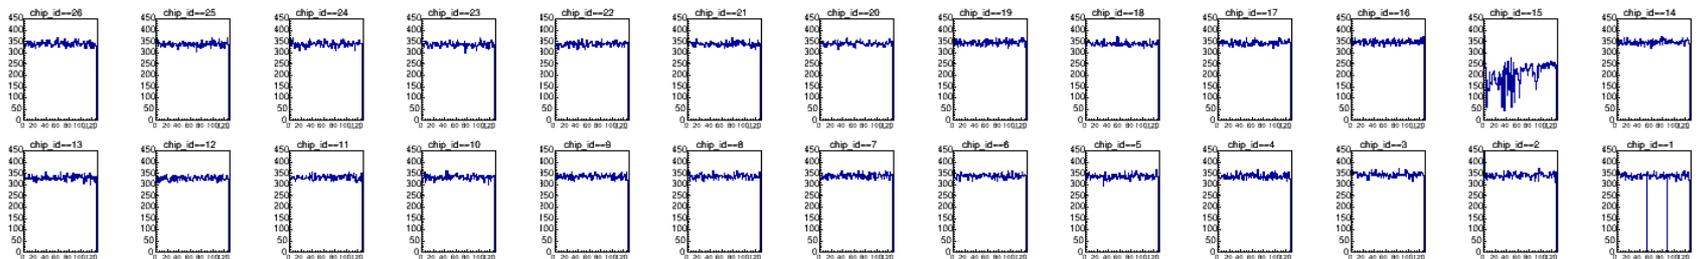
Encapsulation

Acurrent = 160 nA

Bcurrent = 23 μ A

<-- very high!
