Ladder from Taiwan

Test & Inspection

Rachid Nouicer, Milan Stojanovic

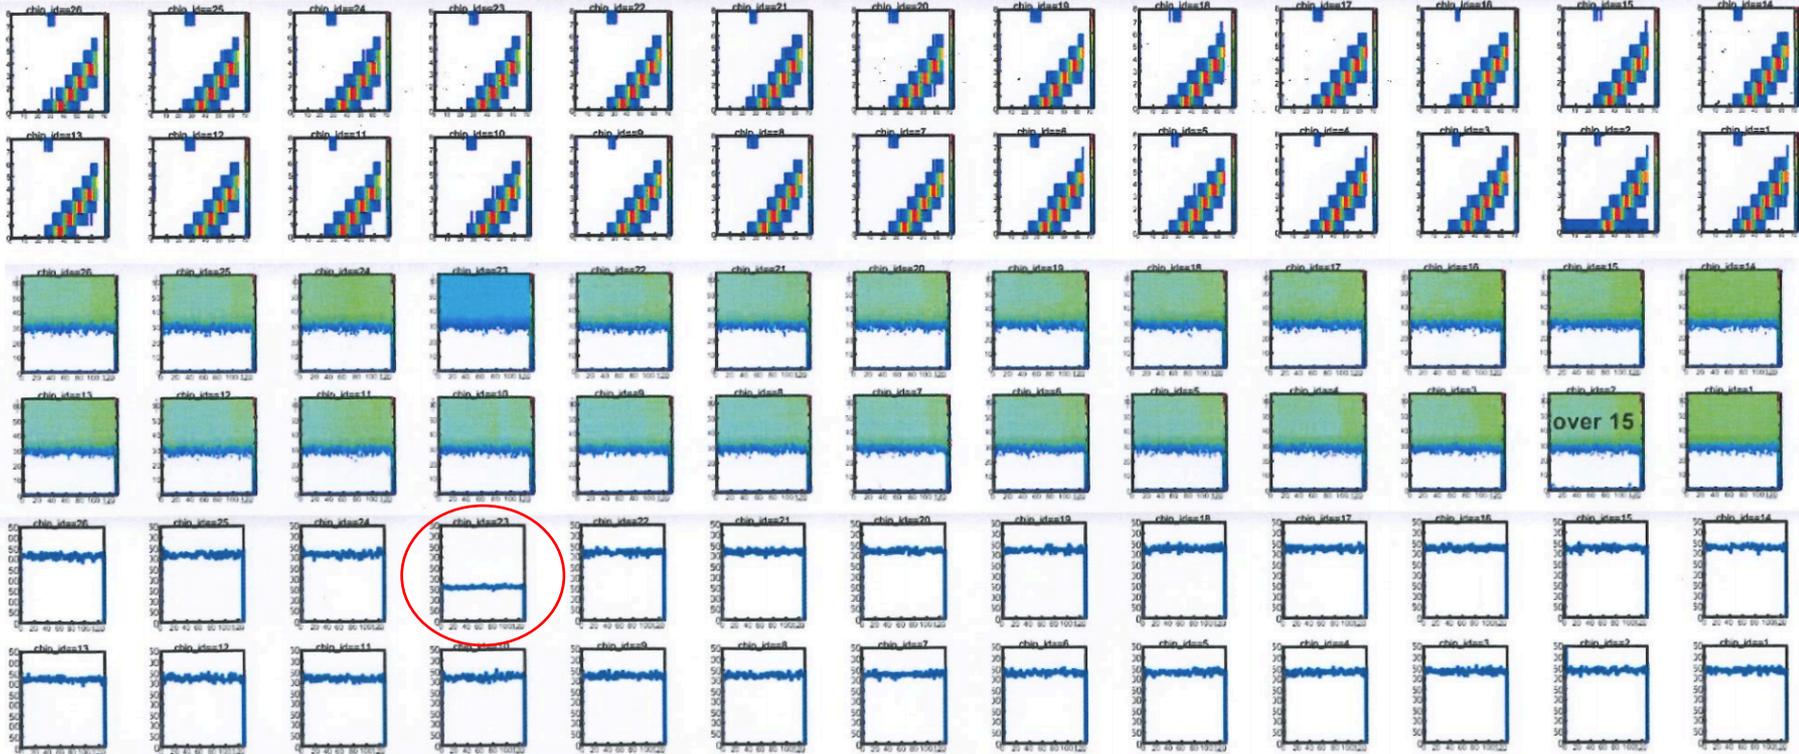
South Side (Module 51) / Bias = 100V at Taiwan

Chip voltage: 3.6V, Chip current: 0.515A
Bias voltage: 100V, Bias current: 0.4 μ A

We observed one chip with half entries, U23

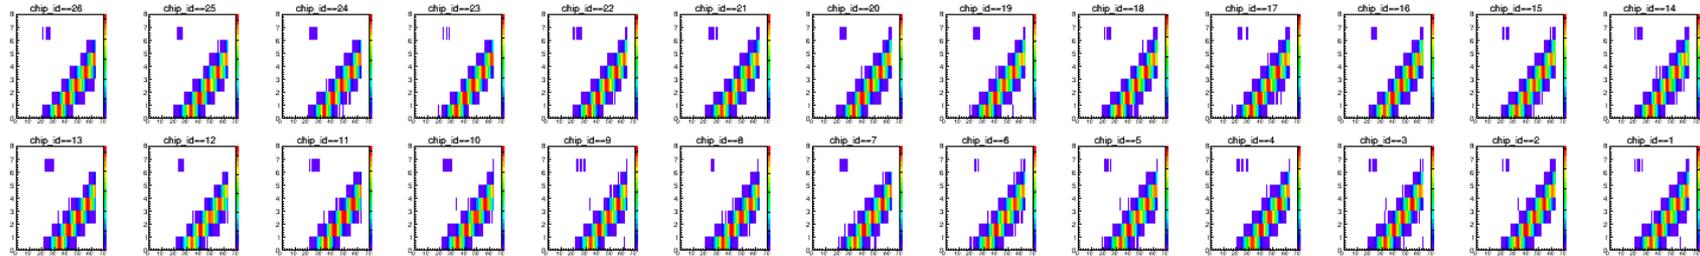
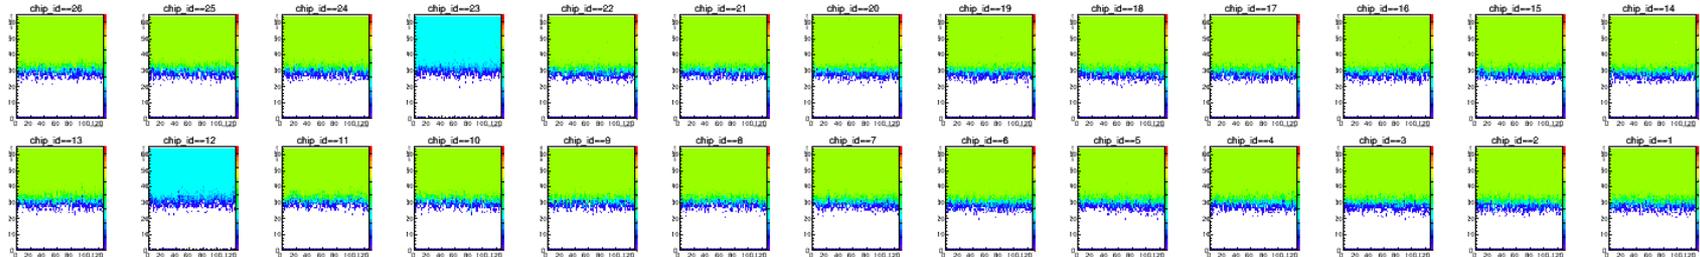
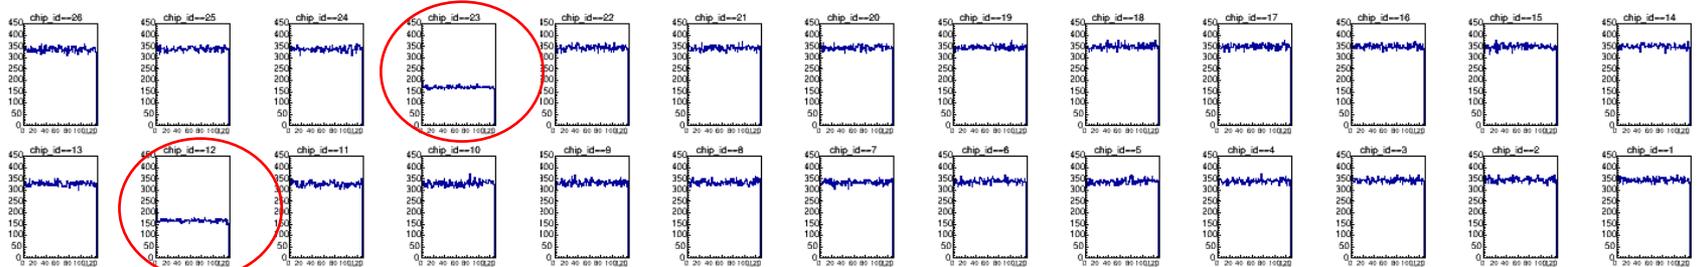
South Side (Module 51) / Bias = 100V at BNL

We observed two chips with half entries, U23 & U12

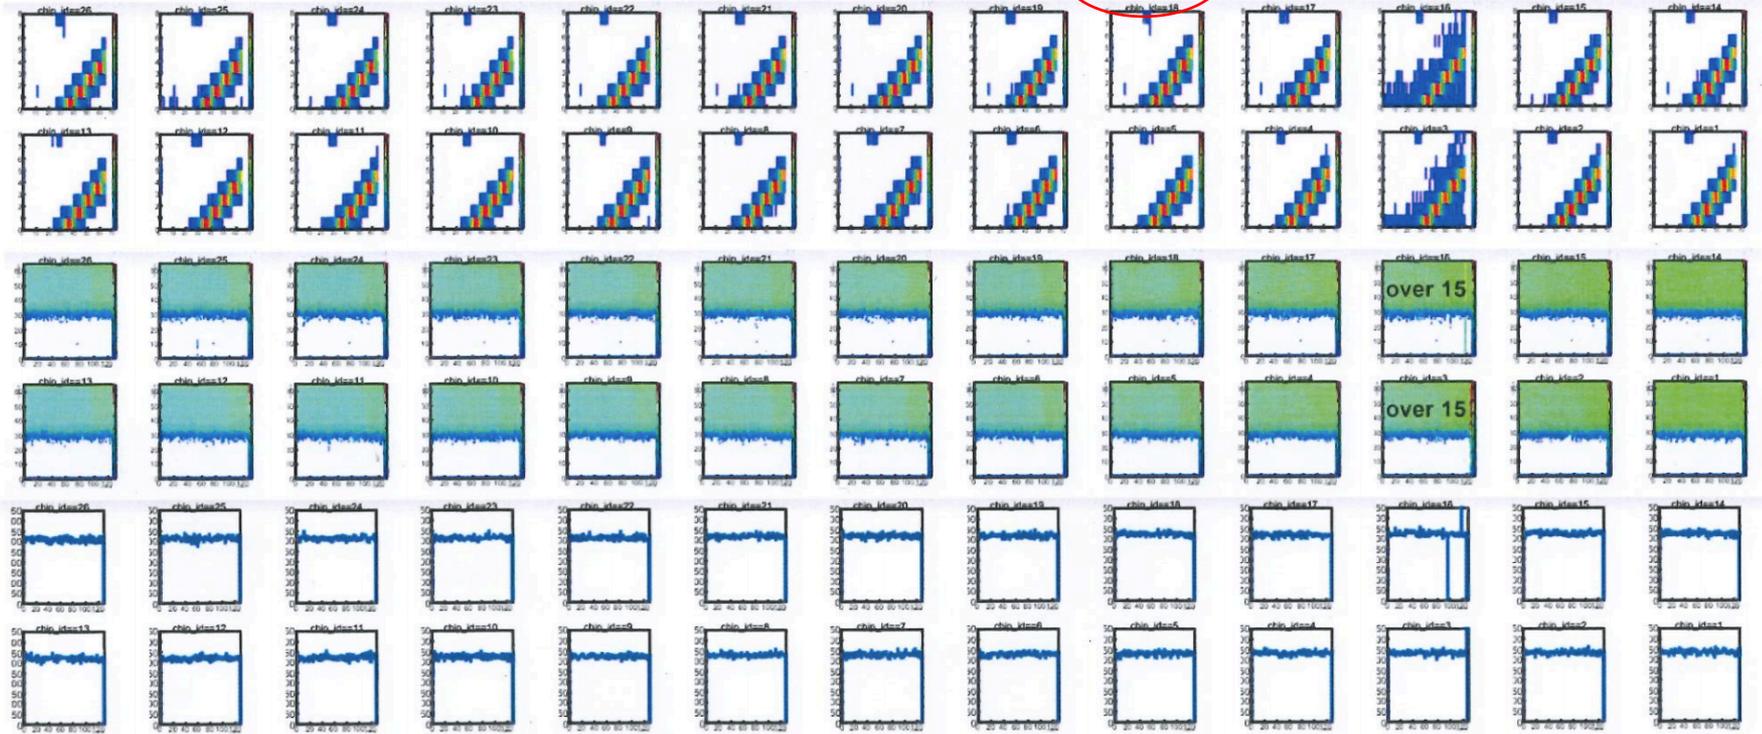
North Side (Module 264) / Bias = 100V at Taiwan

Chip voltage: 3.6V, Chip current: 0.519A
Bias voltage: 100V, Bias current: $2.4\mu\text{A}$

Sensor B has a high current

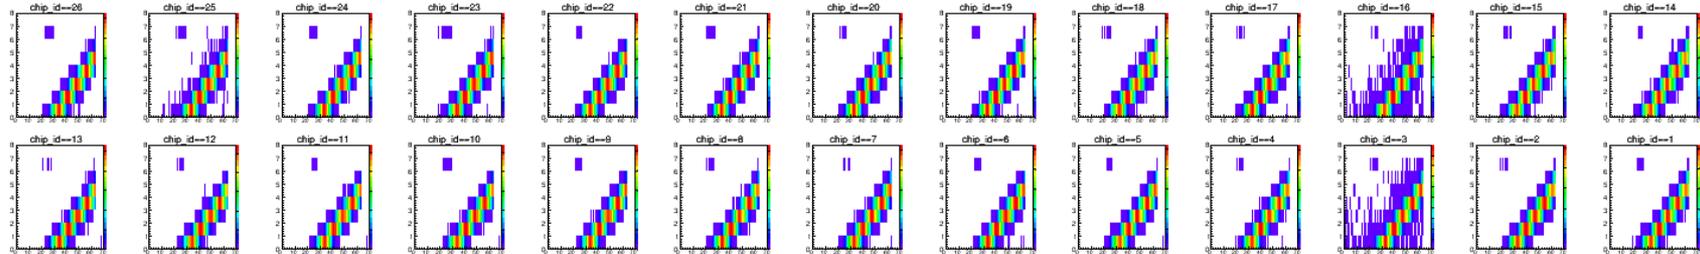
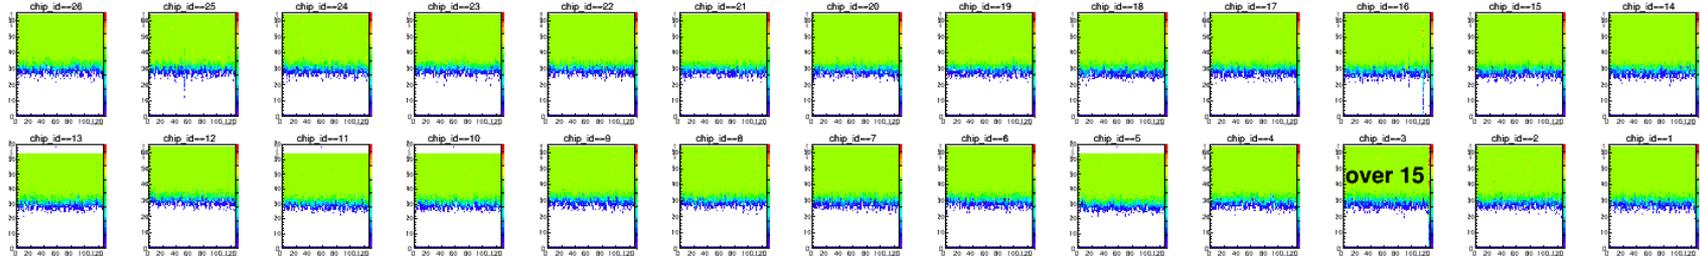
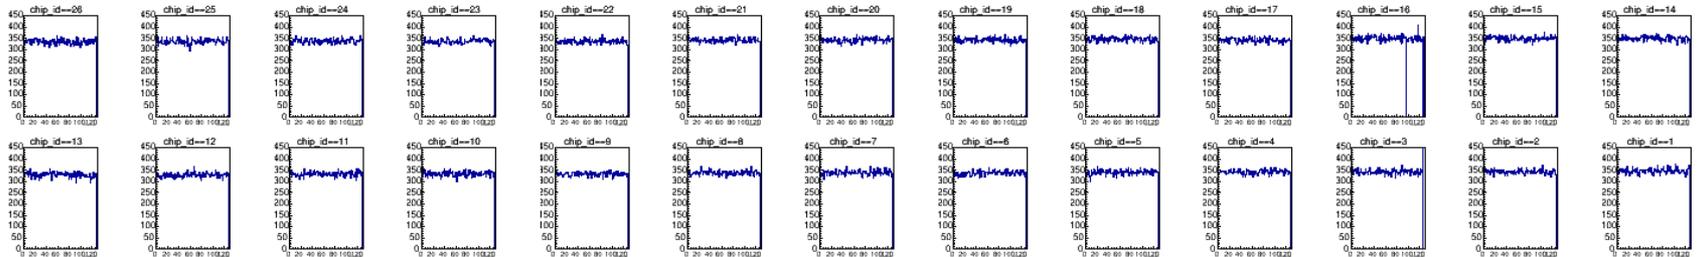
North Side (Module 264) / Bias = 100V at BNL

Current B = 2.3 μ A

Similar high current has been observed at BNL for sensor B

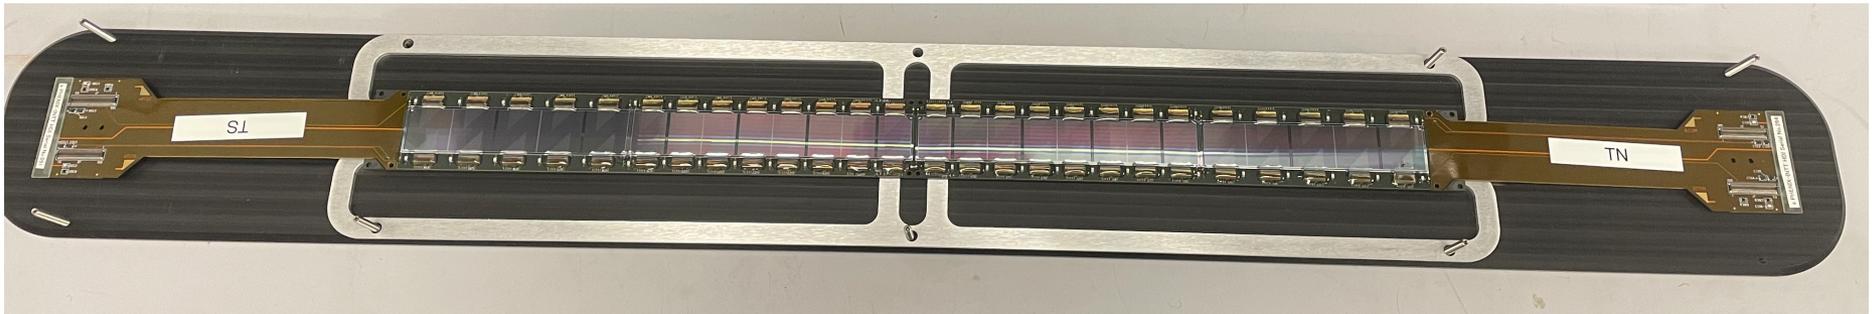
- The ladder safely arrived at BNL
- One new chip has half entries, possibly because of the transportation damage

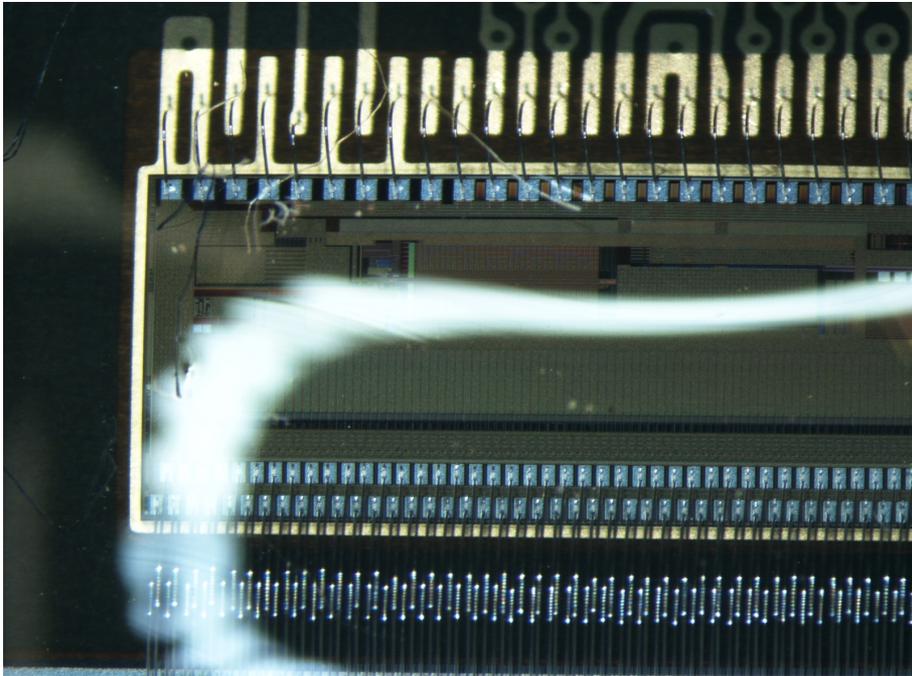
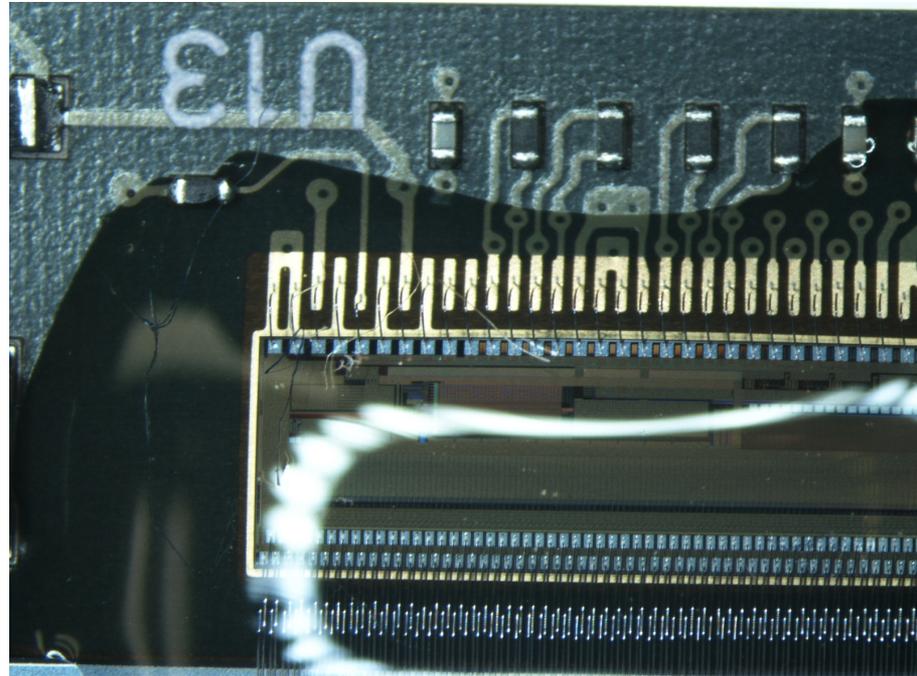
- Lot of fibers observed on the chips

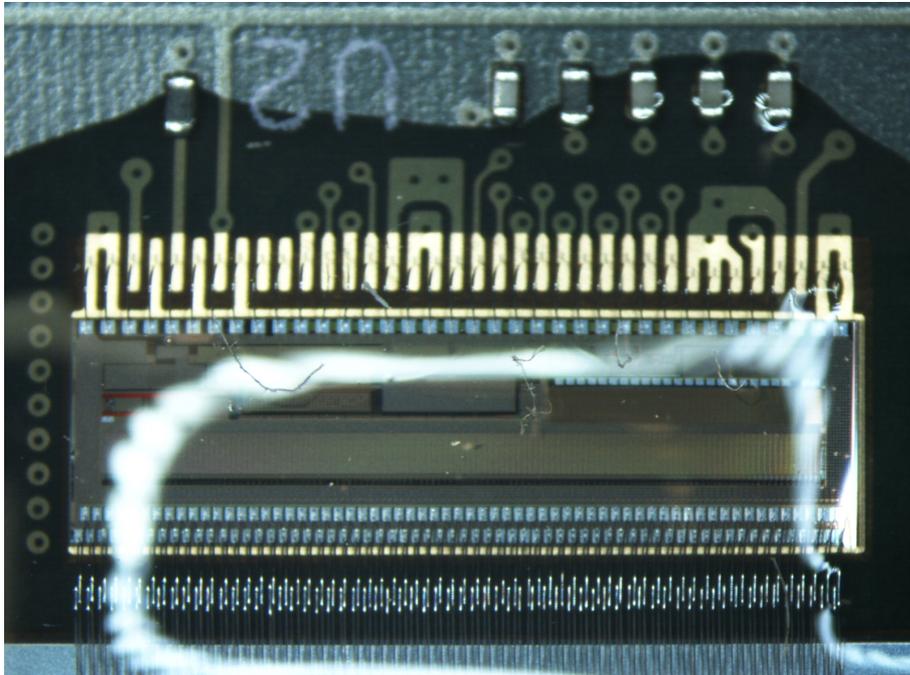
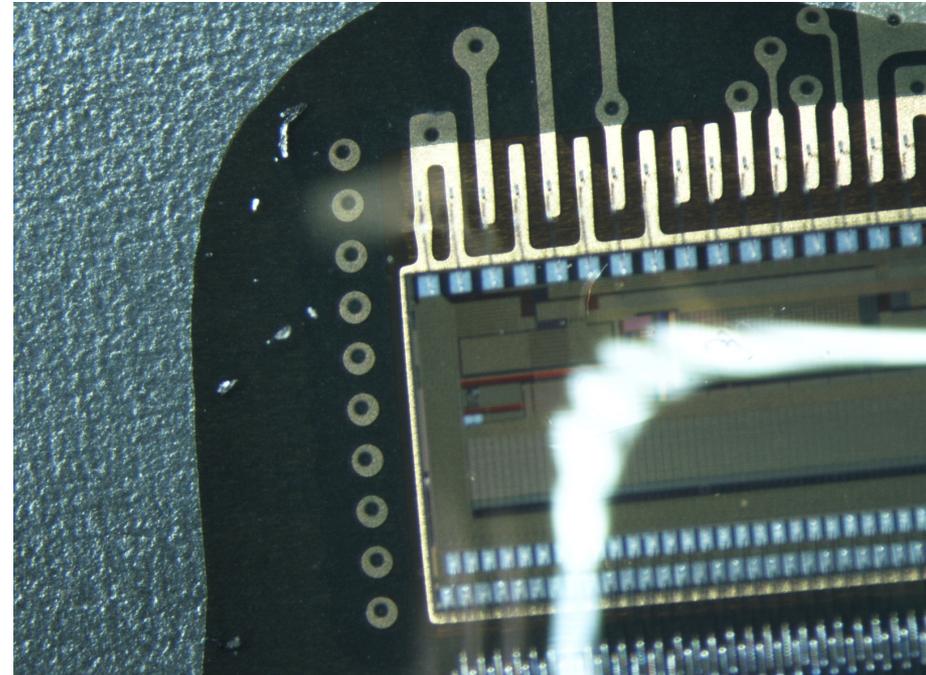
- Lot of fibers observed on the chips

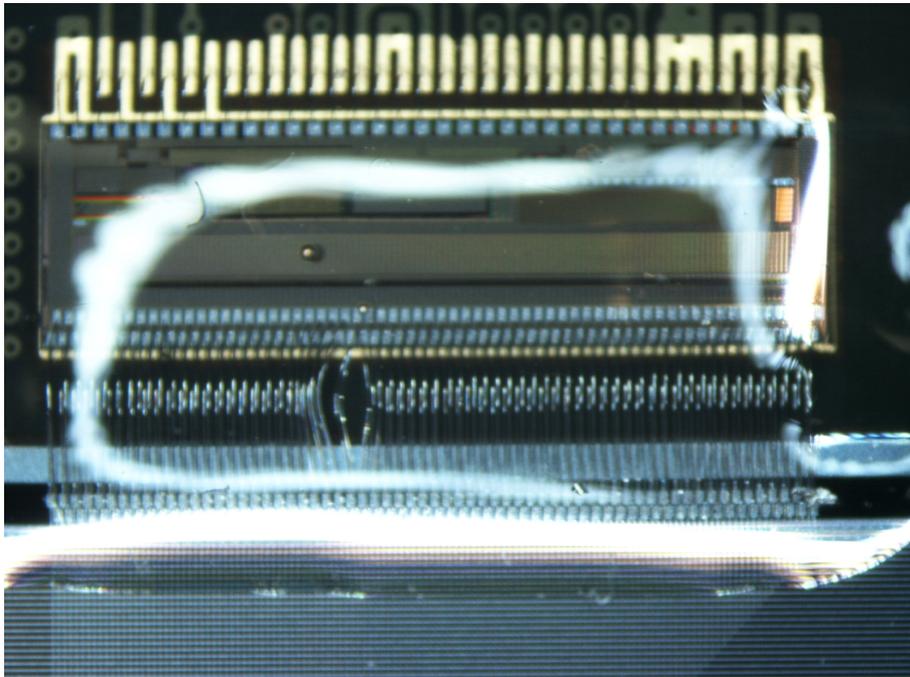
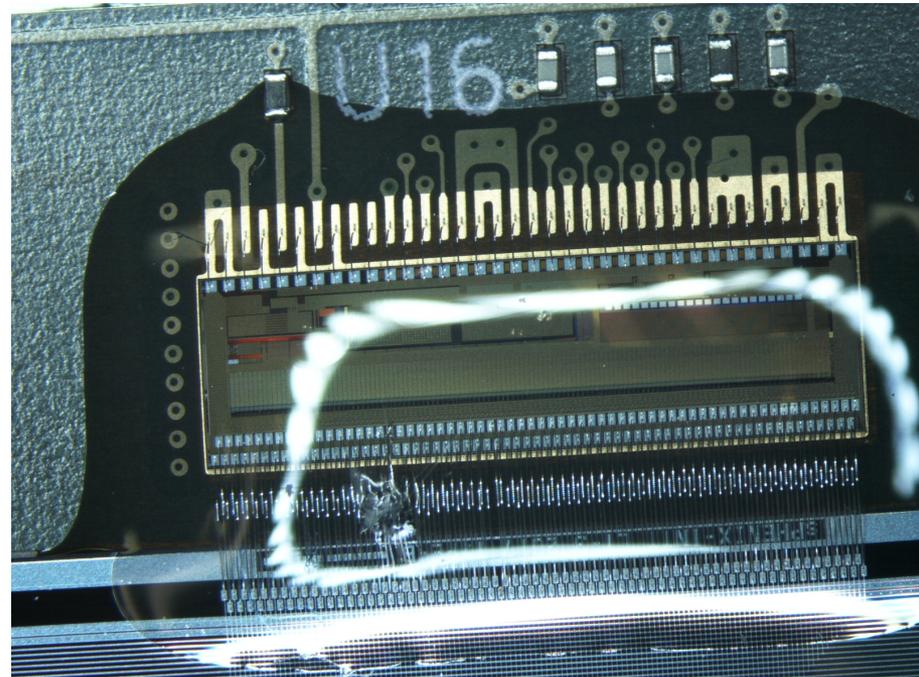
- Wire bonding can be improved

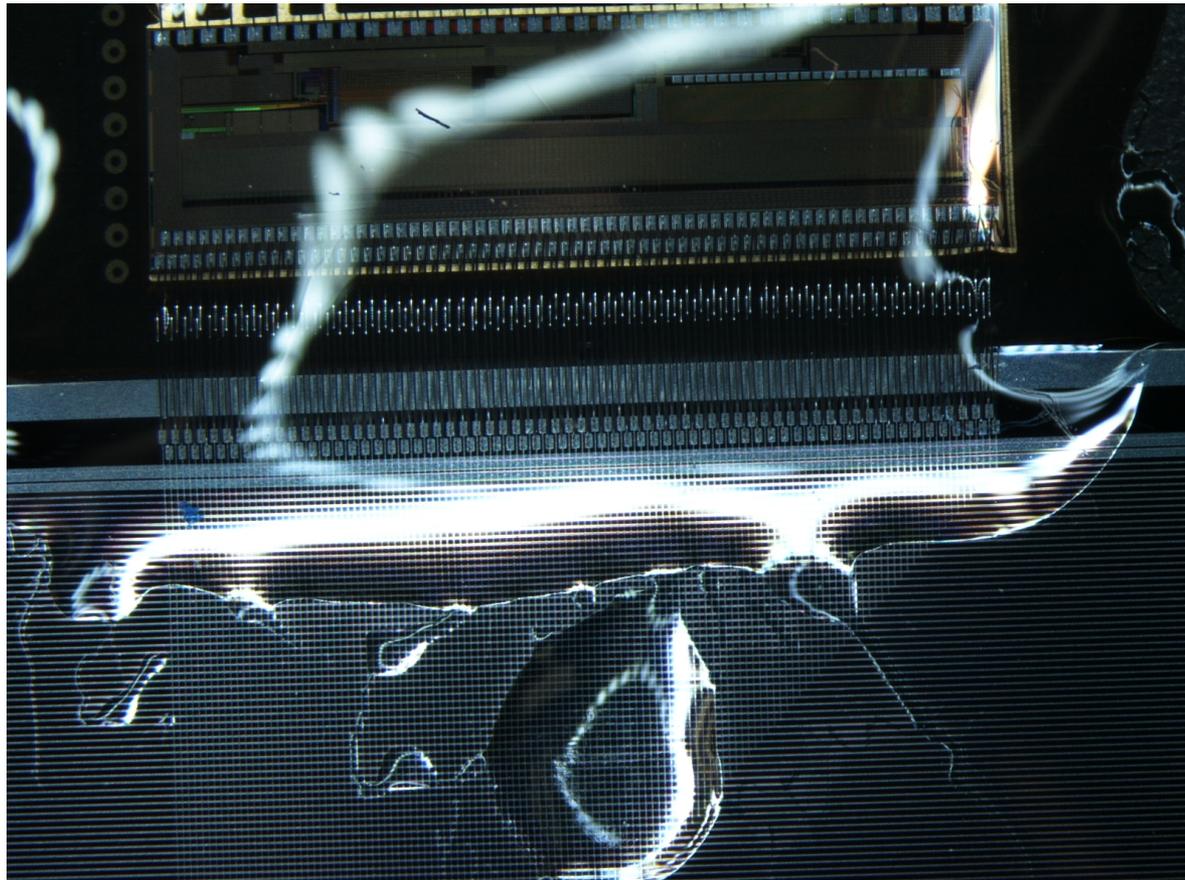
- Encapsulation on the sensor → needs improvement,
- concern: it seems that height of encapsulation is bigger than 1.2 mm

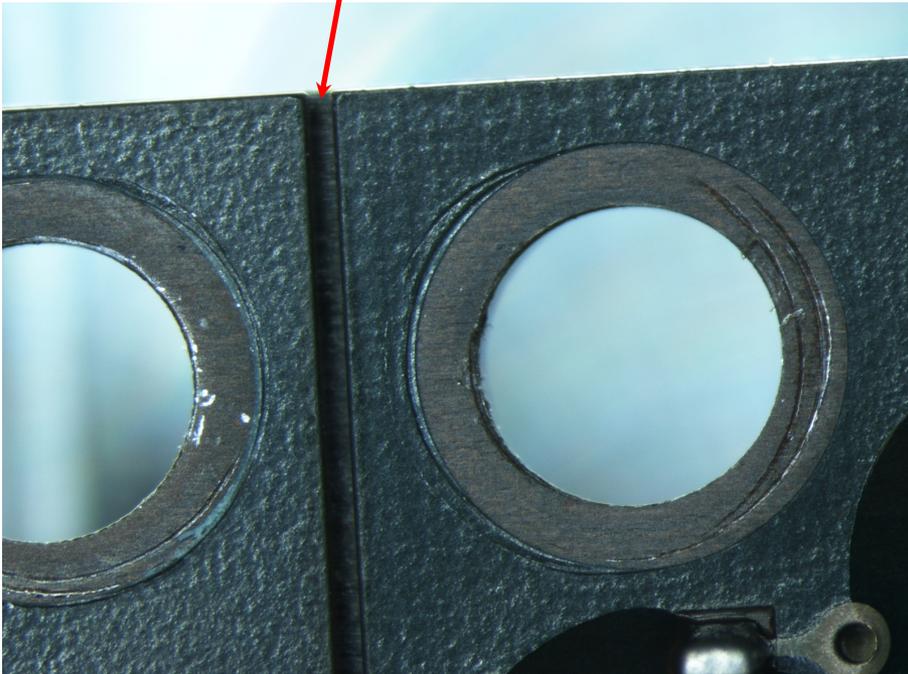
Taiwan Ladder

➤ Gluing issue: Big concern!

- We didn't observe the glue between the two adjacent HDIs nor between the HDIs and the stove
 - This implies the ladder will run hotter than BNL ladder
