HDI Thruhole Discussion with Yamashita co.

RIKEN/RBRC
Itaru Nakagawa

Hideto Enyo, Yasyuki Akiba, IN visited Yamashita co. on May 13th

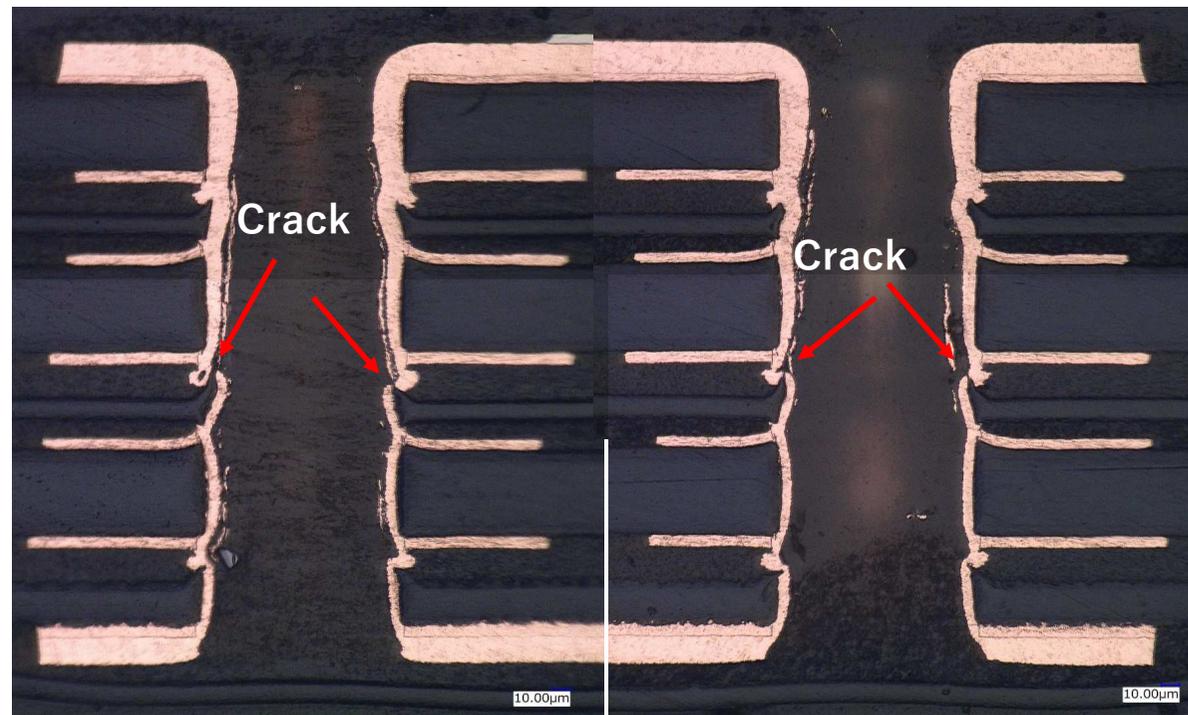
Module-70 Thruhole

- The first HDI inspected thruhole XS
- Cracks in the middle
- Disabled this and next LOT.

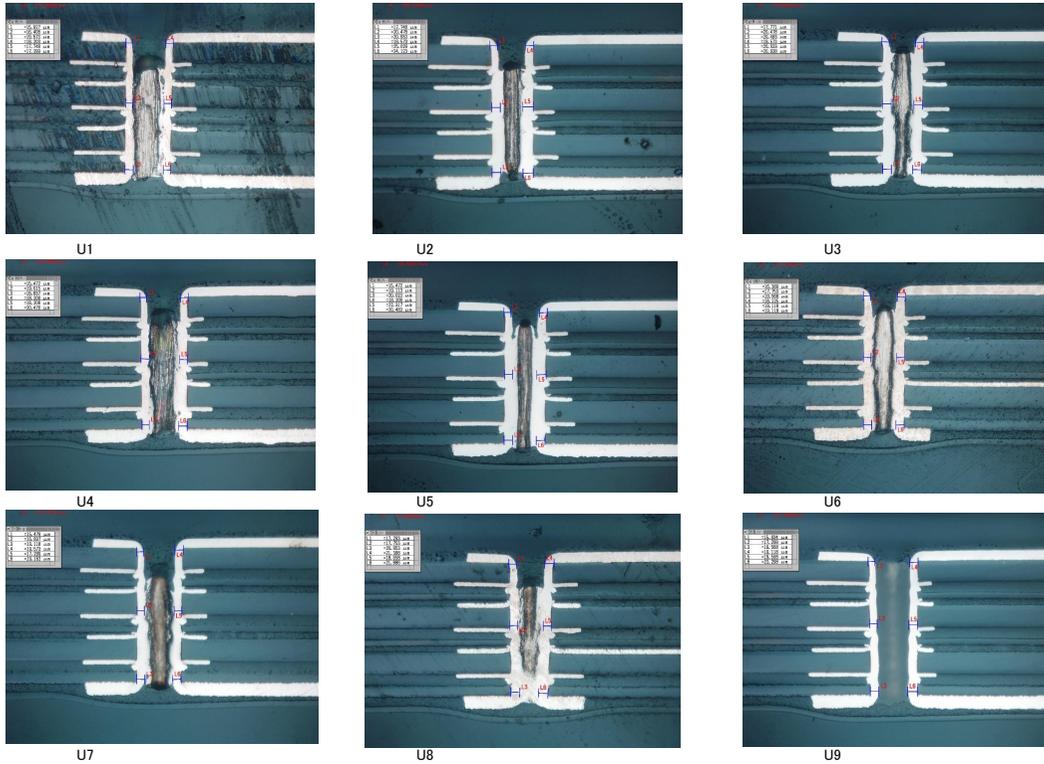
Serial Number 50 Thruhole Inspection

- Report from Yamashita on April 29, 2021.
- 1 thruhole per chip sampling XS inspection showed all OK.

All OK.

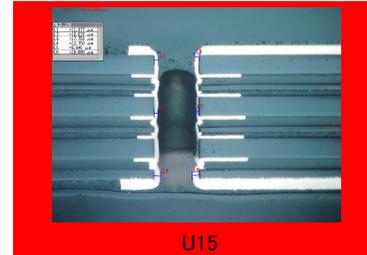
Serial Number 127 (LOT#311615)

Found one bad thruhole

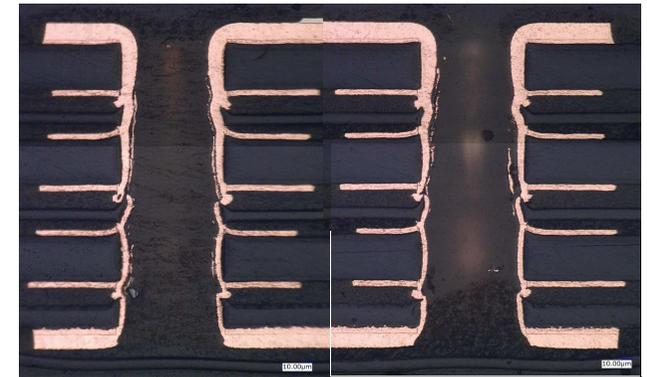
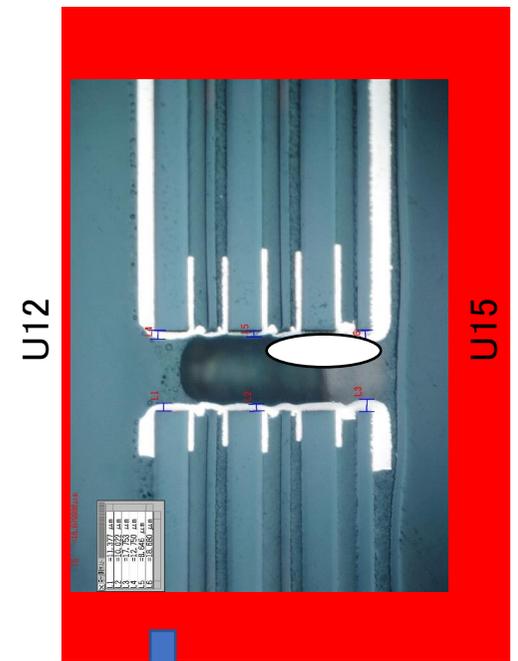
- Low quality drilling process.
- Residual etching liquid in multiple soft etching process made the copper plating thinner.
- Left over bubble in the thruhole prevented the copper plating on the upper part of the thruhole.
- Often the case the trouble is caused by the tight aspect ratio (100 μm diameter vs. 450 μm depth.)

Dipping to etching liquid

- Low quality drilling process.
 - Review drilling parameters and optimize again.
- Residual etching liquid in multiple soft etching process made the copper plating thinner.
 - Consider coating surface for easier exhale of etching liquid from a thruhole.
- Left over bubble in the thruhole prevented the copper plating on the upper part of the thruhole.
 - Likely some bubble is generated by swirl of etching liquid in the plating tank. Try to use alternative production line which is considered to be relatively rather swirl free.
- Often the case the trouble is caused by the tight aspect ratio (100 μ m diameter vs. 450 μ m depth.)
 - There is no way to improve this rather than changing the design. This is not the intrinsic solution though, try to apply 30~60% thicker copper plating in increase the survival rate.
