Cooling Outage in CDCE on 6/29/21

Imran Latif, P.E.

July 2nd, 2021

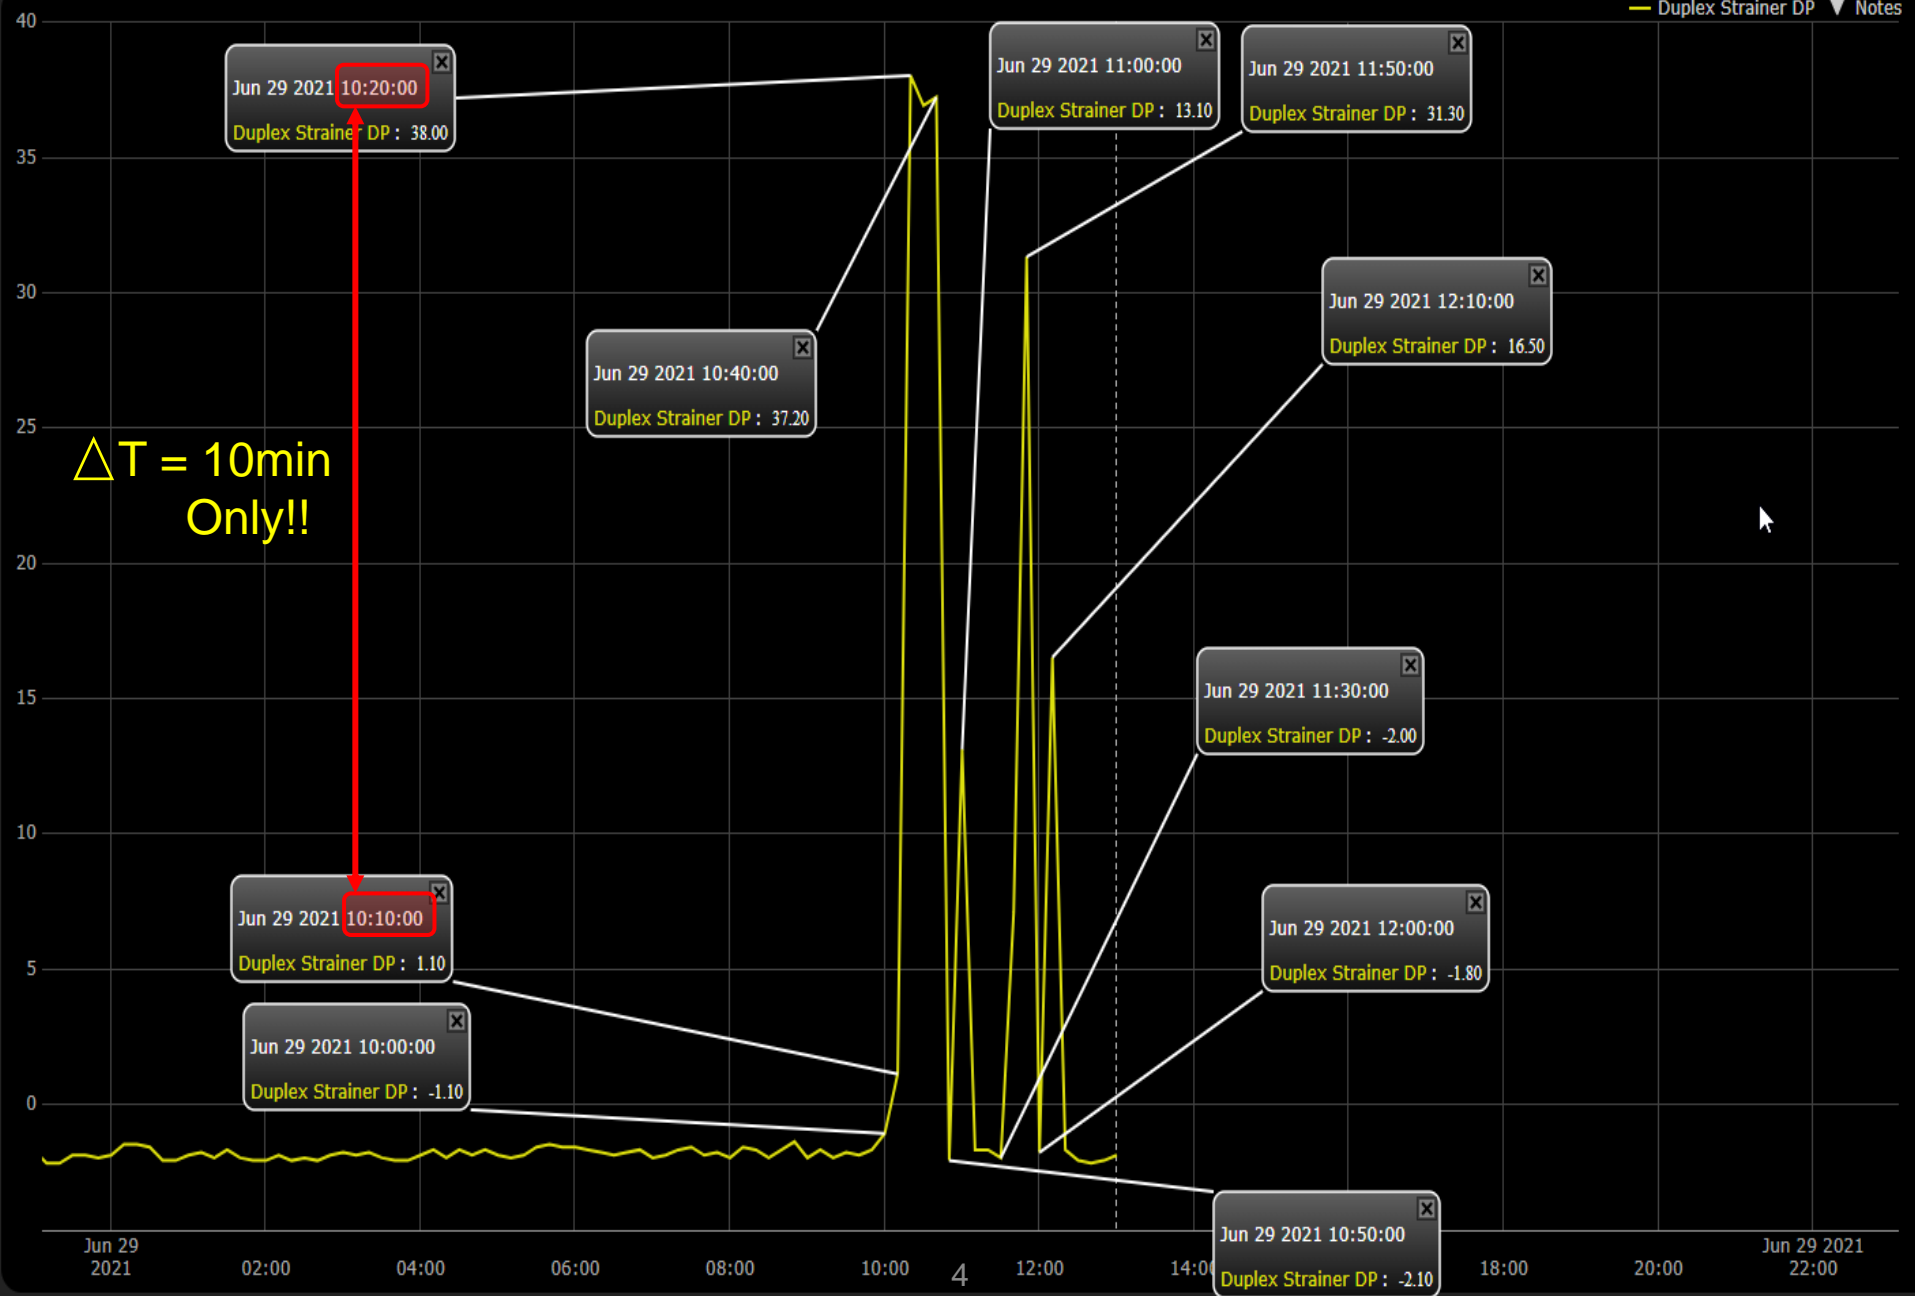
- The primary strainer basket in duplex chilled water strainer system in CDCE got clogged instantly despite getting cleaned frequently.
- This resulted in loss of chilled water flow to Computer Room Air Handling (CRAH) units in CDCE subsequently the space temp in CDCE rose and forced the automated power shutdown on compute nodes
- Data Center Ops team, contacted F&O as the dp reached 2 psi. The F&O AC tech responded within 15 min.
- The mineral deposit in the chilled water stream deposited on the inner strainer mesh within 10 min resulting in no chilled supply to the cooling units in CDCE.
- The strainer baskets with finer mesh were cleaned multiple times but the issue persisted.

- While the finer mesh strainer was getting clogged after cleaned again, the executive decision was taken and the primary strainer basket was replaced with the coarser strainer mesh to allow finer mineral sediments to pass through the system instead of getting deposited on the inner basket surface and blocking the chilled water flow to the cooling units in CDCE.
- The AC techs were deployed during the day on 6/29 and three CRAH units were repaired to boost up cooling reliability in CDCE room
- Two AC techs were scheduled on OT on 6/29 coupled with the site shift team and following work was done till 8am on 6/30,
 - Cleaning of branch chilled water strainer in individual CRAH units
 - Cleaning of the duplex strainer system feeding CDCE
- Same actions were taken on 6/30
- The cooling issue has been resolved and the chilled water flow and pressure and normal in in steady state.

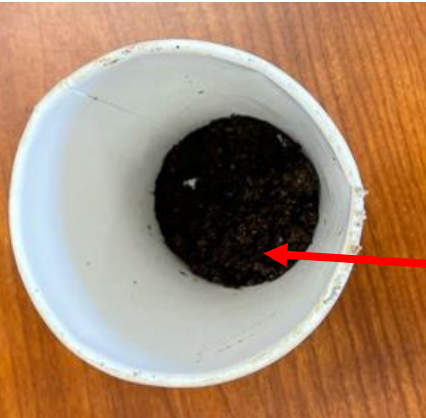
Sediments Collected in fine mesh strainer (now being secondary in the system)

- The sediments samples collected are being evaluated by BNL's geologist to know its composition
- The DP critical response alarm set has been reduced to 2psi through programming in building automation system
- BNL's AC shop and site shift will continue to monitor and periodically clean the coarser strainer
- The bottom chilled water piping tap feeding CDCE is still on course to be replaced by the side tap. The work will be performed in fall after approval from SDCC
- All corrective work performed will not be charged to SDCC

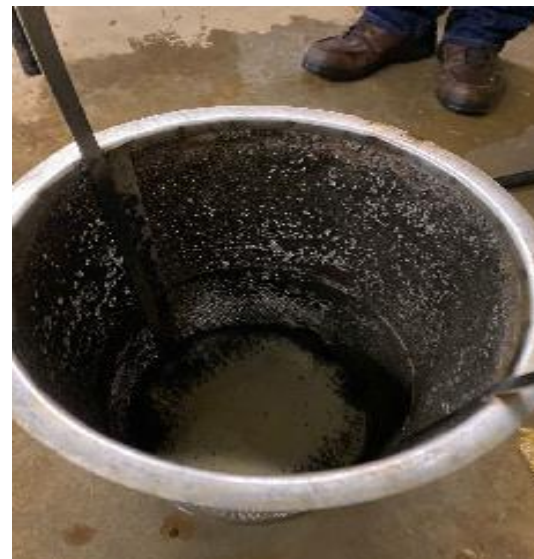
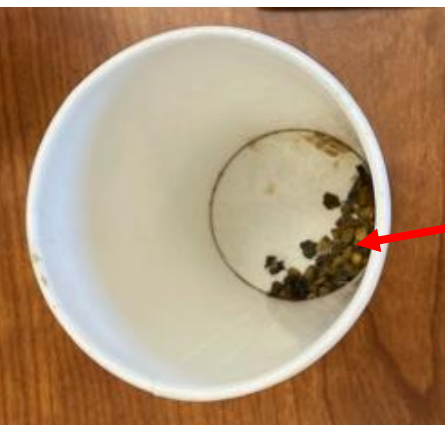
Sediments Collected in coarser strainer (now being primary in the system)
