Features of the s103 Evaporator

Ross Corliss March 18, 2022

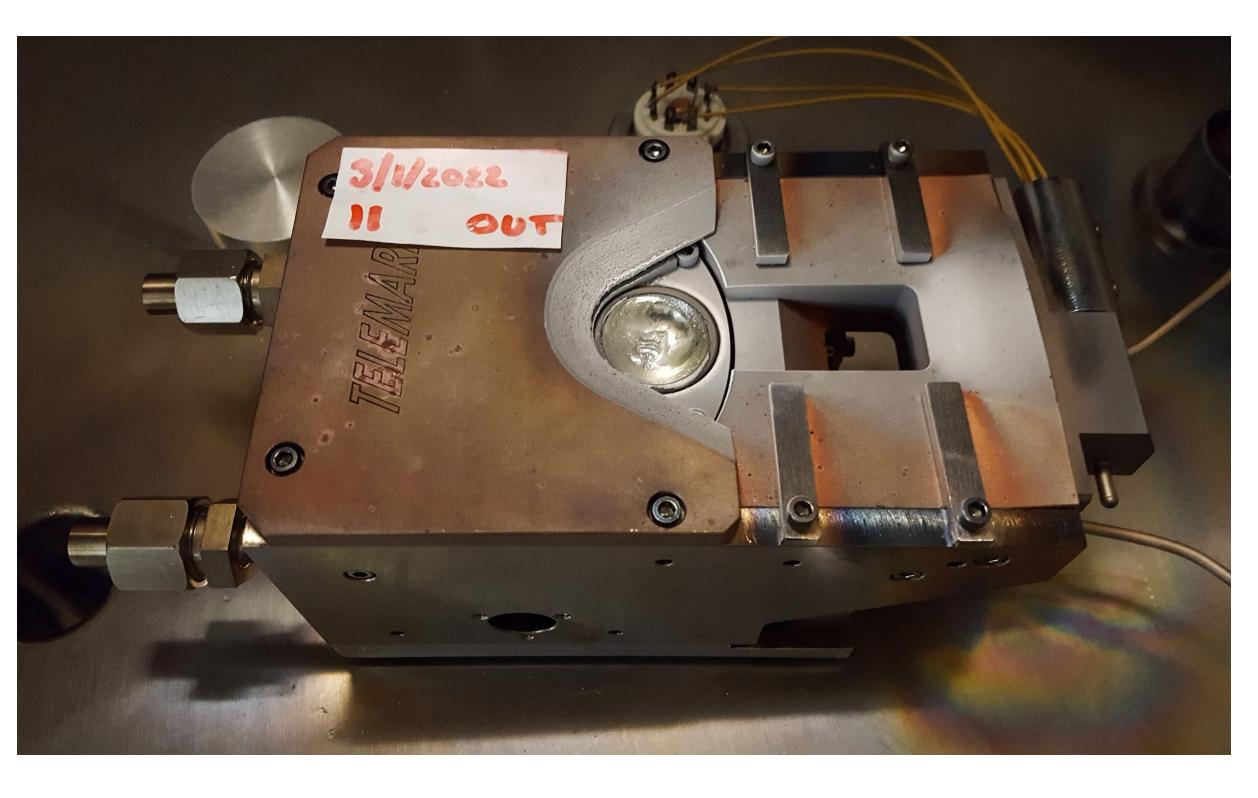
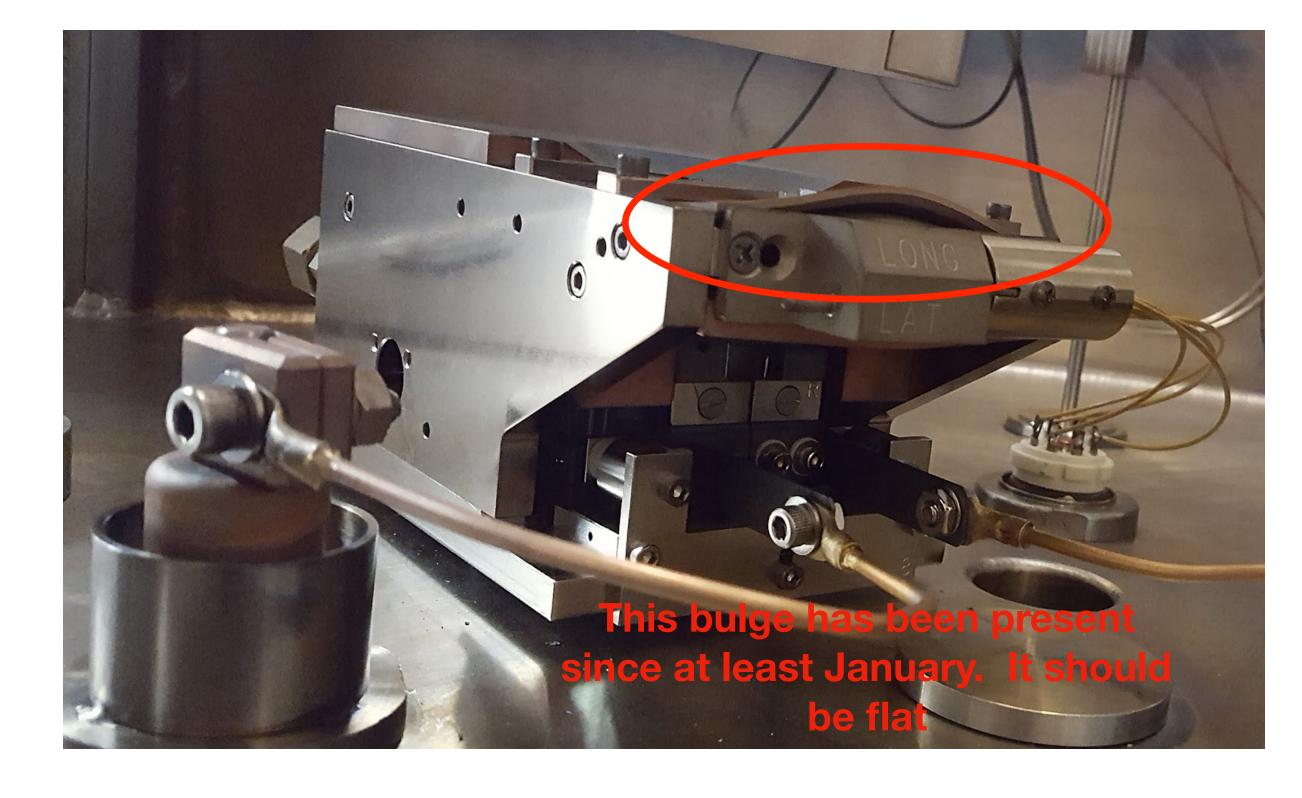
With Aluminum crucible:

From the end:

- Steering coils are now ~kOhm, instead of ~few Ohm as expected. The driver no longer drives the beam
- Likely this has been evolving since we repaired the wiring (late last year).

- The last evaporation had no steering. The result is we bored a deep hole in the Chromium, which affected the angular distribution ('spectral power') of the emitted material.
- We intend to manually steer by adjusting voltage, so that we do not bore deep holes

- We will repair once the CM petals are complete (partial list of tasks):
 - Add water cooling
 - Replace steering magnet
 - Repair top plate
 - Clean accumulated material on crucible carousel
 - Identify and repair helium cryo leak.

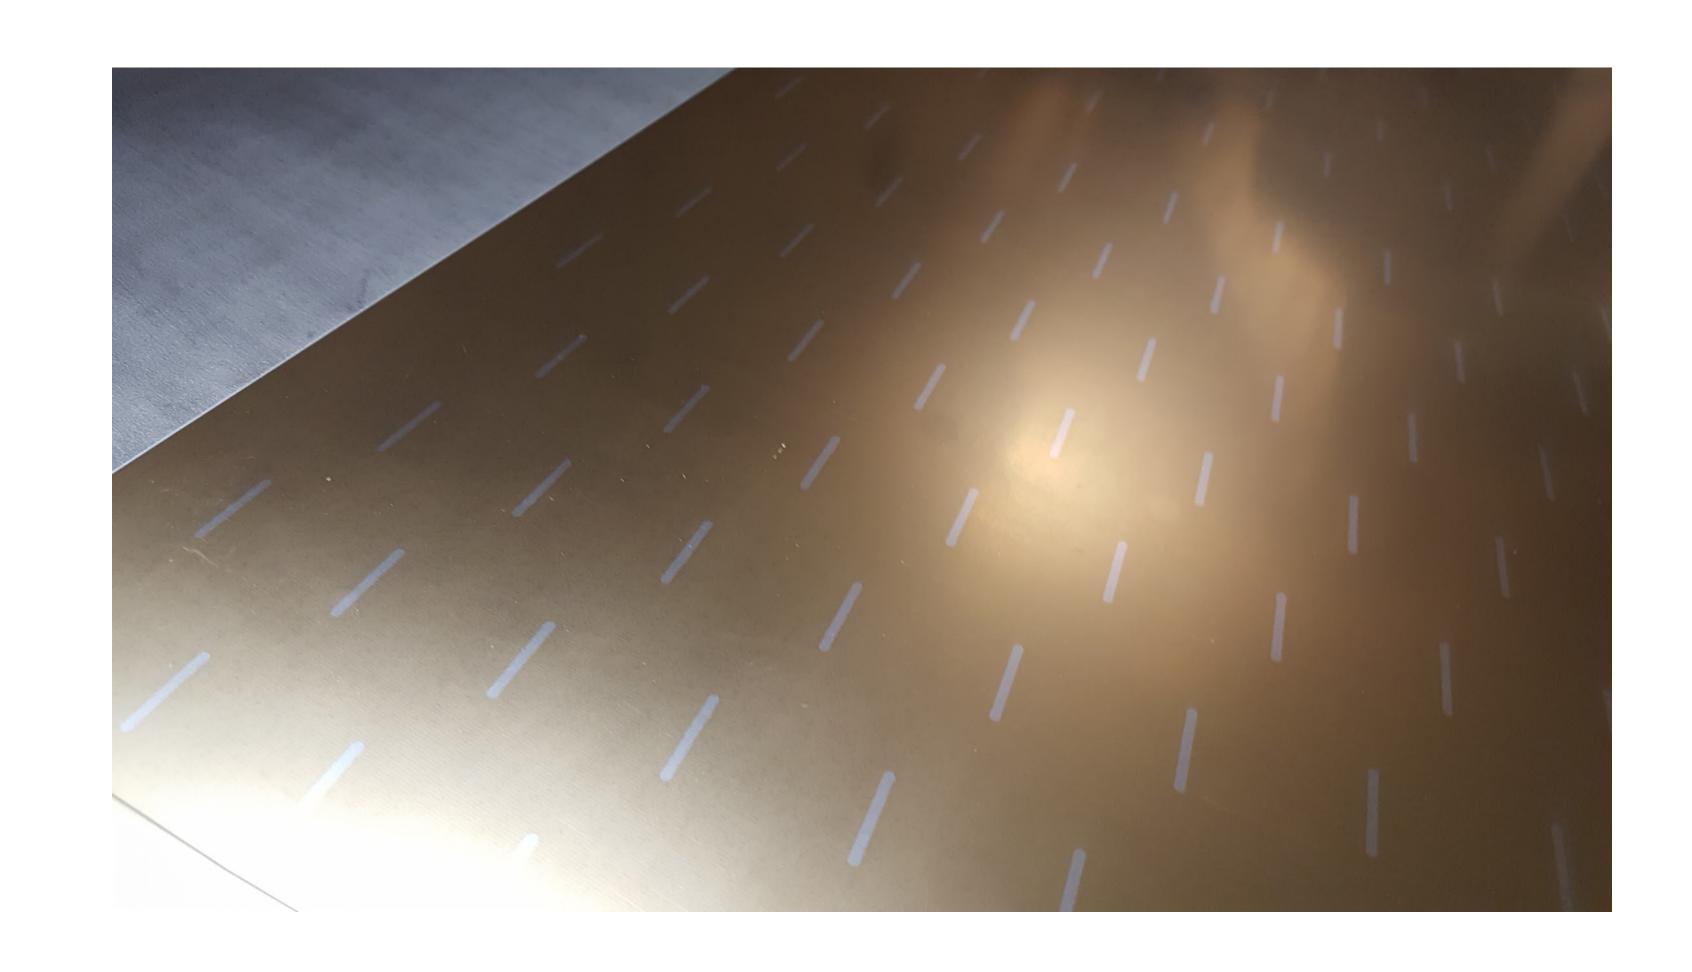
A Successful Petal

- Al is deposited atop Cr to help the Al adhere to the ENIG substrate, to form the 'test pattern' on the central membrane. 1/18 of one side of the membrane is one petal
- Good fill, sharp edges on each stripe is desired
- Al also coats the edges of each petal (<1mm) to ensure no insulator is exposed
