Solution for A1 Port Analogue Regulator Wrong Grounding

RIKEN/RBRC
Itaru Nakagawa

Input Voltage Anomaly for A1 Analogue Regulator

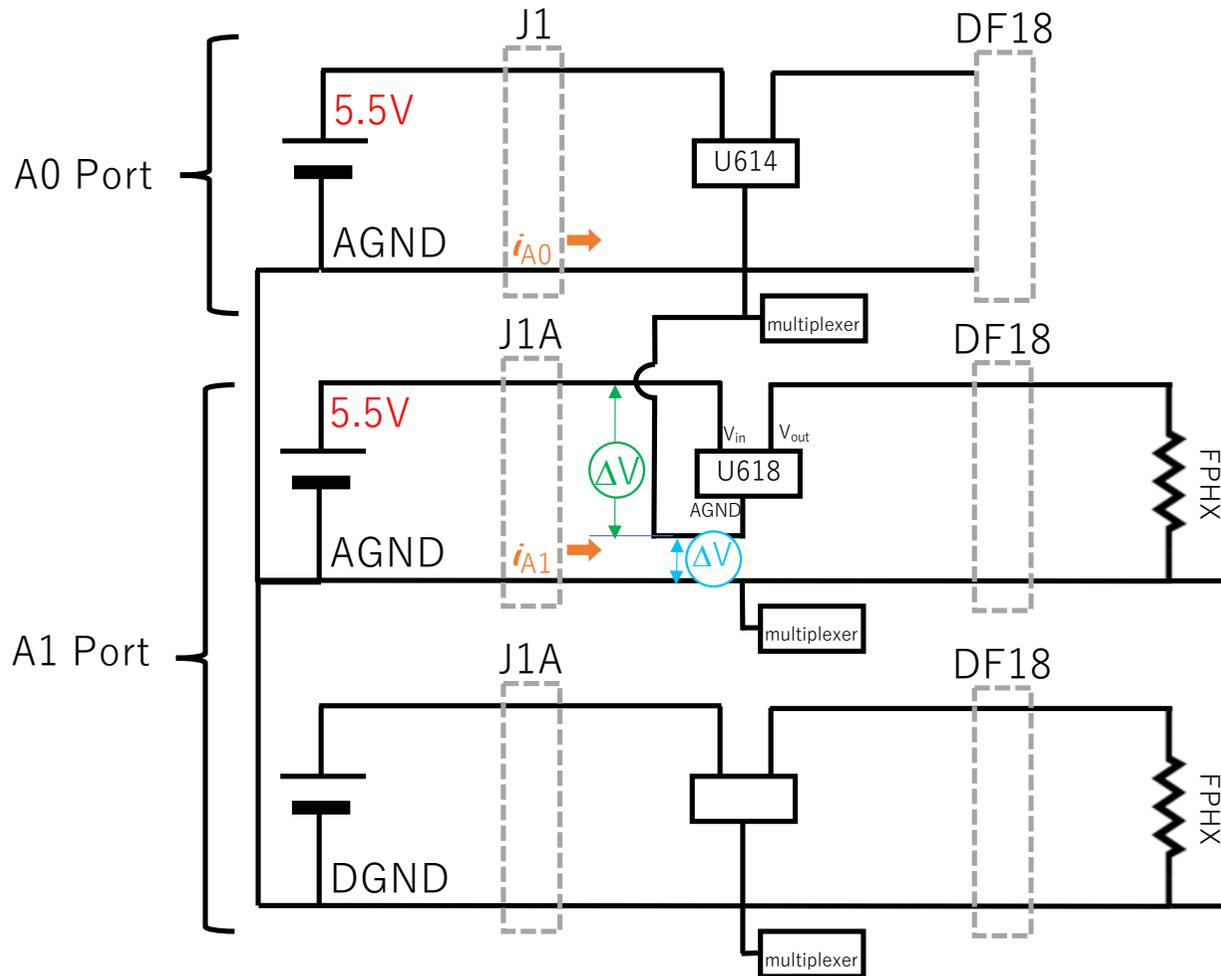
FVTX Case Circuit Diagram

$$i_{A0} \neq i_{A1}$$

The voltage drop between PS and the regulator is not necessarily same between A0 and A1.

$$\Delta V = 5.406 \text{ V}$$

$$\Delta V = 0.0001 \text{ V}$$

This is acceptable.

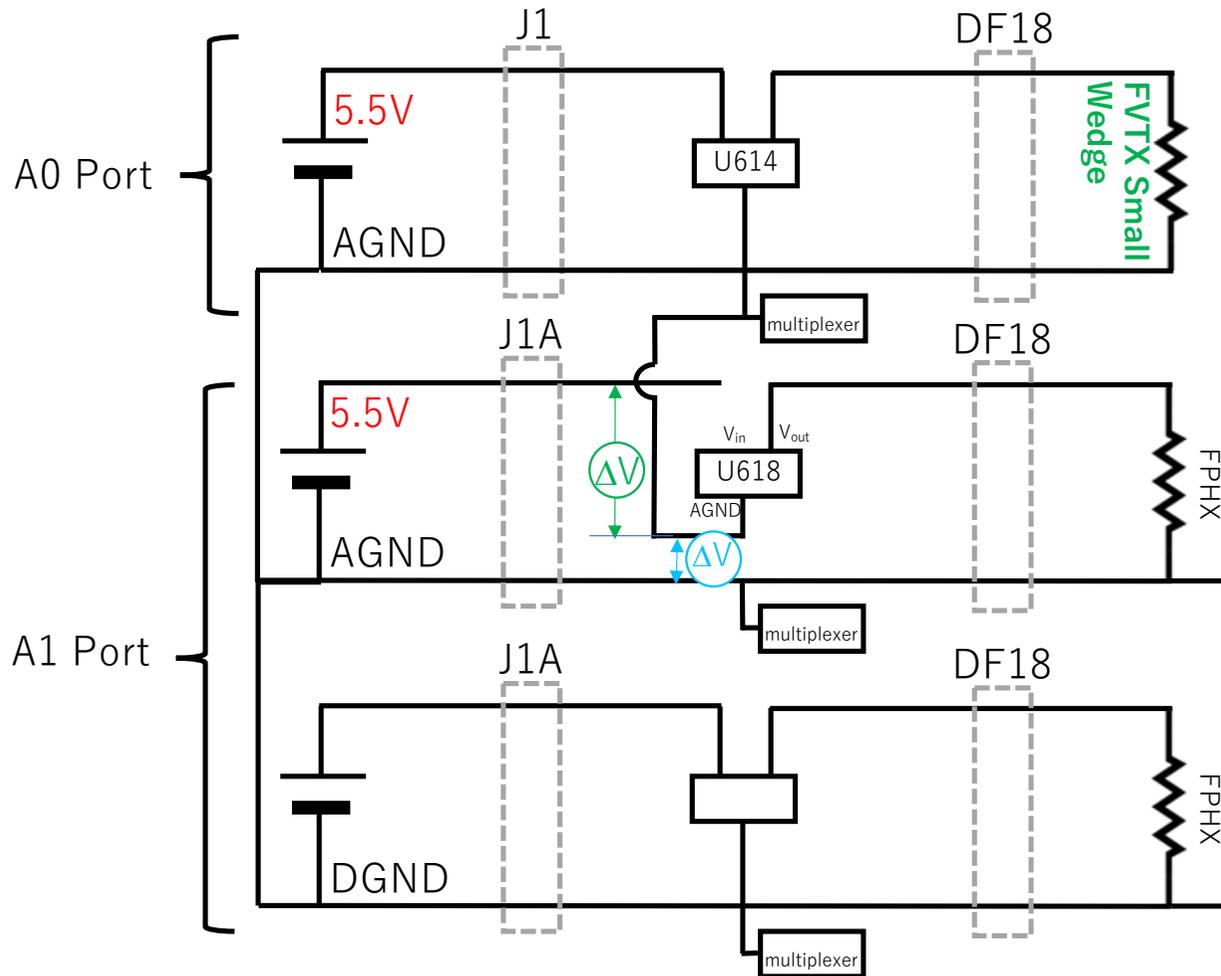
FVTX Case Circuit Diagram

The drawing current can be different with/without **FVTX Small Wedge** though, turns out the voltage drop different between A0 and A1 ports are negligibly small. Presumably because the analogue current draw is relatively small compared to digital to begin with.

$$\Delta V = 5.413 \text{ V}$$

$$\Delta V = 0.0001 \text{ V}$$

Implementation of FVTX small wedge may not be crucial to operate A1 port.

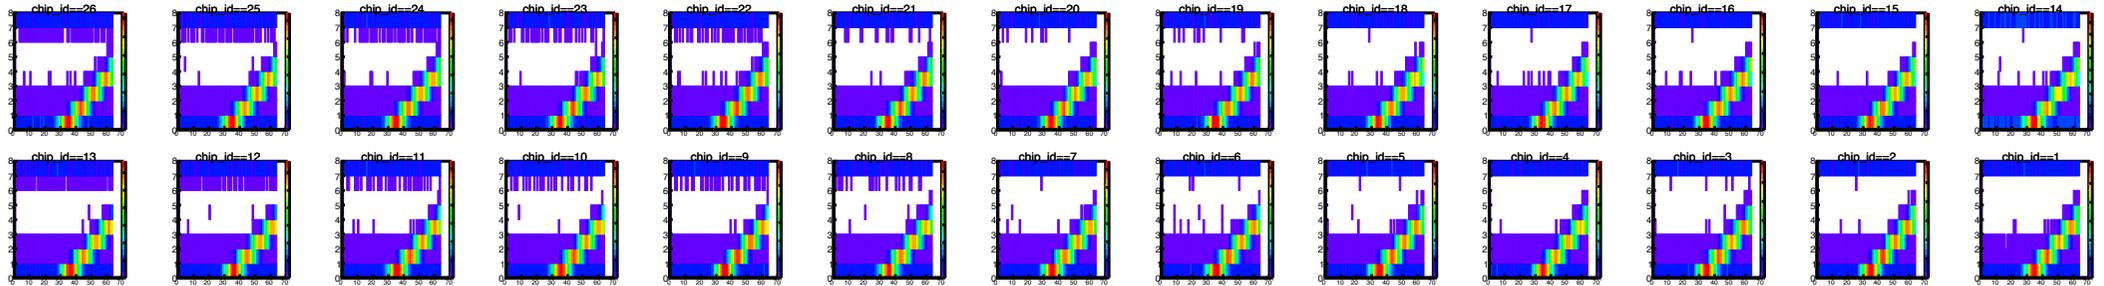
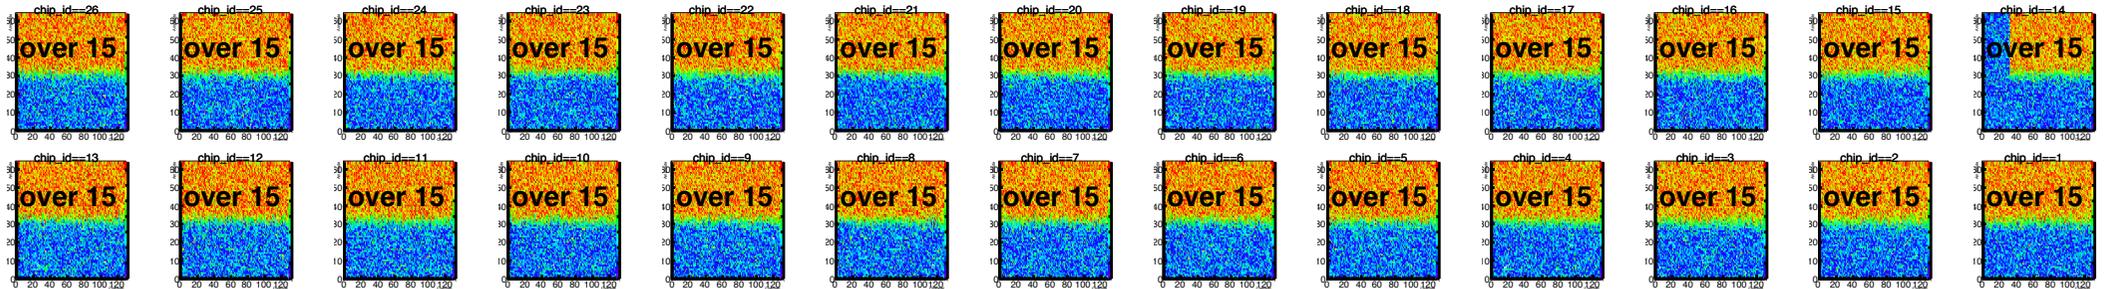
Without J1 power cable Without small wedge

Same condition, but different take.
Thus floating analogue ground doesn't secure stability.

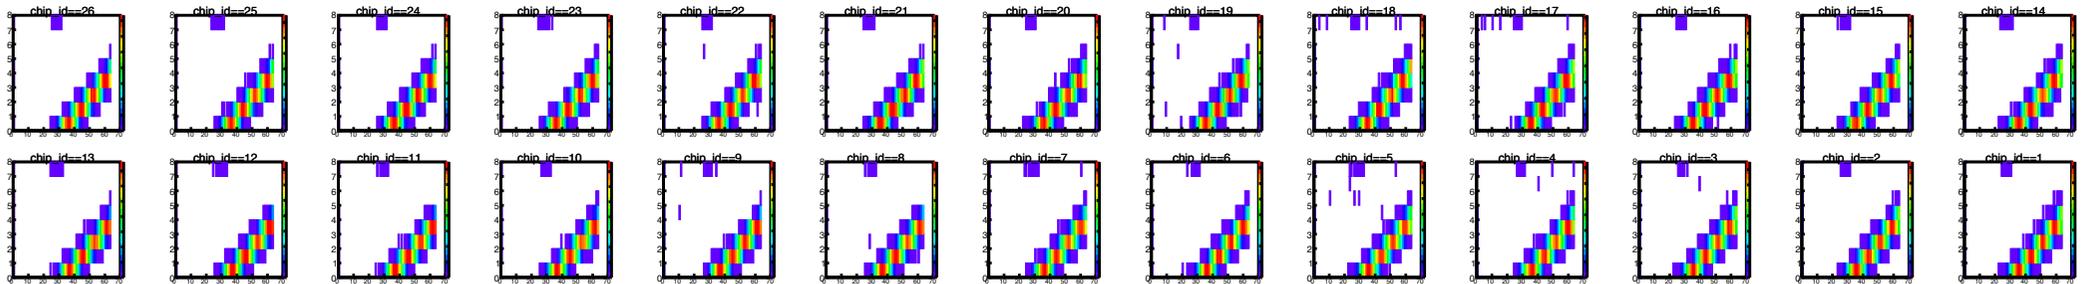
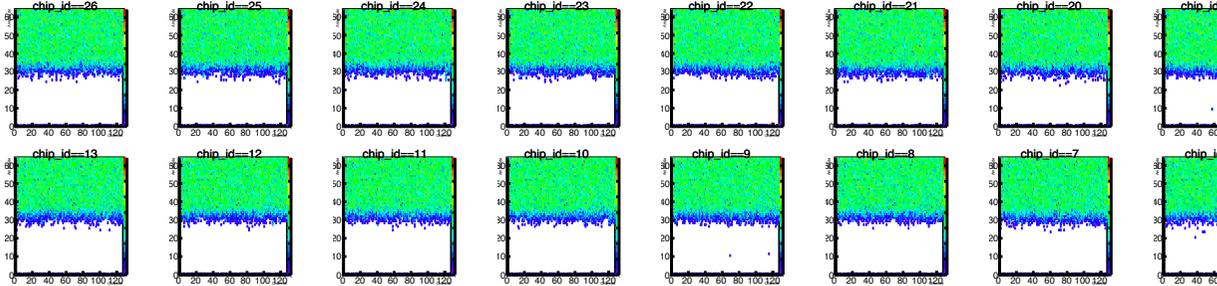
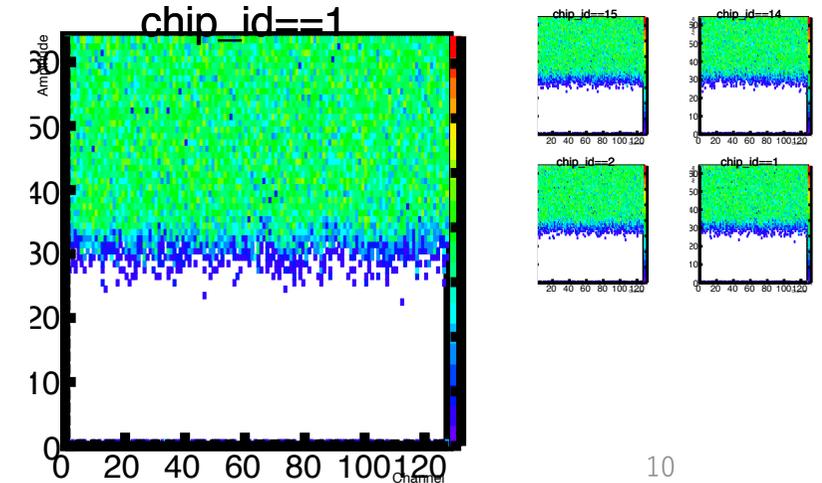
With J1 power cable With small wedge

Observed something similar without small wedge.

- A1 port operation together with J1 power cable seems to work regardless of small wedge plugged in or not.
- We only need to connect analogue ground cable of A0's U614 regulator. No need to power other regulators in B0, C0, D0 . Better to make dedicated cable.
- Better to confirm the silicon response with source.

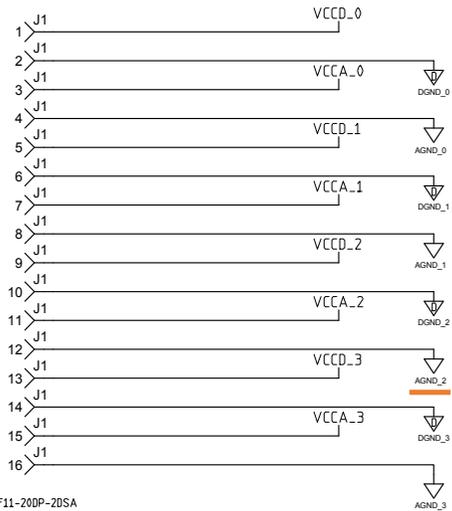
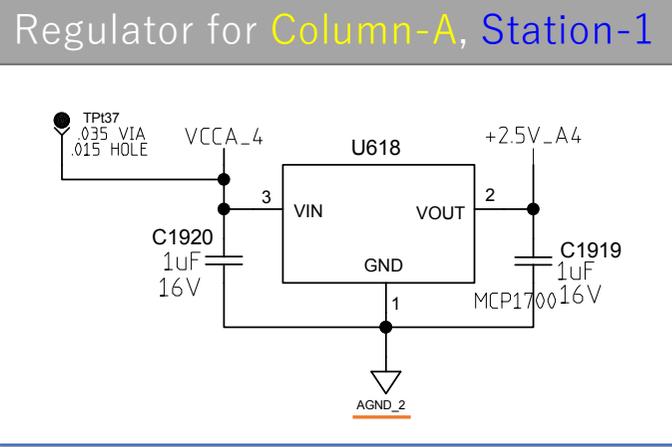
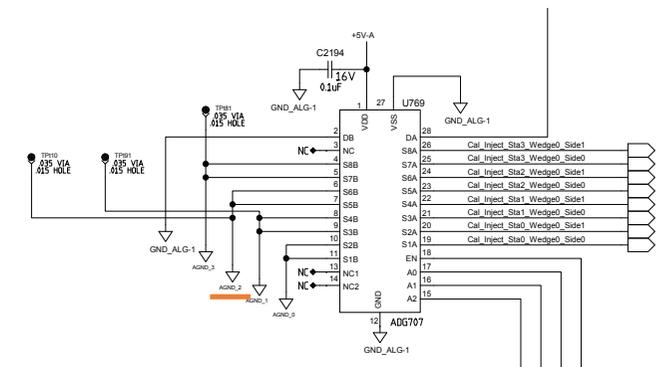
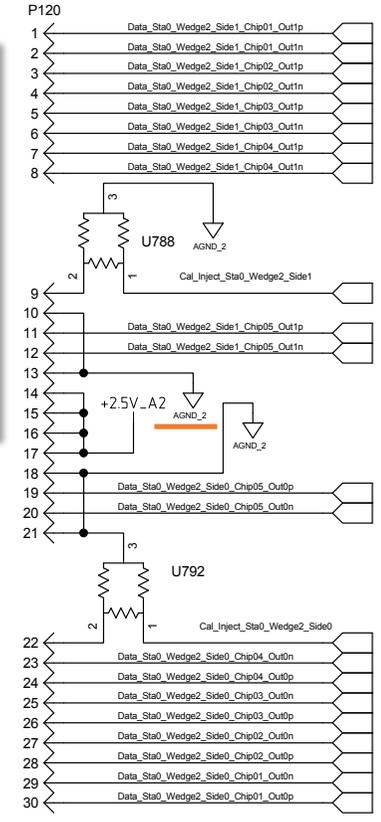
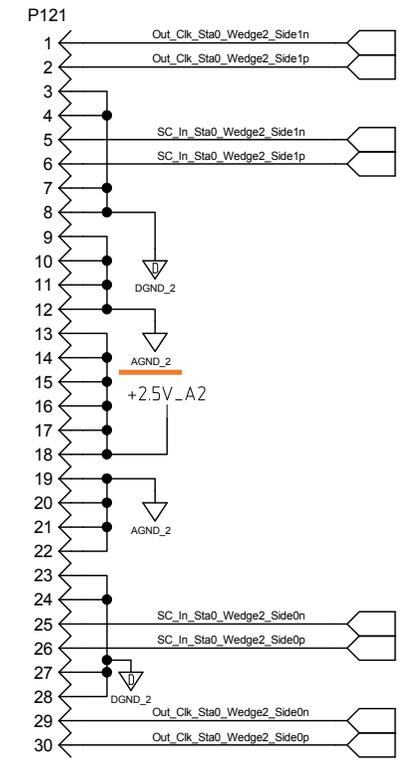
AGND_2 Trace on ROC

Evidently, there is mis-match in the analogue GND. Station-0 and Station-1 are mixed.

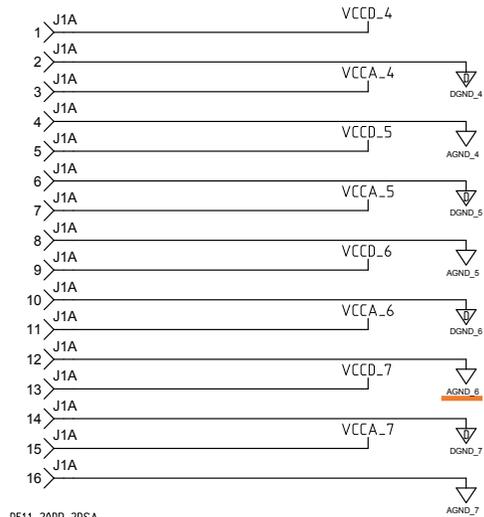
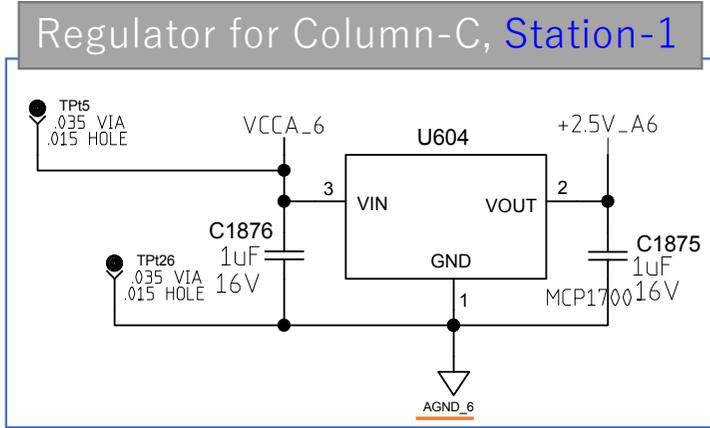
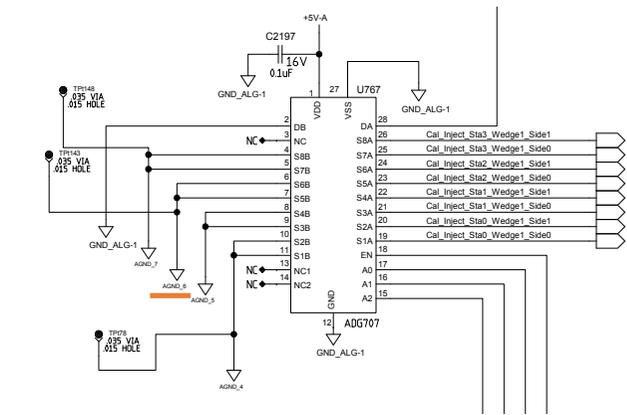
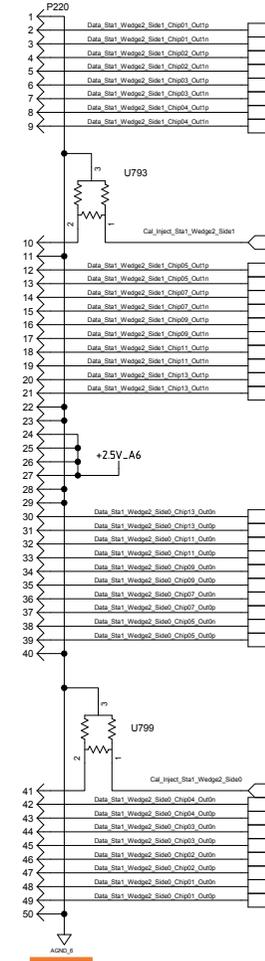
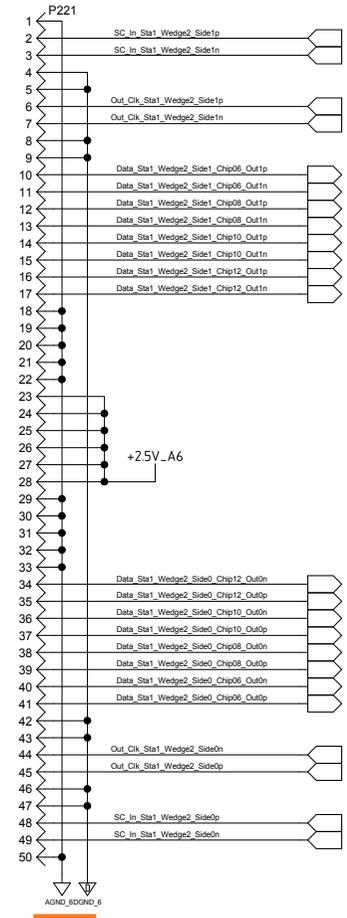
AGND_6 Trace on ROC

AGND is wired within Column-C, Station-1 throughout ROC trace as expected.

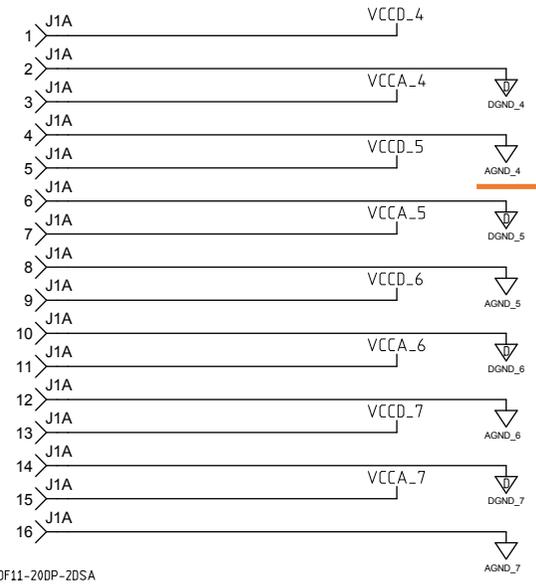
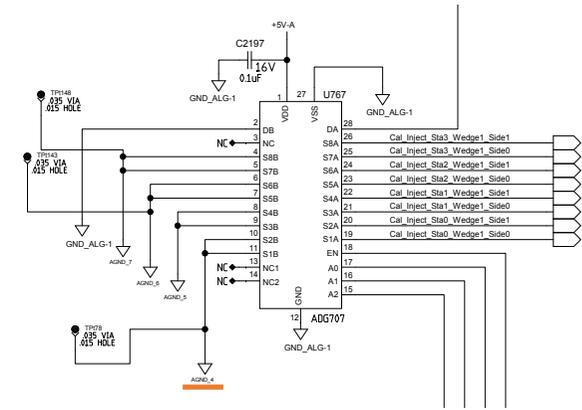
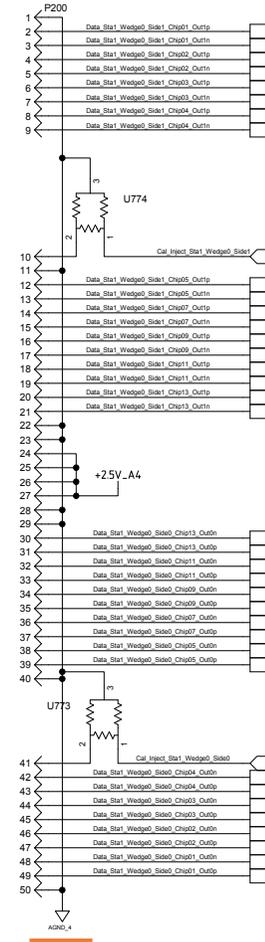
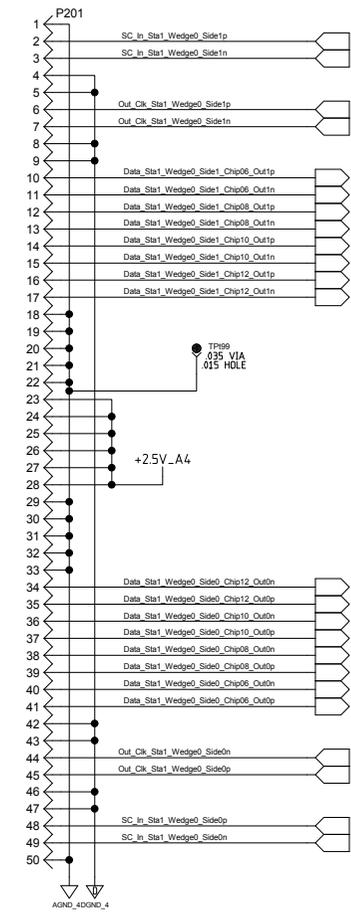
AGND_4 Trace on ROC

No regulator is wired from AGND_4

The AGND_4 analogue ground is not wired to any regulators.

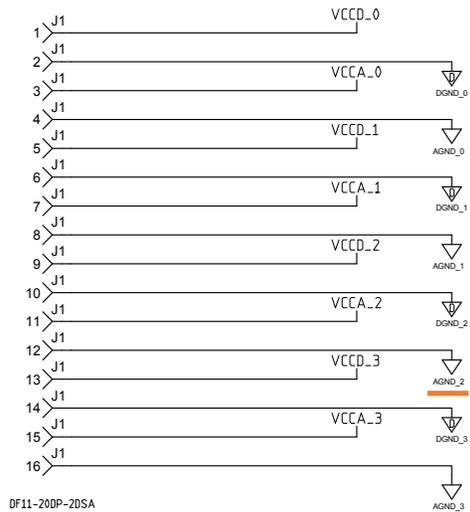
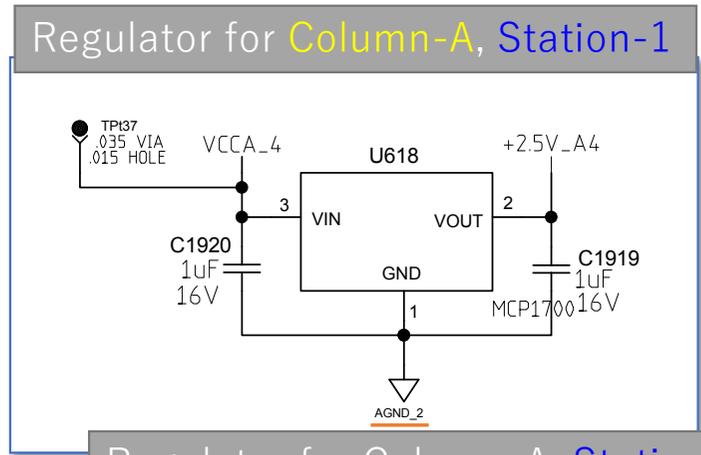
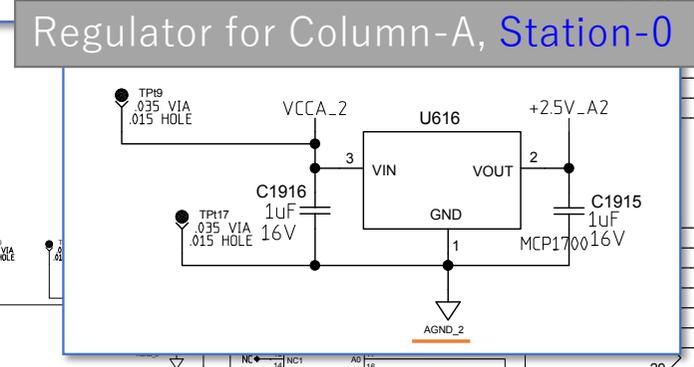
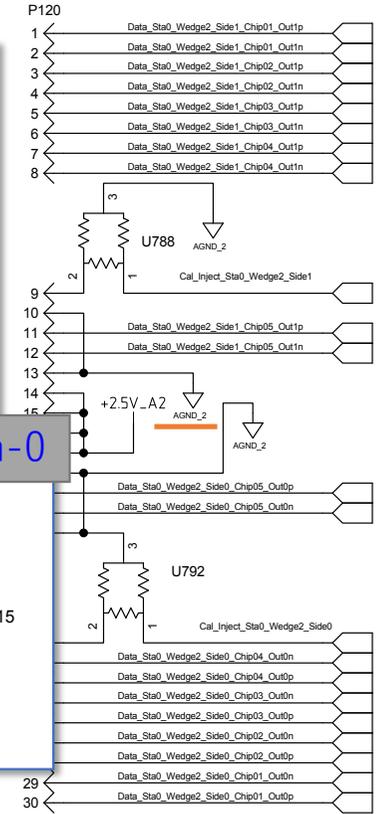
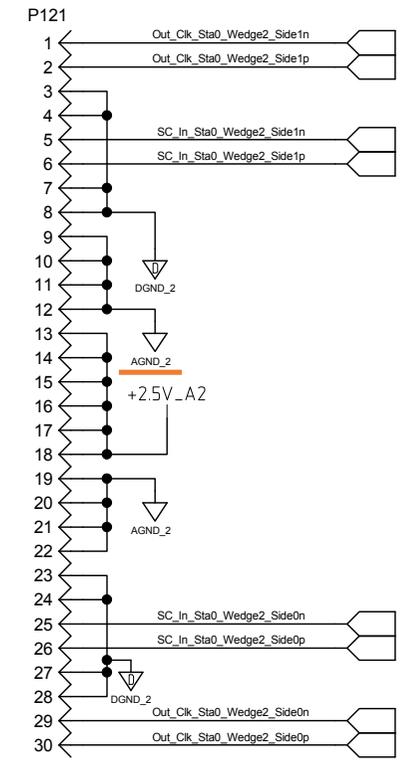
AGND_2 Trace on ROC

AGND_2 is shared with Column-A, Station-0 and Station-1 analogue regulators.

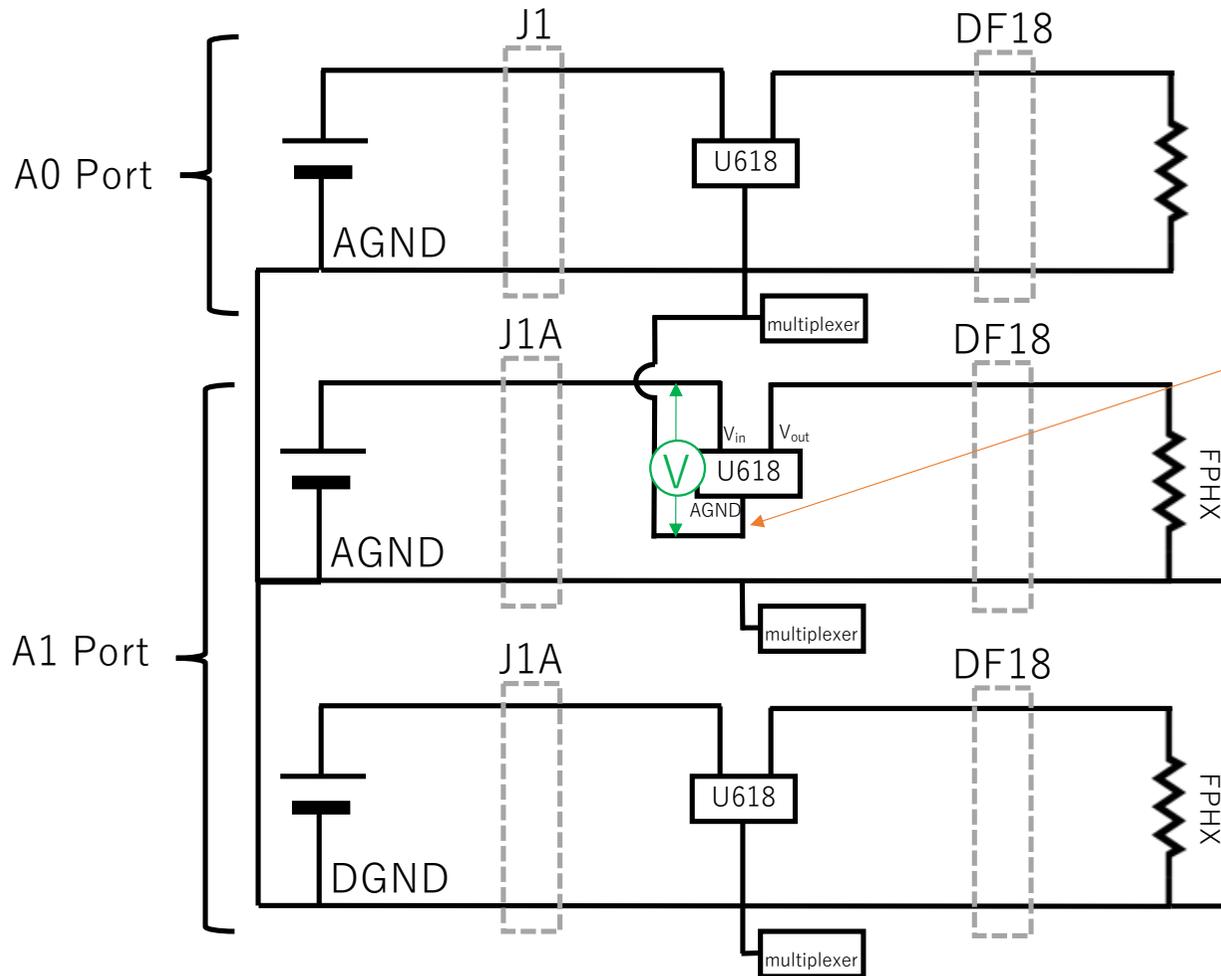
FVTX Case Circuit Diagram

AGND is provided by A0 power supply which is likely to be shared with the GND of A1 analogue power supply. This circuit effectively secures stable operation of U618 regulator presumably.

Not sure how stable U618 regulator output is with the floating ground with open J1 and DF18(P100,P101) for INTT case. It is not guaranteed INTT works as well as FVTX.

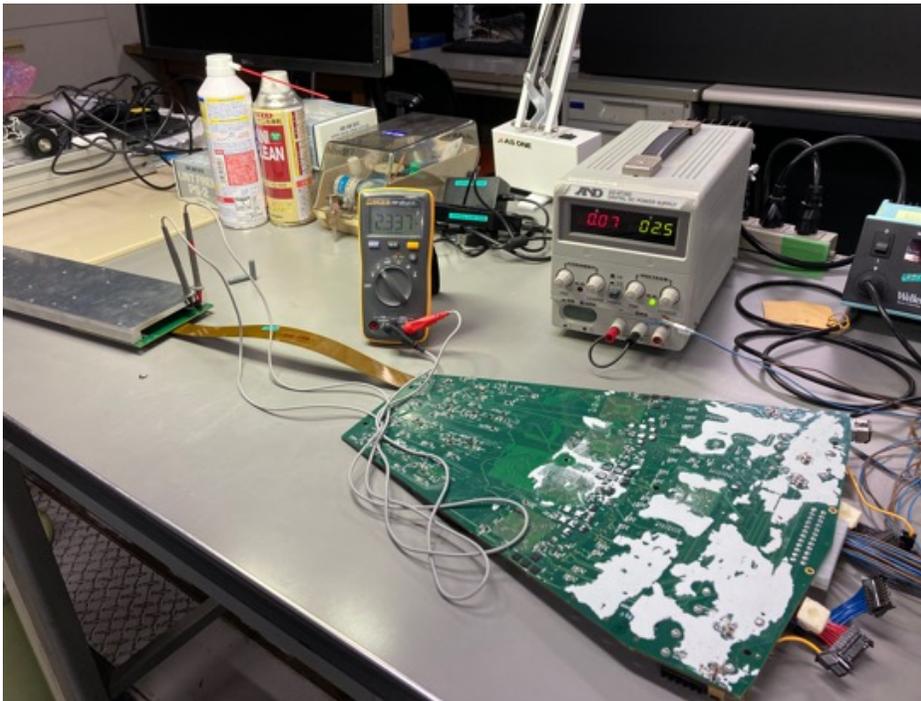
Column-A1 Analogue Regulator Measurement

The output voltage at analogue regulator is 2.8V.
Observed +0.4V higher voltage at the interception board.
Presumably it is caused by the ground level difference.

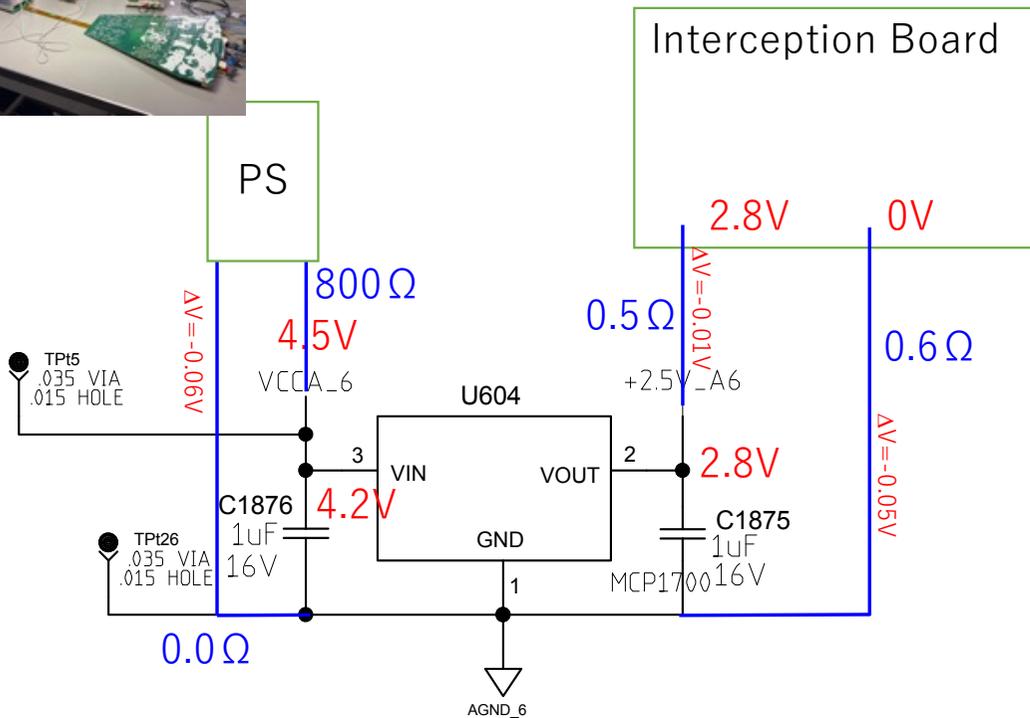
C1

Analogue GND Line is directly connected to AGND of Interception board

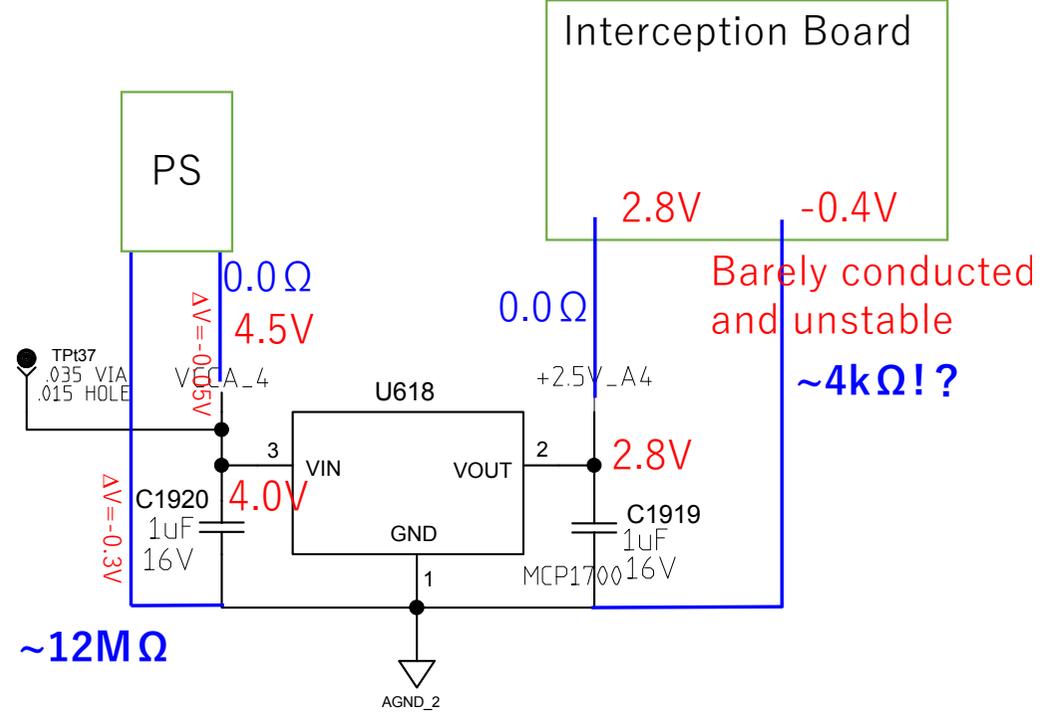
A1

Analogue GND Line is **not** directly connected to AGND of Interception board

Barely conducted and unstable
~4kΩ!?
