Taiwan Ladders

Calibration tests and inspection with a microscope.

G. Nukazuka (RBRC)

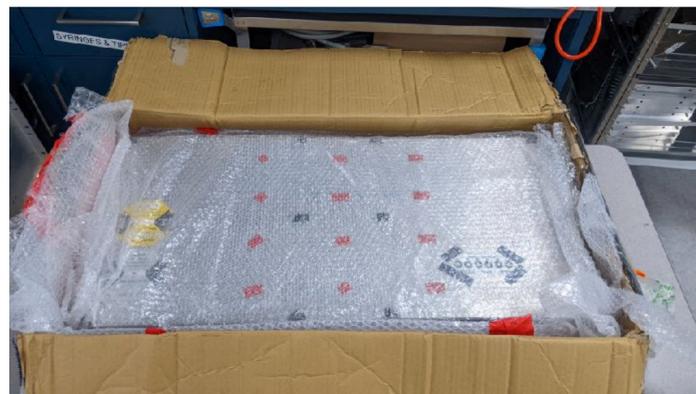
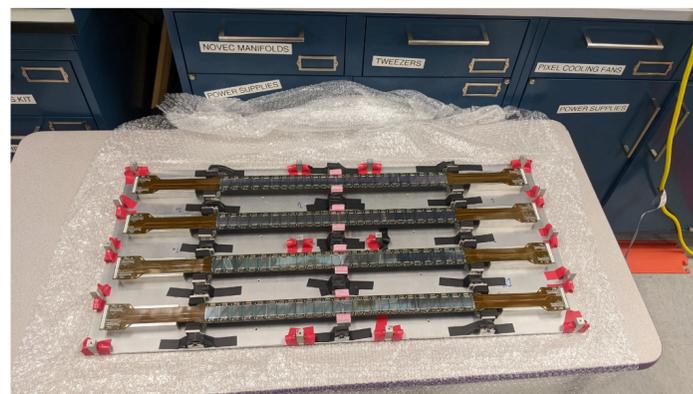
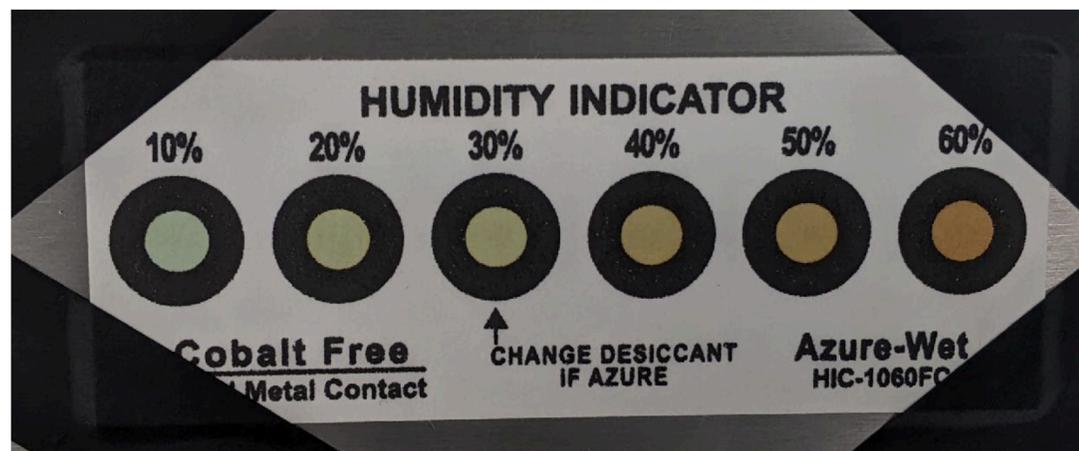
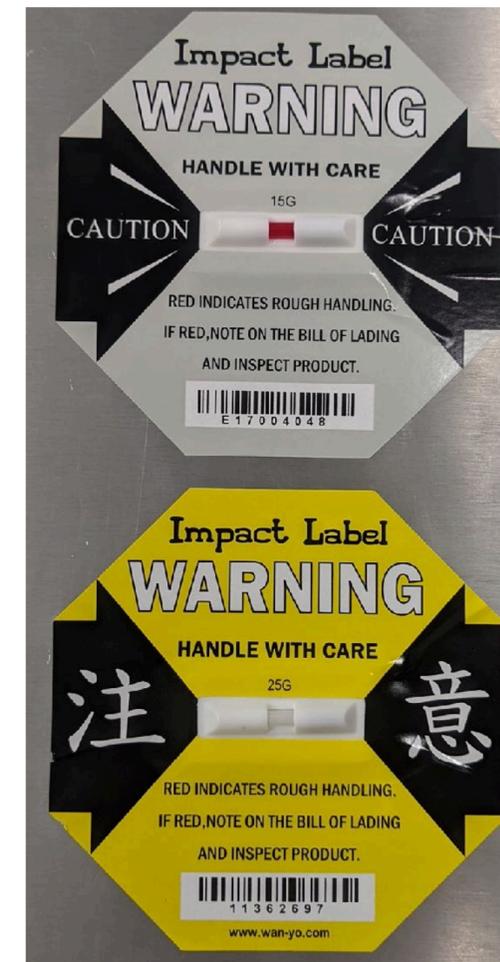
The impact indicator was lost...?

The impact indicator (15 G) turned red
The impact indicator (25 G) was white.

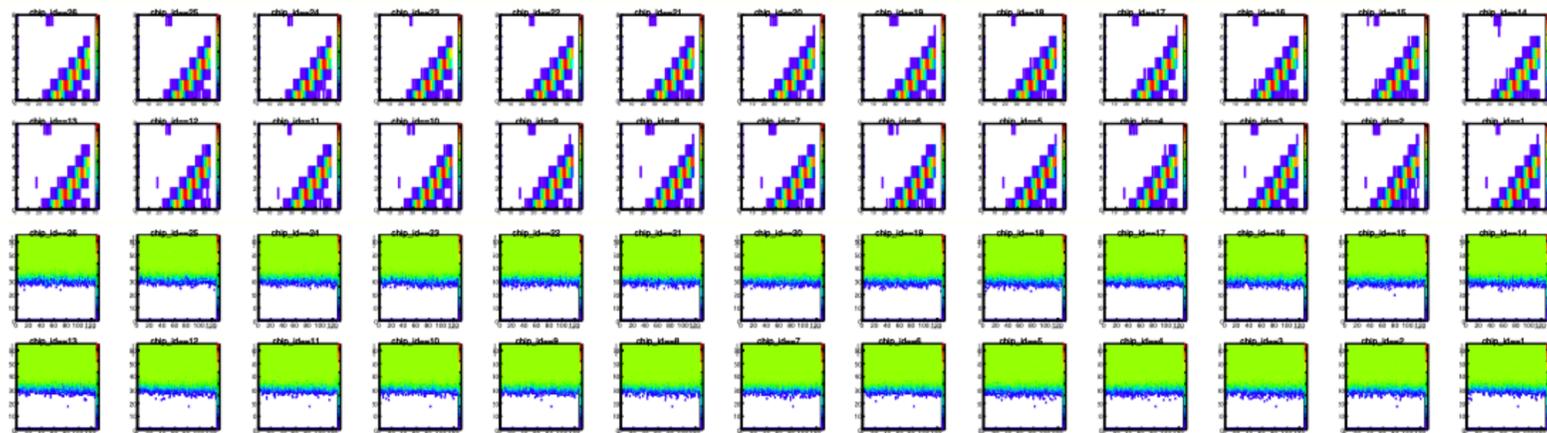
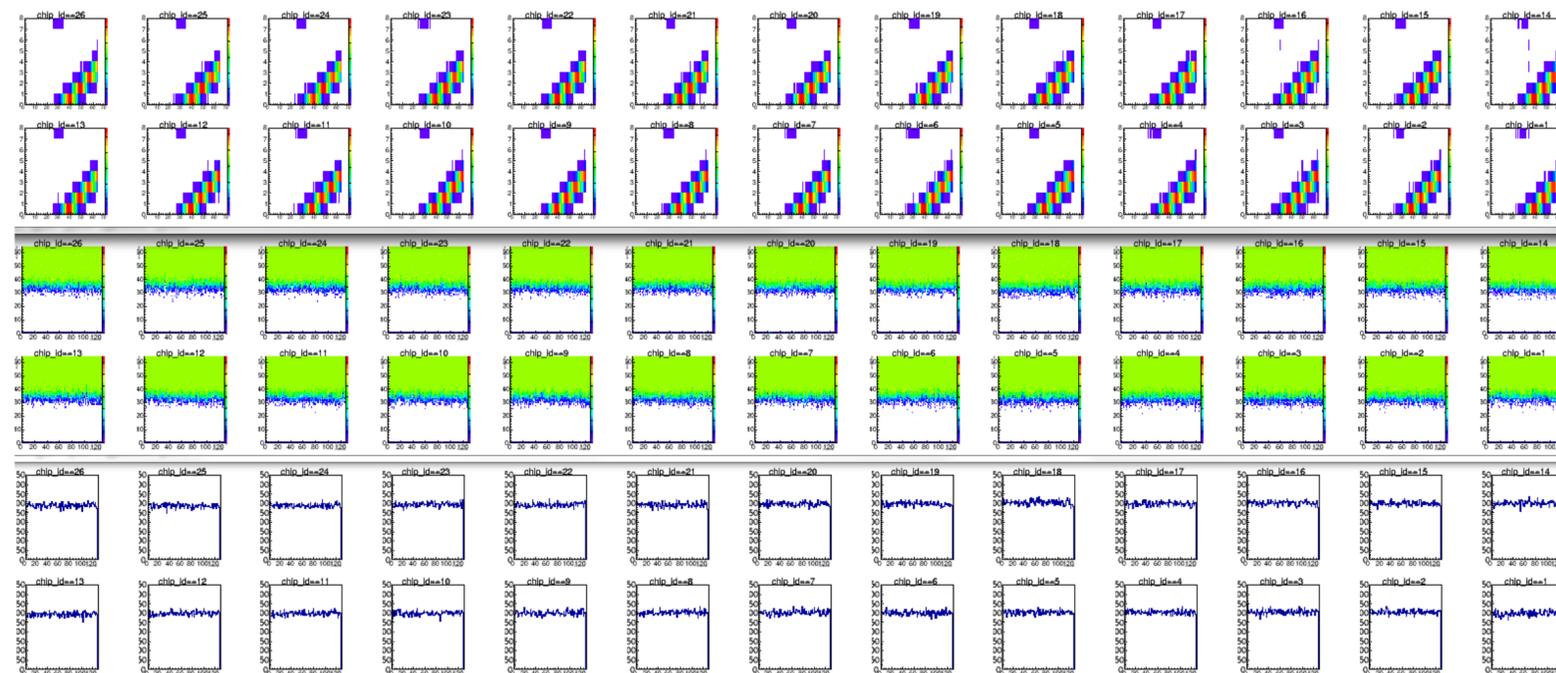
North (HDI #258), Bias: 200 nA

Known bad channels: U13-104, U14-96, U14-98, U16-28

Good 🍌

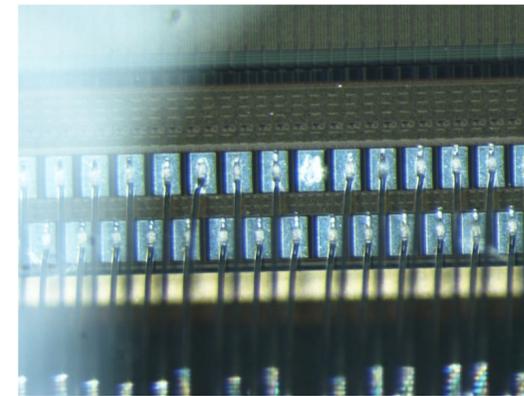
South U13
b/w chip & HDI

Ladder - bonding	
Number of total un-bonded channel :	
# of un-bonded channel	percentage
4	0.1 %

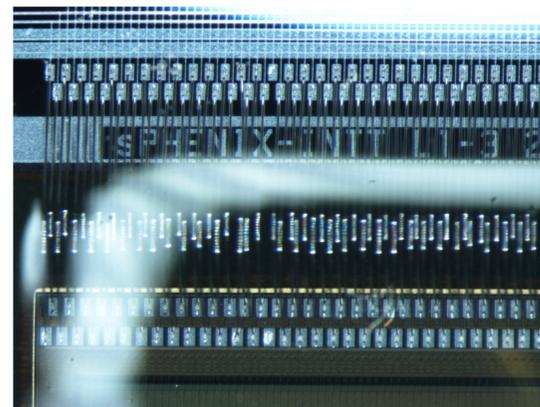
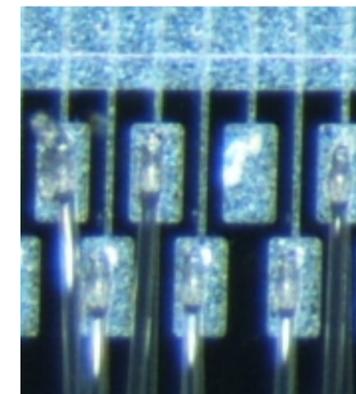
South U16
b/w chip & sensor

No additional un-bonded ch found.

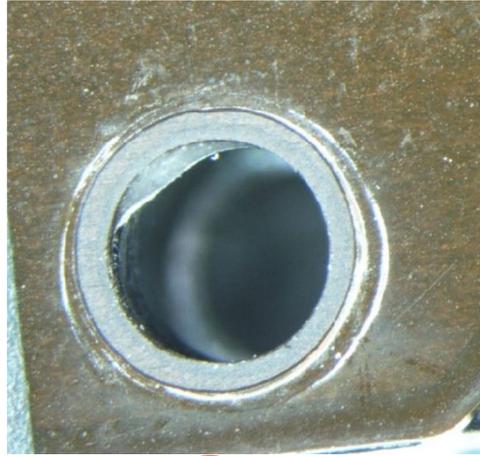
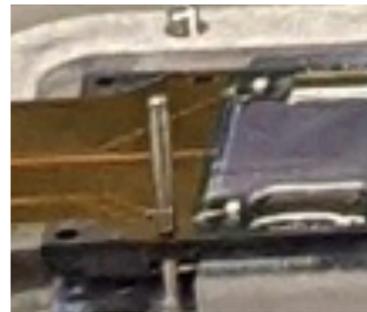
The hole is blocked by ???
A pin cannot go through the hole.
It means the screw for the barrel assembly may also not go through the hole.

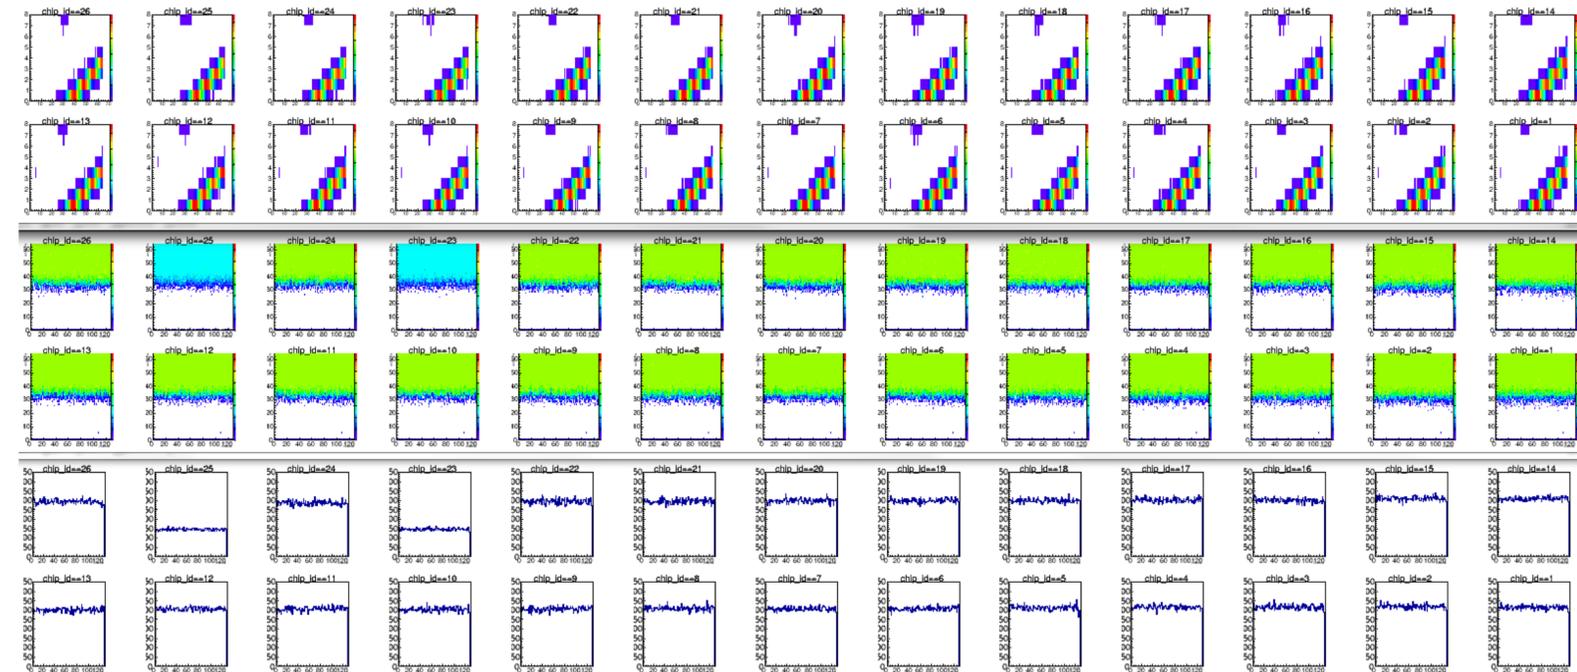
North (HDI #345), Bias: 120V, A = 217 nA, B = 120 nA

Chip23&25 always had only half entries. LVDS 8mA didn't help.

LVDS 8mA didn't help chips #23 & #25. I have no idea to explain why it happened.

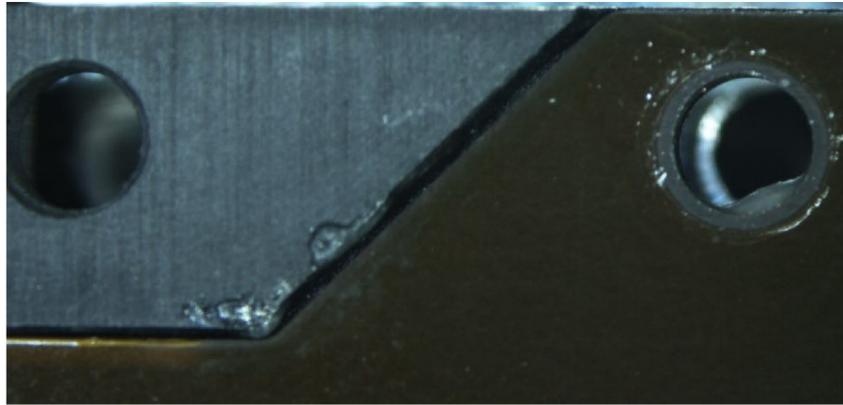
All wires (chip—HDI, chip—sensor) look good.
The hole next to U1 on the south side was blocked by ???
A pin cannot go through the hole.

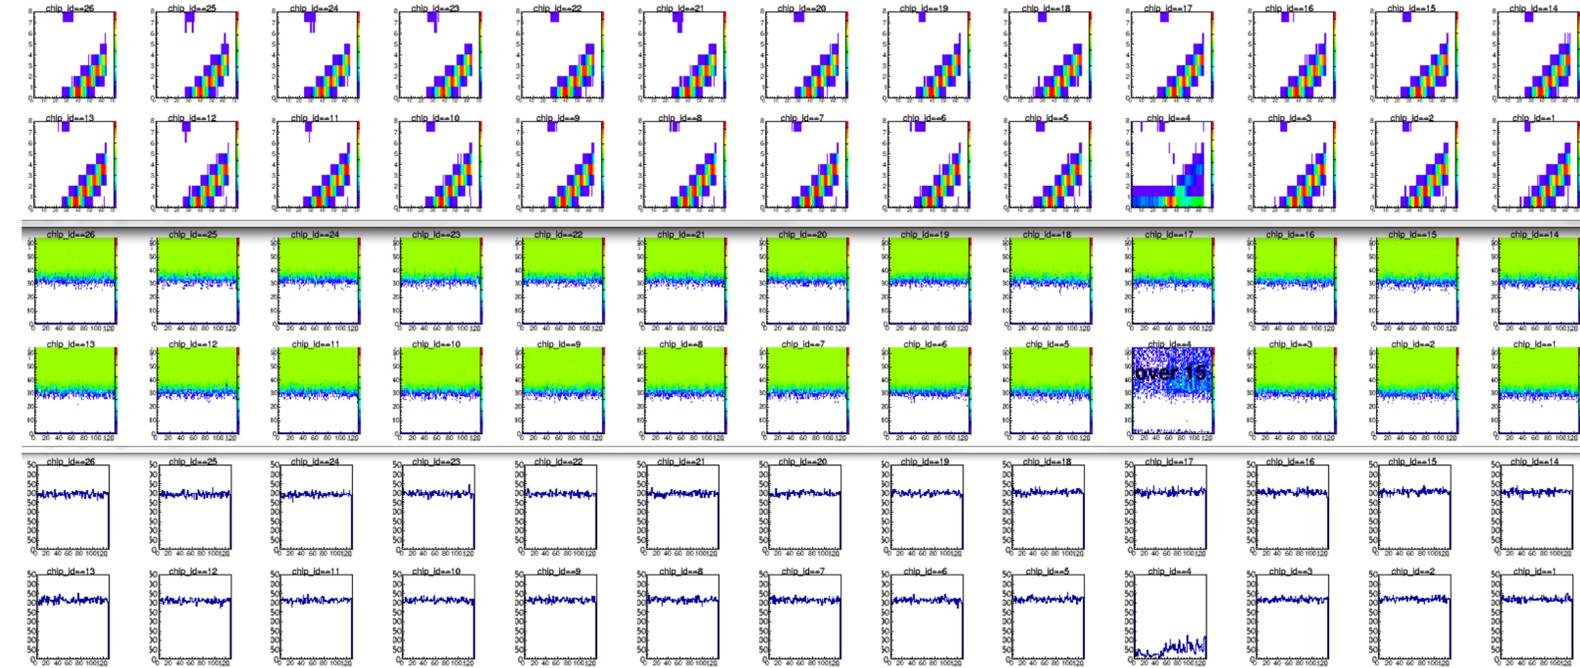
South (HDI #348), Bias: 120V, A = 158 nA, B = 106 nA

Chip4 had strange data.

Chip4 had almost no data. 3 attempts obtained the same results.

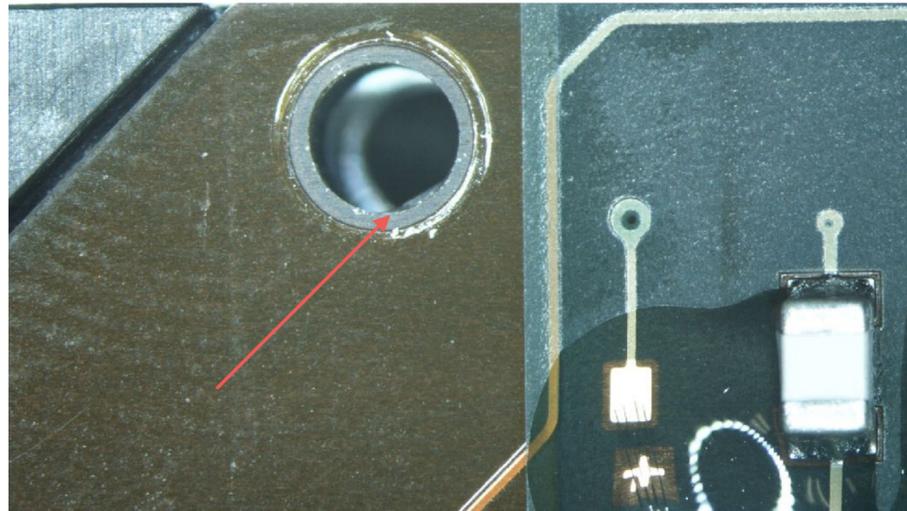
All wires (chip—HDI, chip—sensor) look good.
The hole next to U1 on the south side was blocked by ???
A pin cannot go through the hole. The screw may also not go.

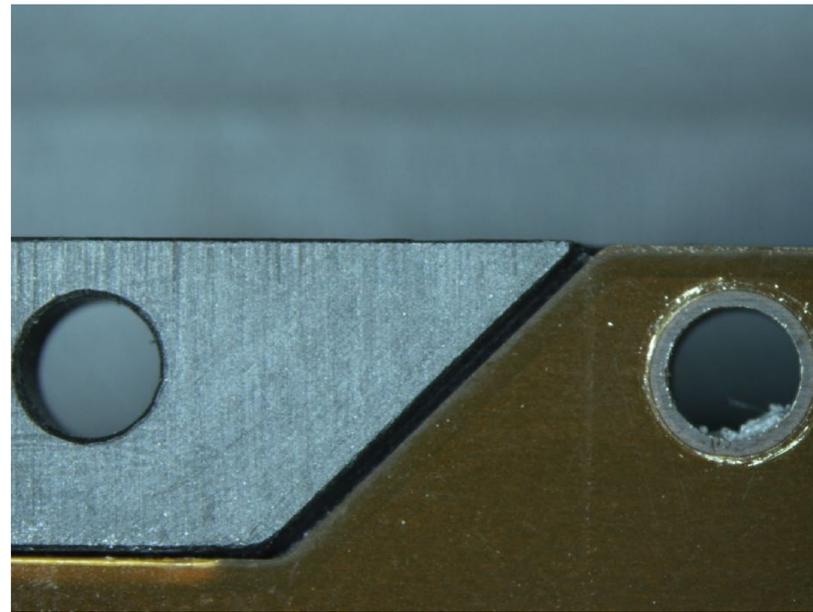
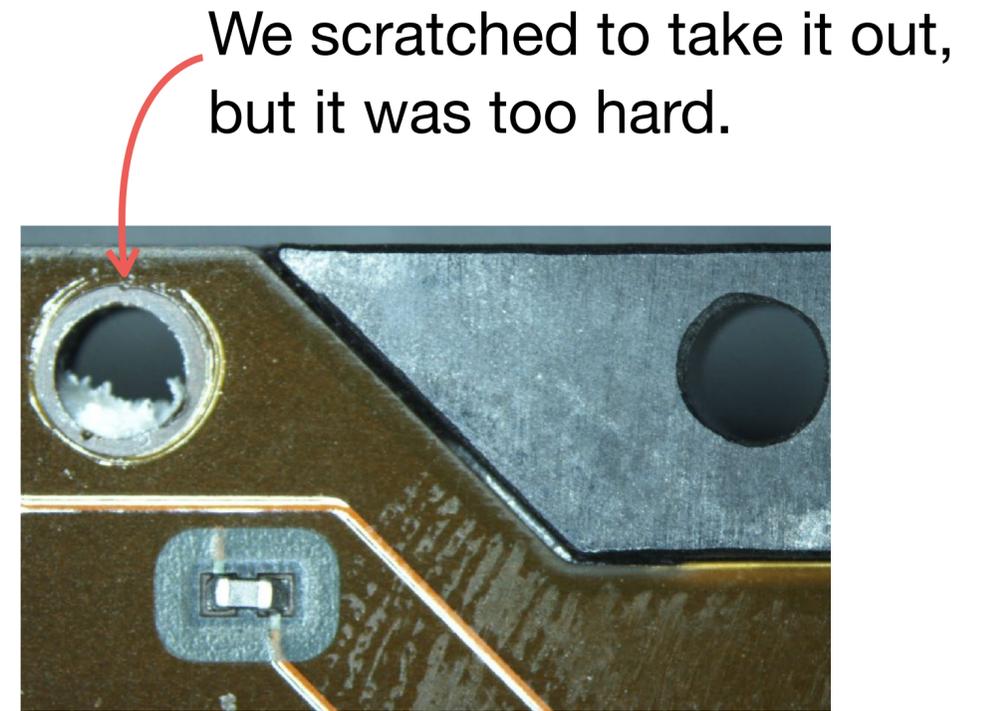
Those 3 holes have something inside.
A pin cannot go through them. It means the screw
for barrel assembly may also not go through them...
