# Beam test of LAPPD at CERN PS

INFN - Genova, INFN - Trieste, BNL

**INFN test beam at CERN, observed LAPPD Issues**

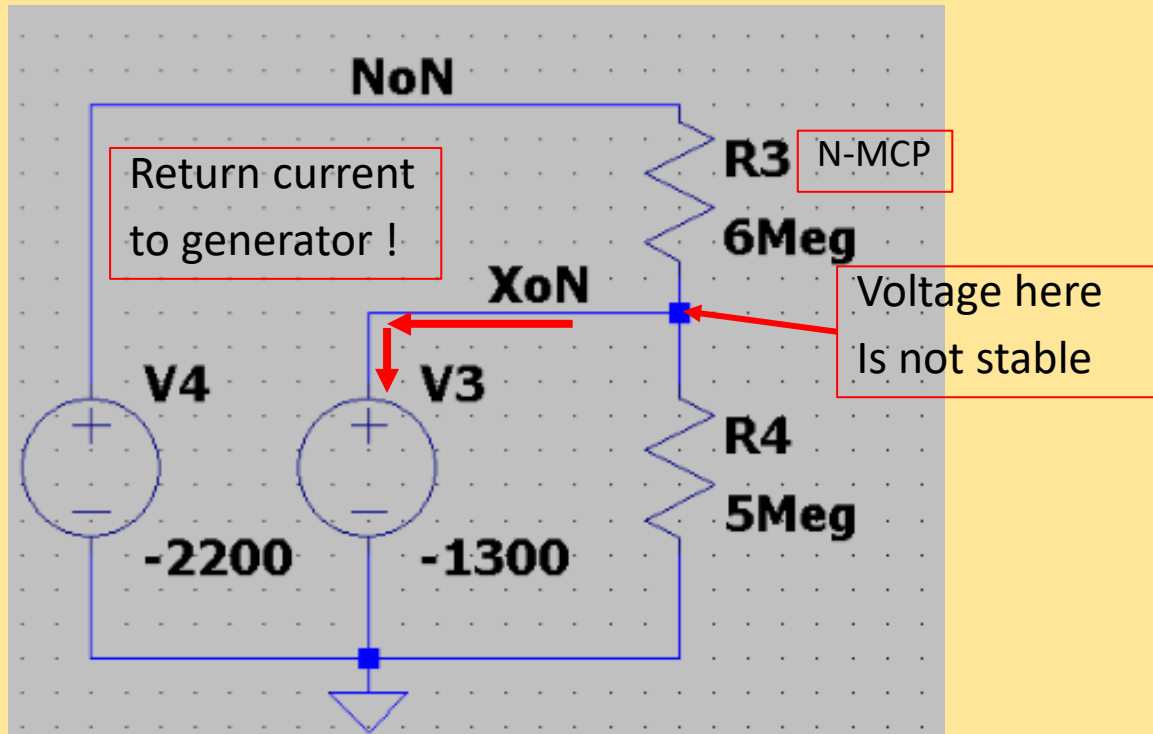
All these CAEN modules have “Common floating return”

Is the accident with tile no. 87 (short on X-MCP) related to the HV supply scheme used at the beginning?

- electrical instabilities observed at our test beam
  - incorrect current read-out with related overvoltage
- use a conceptually different PS

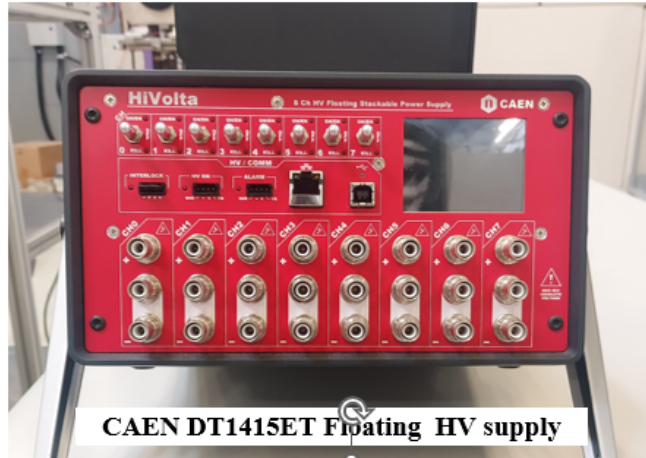
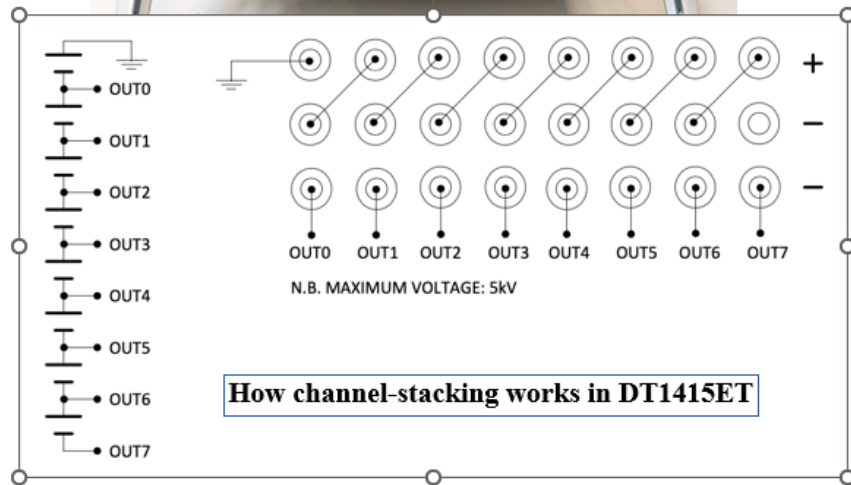
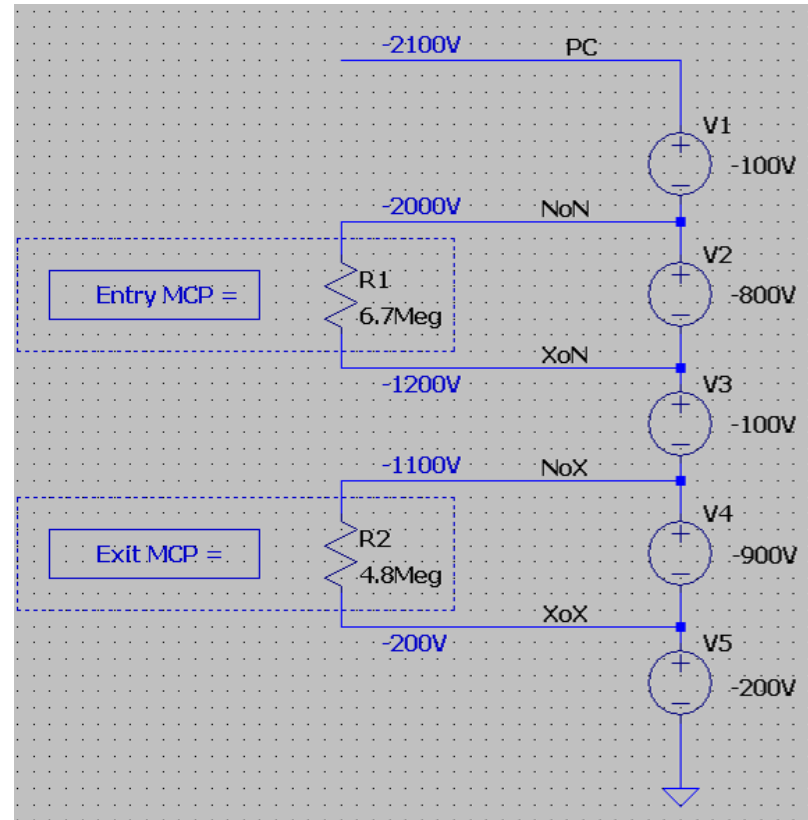
CAEN DT1415ET Floating HV supply

electrical stability obtained

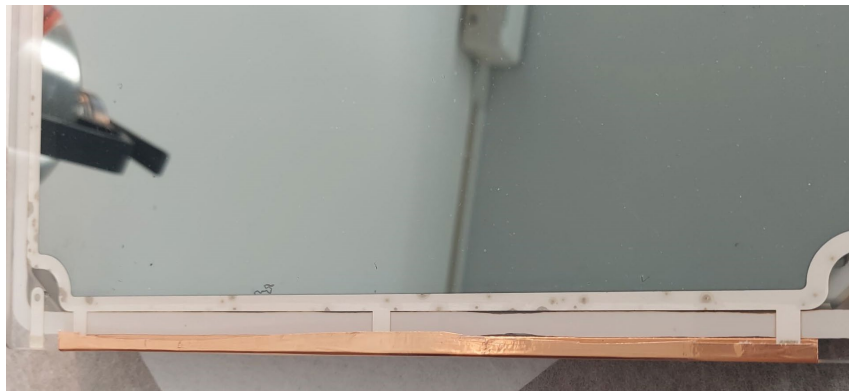
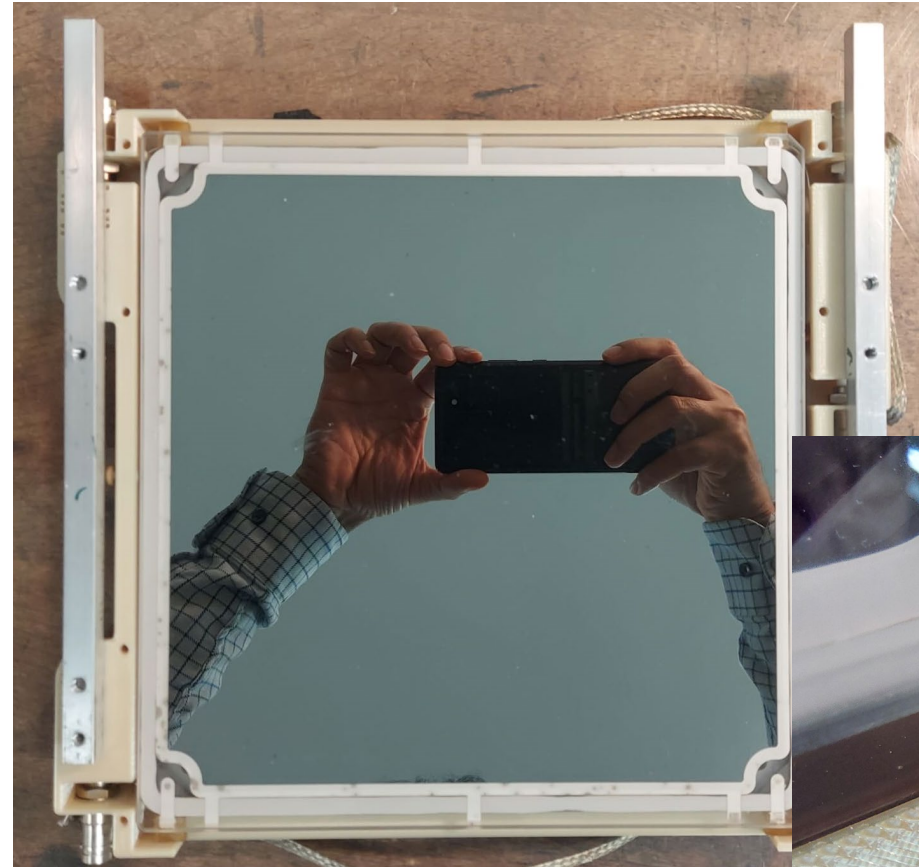
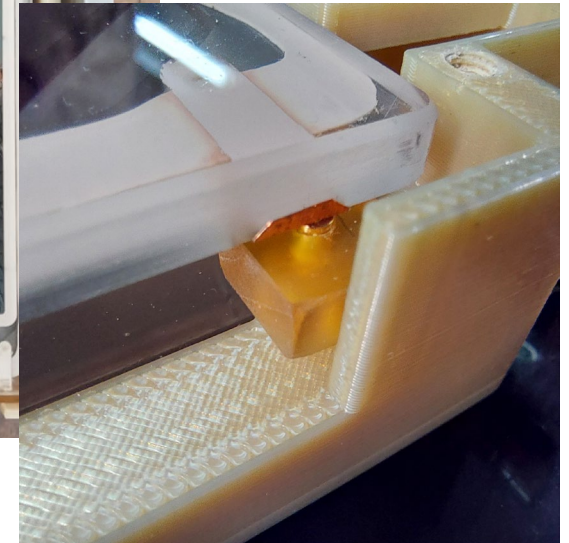
HV distributed to the various electrodes via Pogo Pin Connectors touching a small strip

- small contact surface
- oxidation of the contact point
- Critical alignment
- The elasticity of the plastic tile support can produce misalignments (observed)
- Contact point different for different tiles,  
In particular Grounding  
(in our case tiles no. 87 and 124)

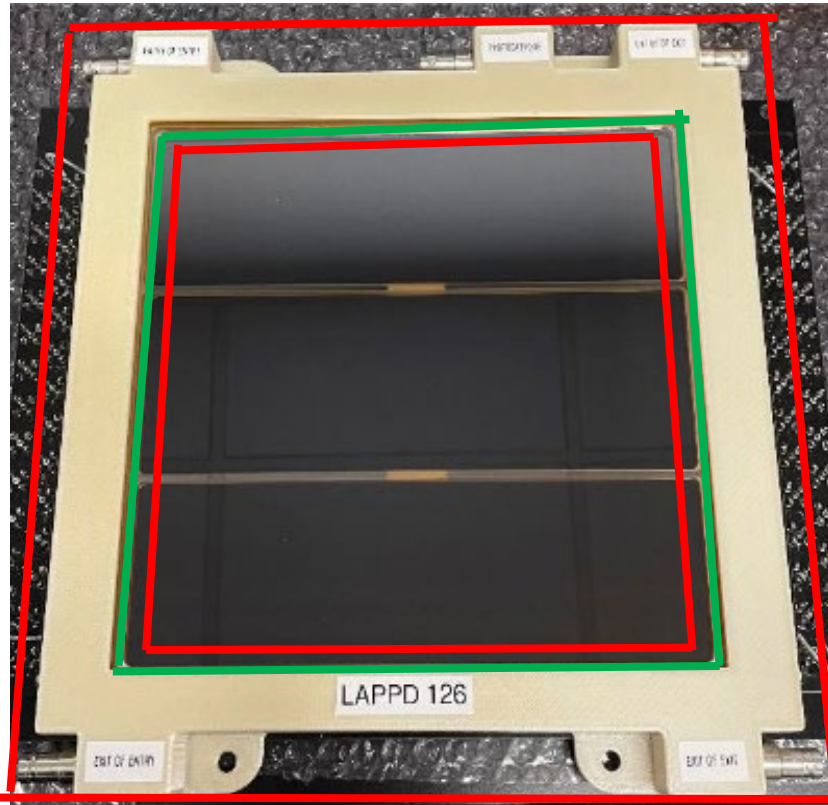
- Re-engineering the electrical and mechanical aspects
- All services within the green contour, in vertical arrangement
  - At present, active area < 50%
- Reliable electrical connections
- STANDARDIZATION: tile of a same family should have the same electrical layout
