NE5 Fiber Latch Problem

Itaru Nakagawa

RIKEN/RBRC

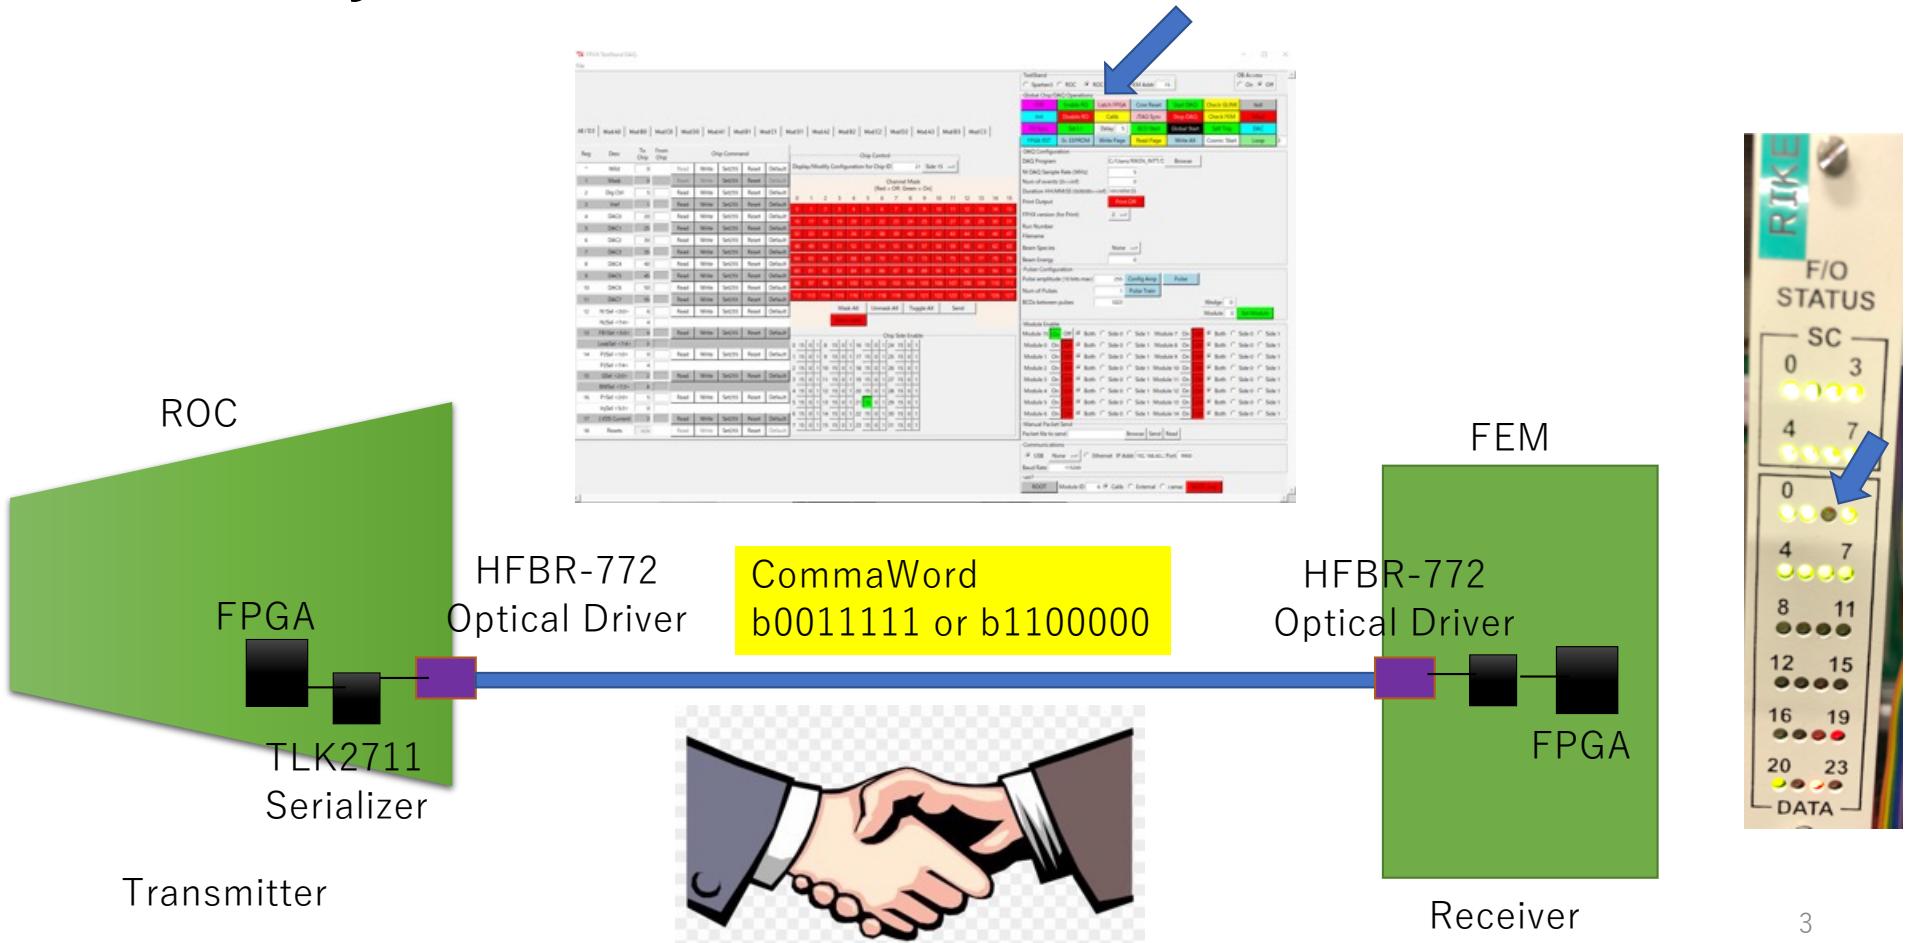
Fiber Synchronization Error

- We did observed collapsed comma words which is the smoking gun of the fiber sync error.
- However, the cause has not been identified. Signal shapes, reference clock jitters etc all look normal. This problem remain no solution yet.

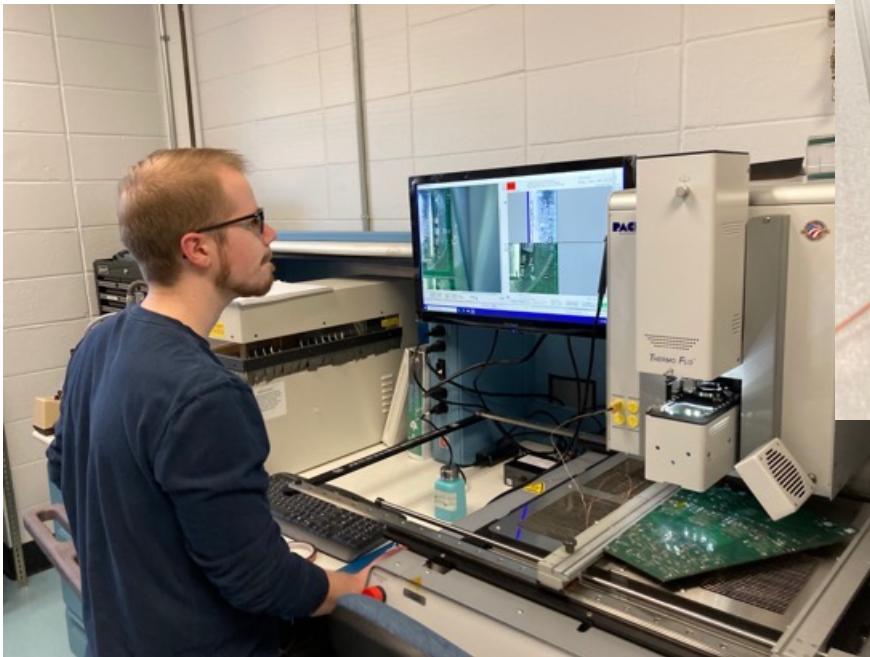
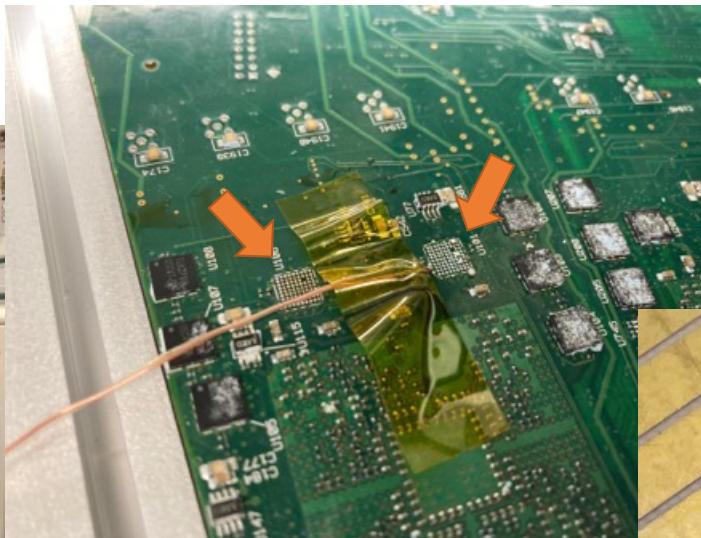
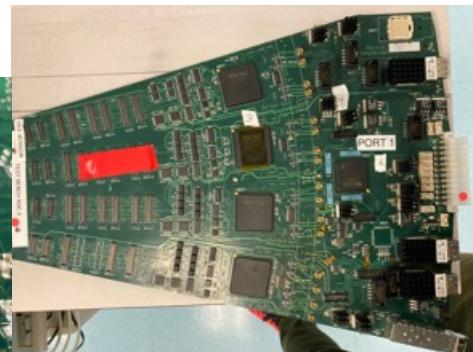
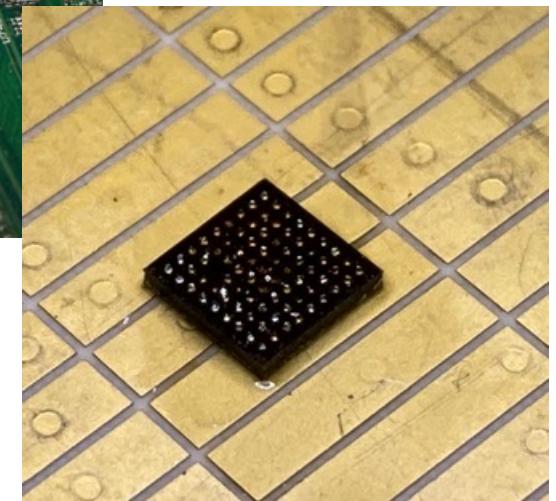
Removal of TLK2711 from “Old ROC”

TLK2711 removal from “the old ROC” the version BCO cable input is incompatible with production version

By Joseph Pinz @ Instrument Div.

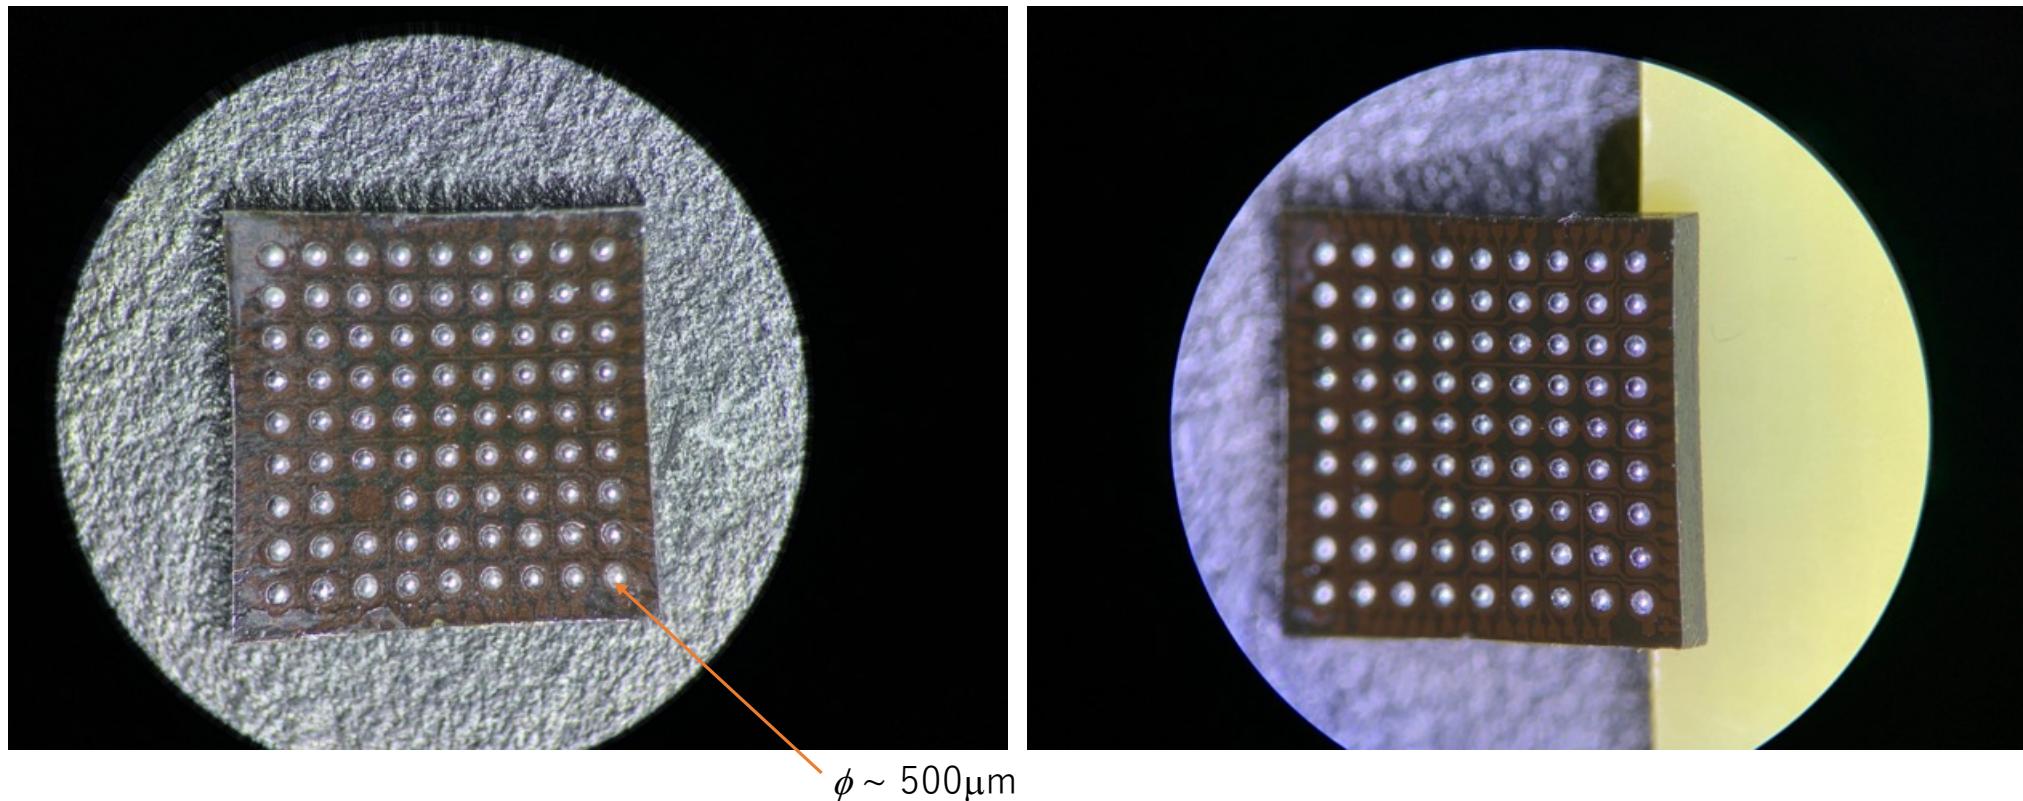
Re-balling solder on the TLK2711

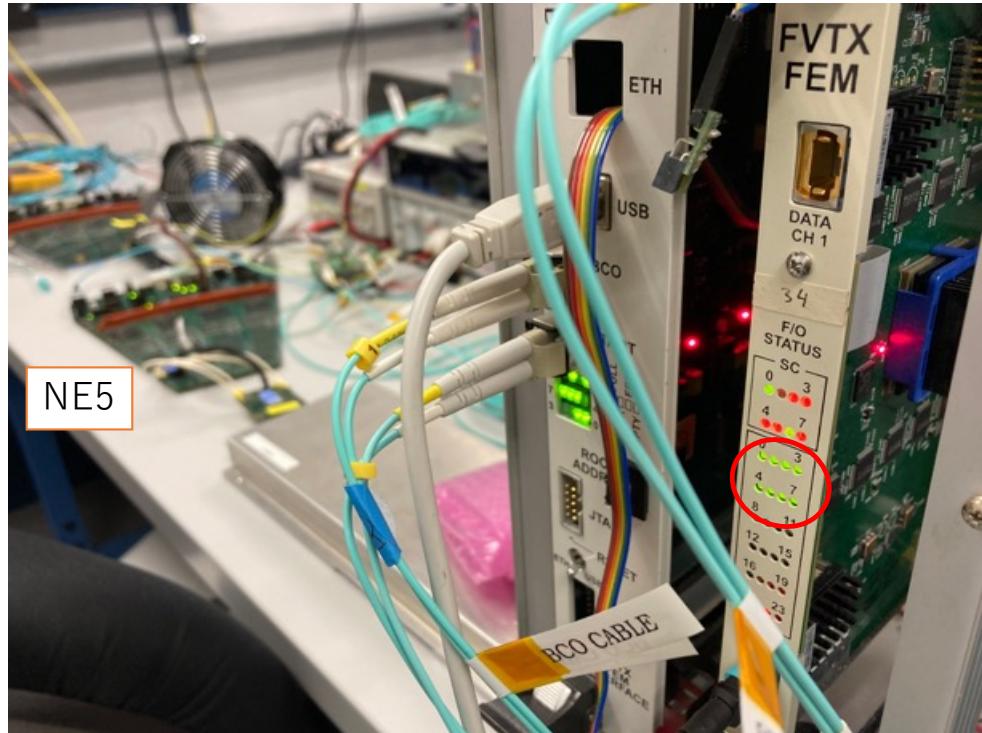
Calibration Results

Now the data fiber latches successfully.

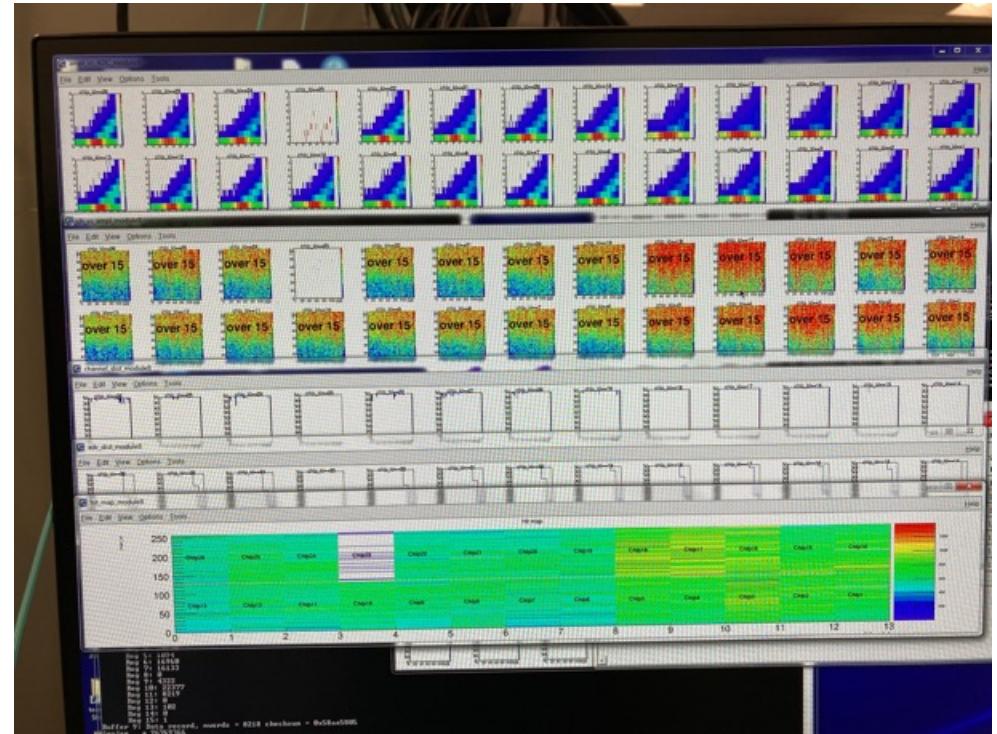
Resulting calibration data. Need to debug further besides the fiber issue, but now we have ways to investigate.
