# Slow Control TLK Replacement

RIKEN/RBRC

Itaru Nakagawa

# TLK Replacement at BNL

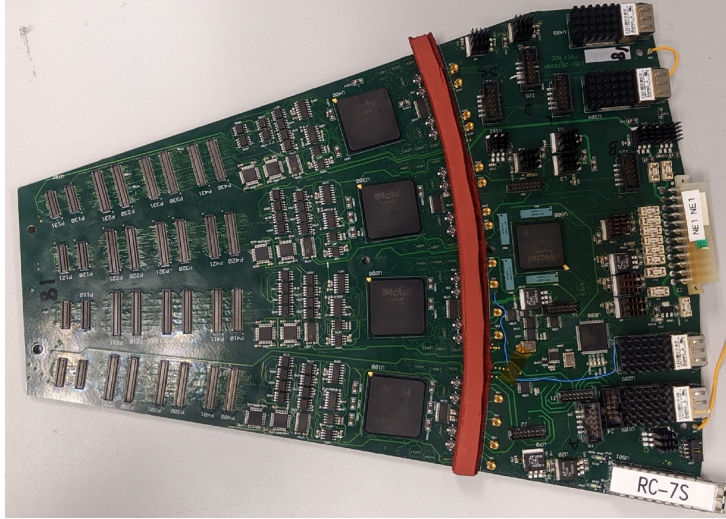
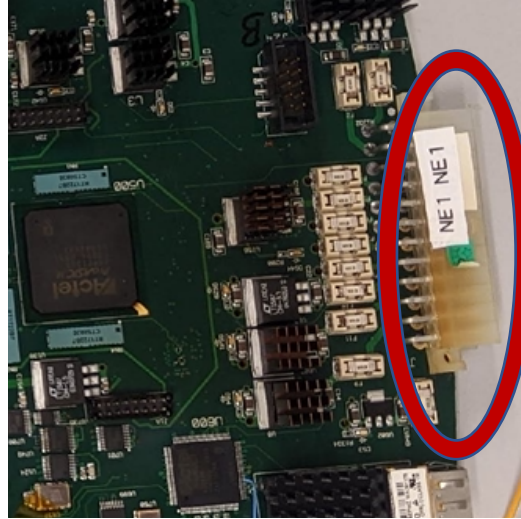
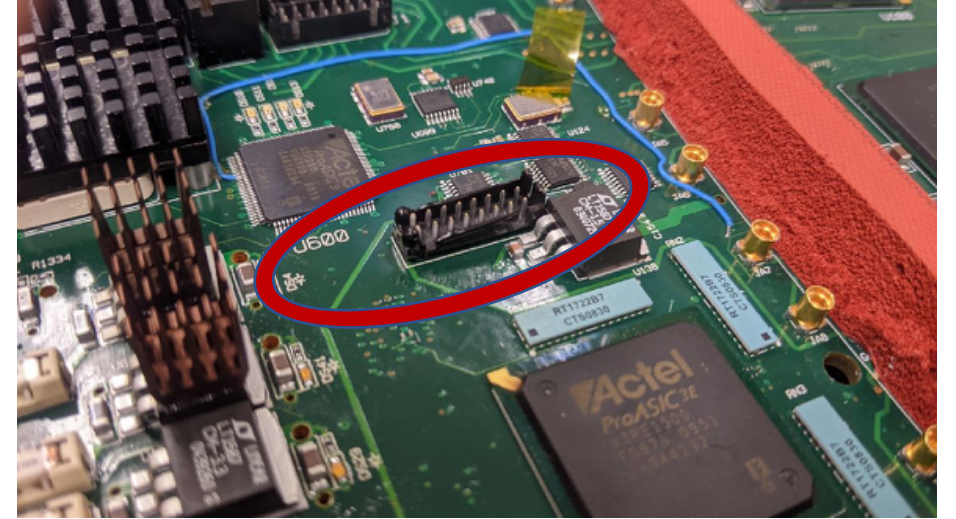
After Slow Control Replacement, some surface mount components on the opposite side are damaged.

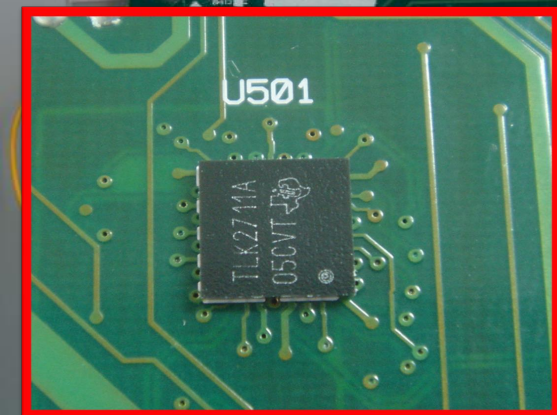
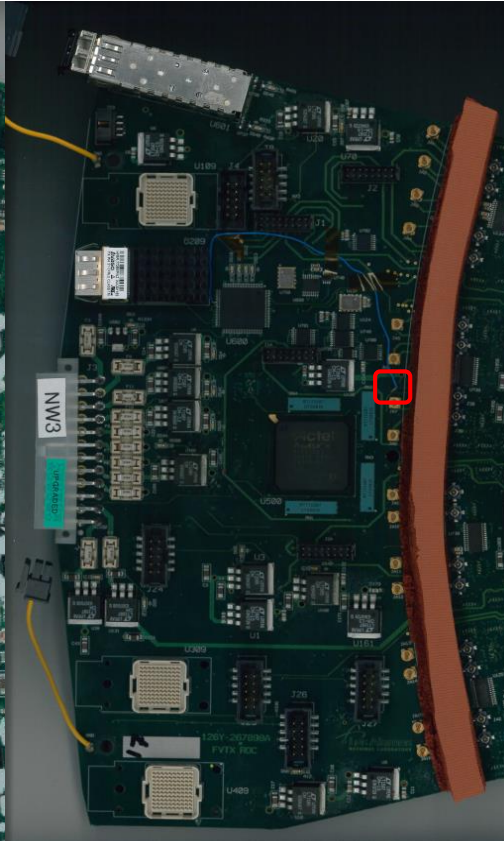
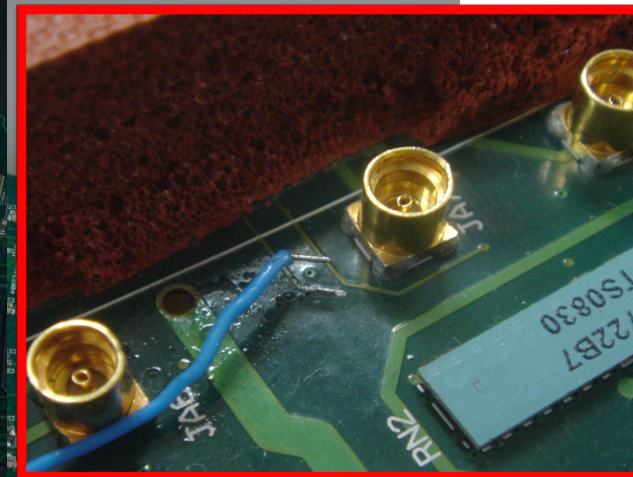
Jan 26, 2023 Replaced Slow Control TLK

Disconnected  
Jumper cable.  
-> Most likely this is  
the cause of the slow  
control problem.

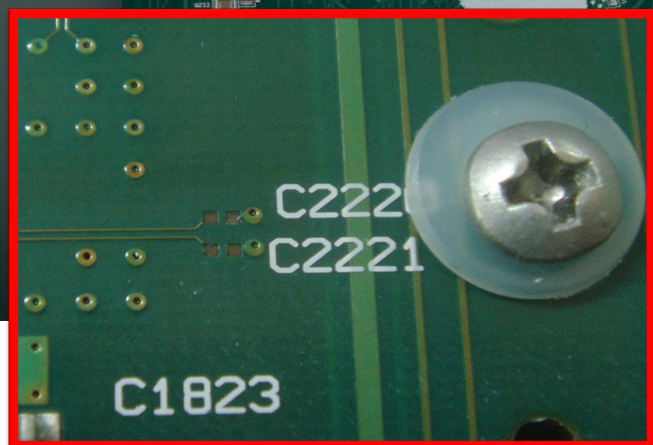
NW3

C2220, C2221 are lost.

They are AC-coupled capacitors which bridge between TLK2711 serializer and the HFBR722 optical driver. Loosing these capacitors directly means loosing the contact between them. This results in fiber latch problem. This is another scenario of the fiber latch problem. Again, the fiber latch problem is still 100% fixable.

- ・ U501の交換 (TLK2711AJRZQE)
- ・ C2220、C2221 (パット無し) : 0201 6.3V 0.1 $\mu$ F  $\pm$ 10%
- ・ ジャンパー線の再配線

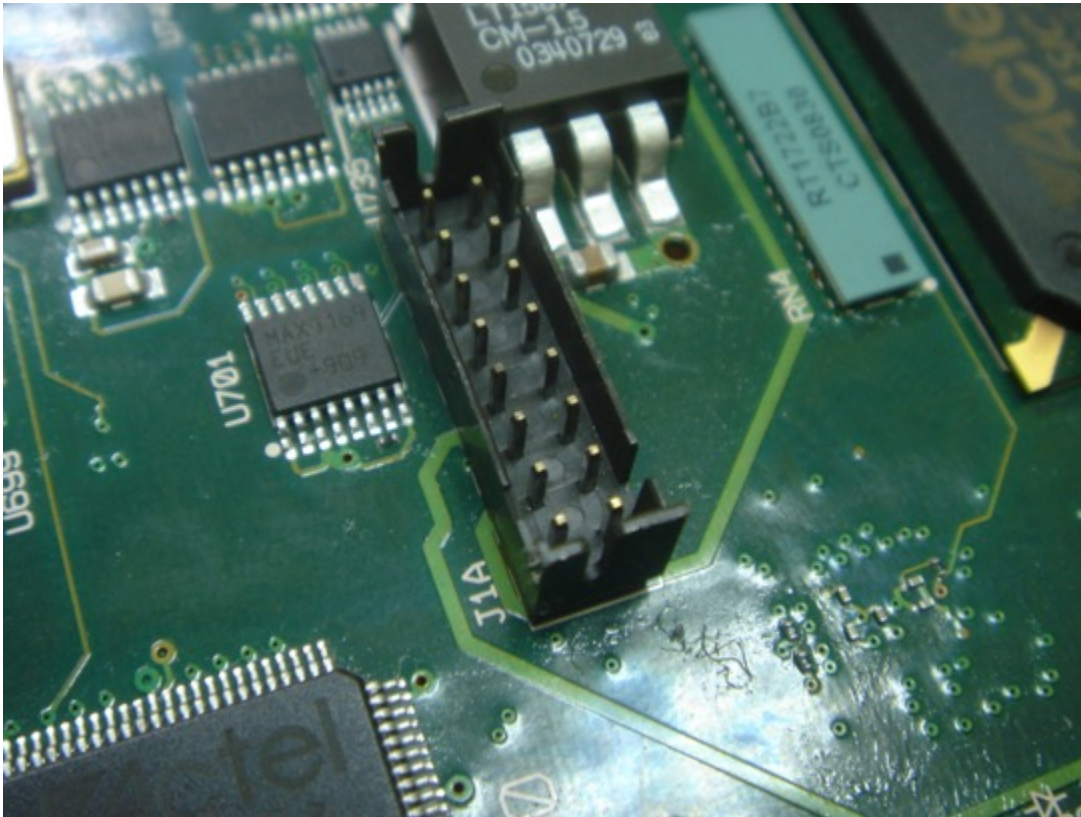
J1A connector is OK (no damage)

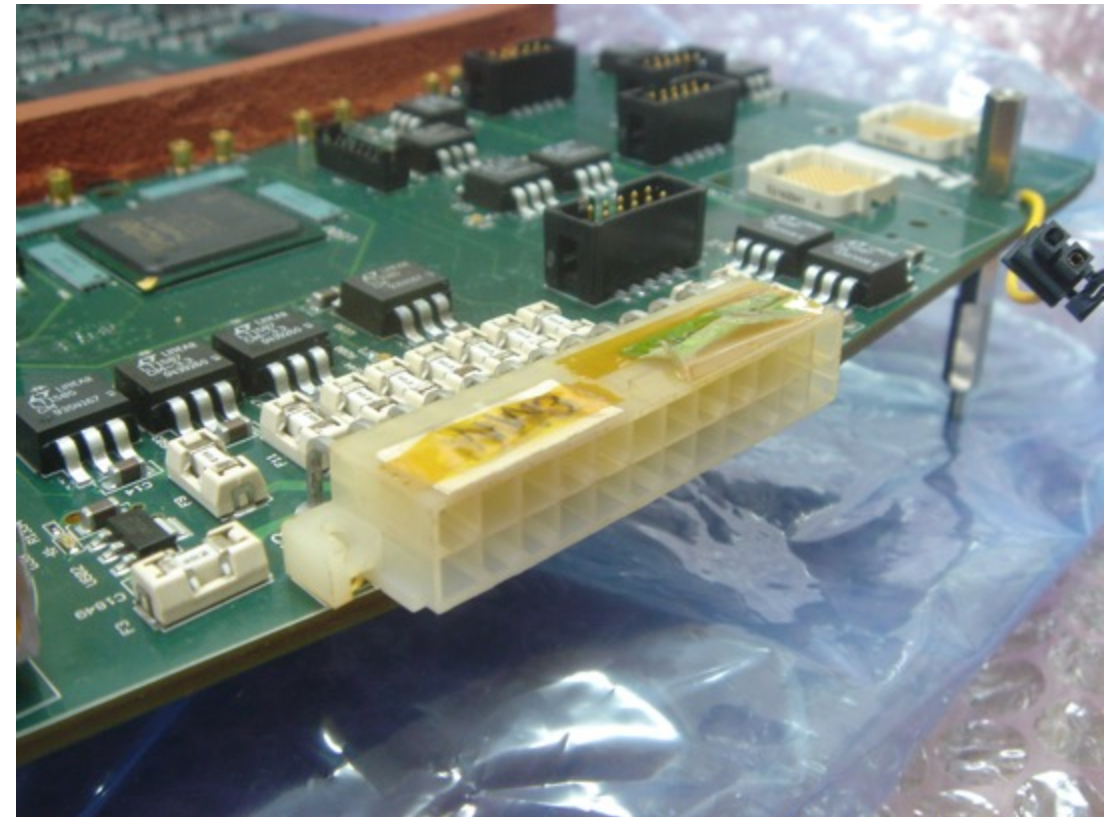
J3 connector was somewhat deformed by the heat

The replacement procedure was one-side heating, not double side in the company.

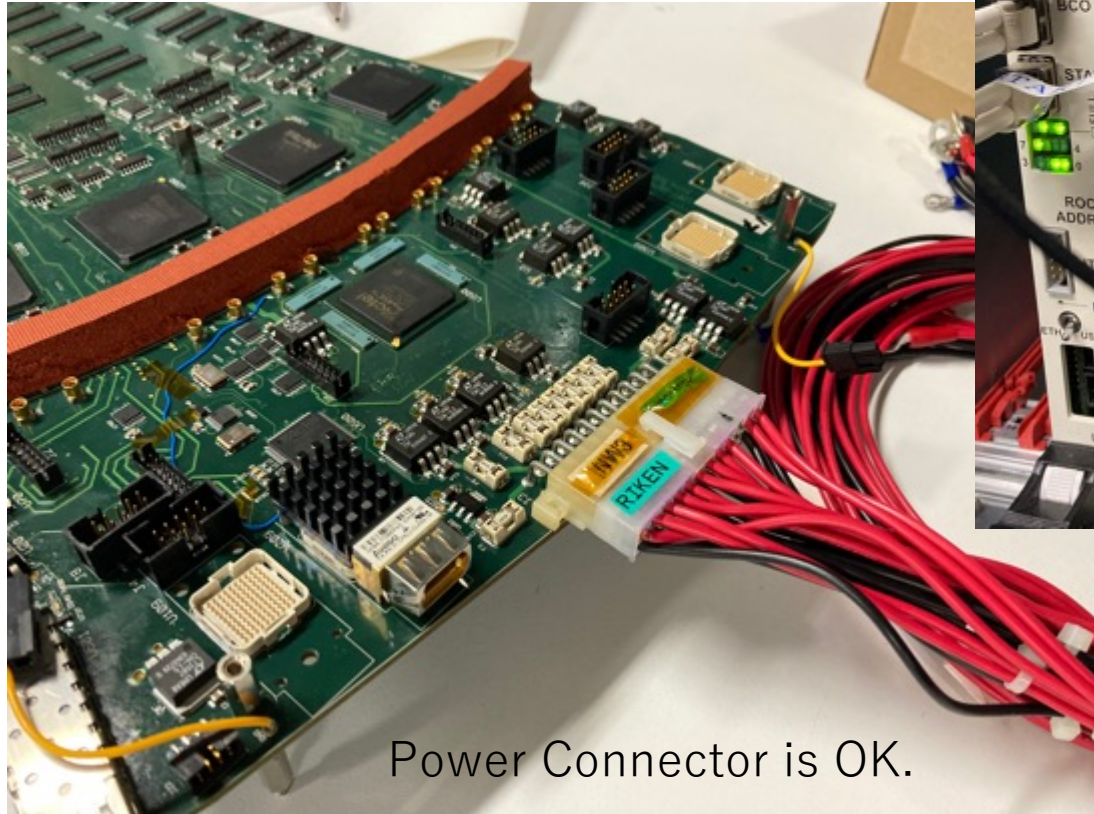
Power Connector is OK.

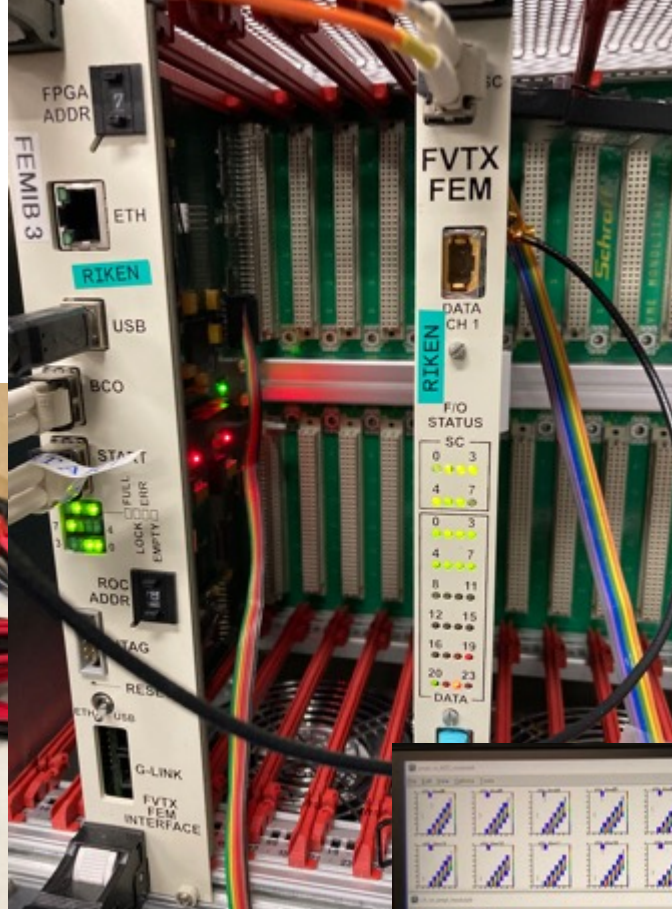
Slow control back in working.  
Fiber latches OK for all ports.

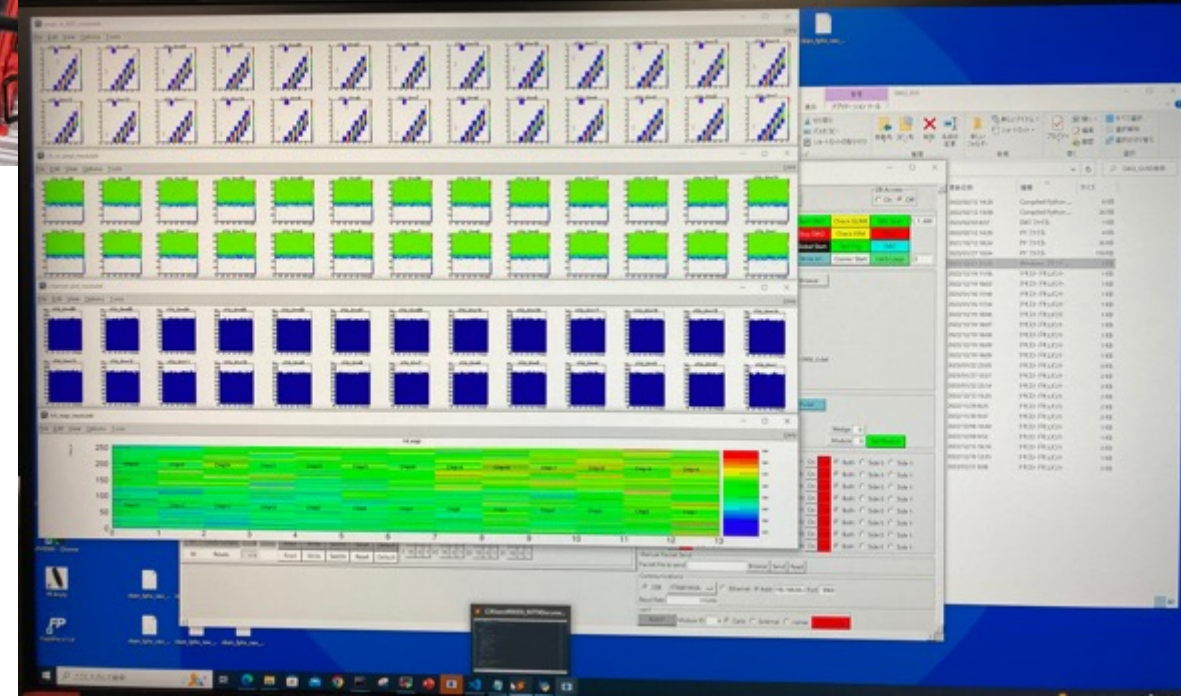
Good calibration data from B1 port.  
Other ports are to be tested next week.

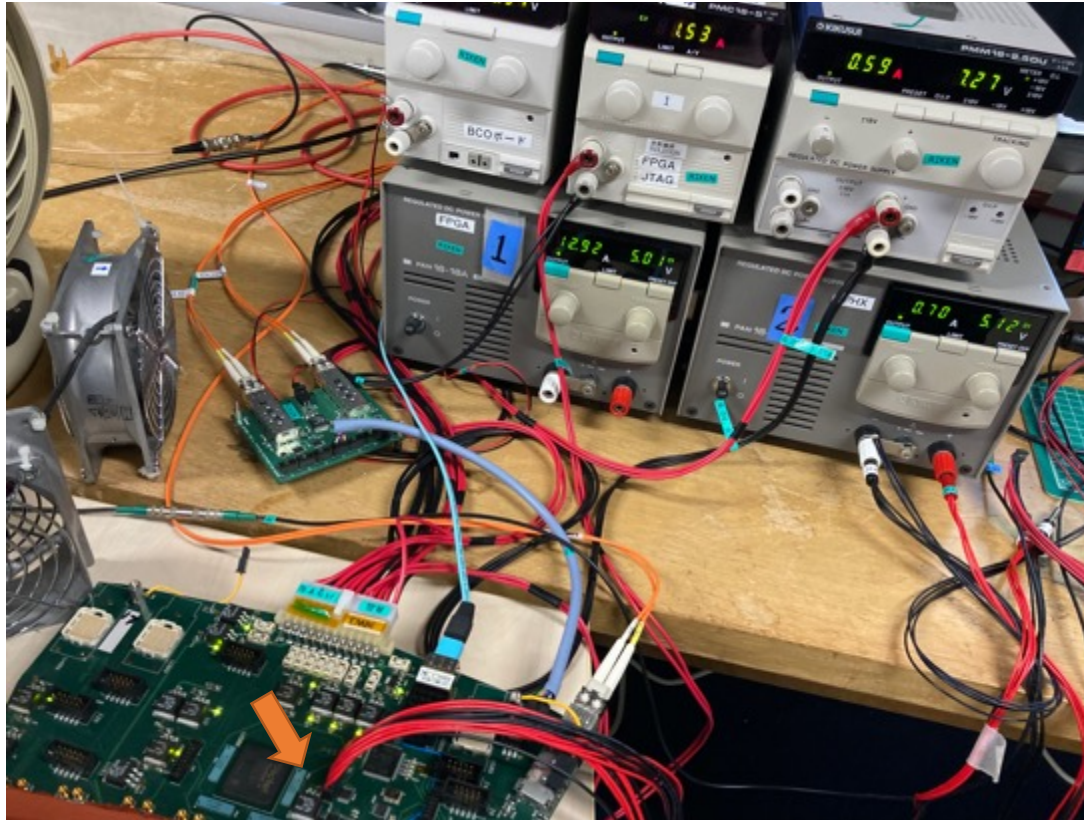
# Damaged J1A port

I happened to damaged J1A connector. It still holds the cable, but may be better to be replaced before use.
