U.S. MAGNET
DEVELOPMENT
PROGRAM

MDPCT1 coil 5 CT scan

U.S. MDP Collaboration Meeting
3/21/2023

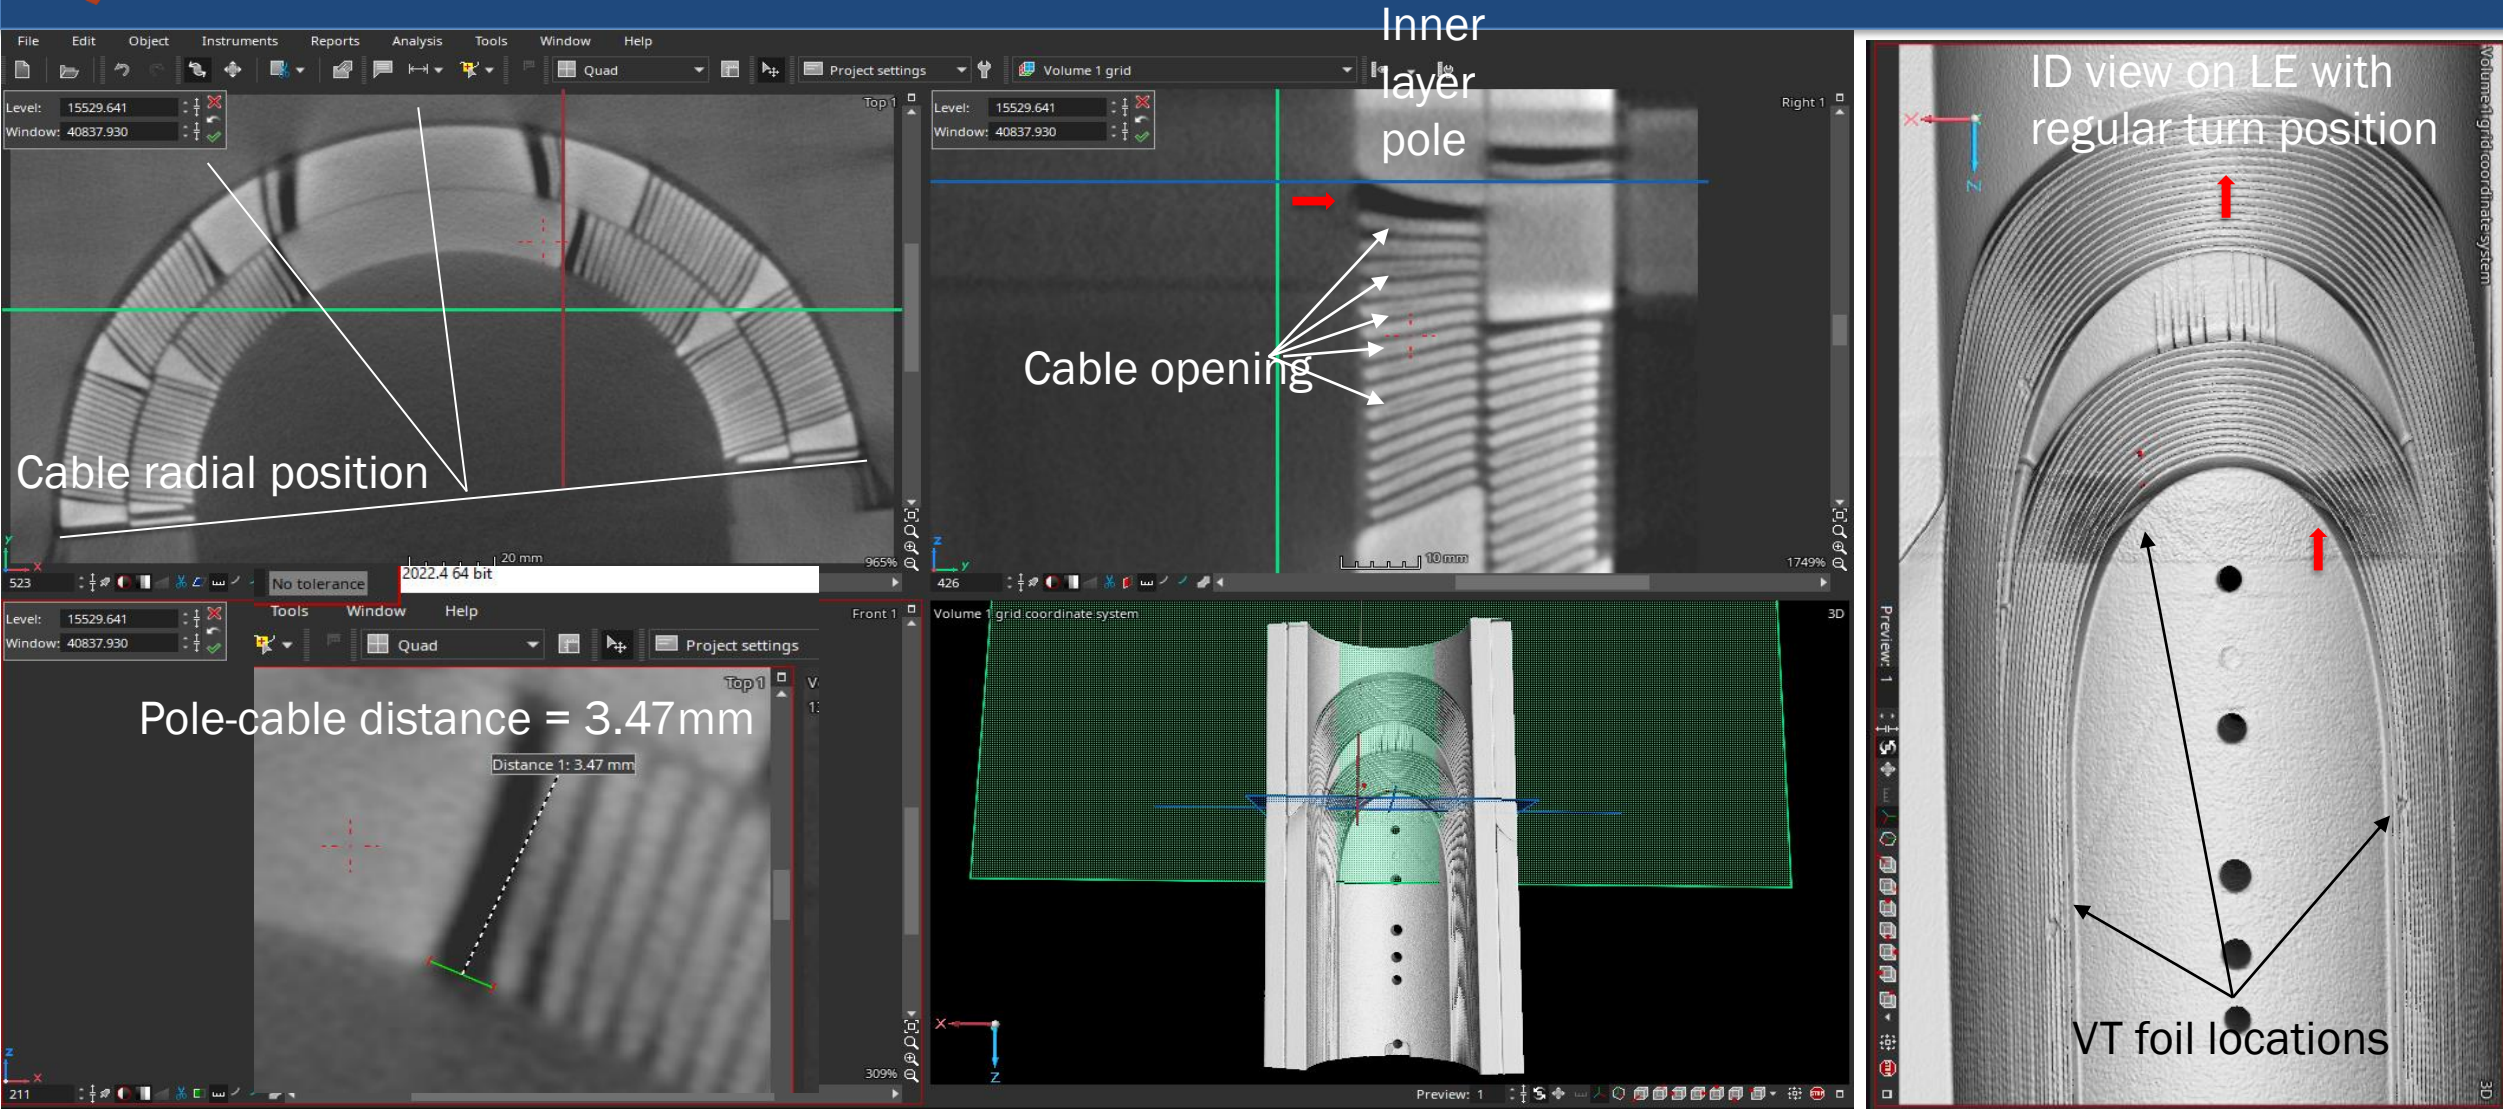
Coil LE winding quality

- First result of the coil 5 analysis shows a regular coil winding w/o visible parts defects
- Cable strand separations at the ends pointed to a soft coil structure for axial loading

- need better and more rigid end design
- Cable pole turn position is not optimal in the straight section and in both ends
 - require coil design optimization: to provide radial pole turn position in the outer coils by introducing wedges in the coil straight section and improvements of coil-end parts interface

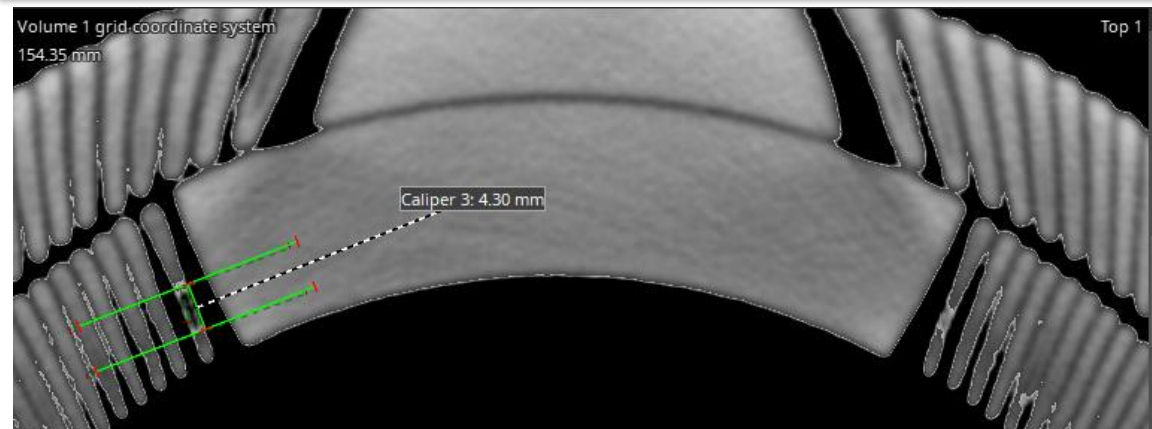
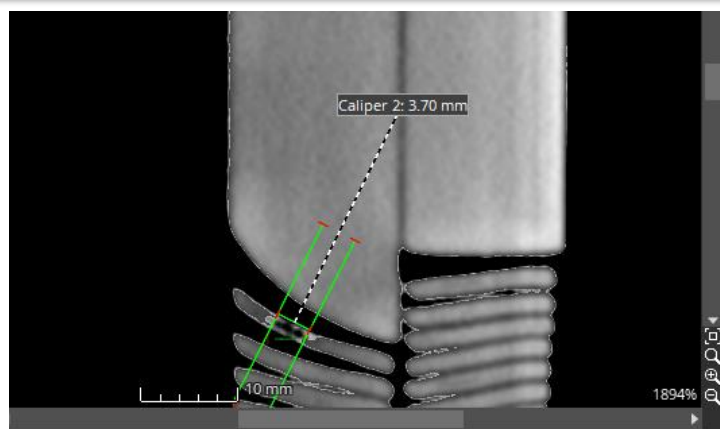
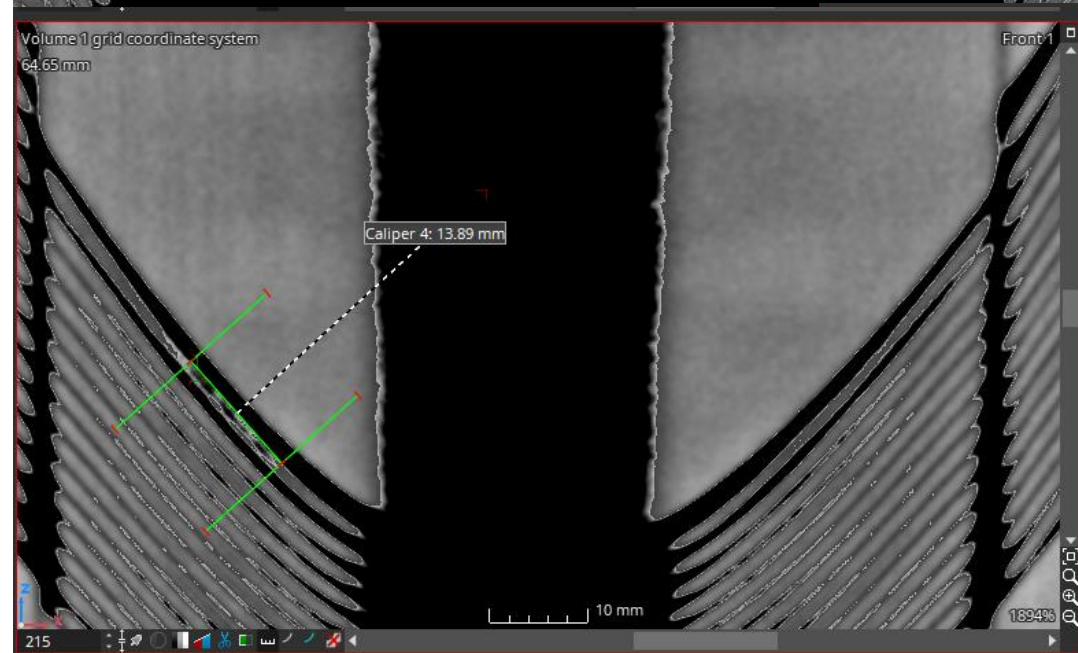
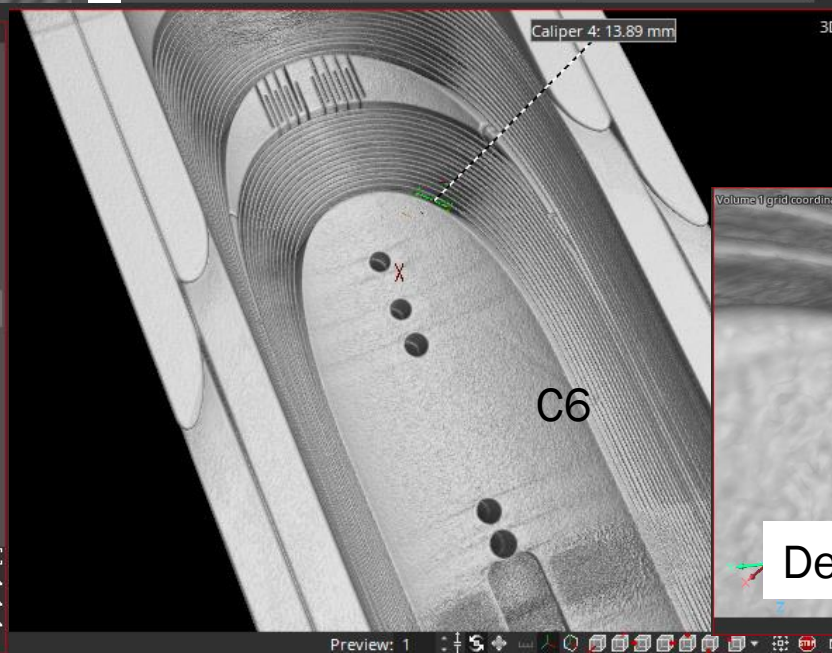
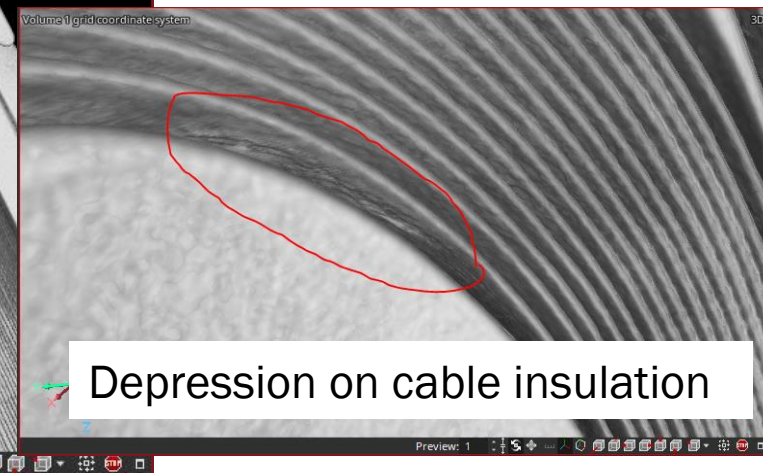
“Low-density area” on RE pole turn

- “low-density area” size ~4.3mm x 3.7mm x 14mm
- Two symmetrical spots
- Not on the cable edge
- Depression of cable insulation on one side
- Correlates with the limited quench location

Depression on cable insulation

- Cable property change, “low-density area”, observed in the RE, correlates with the limited quench location at TC3
- A similar but less noticeable defect is also observed in the straight section

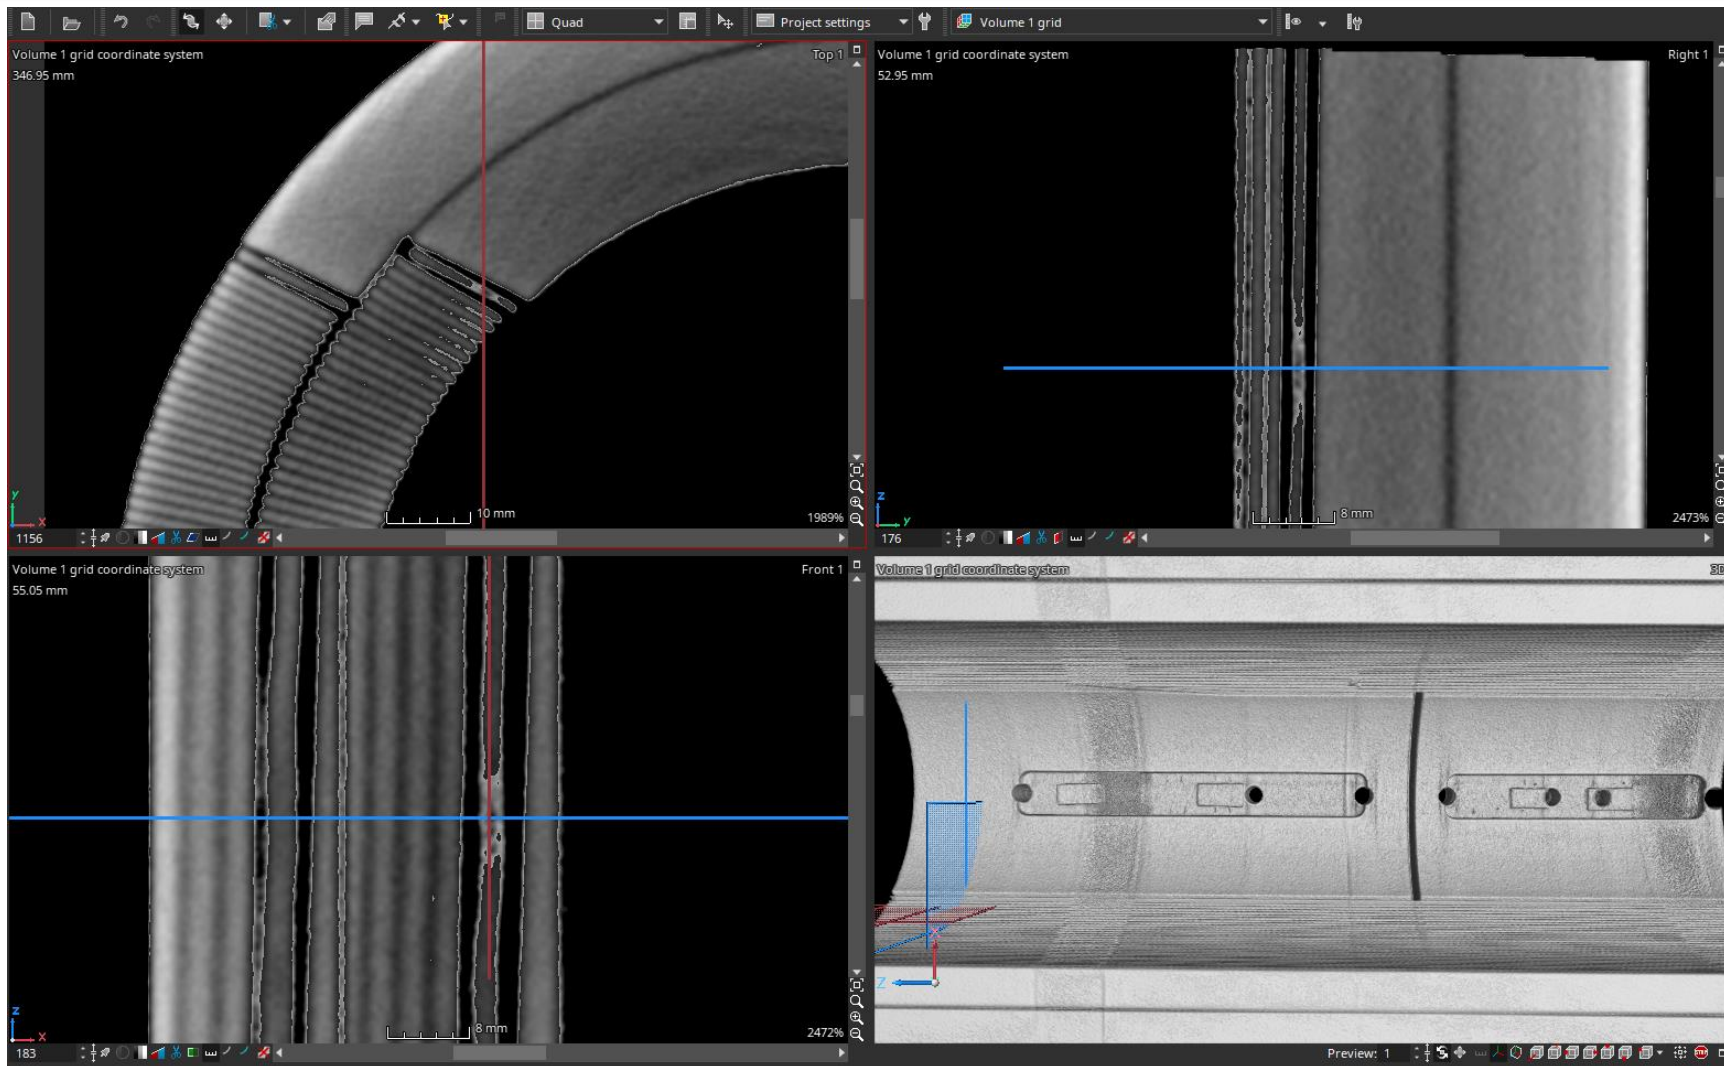
“Gray area” in the straight section pole turn

- Similar, smaller spot can be seen on the pole turn in the coil straight section near the LE
- Not on the cable edge

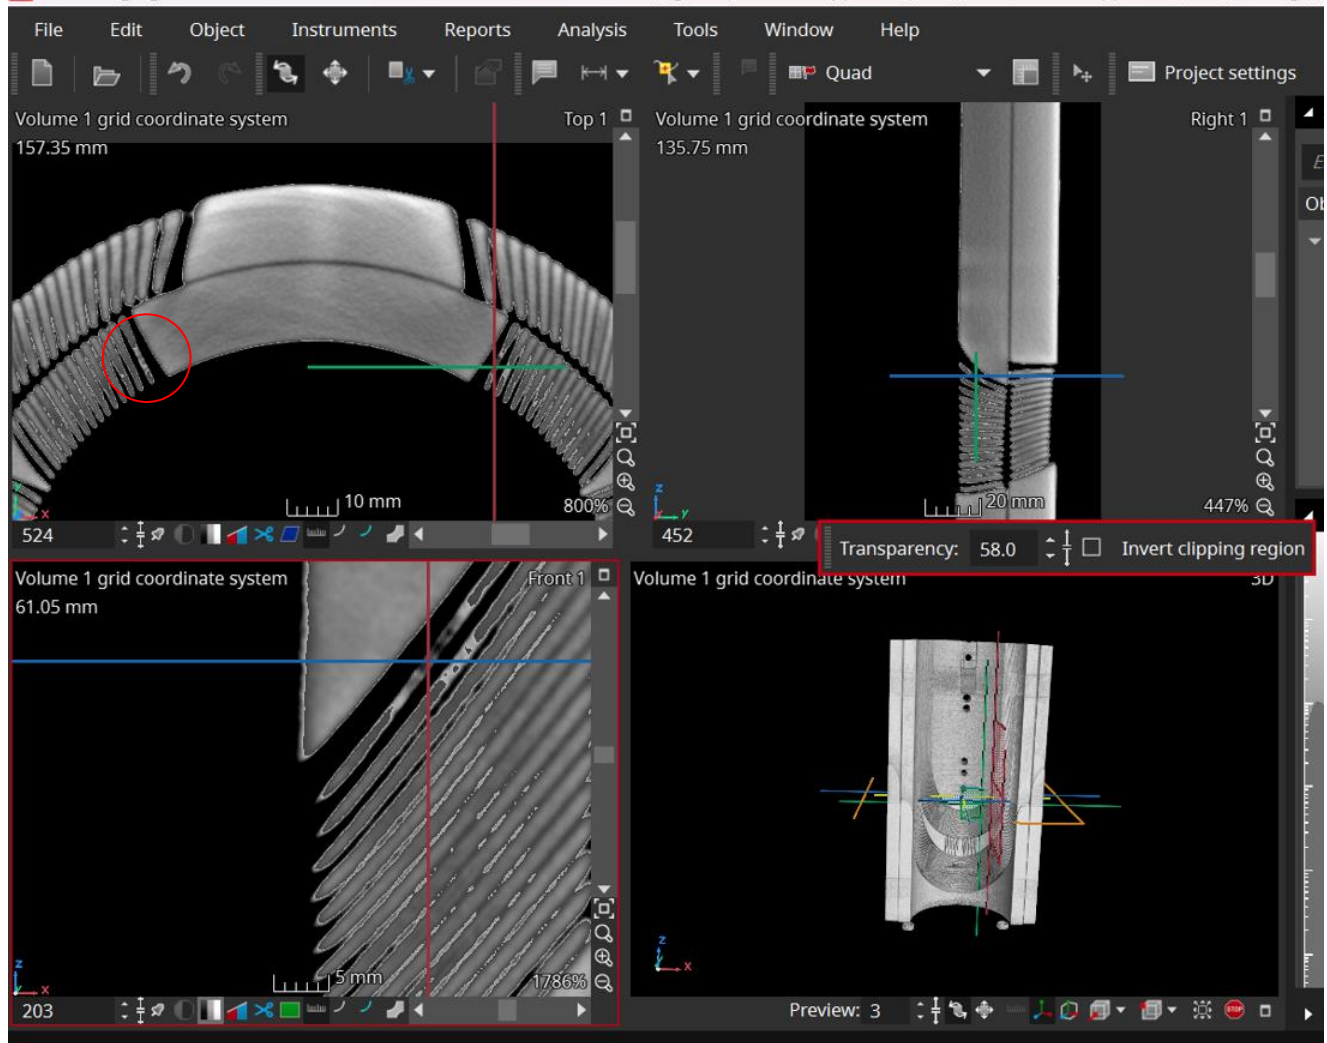
In some areas along the coil ends, we see spots in pole cable cross-section on both sides (marked in the pictures). Could be interpreted as a cable properties change or it's just a software problem?

- In our opinion, it appears that the wire is stretched or smashed so the density is less. In the color and opacity mode the window and level is changed so that the contrast is much higher and it shows the surface changes.

- Also, if we manually change the window and level of the exploded area we can see changes in density. The copper strand resistance may increase with a stretching fatigue and will turn into a crack over time with heat and flexing.

- I don't know if this helps but it is a good bet that the strands in question may be damaged.
