Status of machining of tiles at UCR

Miguel Arratia,
University of California, Riverside

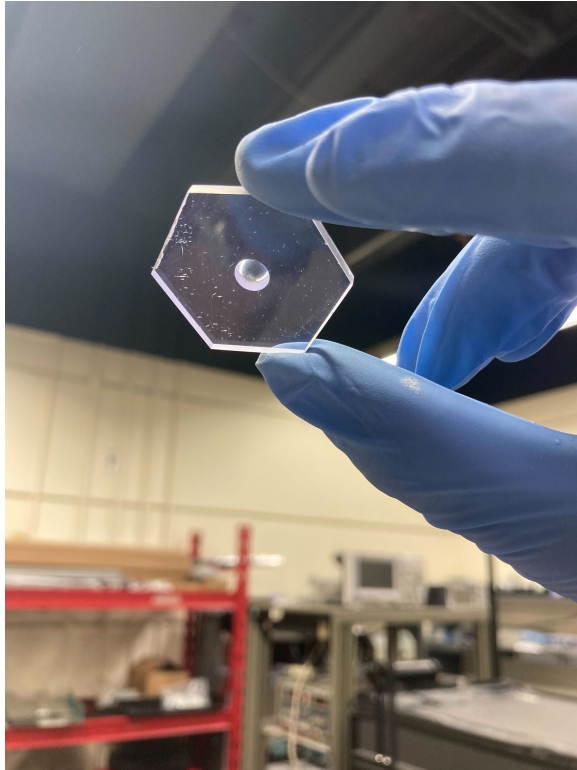
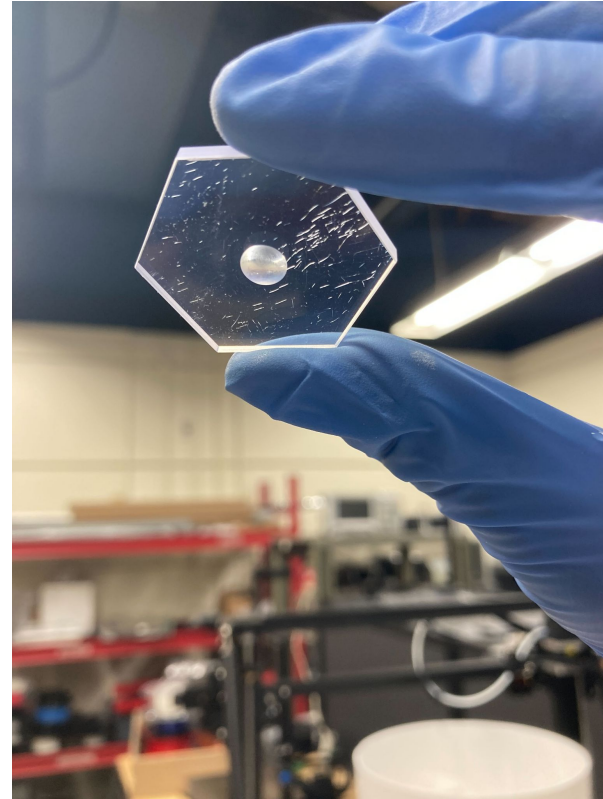
But after a while (weeks), we started noticing crazing

Likely culprit: Traced that our machine shop was using standard coolants , and “scraping” piece afterwards by hand.

New method: submerge in water while in vacuum chuck

we got rid of most obvious culprits (we are not using chemical coolants, or compressed air, or alcohol, or clamping of any sort)

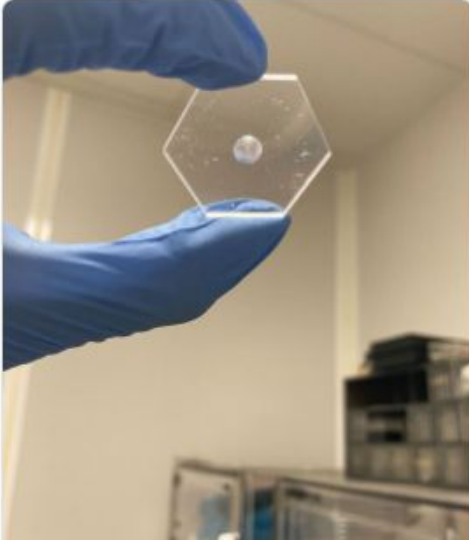
IMG_4694 ▾

There are many scintillators created last week done by the old method in the clean room that are already showing crazing. This doesn't apply to the ones created in the new method.

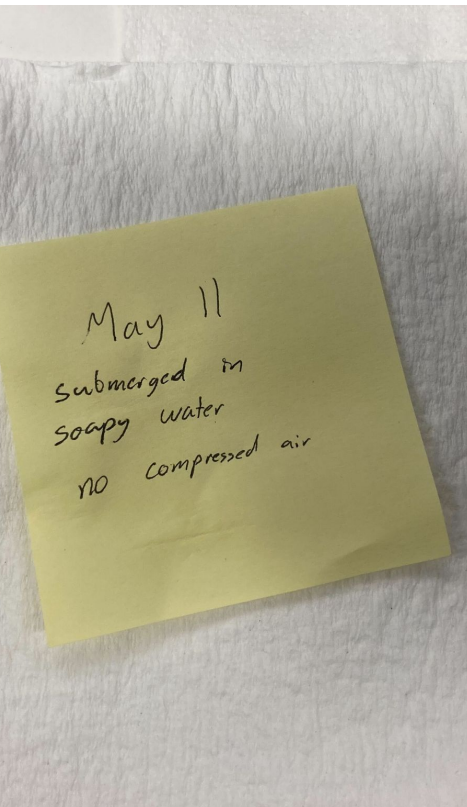
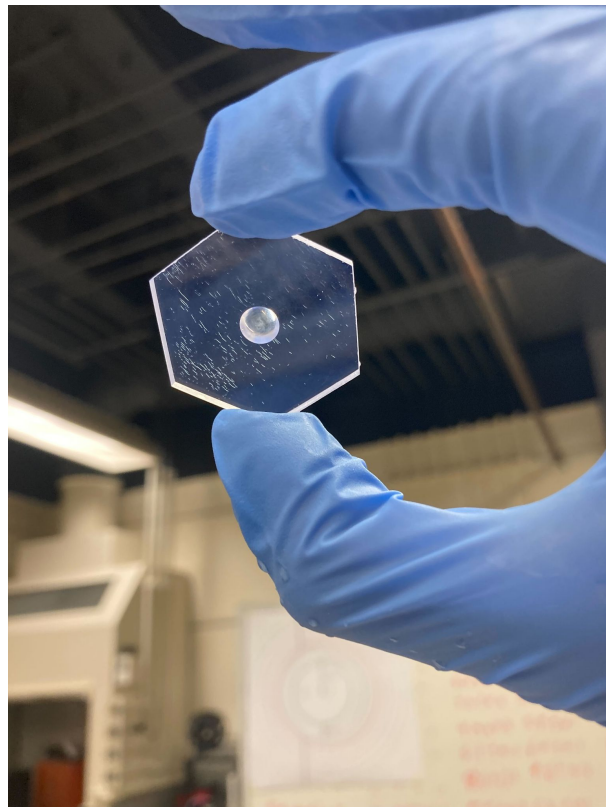
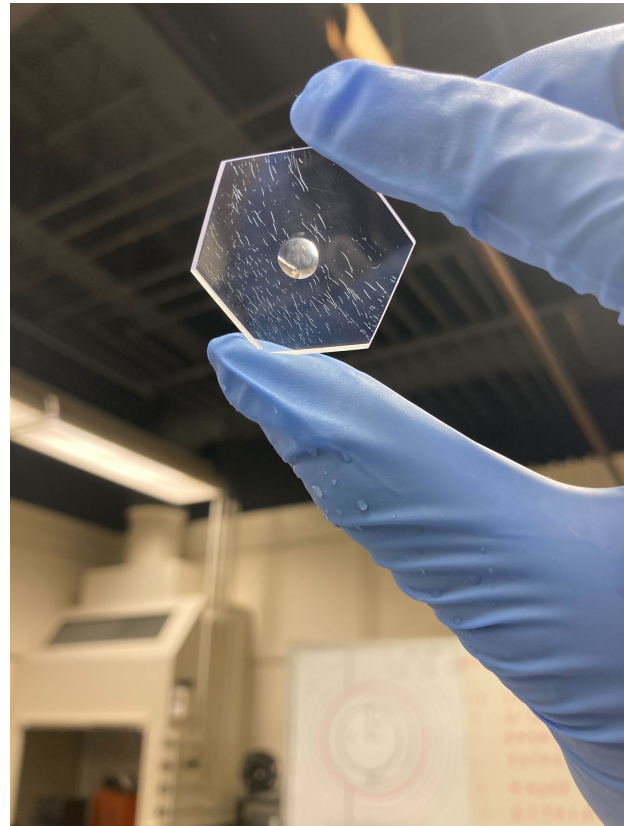
Bad news, newer method still produces crazing (but later than old method)

Batch made with refined method (submerged in water for cooling, no compressed air) shows this level of crazing after ~1 month

We suspect that annealing of the scintillator might help with the crazing

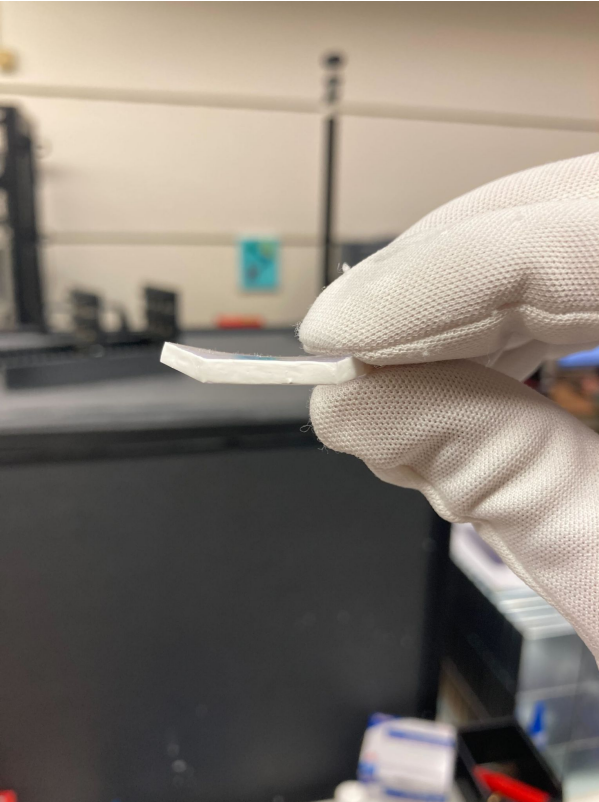
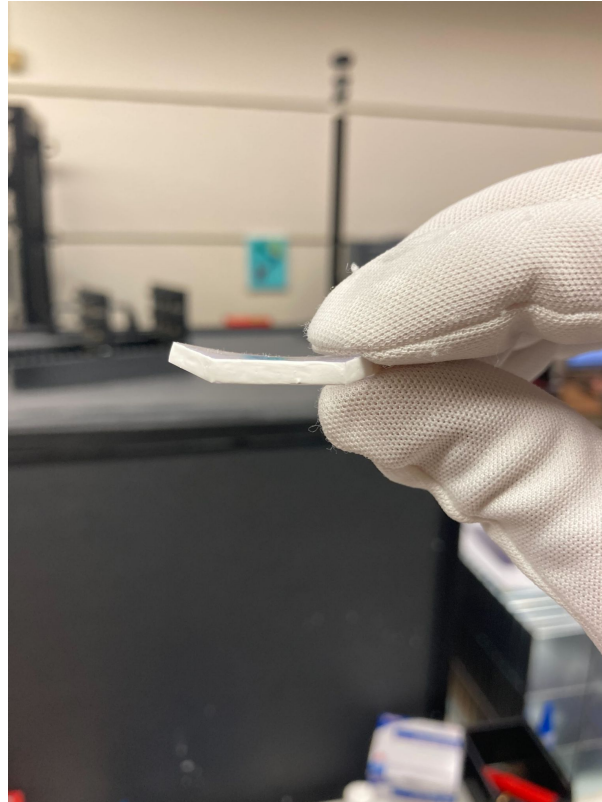
First try at annealing (48 hr, 80 C)

Some warping seen in the scintillator tiles (right one)

→ This was too much

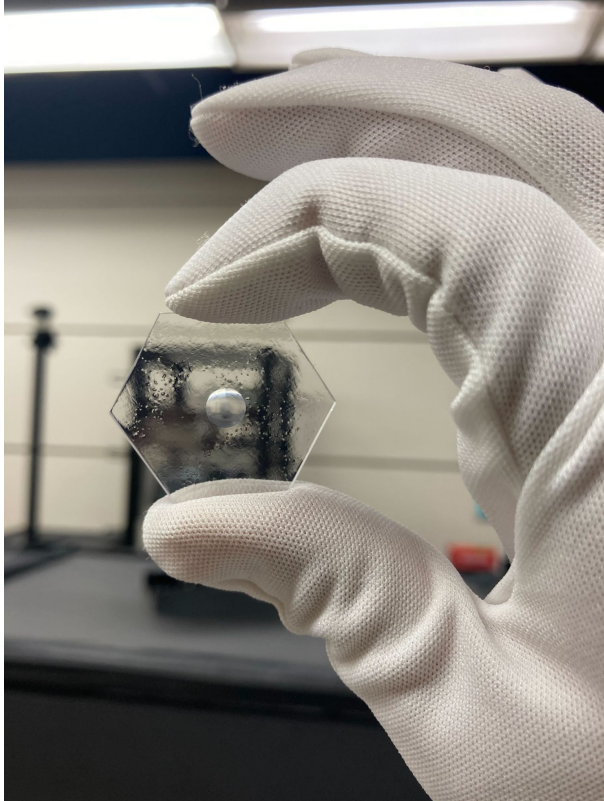
First try at annealing (48 hr, 80 C), continuation

Crazing is gone, but some texture appears

→ This was too much.

We also changed the resting surface to soft cloth (from plastic)

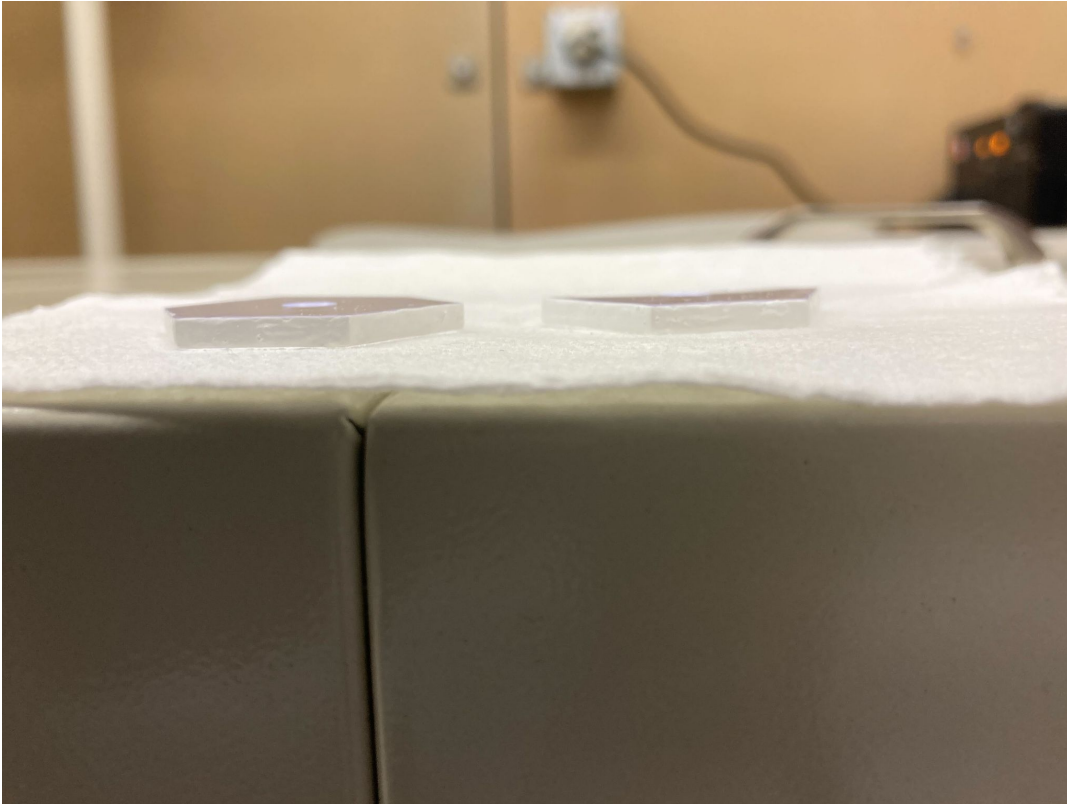
Second try (12 hr, 80 C)

Some warping seen in
the scintillator tiles
(right one)

→ This was too much

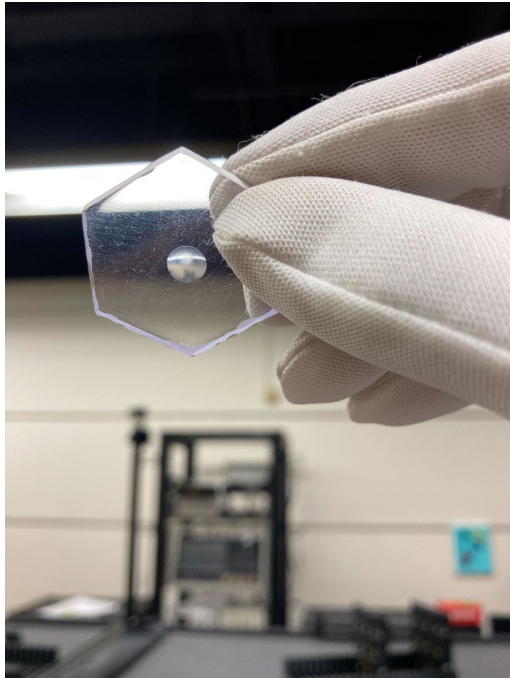
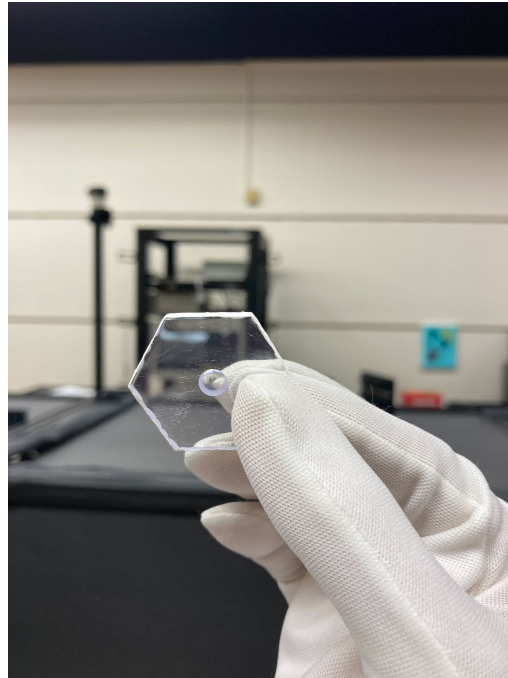
Second try with another pair (12 hr, 60 C)

No warping or texture added to scintillator but crazing still there

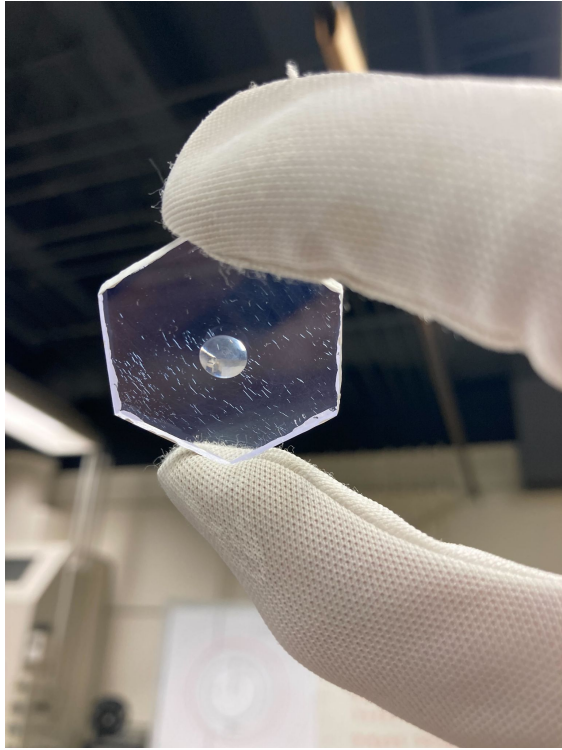
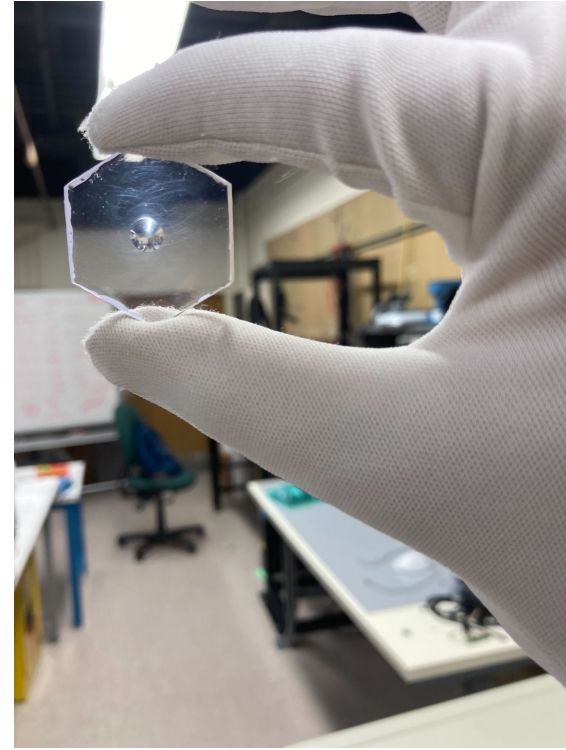
Before and after annealing (4 hr @ 80C)

Crazing goes away with annealing, no evident trace of it. We will keep the tiles using these tests under observation

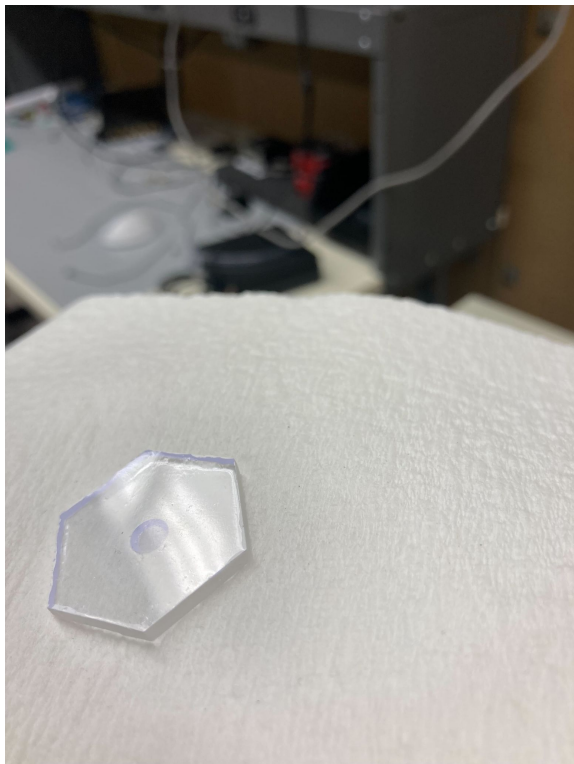
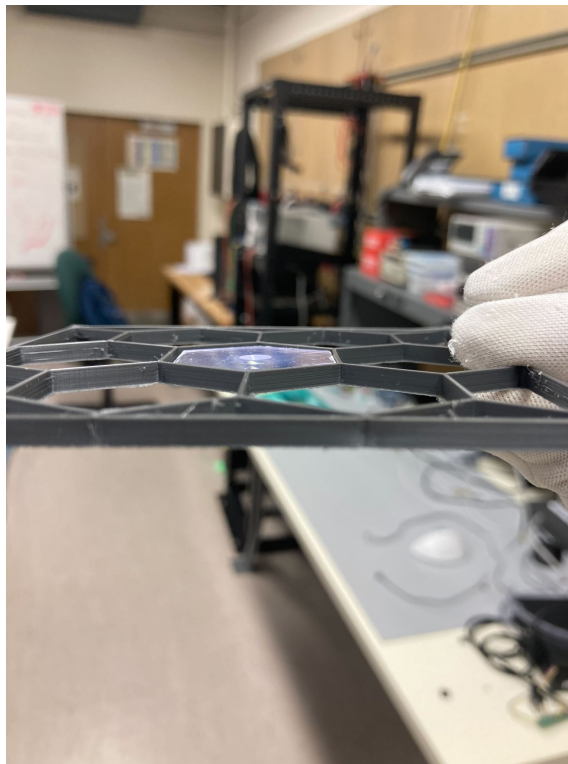
No noticeable warping or texture in the scintillator with the annealing (4 hours, 80 C)
