Status of 1004B Valve Box / Ring Repair

3 Oct 2023

1004B "Valve Box" Failure Timeline

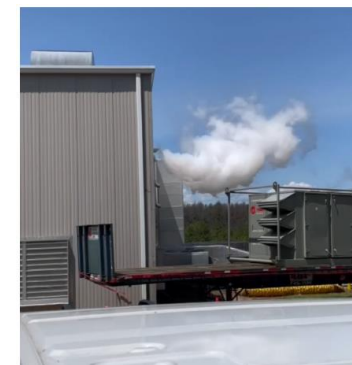
Helium venting at Bldg. 1004B

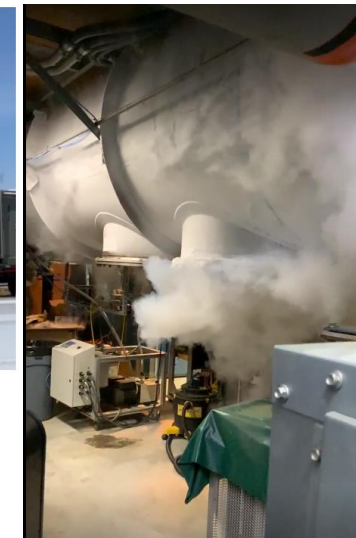
1004B Valve Box

Helium leak

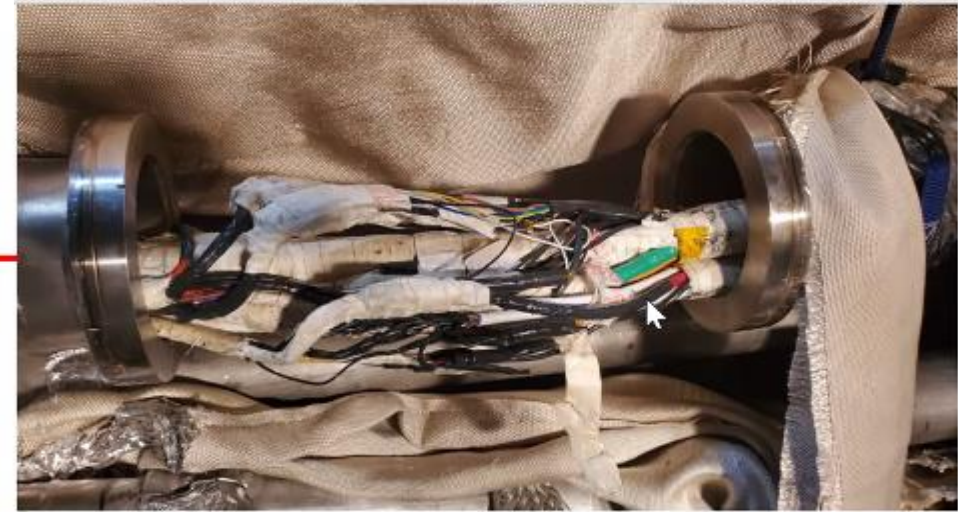
Splice can #1 after opening (no trouble found)

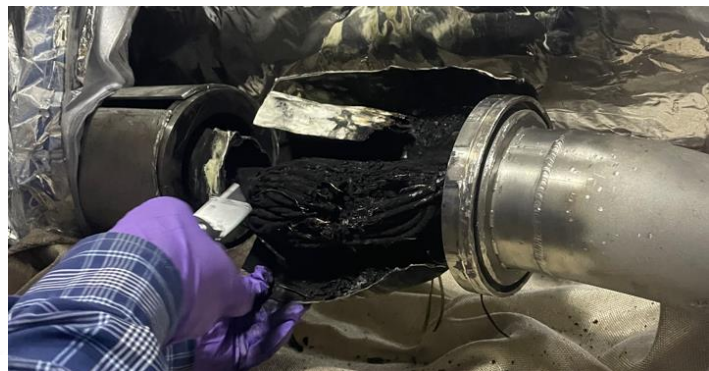
- “splice can #2” at IR4 DX magnet found severely damaged 27 Sep 2023

damage inside splice can

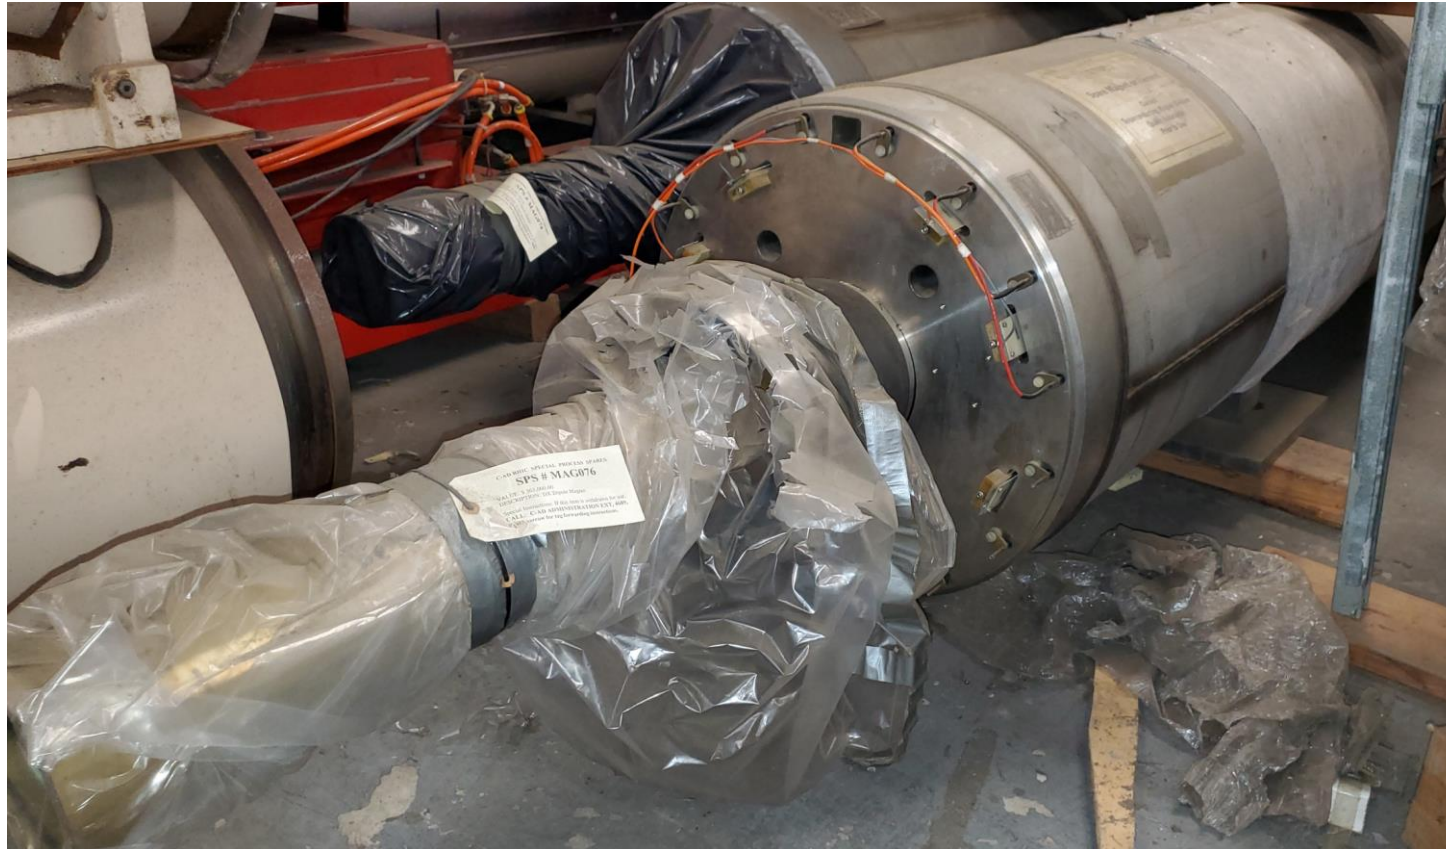
DX Cold Mass/Yoke assembly - without end volumes (from special process spares inventory)

- The DX magnet from the tunnel and two other magnets from storage (spare and prototype) being moved to Bldg 912.
- Spare DX magnet to be built-up for installation, tested warm, and re-installed. Scott Seberg is lead engineer.
- Samples of the Cold Crossing Superconducting bus (CCB) will be used to train and test staff on doing the SC cable splices.
- Causal analysis not complete, contingent on inspection of DX magnet.
- Schedule yet TBD, contingent on inspection of DX magnet.

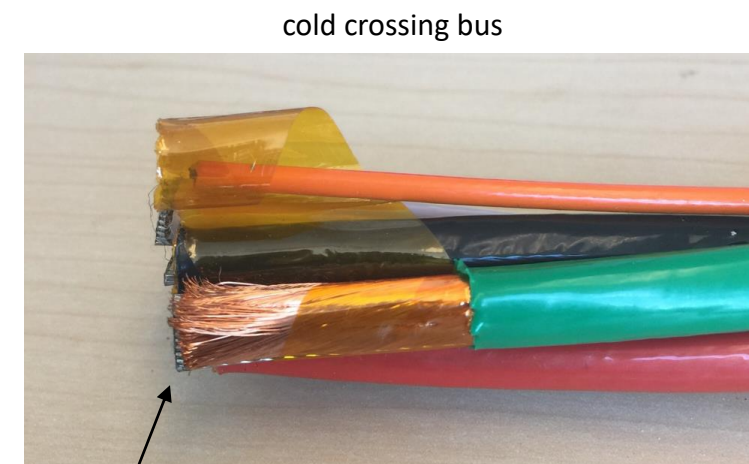
flat superconducting
cable (hard to see)

The very last sentence mentions the 40 ohm measurement that as not understood. That value has increase to many megaohms after the bad splice joints were opened. It was an artifact of all the cables in the spice can being shorted together and the soot that covered many things.
