12 by 150 amp warm to cold feedthrough Failure analysis

John Escallier

11/28/23

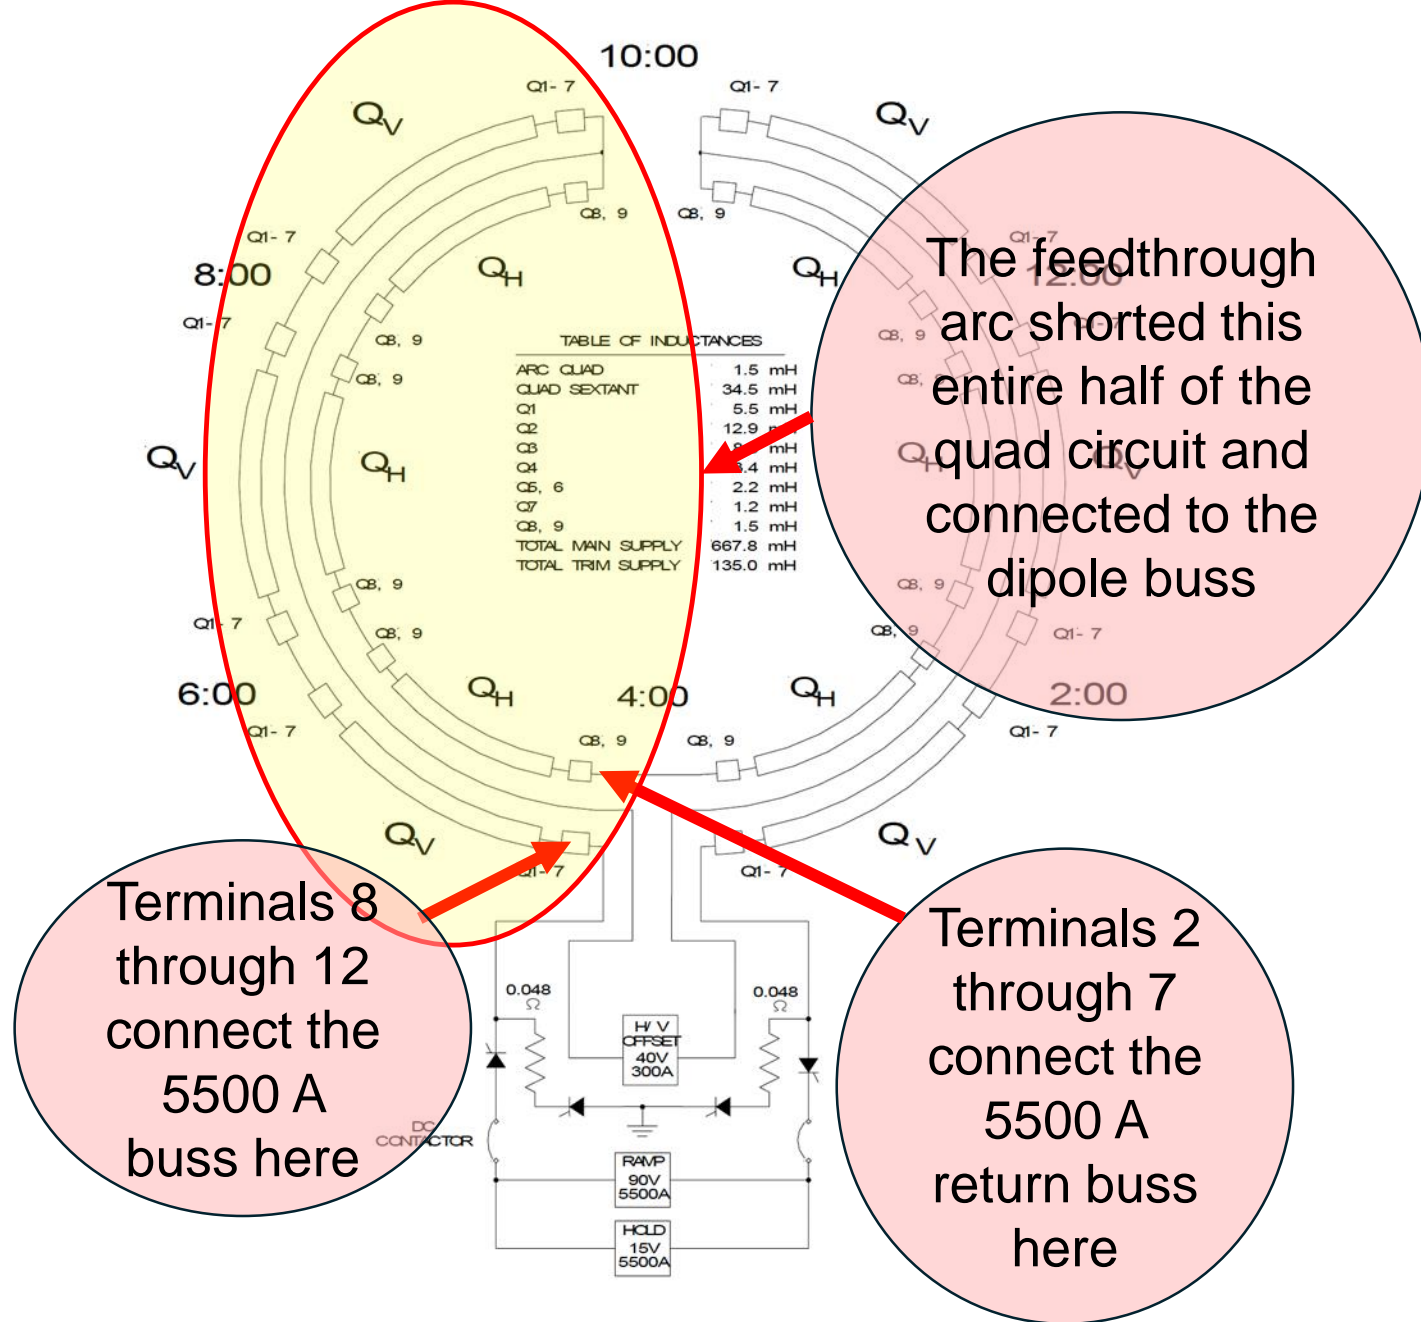
Feedthrough TBD
Where it connects to in
the ring

Fig. 2-3. Main quadrupole bus layout.

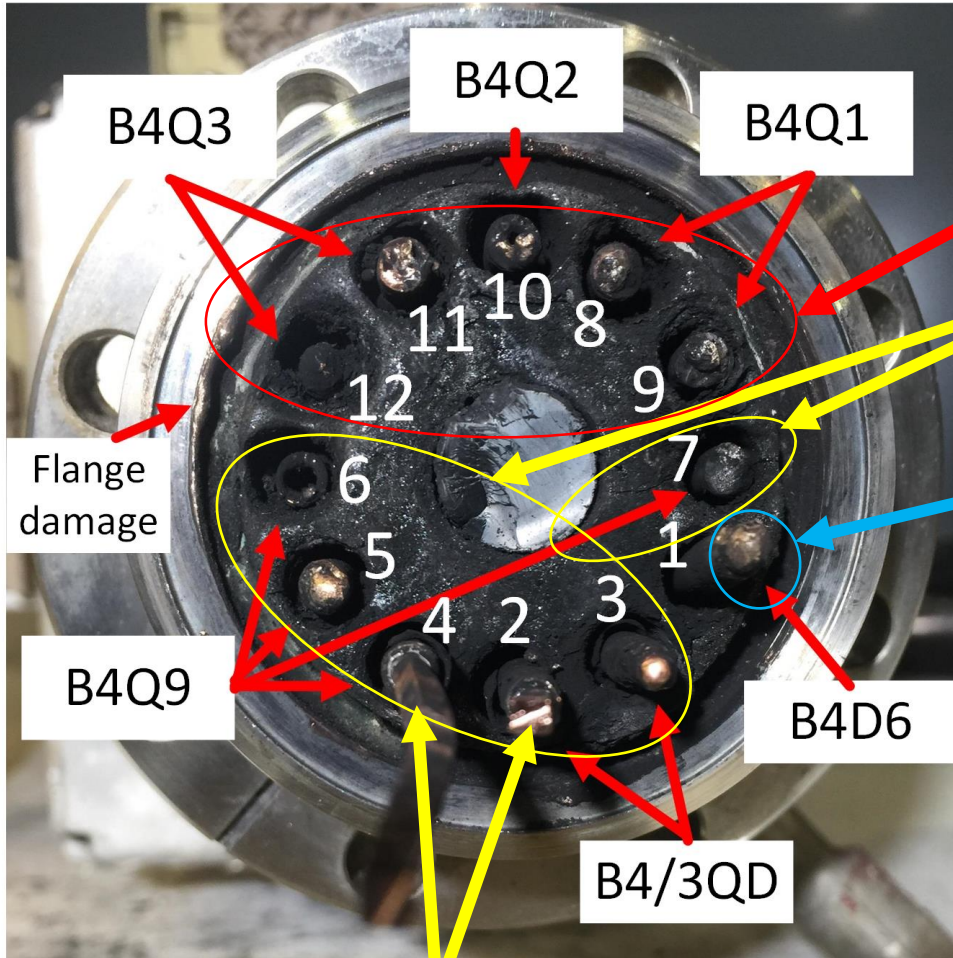
Terminal layout at the end flange

Note pin pairs 9/7 and 12/6 have half the full quad string voltage between them during ramp up and down

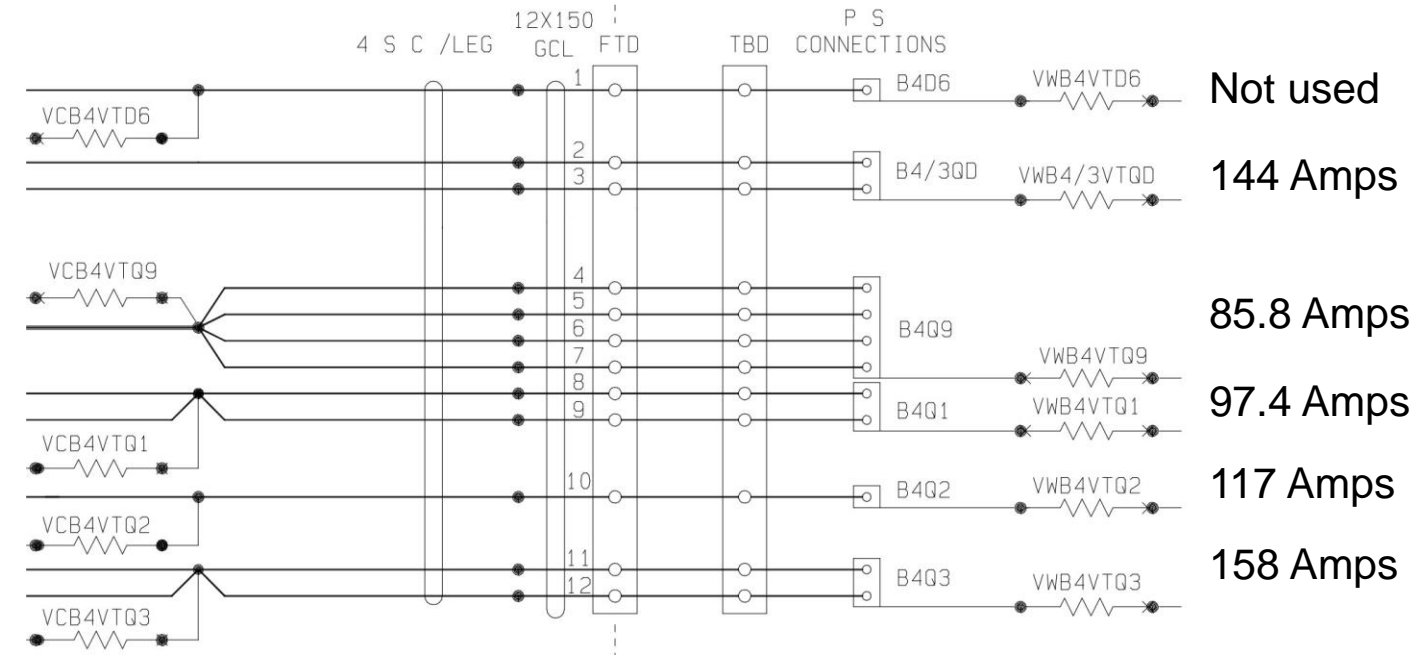
Terminal connection schematic

Two conductors untouched by arc at flange. Both were cut at the bench

Burn pattern in the heat-shrink Teflon (FEP) points to one conductor

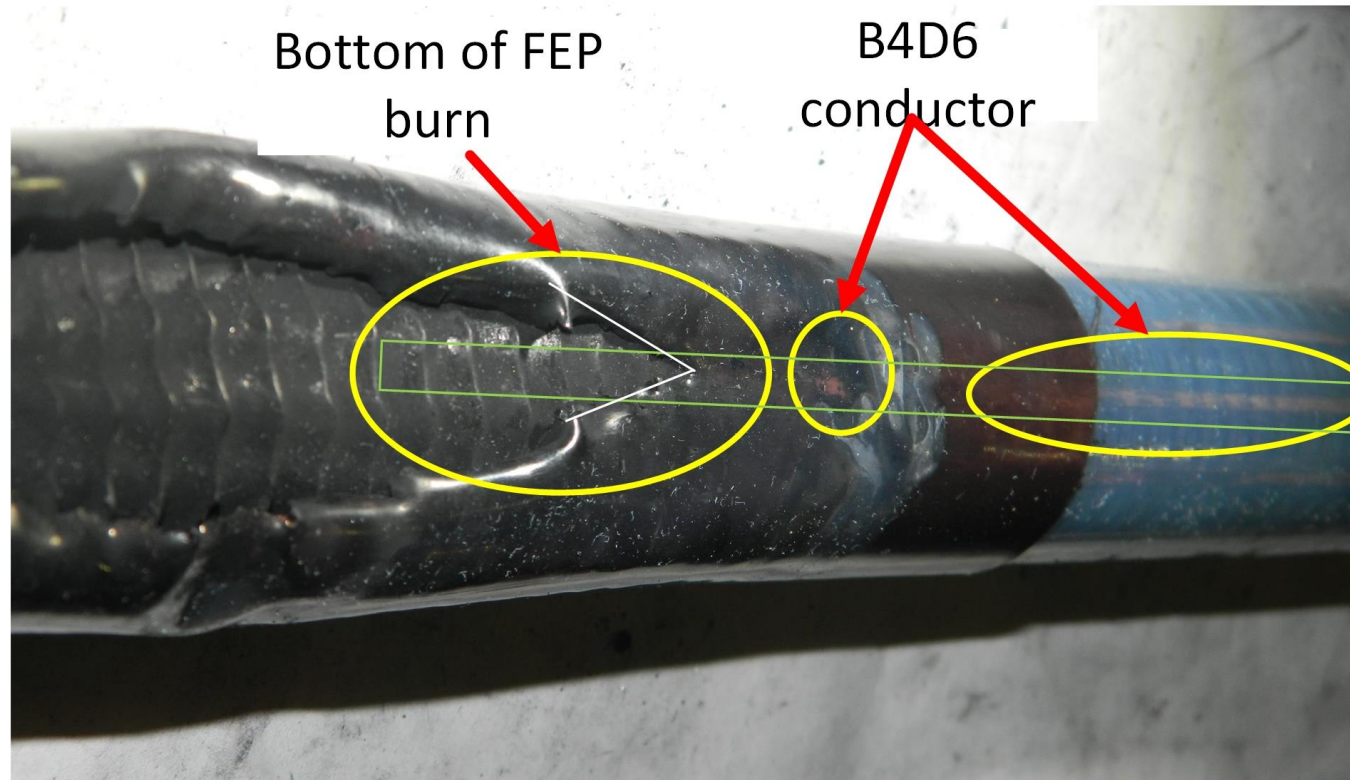
The B4D6 conductor connects directly to the dipole 5500 amp buss at magnet D6. It remained energized the longest of all the conductors in the feedthrough. When the arc initialized, it instantly connected the dipole buss directly to the quad buss. At .45 seconds, the hard quad connection broke to intermittent. The dipole remained hard to ground until 1.35 seconds in, then went intermittent. During this fault, very high currents were travelling through the B4D6 wire. These currents exceeded the solder joint design capability in the splice bundles at the ends of the DX cryostat.

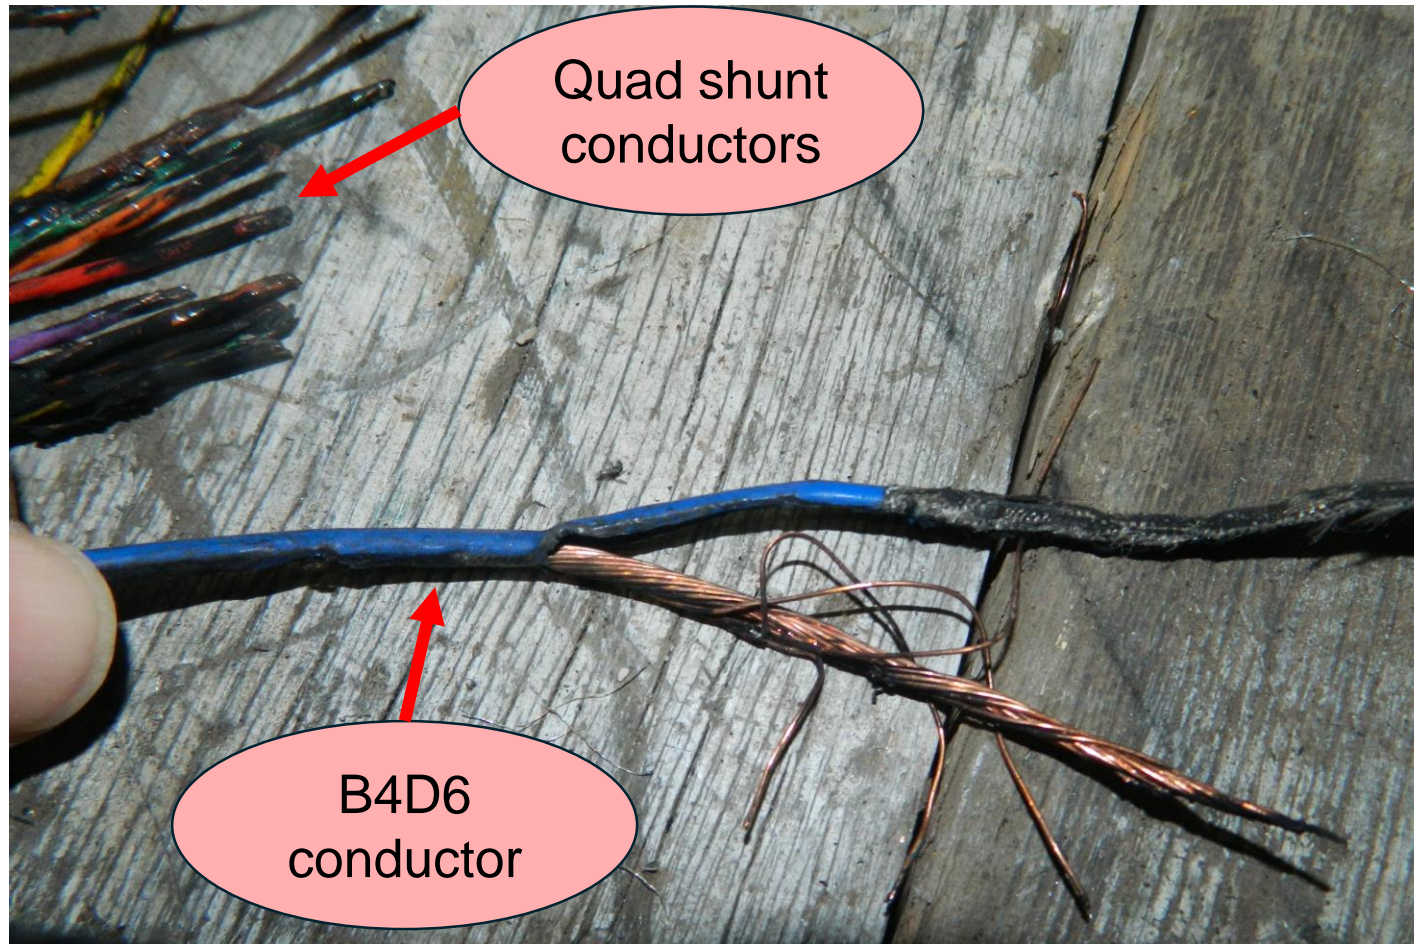
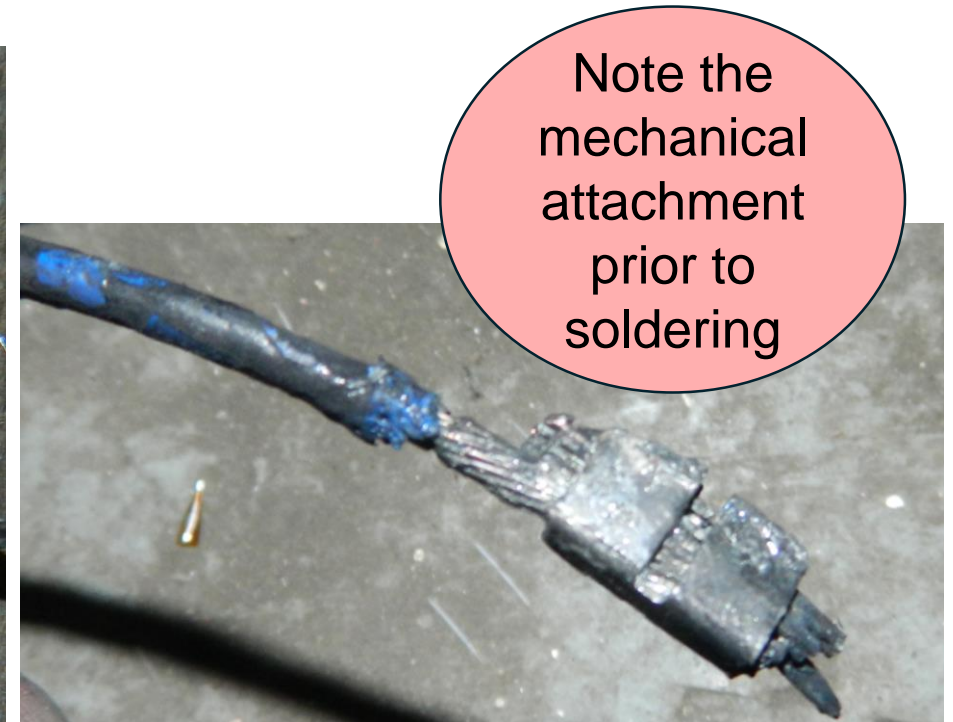
B4D6 to DX trim supers splice joint

Wires that were burned in the splice joint in the tunnel: B4D6 (blue) and trim supers for Quad shunts

The splice package had to support the >500 amp ground currents on quad and dipole through these wires and splices. As a result, the splice dissipation forced the conductors to go normal and burn. The 5500 amp cables were not burned in this manner, they had sufficient mass to carry them through the event.

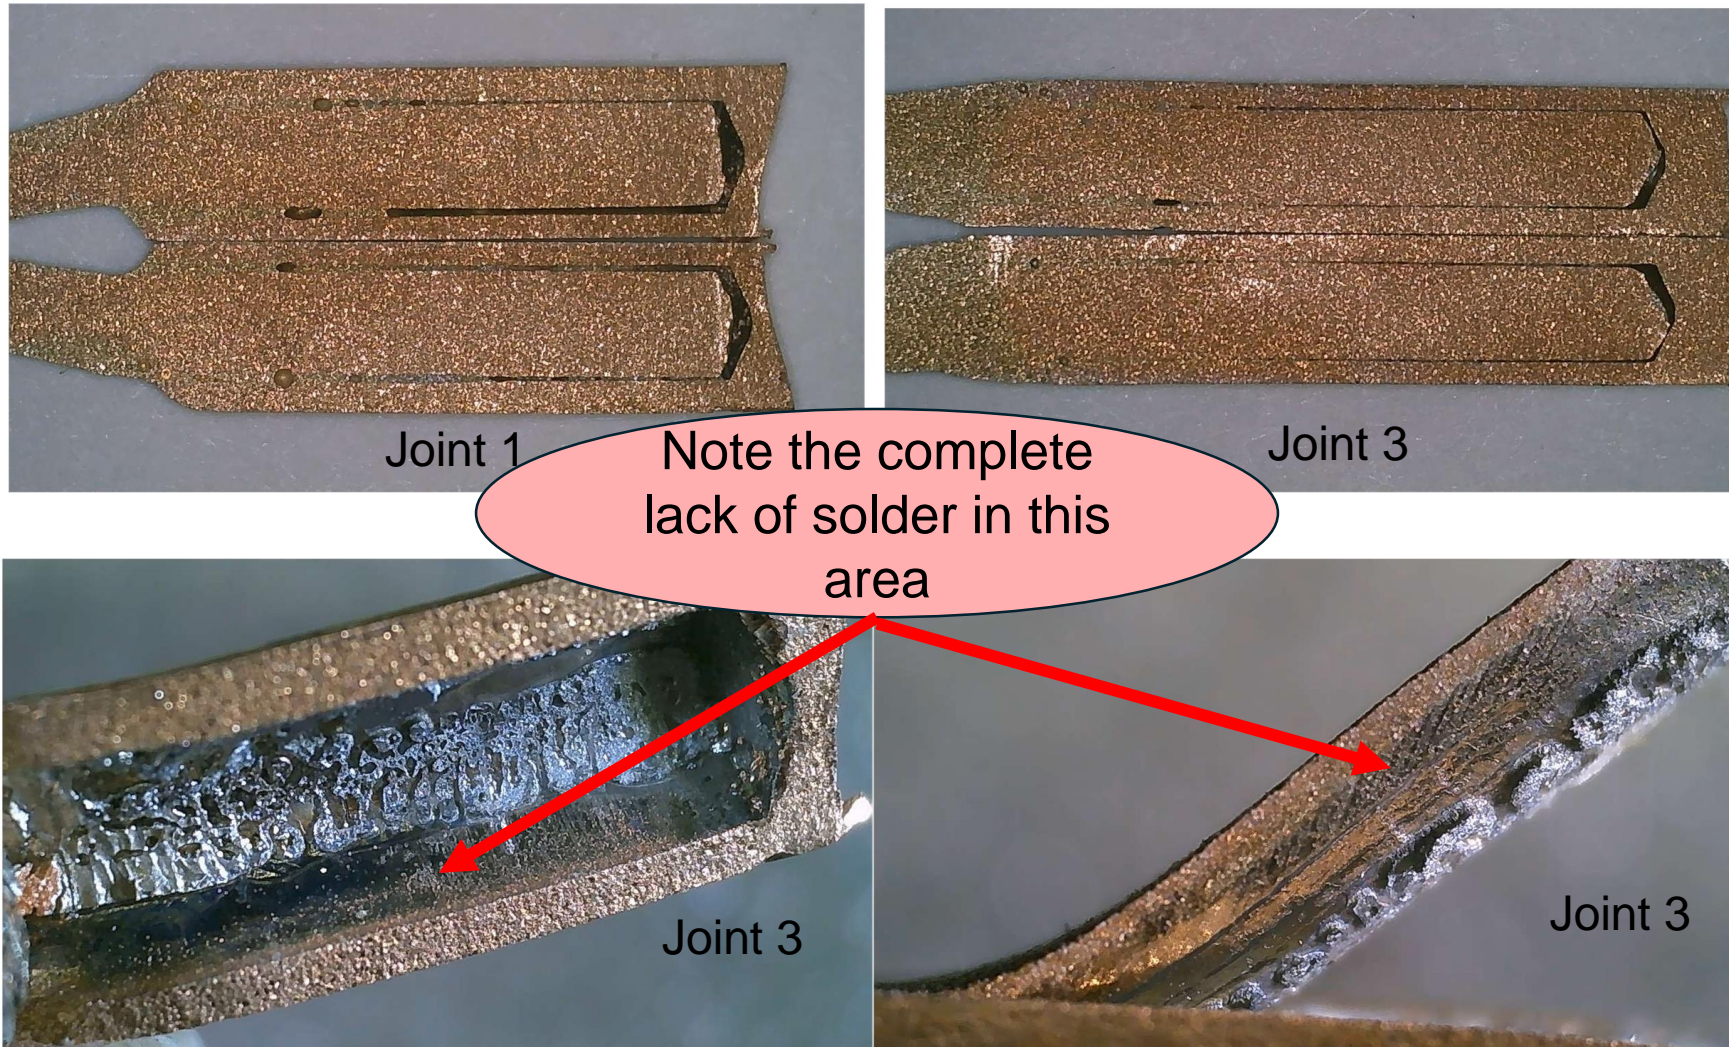
Wire EDM slitting of the feedthrough ceramic lead to 90 mil square copper solder joints

Both show voids in the 60 to 70% range. Joint 3 is peeled back to reveal the hidden voids.

There are NO weep holes in the lead, soldering was attempted into a blind hole. These voids are consistent with a failure to include weep holes.

- Blind holes should never be used for soldering. Trapped flux and evolving gases will conspire to prevent filling of the joints with solder.
- In this feedthrough, 9 ribs of the helix structure were not present under the Teflon heatshrink, 7 more were cracked but in place (in just the lower 4.5 inches)

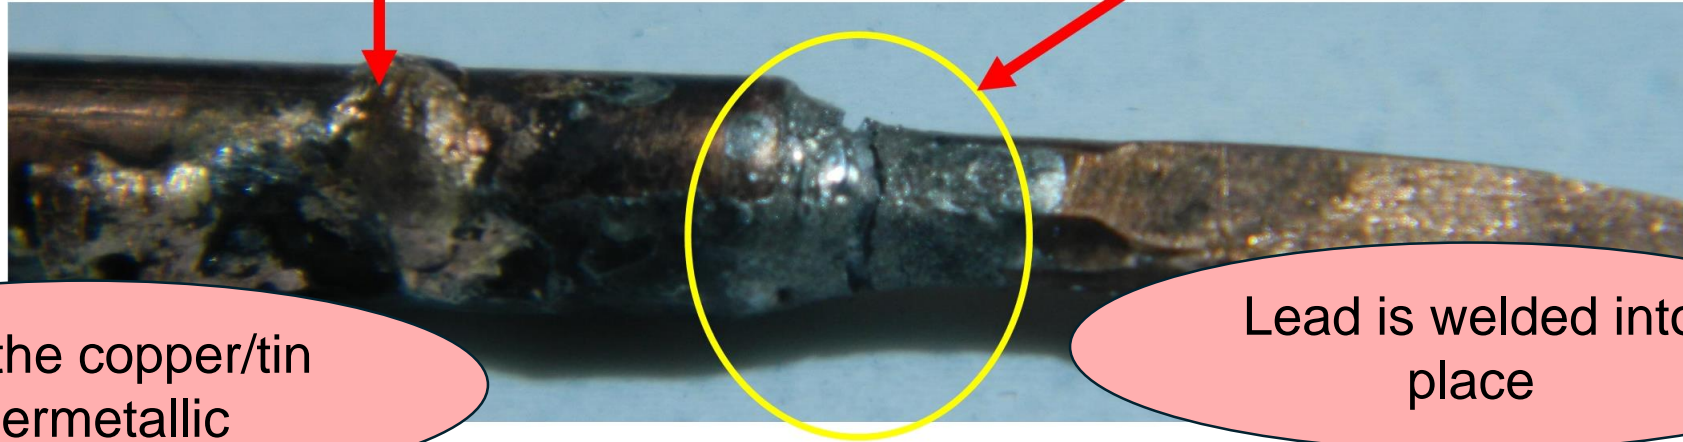
Joint #4, which was untouched by the arc. The entire fillet was cracked, and there was a side eruption

Side eruption

Cracked fillet

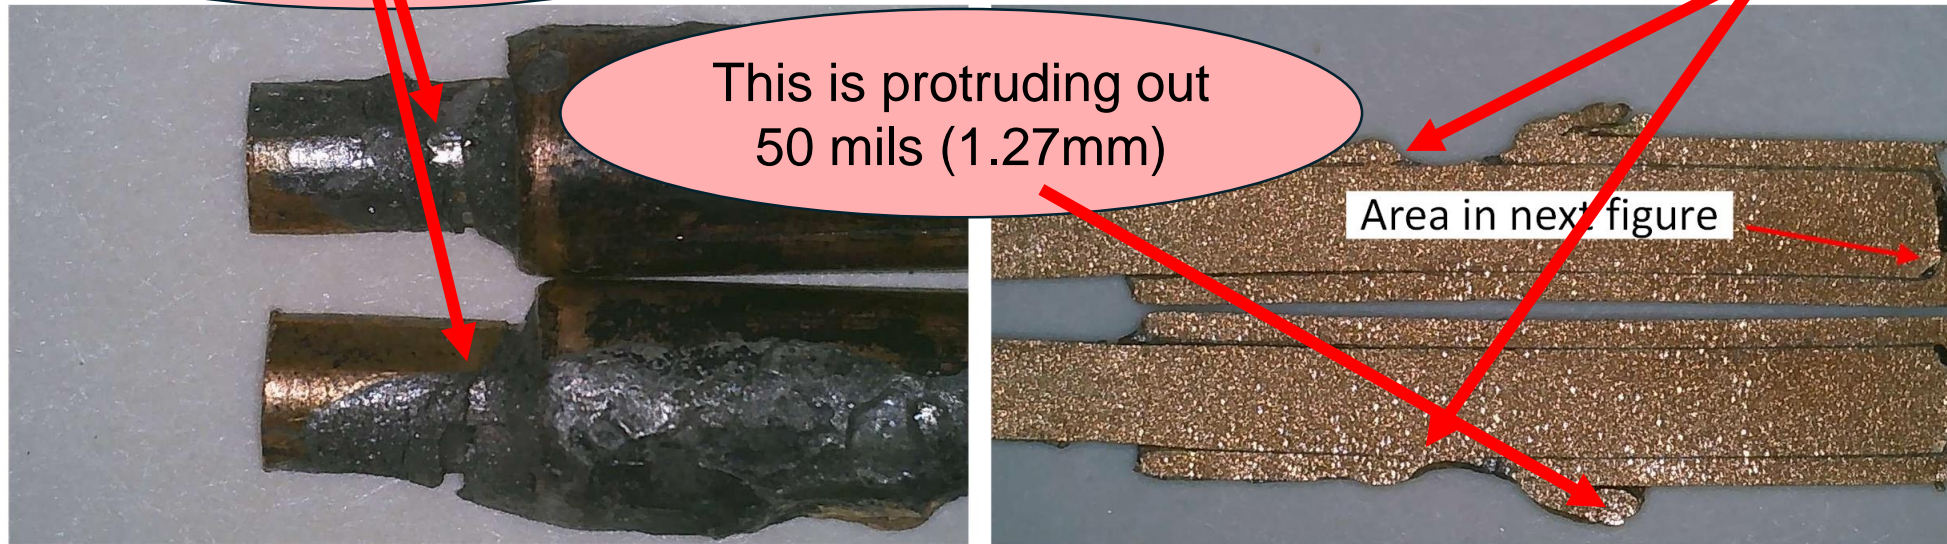
Note the copper/tin intermetallic

Lead is welded into place

This is protruding out 50 mils (1.27mm)

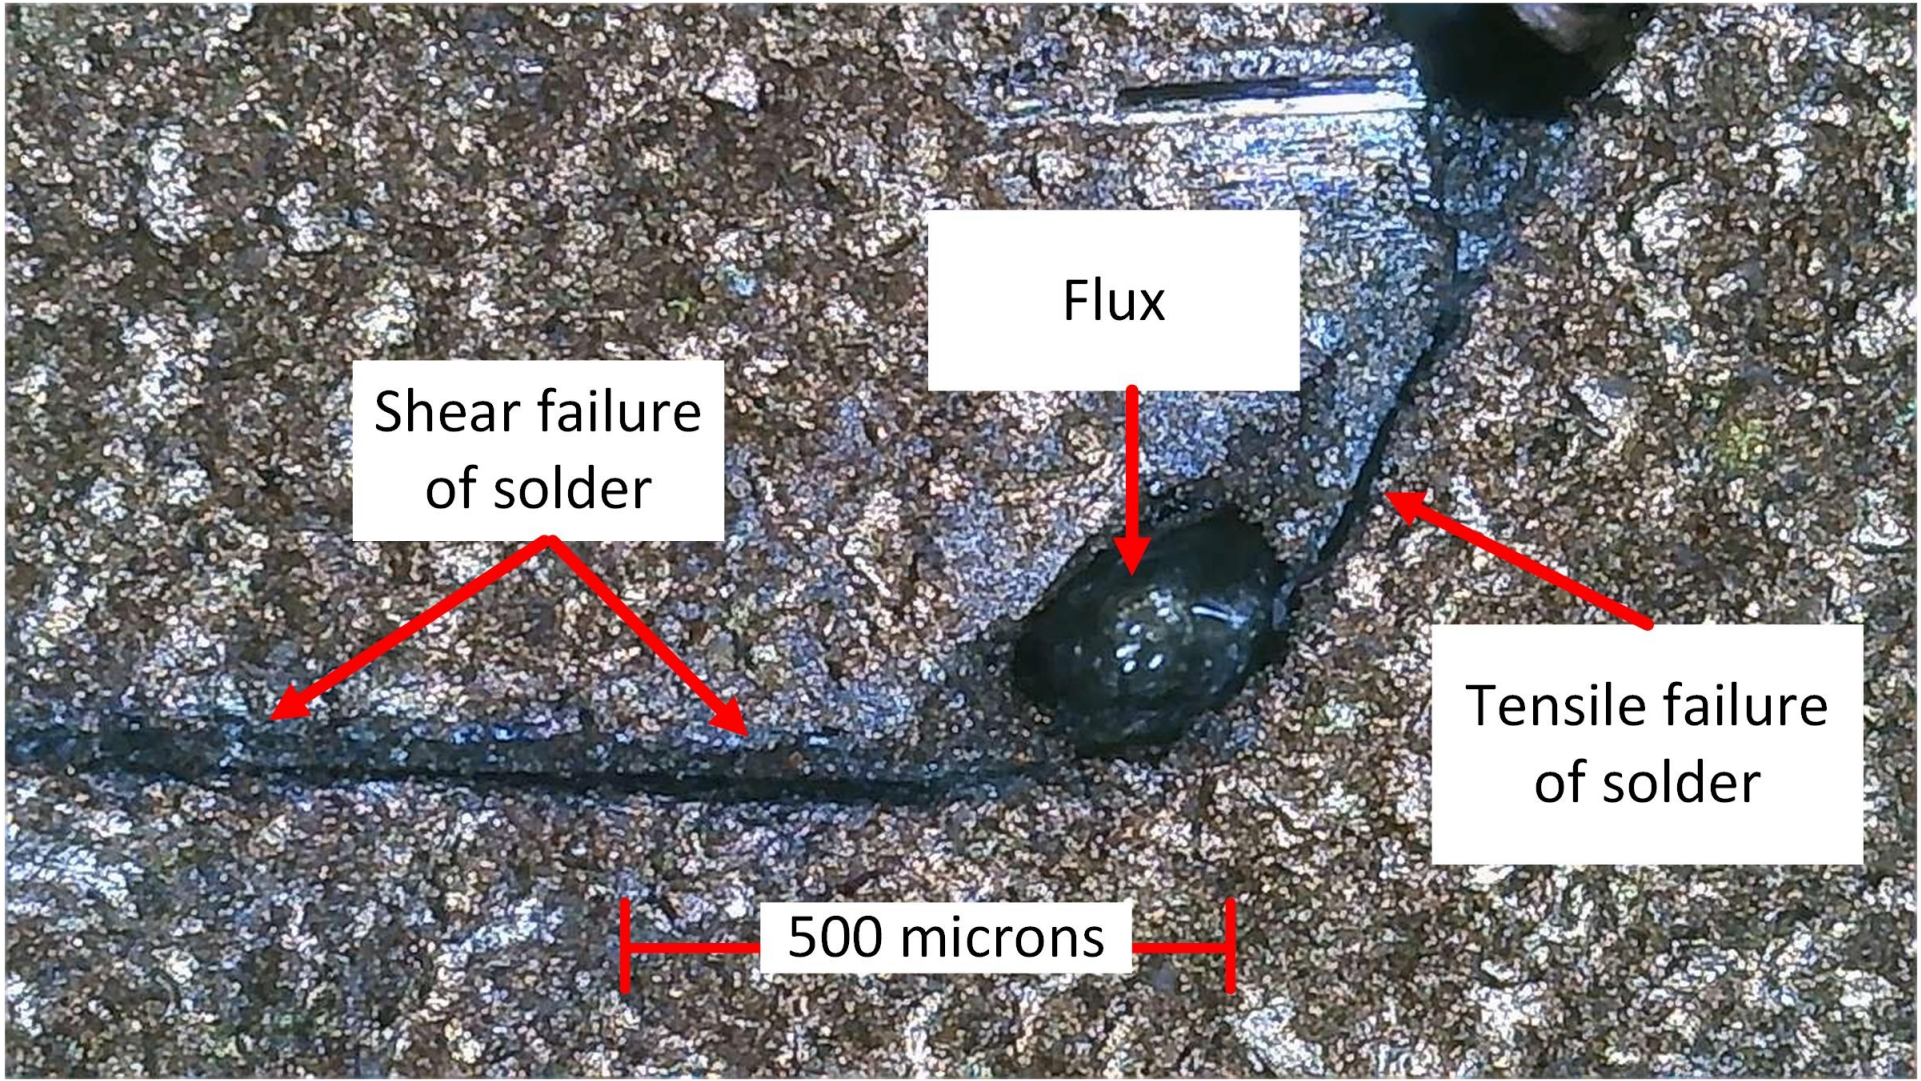
Joint #4, showing failure of the entire solder joint internal to the joint

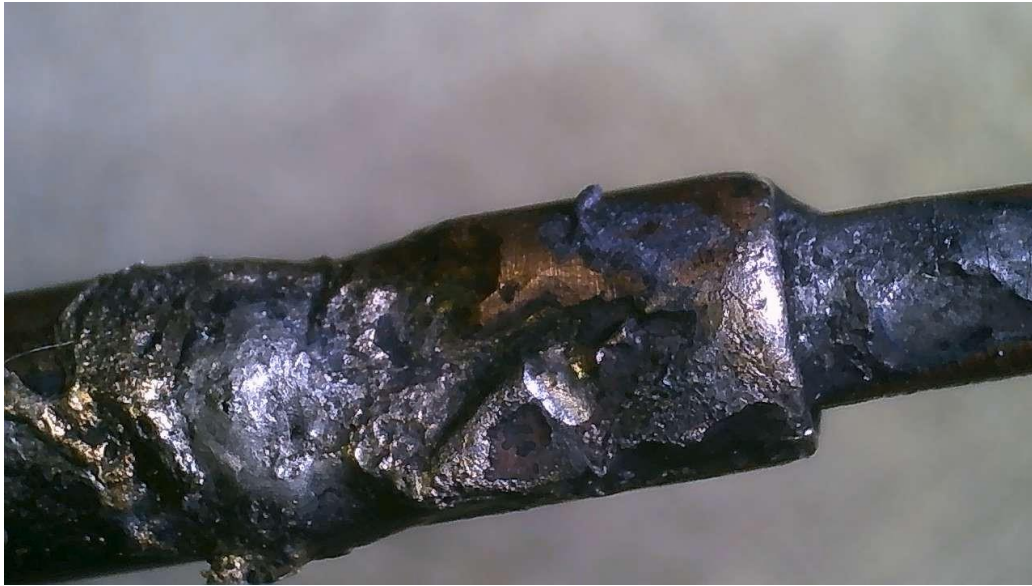
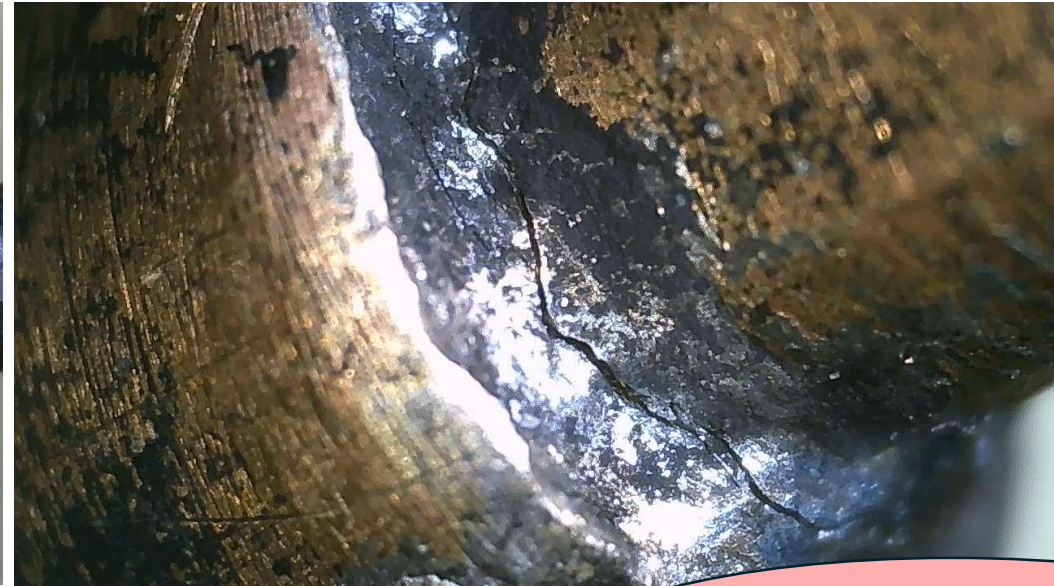
Joint #2, which was also untouched by the arc. The entire fillet was cracked, and there was a side eruption as well

Both joint 2 and 4 show extensive evidence of **thermal cycle fatigue**. Both have a fully detached solder joint, and both have a side eruption which welded the inner wire to the outer.

The side eruption also destroyed the tefzel heatshrink tubing that covered the end of the lead, lowering the voltage withstanding capability to any neighbor.

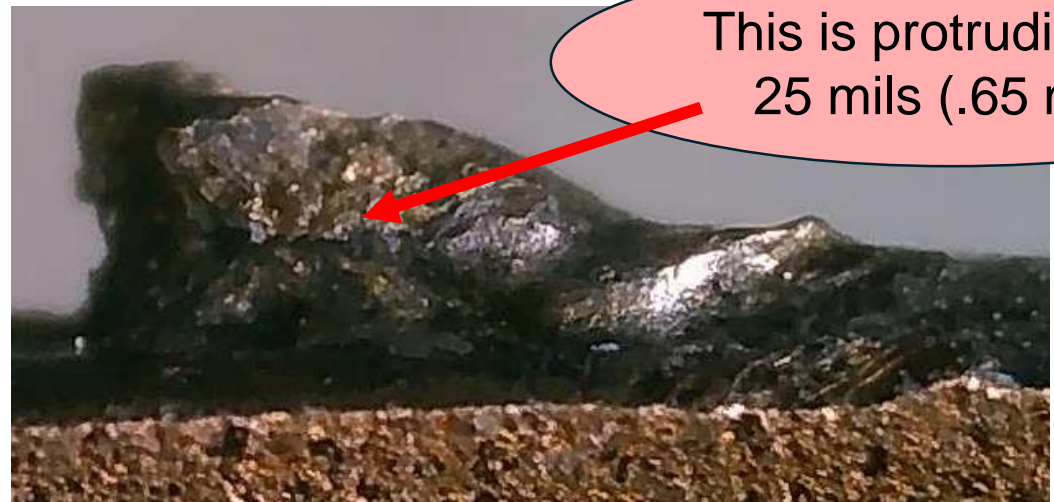
This is protruding out
25 mils (.65 mm)

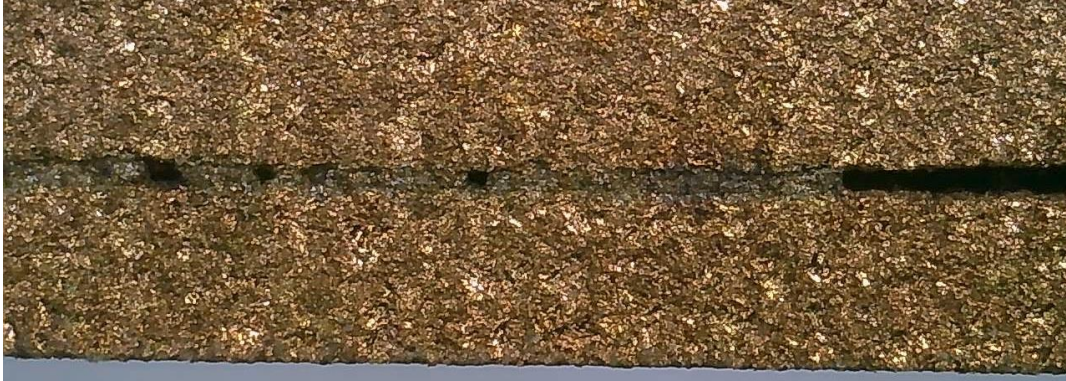
Joint 2

Joints 2, 5, and 8 also show shear failure of the solder. Leads 6,7,9,10,11, and 12 have nothing left to examine.

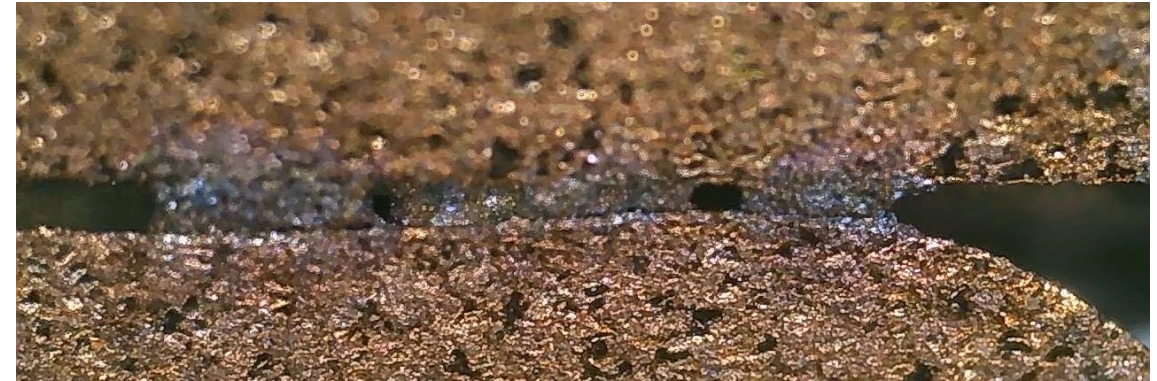
Joint 5

4 joints show mechanical failure of the solder by temp cycle fatigue.

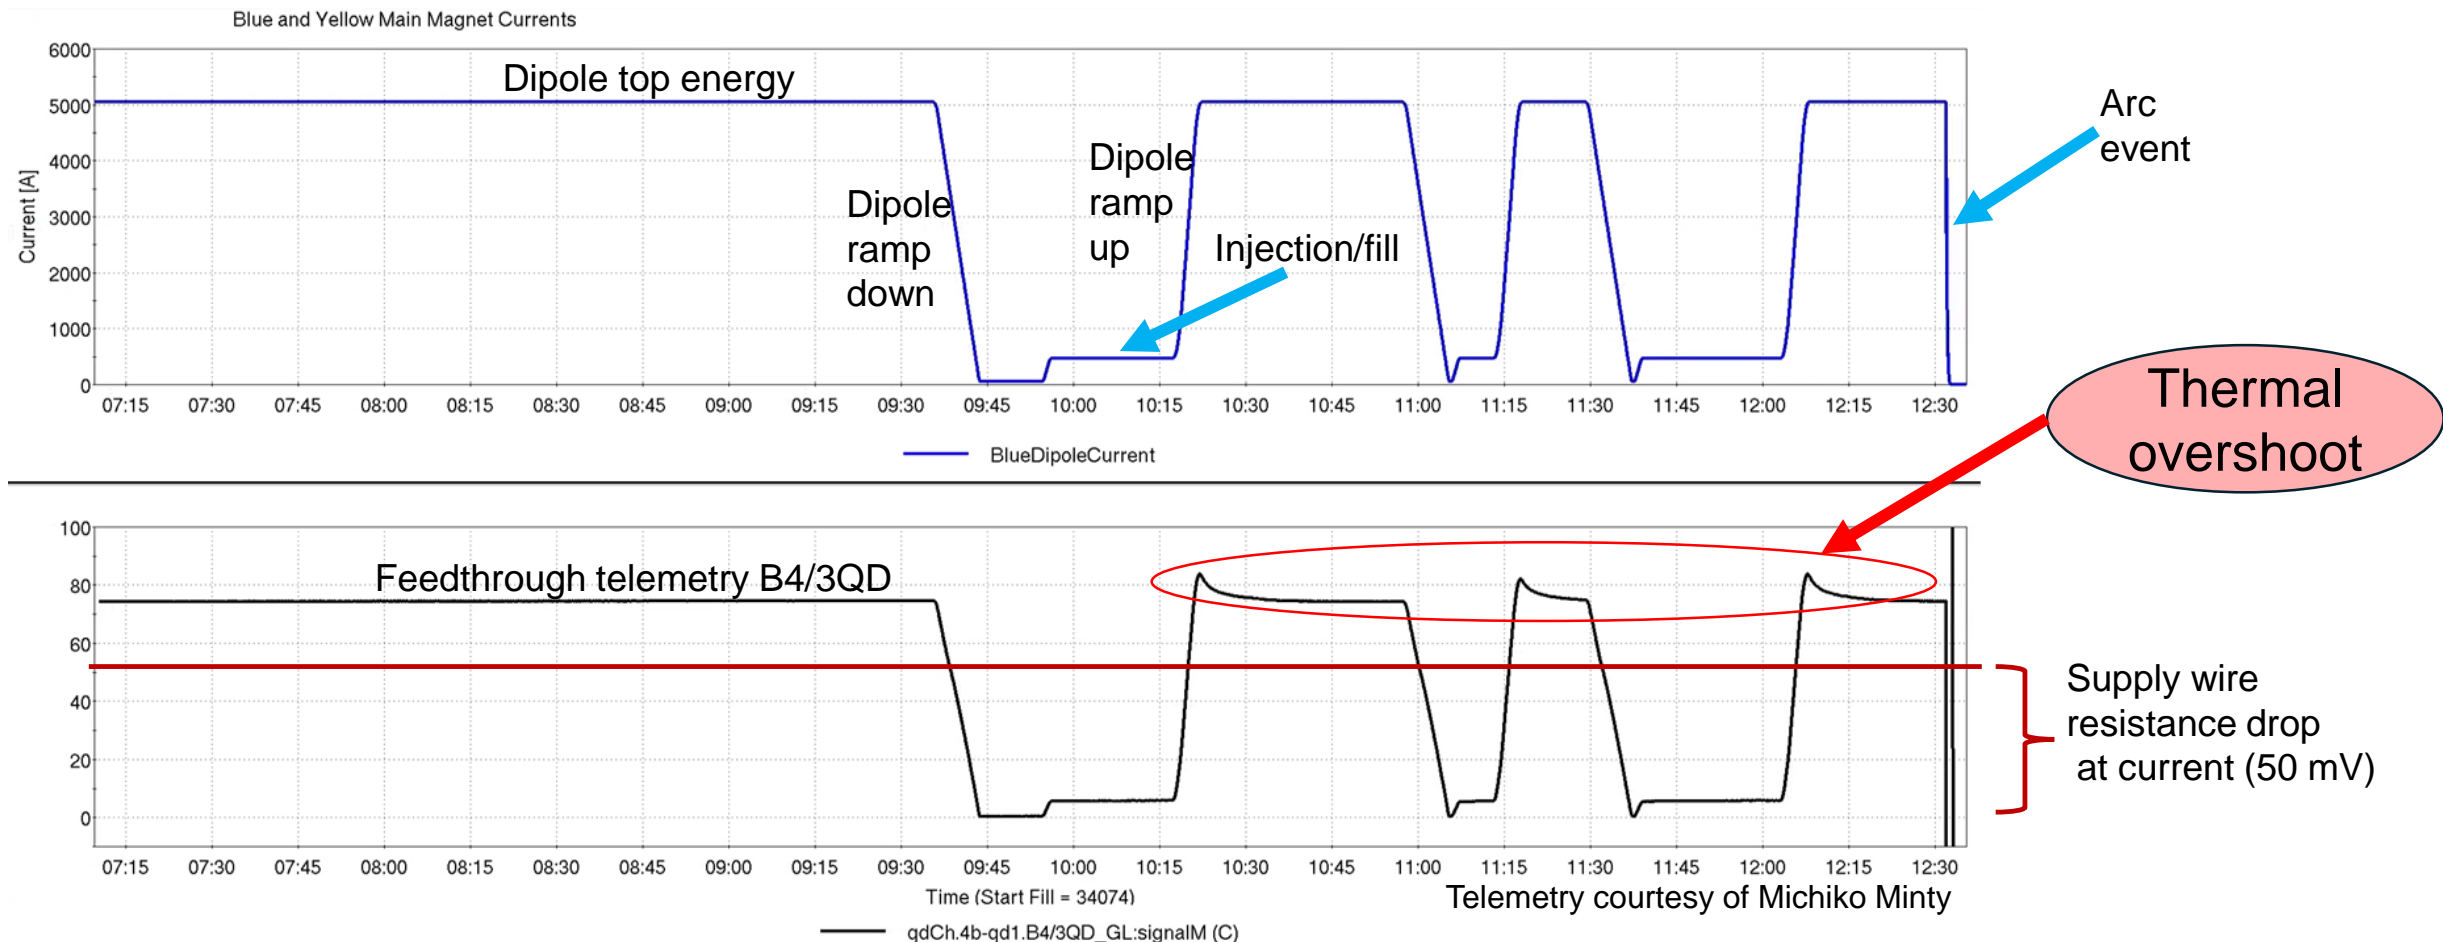
Telemetry of the feedthrough was then examined. It shows that the solder joint area of the feedthrough was experiencing thermal swings of between 50 to 150°C during every RHIC ramp to full energy. The overshoot at the leading edge represents the increased resistance of the lead.

The resistance of copper increases .4% per degree C. With the 50 mV of the 2/0 wiring drop subtracted, this 85 to 75 mV drop is actually 35 to 25 mV in the feedthrough. This represents a 40% drop in voltage of the lead on average, or 100°C **on average**. Since the super did not quench, the lead bottom never exceeds 10 Kelvin.

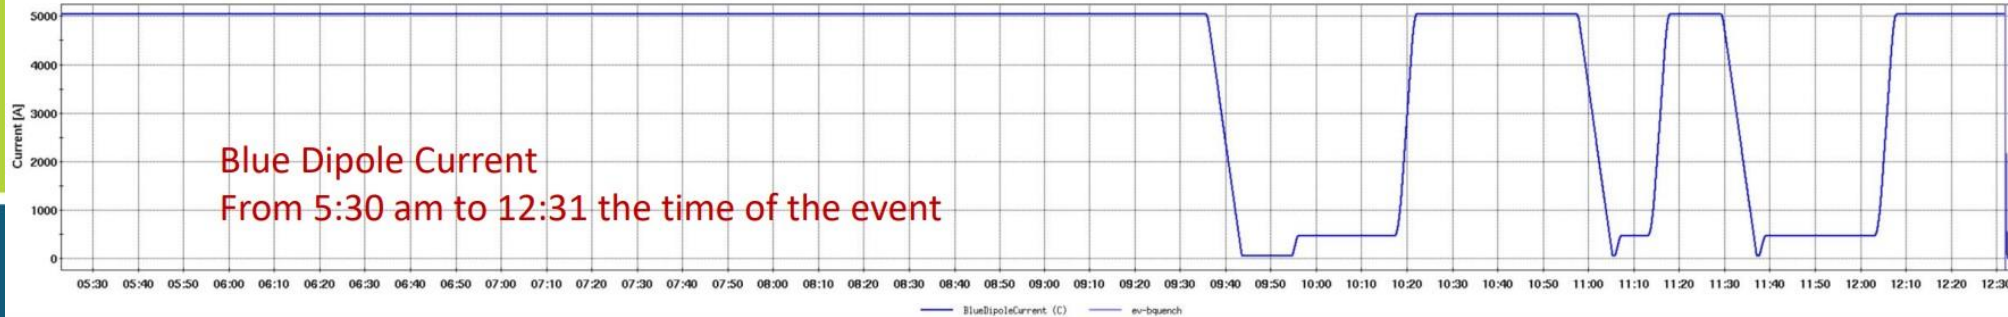
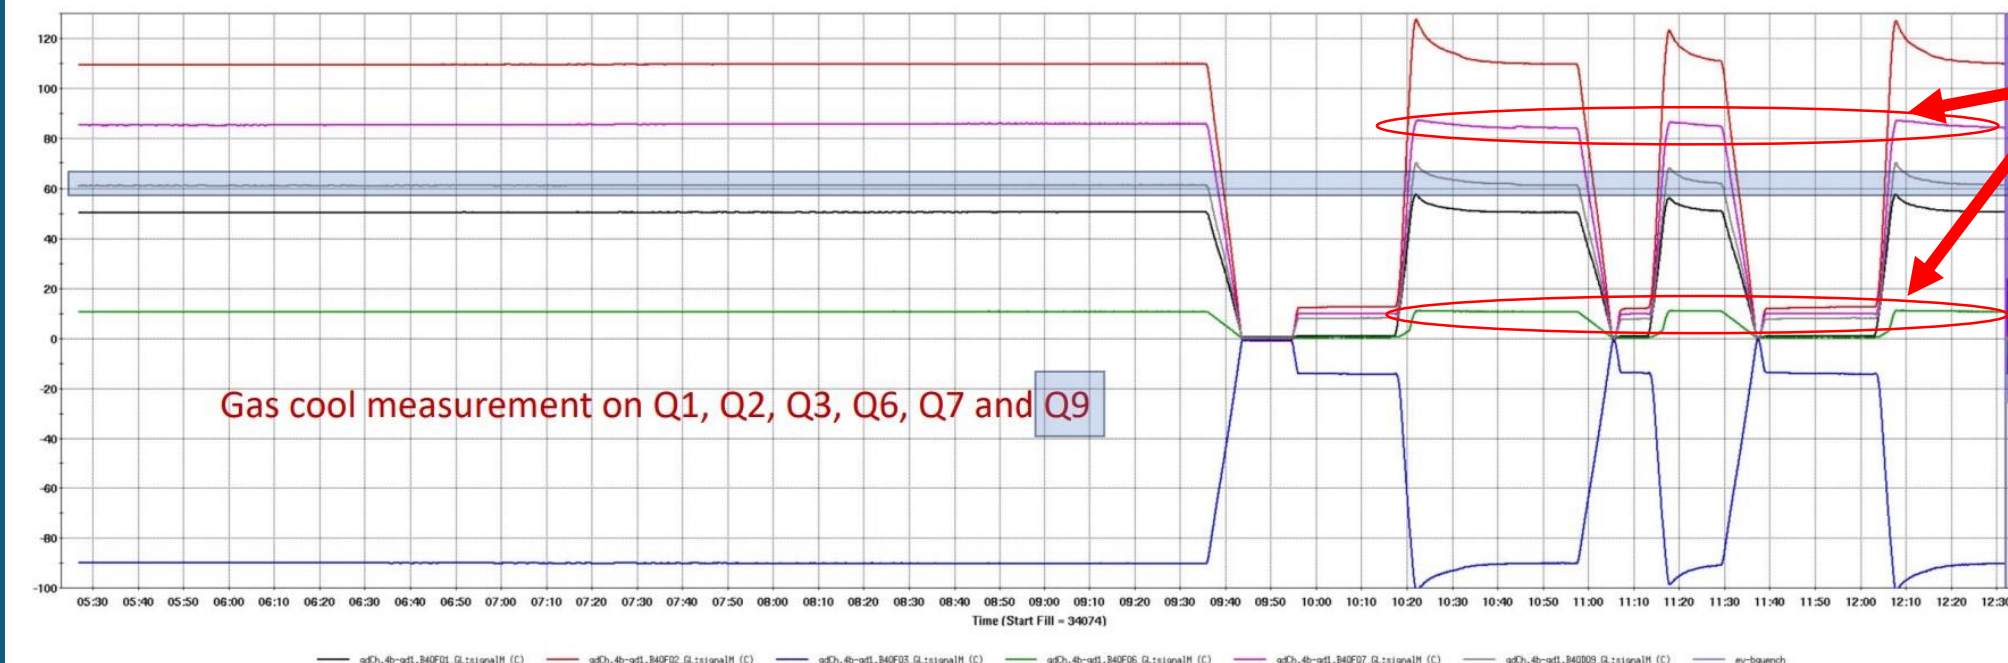
Telemetry for all quad supplies at this Blue valve box

No thermal overshoot. These two are in a different feedthrough

This shows that it should be possible to adjust the helium gas flow rate algorithm to minimize thermal cycling of the solder joints.

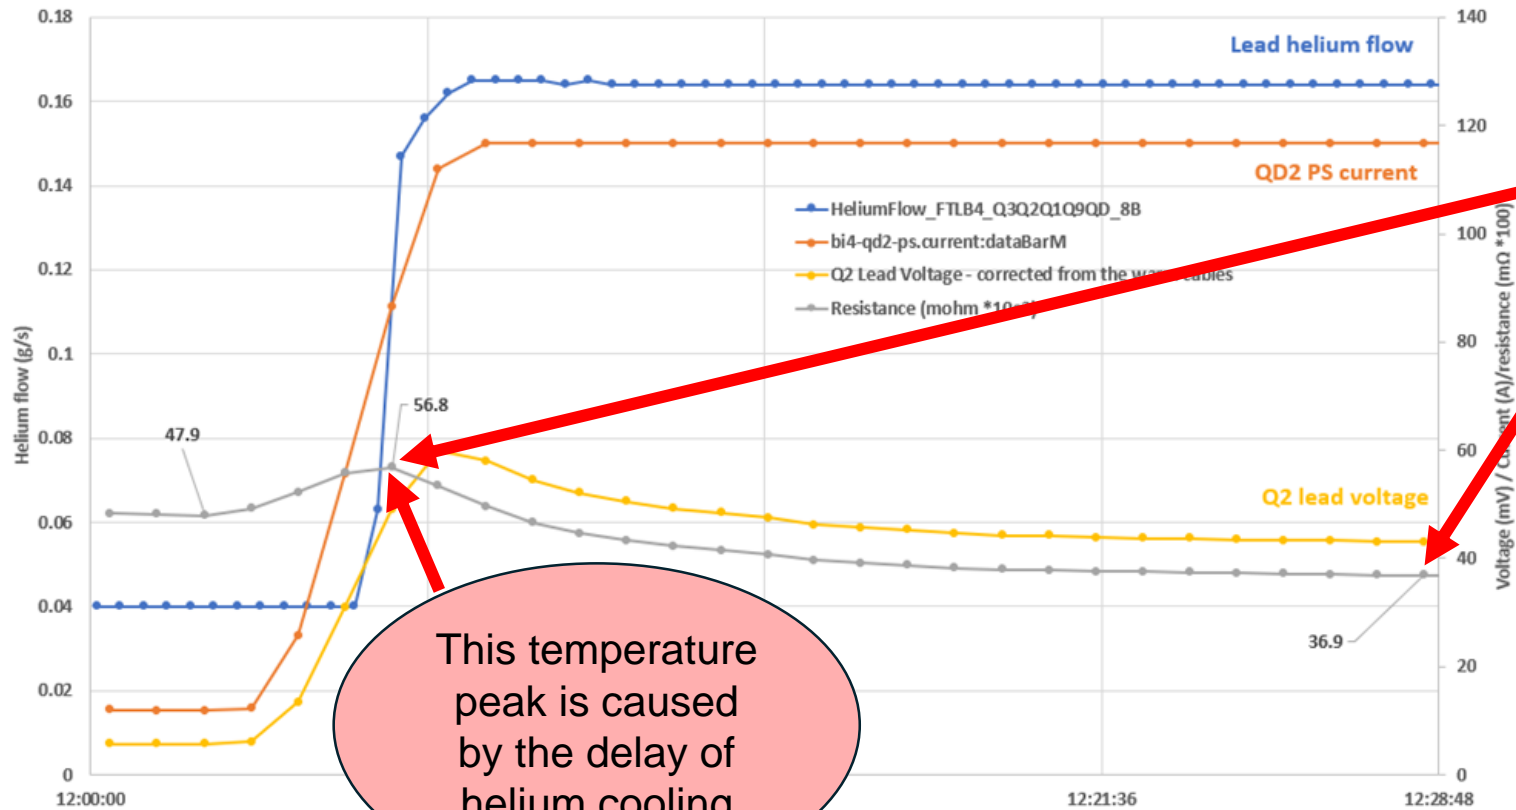
Lead Q1Q2Q3QDD6 - 8/1/23 12:02pm current ramp up data measured

This temperature peak is caused by the delay of helium cooling

The peak to steady state resistance reduction is 35% W/R to the peak, this reflects an 87°C change in **average** temperature using room temperature resistance coefficients

The entire feedthrough is being drastically overcooled. This was to prevent thermal runaway, but introduces temperature cycling

It should be possible to advance the helium cooling to minimize the peak and decrease the overcooling to reduce the final temperature. Tests in that regard must look for thermal runaway of the lead, a known factor..
