TAKE FIVE for Safety-C-AD LOTO Events in 2024

Wolfram Fischer

April 30, 2024

2024 Events related to LOTO

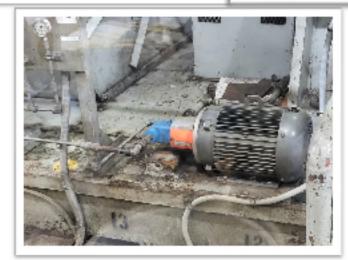
Title: LOTO Lock not reapplied after completion of Maintenance

On January 29, 2024, in Building 911, during a pre-job walkdown it was noted that a Complex LOTO for the Westinghouse Motor Generator Set which was applied in March 2023 was missing a lock. Subsequent investigation revealed that the LOTO was properly installed and then this lock was removed when the LOTO was temporarily lifted for shaft rotation with no other maintenance performed since the temporary lift and all covers and guards were in place. After discussion with the workers, engineers, CAD ESSHQ and the LOTO SMEs, it was decided to reevaluate and reapply the LOTO before performing any work. There was no potential for exposure and no injuries.

LOTO temporarily lifted to rotate the motor generator shaft

- C-AD ESSHQ and LOTO SME investigated the scene.
- LOTO will be reevaluated and reapplied before any work can start.

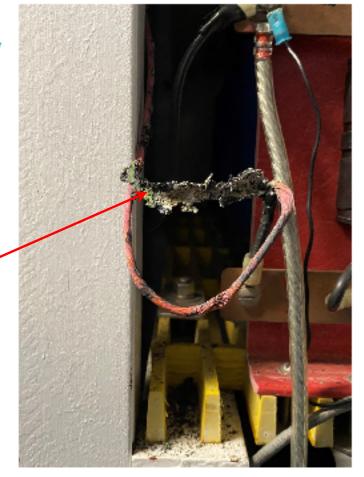
Damaged Wires Discovered on Power Supply

Description & Categorization Level: On April 1, 2024, during equipment check out, the AGS H10 Septum power supply could not be turned on. The following day, technicians found that safety grounds which were applied during Lockout/Tagout of the power supply had inadvertently been left in place.

- There was a long delay from the time when the LOTO was applied until the locks were removed.
- Personnel did not recognize that the safety grounds had not been removed
- The attempt to energize the power supply with the grounds attached caused insulation damage to four wires within the power supply.

- The Power Supply was Locked Out and put into an electrically safe condition for repair.
- Planning for repair and test of the power supply are ongoing.
