Status report for HRPPD #26

Arshak Asaturyan (JLab)

eRD110 meeting, June 26, 2024

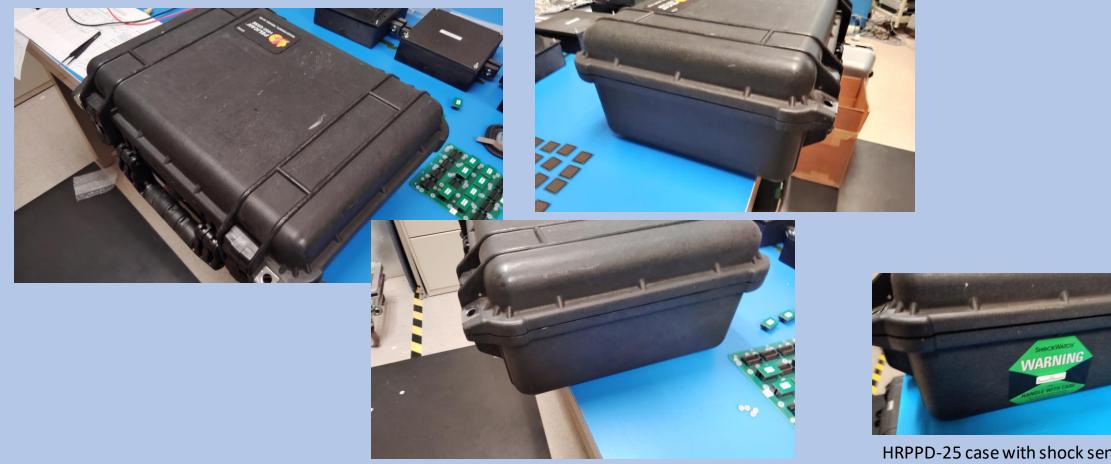
There is no shock sensors attached to the case

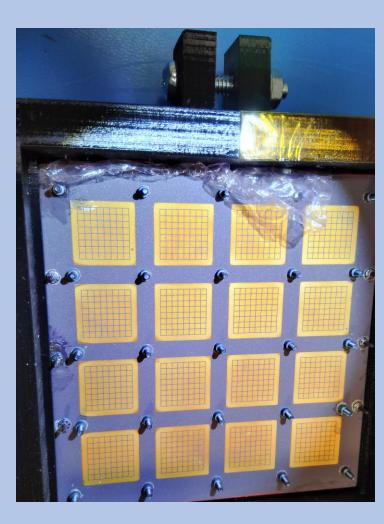
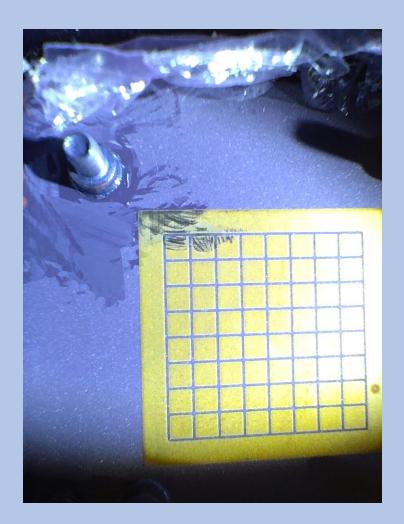
Visual Inspection-2

• There are couple of holder/pressure screws that seem to me were re-glued

• The connectors were not polished, and some of them have signs of scratches and "glue?" or silicone? leftovers on them

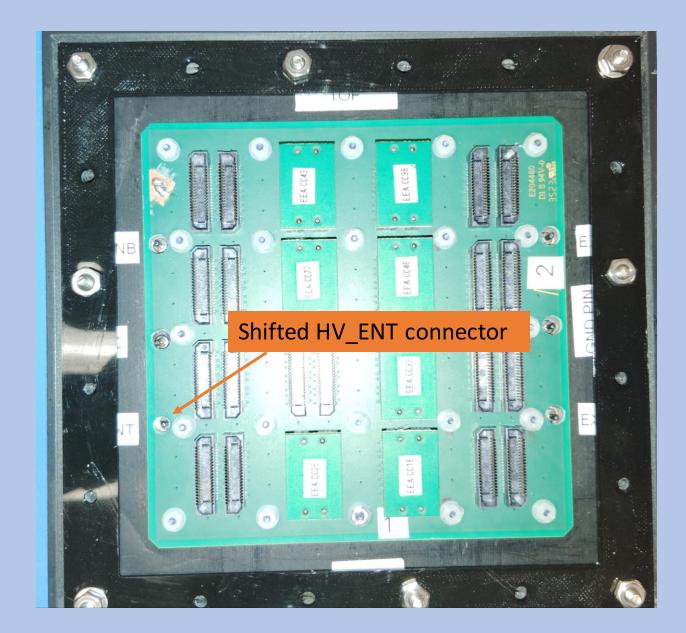
- One HV_ENT connector is shifted from its regular spot,
- Need to modify the PCB_board's corresponding hole,
- but still the HV pin is too close to the wall of the PCB, and there is almost NO space to widen that hole

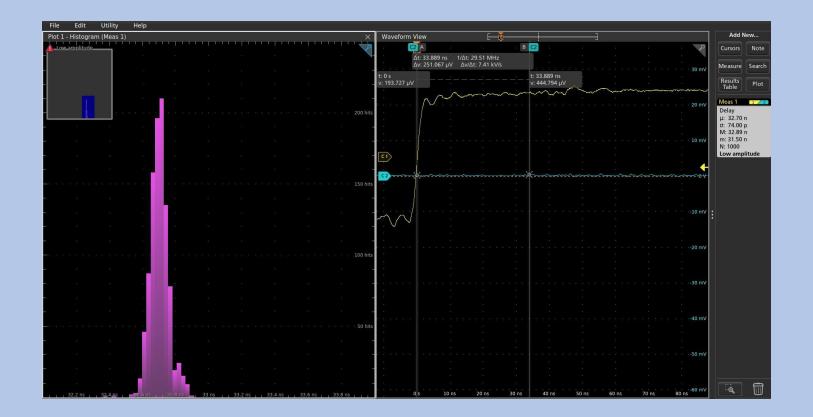
Initial test results TTV(Transit Time Variation)

This test was done at 700V on MCPs, and 300V delta on Photocathode The TTV=74.00 picoseconds

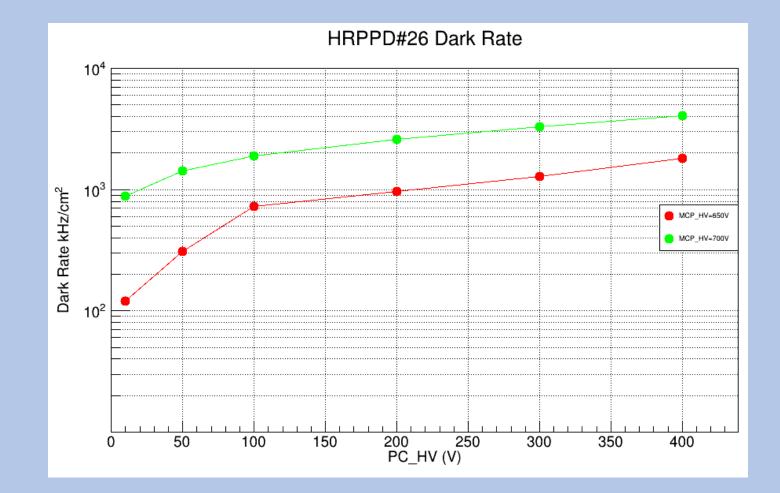
Dark Rate measurement

- Dark rates were measured at -650V and -700V on MCP
- 10V, 50V, 100-400V on PC
