CAEN Noise Peak Issue

by: Cordney Nash (UTK student interning at ORNL)

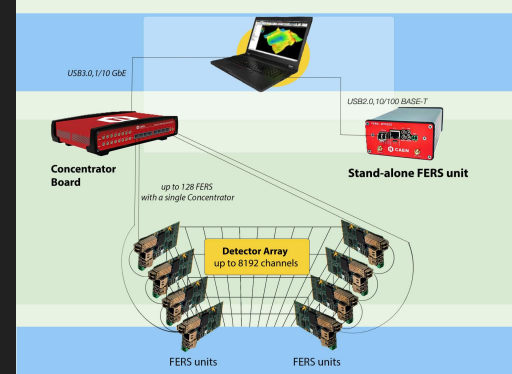
- We tested several DT5202 units with the concentrator board

- Noise peaks were all over the place
 - Should be 50
 - Shifted peaks varies between 7-100
- One single units works but multiple in series or in parallel do not.

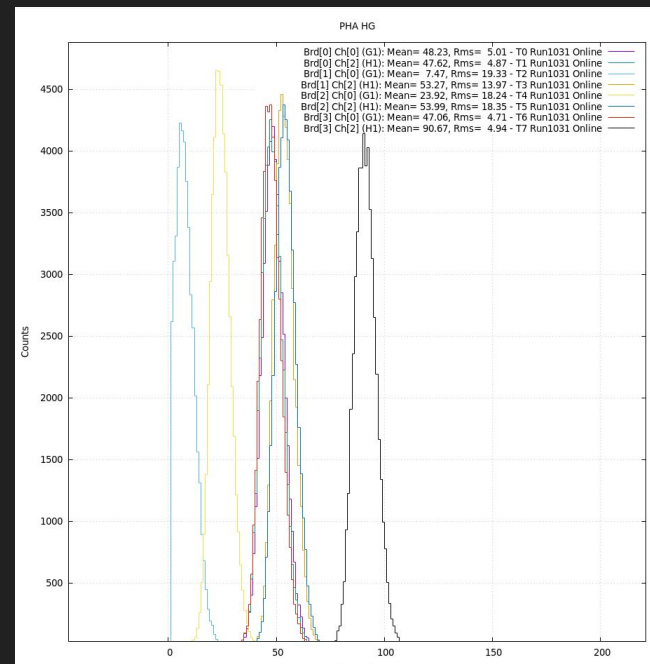
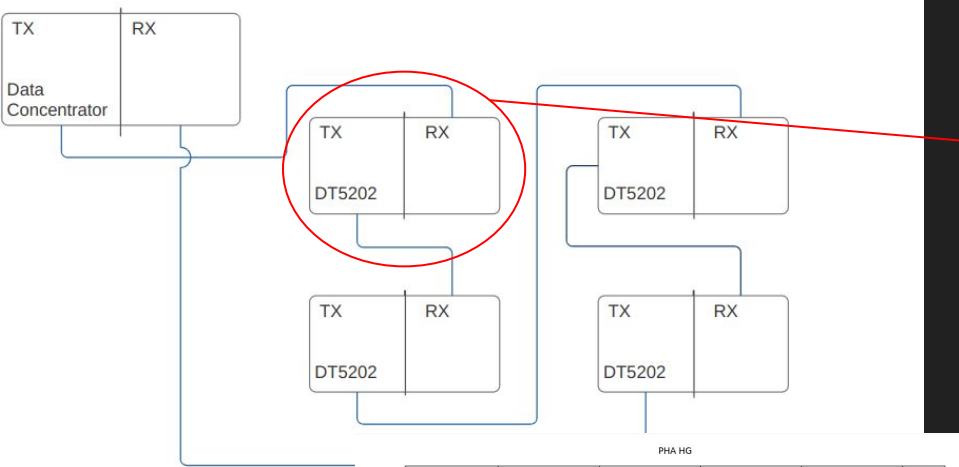
- We suspected grounding issues
 - Internal triggering (PTRG) -> No electrical connections
 - We still seen this problem
 - Connections between the DT5202 units are fiber cables.

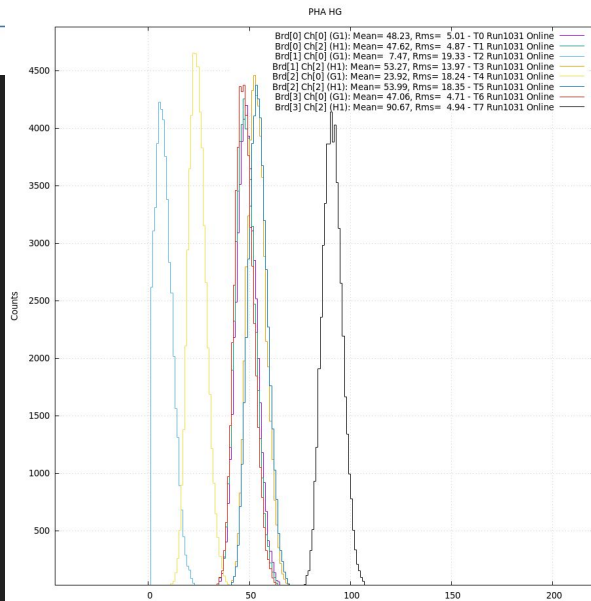
- When connected in series the mean of the first unit is normal, BUT the noise peak of the following units are displaced.
- This trends happens no matter the order of the DT5202 units in their physical connections.

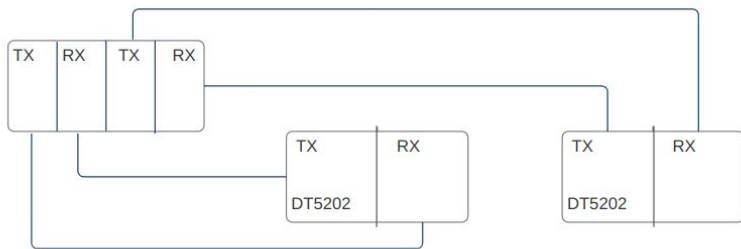
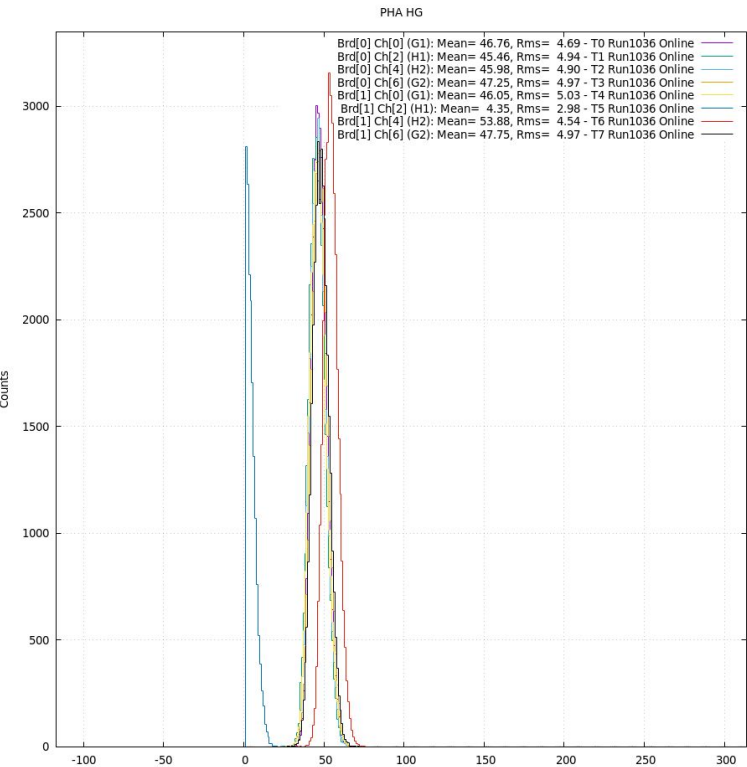
- Even when connected in parallel we still see shifted noise peaks.

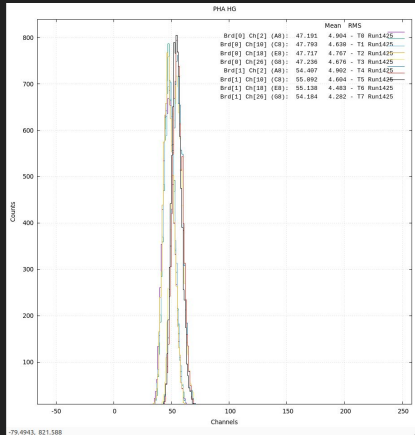
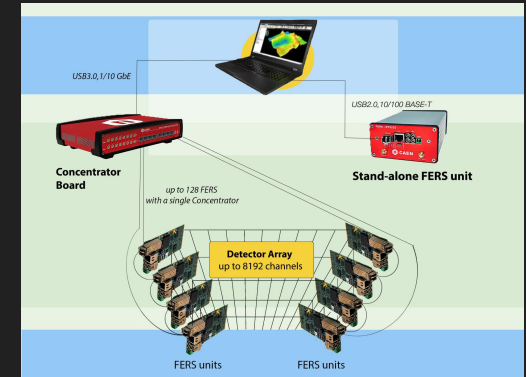
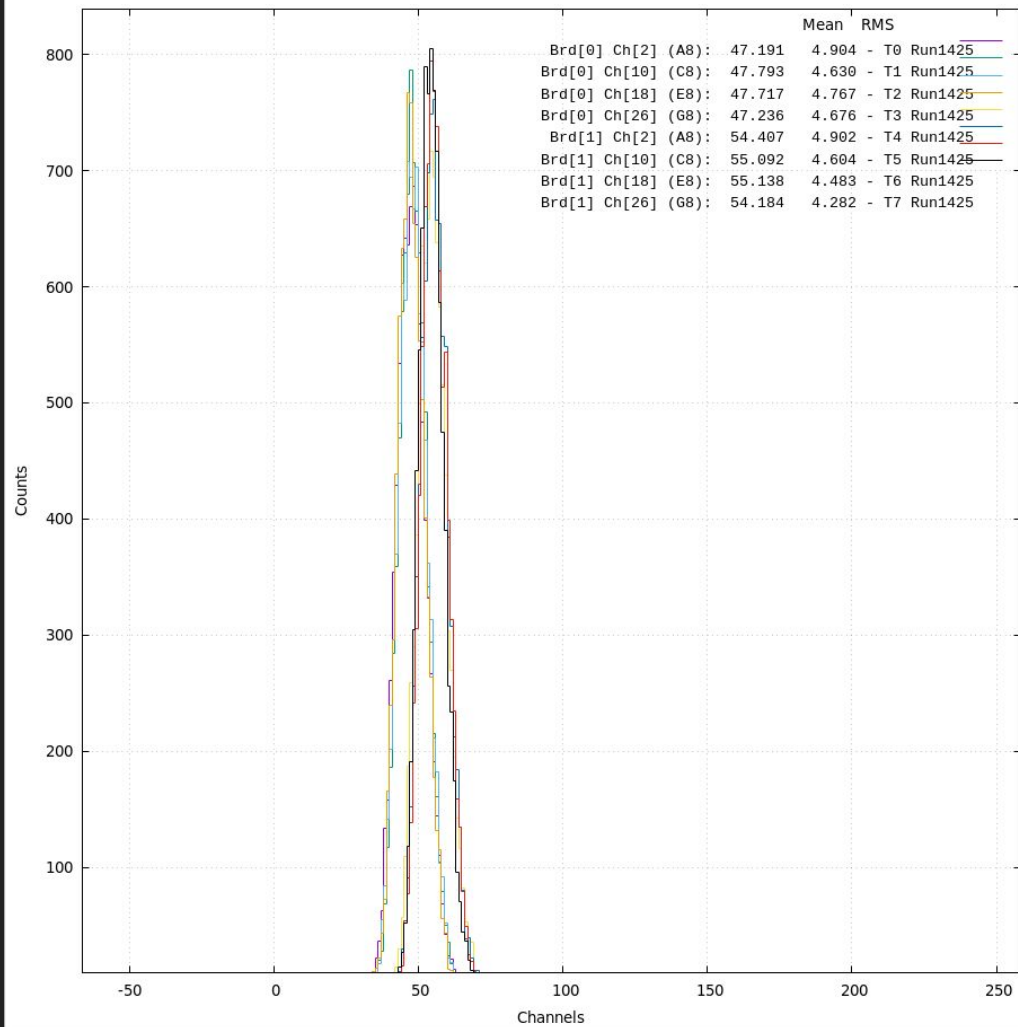
- This is purely a software issue.
- We do not see this problem when only one unit is connected to the DT5215 unit or directly to the computer.
- We suspected it being a software problem and thus updated the Janus software
 - After updating the Janus (v 3.6.0) software we did not encounter this problem .
