The possible compensation idea of the “half entry chips”

Tomoki Harada, Hayato Yanagawa, Yusuke Fujino
Rikkyo University

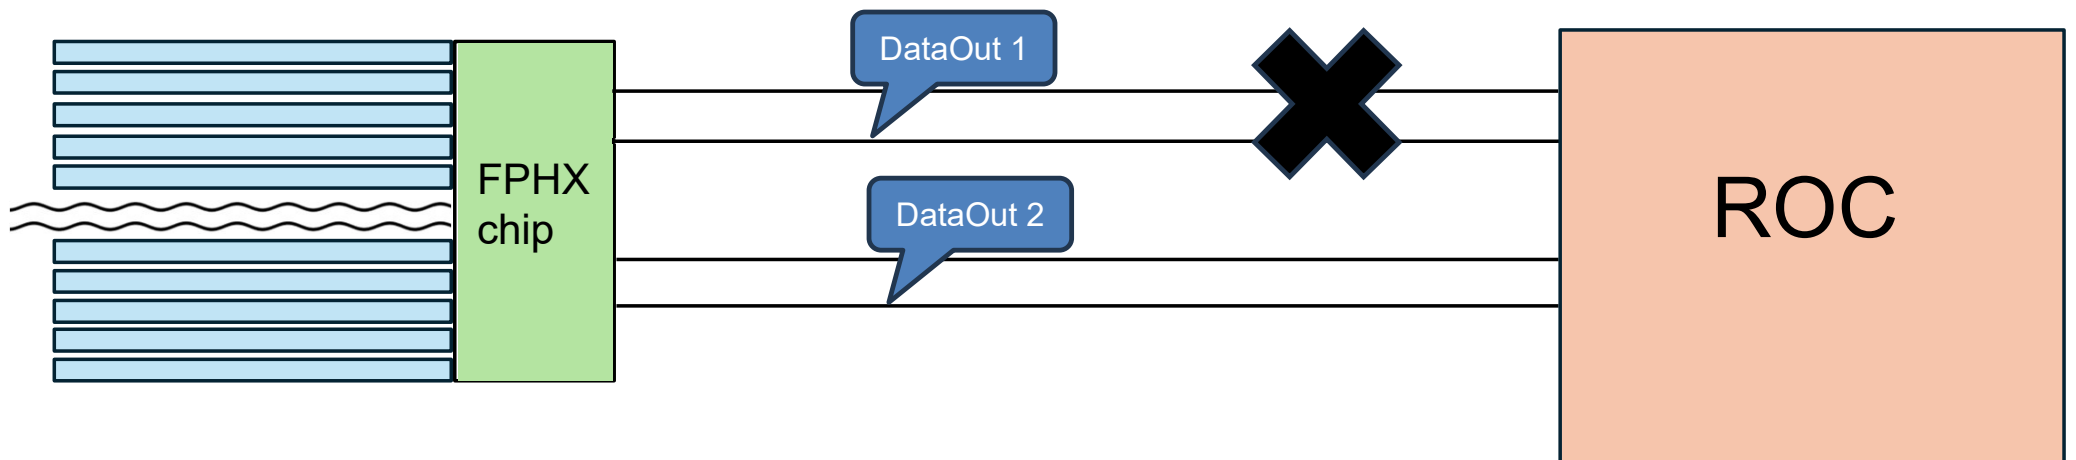
- The half entry occurs when one of the output LVDS pairs is not functioning.
- There is a slow control function implemented which controls these output LVDS lines.
- Using this function, we explored if we can send all hits using only one DataOut line which is alive.

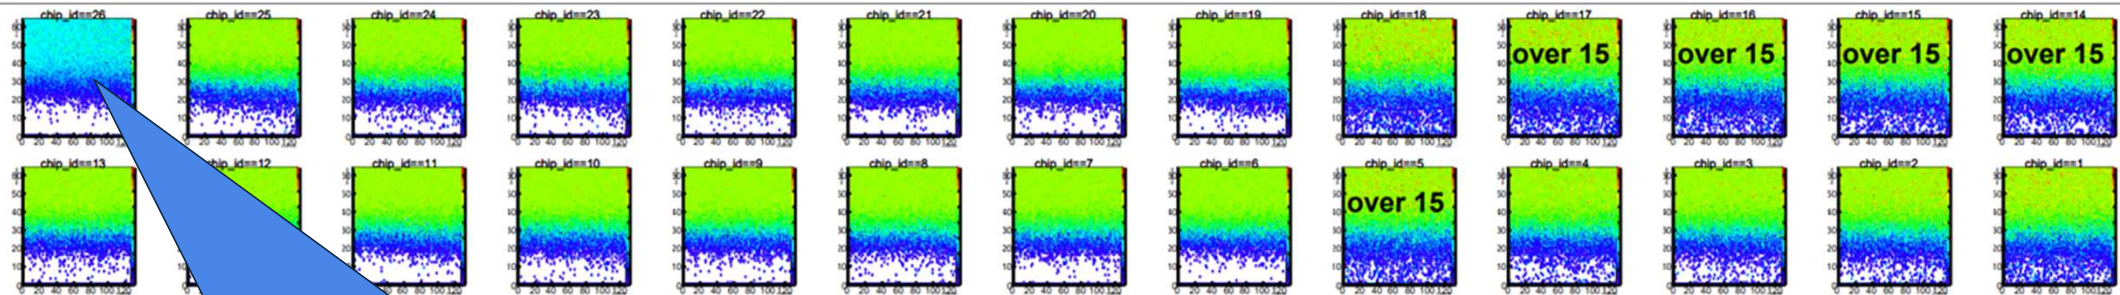
Run#1546

Digital Control Parameter = 1101(no clone hit)

Short chip#26

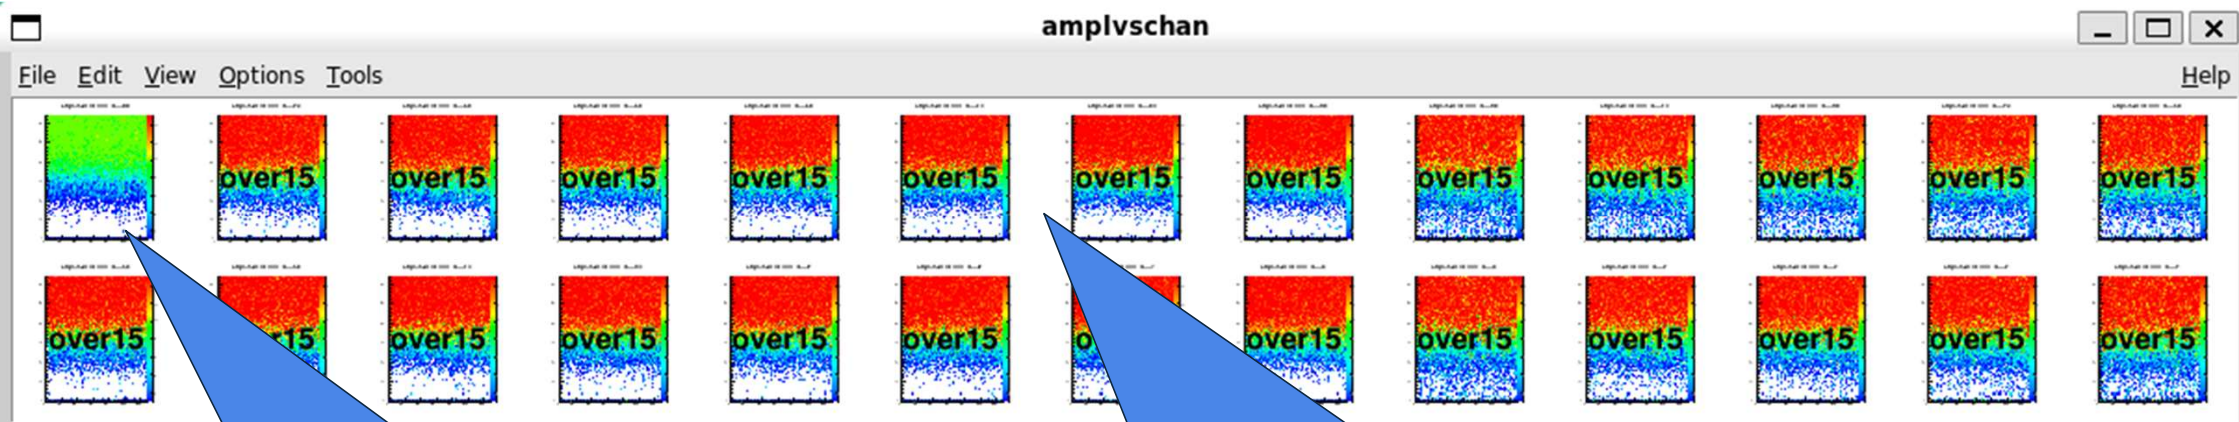
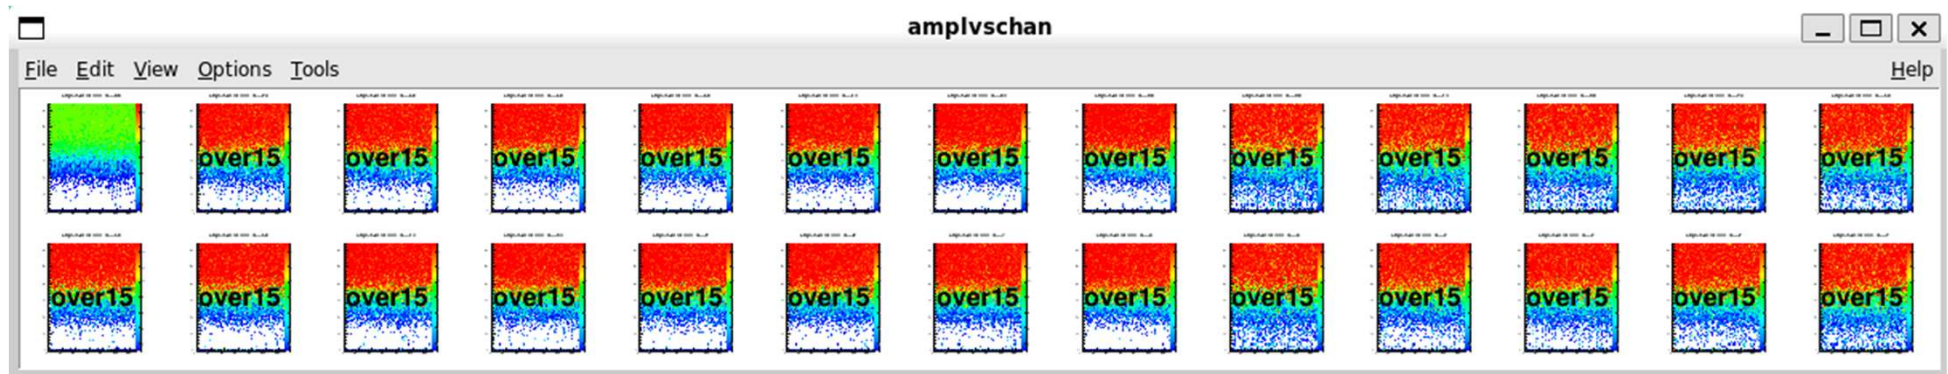
Run#1544 DC = 1100 Introduce clone hit

chip#26
restored full entry

chip#1~25
Extra entries for non-shorter chips

- The red raw histogram accumulated 150% of normal calibration entries except for chip#26 as expected
- After removing clone hits from chip#1~25, the entry becomes normal as consistent with chip#26.
- Excess of the data in un-shorted ones are perfectly explained by the clone hits.
- For those of chips that the DataOut2 is not functioning, DC=1101 will restore the full entry

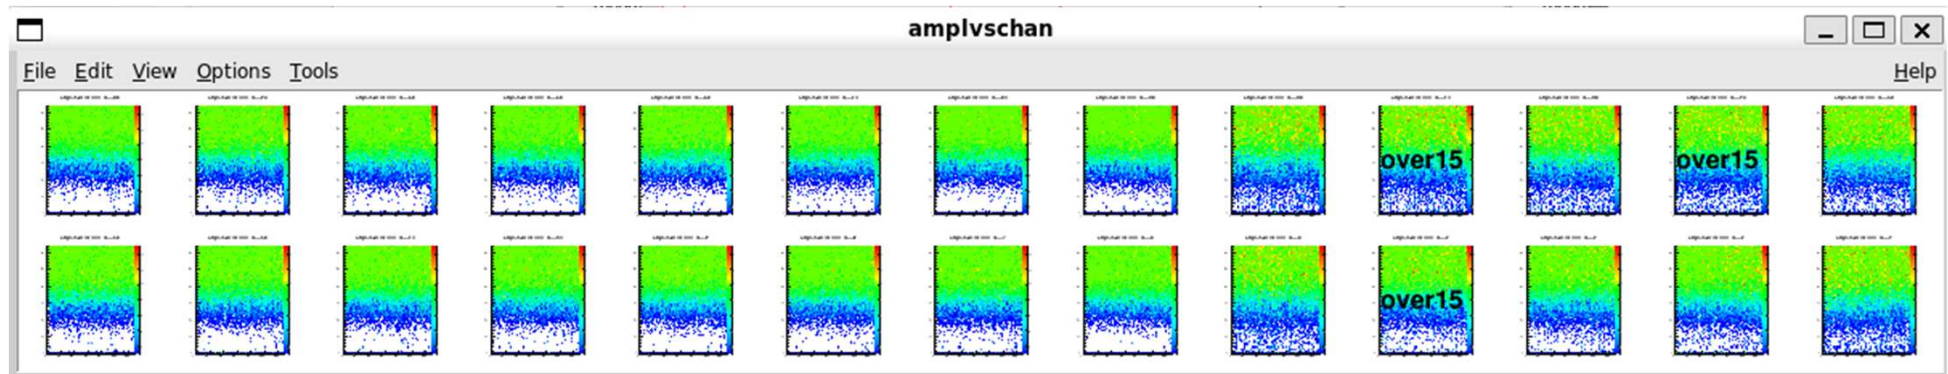
Run#1544 DC = 1100 remove clone hit

After removing clone hits in offline,
the entries become normal for non-shortcd chips

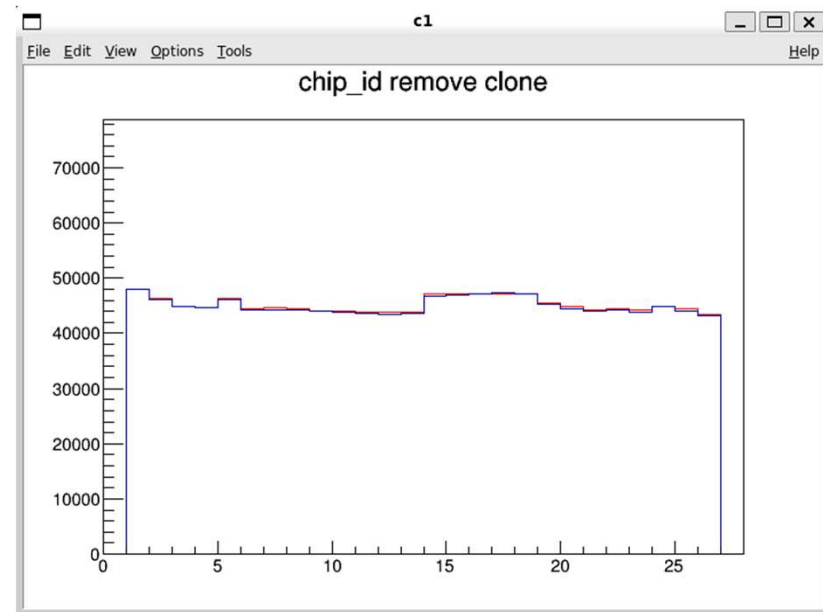
Red:1544(DC1100)remove clone
Blue:1523(DC1101)

After removing clone hits, the entries of the normal calibration run are almost perfectly reproduced even with copy hits mode.
