FPC mounting & bonding (spTAB) - update

James Glover

ePIC SVT WP3: Electrical Interfaces Meeting

Thu, 13th March 2025

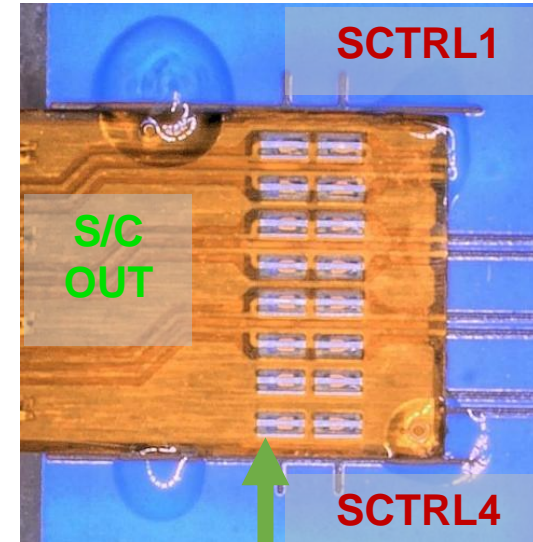
- Used a Kapton coated weight to hold FPC while applying glue.
 - Utilised the solder/probe pads on the **Power/data IN** side of the FPC – mounting was easy!
 - Limited locations for the weight on the **S/C OUT** side of the FPC.

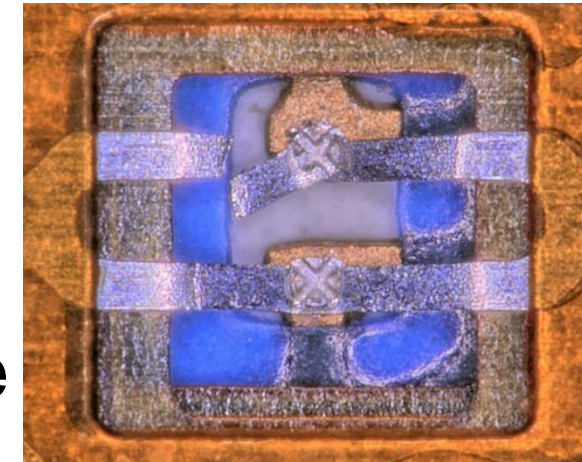
- The FPC was mounted up-side-down, therefore aluminium foil was being stretched further than planned
 - Bonding top layer, instead of bottom, to the PCB!
- It was found that this appeared to be pushing the foils to their limits.
 - A lot of foil traces were damaged!
- Especially bad on the **S/C OUT** side.
- Since the bonding, we have been handling the structure to prepare mounts for shipping.
