CeC status – 7/29/25

CeC gun quench/new field emitters

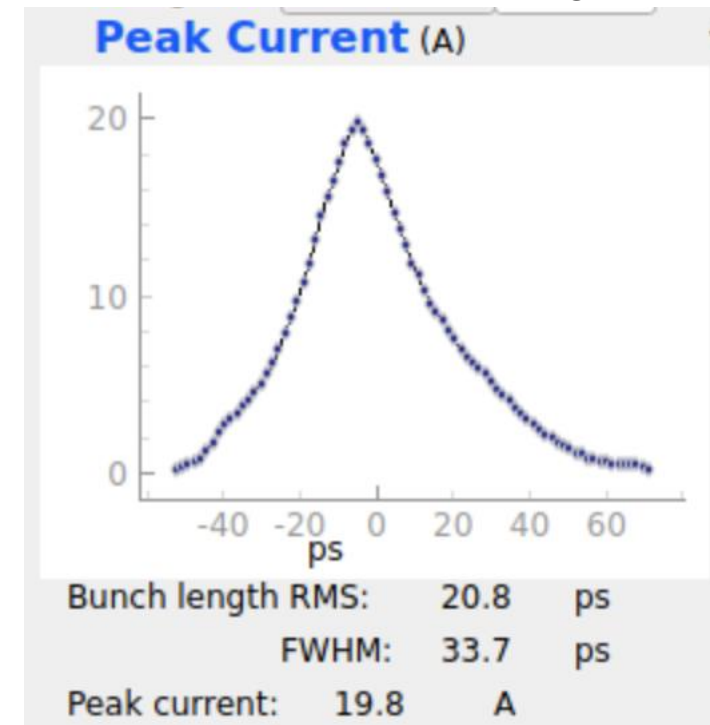
Slice emittance along beam

- Slice emittance for core ~ 1-1.2 μm normalized. Requirement < 1.25 μm
- Projected emittance 1.9 μm .
- Peak current for core ~ 19 -20 A
- Next step would be longitudinal tuning to minimize slice energy spread ($\text{rms} < 2\text{e-}4$) and maximize energy flatness across slices ($\text{p2p} < 1\text{e-}4$)

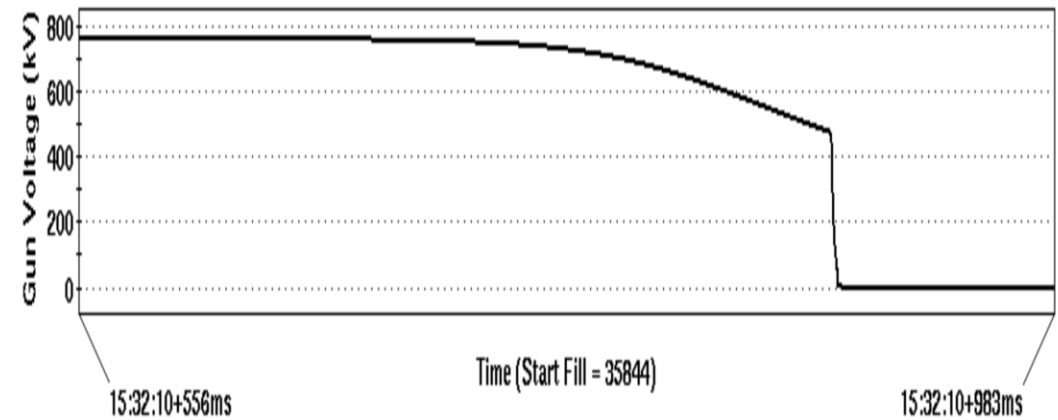
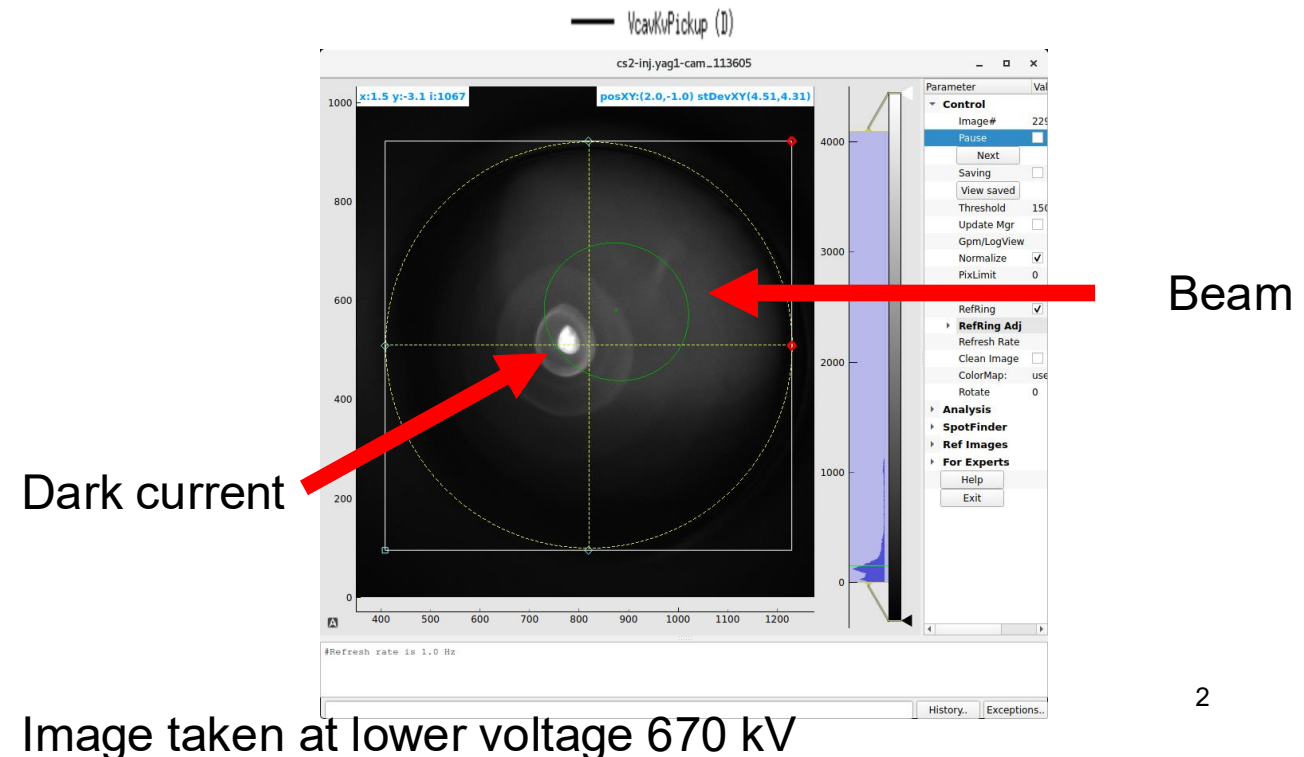
CeC gun was down due to quench protection (significant drop in Q, ~ 10 fold est.) when operated in higher voltages (> 700-800 kV)

- This feature developed unexpectedly and there was no sign of similar behavior earlier, gun has been up and running for the past month without problem.
- Initial suspect was something fell off into the gun, later found this might be caused by newly emerged emitters, radiation level was found at much higher level (700 kV now is comparable to 1.2 MV before)
- The plan is to extract cathode during maintenance (need 1 hour access) and try to bring gun up to normal operational voltage to perform He conditioning to restore performance.
