# Investigation of physical damages on SiPM after annealing

Incremental Preliminary Design and Safety Review of the pfRICH, dRICH, and hpDIRC,  
1-2 Apr 2025

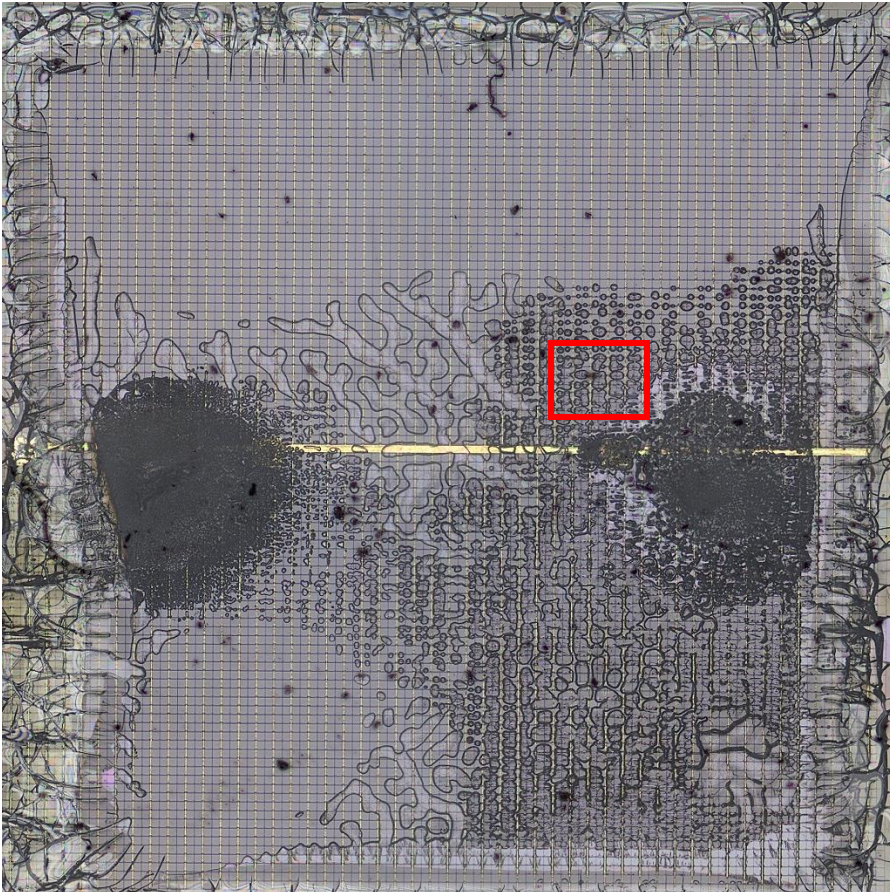
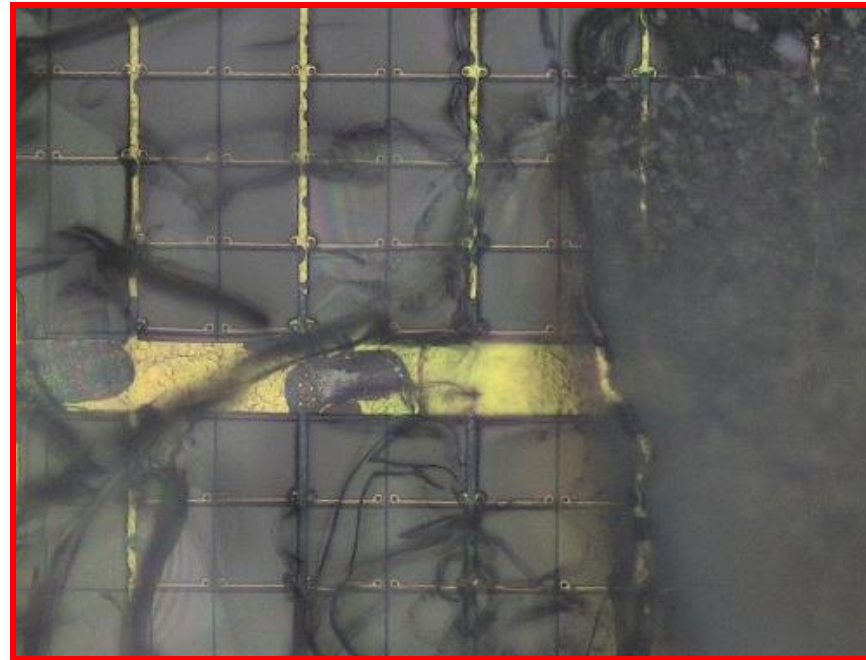
## BCOM SiPM was tested at 250 °C

High current/temperature caused the metallic structures to fail and led to the fracturing of the glass window

- Keep the temperature lower than 200 °C
- Glass is not suitable thus we have resin optical window

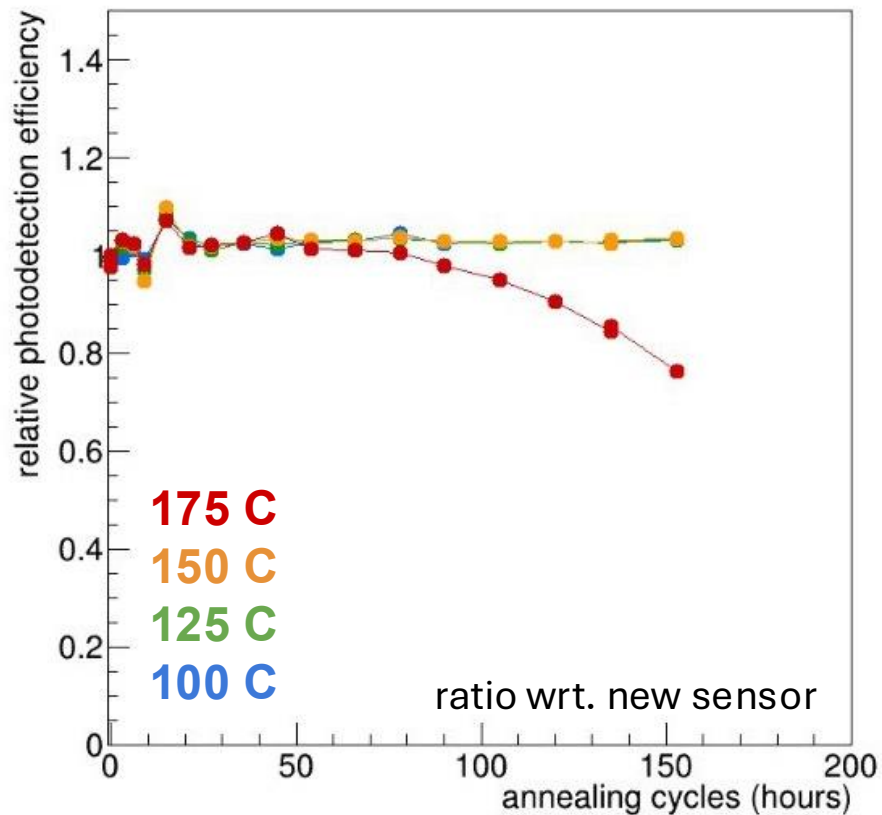
Late studies revealed that a combination of high temperatures and prolonged annealing time can lead to yellowing of the resin optical window, resulting in a loss of transparency.

While the **sensor** remained **functional**, we investigated whether the **resin** window **deformed** and whether any **structural defects** developed in the SiPM.

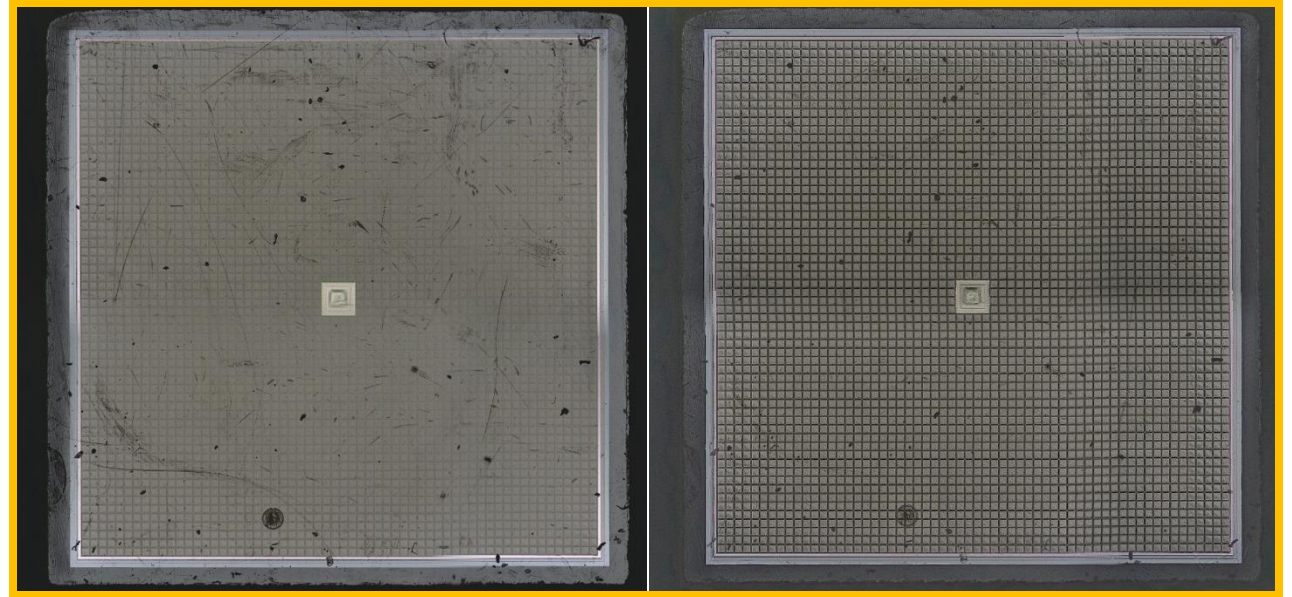
Scratches and particles on the surface

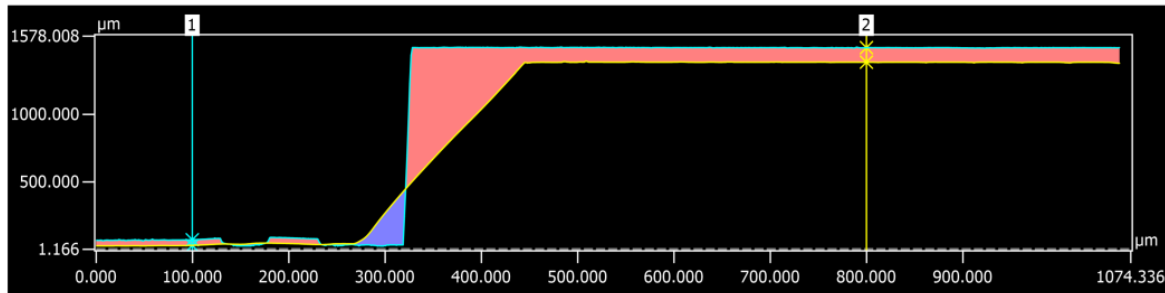
Comparative profile

No.	Measurement name	Measured value	Unit
1	1 point difference(Z axis)1	41.539	μm
2	1 point difference(Z axis)2	107.553	μm

Delta = 66 μm

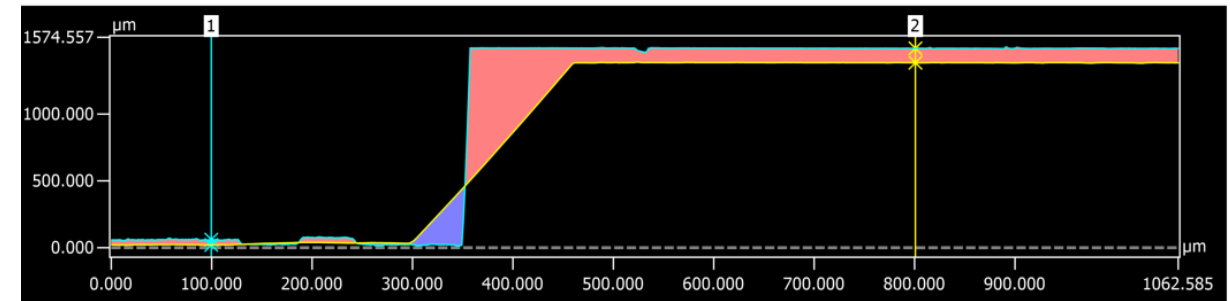
Comparative profile

No.	Measurement name	Measured value	Unit
1	1 point difference(Z axis)1	40.405	μm
2	1 point difference(Z axis)2	108.389	μm

Delta = 68 μm

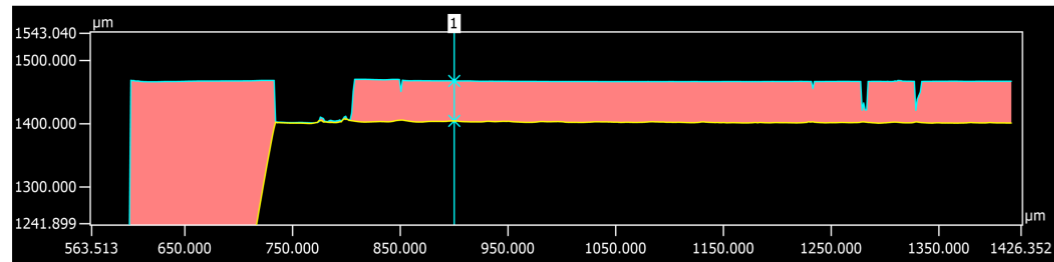
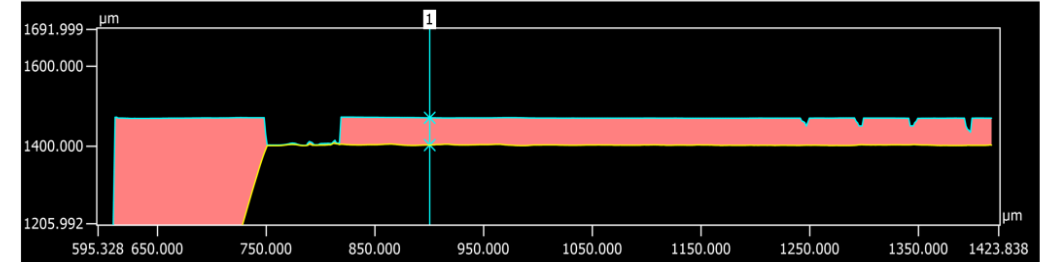
No.	Measurement name	Measured value	Unit
1	1 point difference(Z axis)1	68.128	μm

- Negligible or no distortion was observed in the resin optical window.
- No defects were found in the electrical interconnections
- Minor inclusions were detected at the silicon level, with three inclusions identified within a  $3 \times 3 \text{ mm}^2$  sensor that probably don't affect the sensor itself. We don't know if these «defects» were there before the irradiation and annealing
