Recent Mirror Findings + Timeline

Preet Mann (SBU), Kong Tu (BNL/SBU), Jan Vanek (BNL), Mahmodol Mojumder (SBU), Bishoy Dongwi (SBU), Yongxin Deng (BNL)

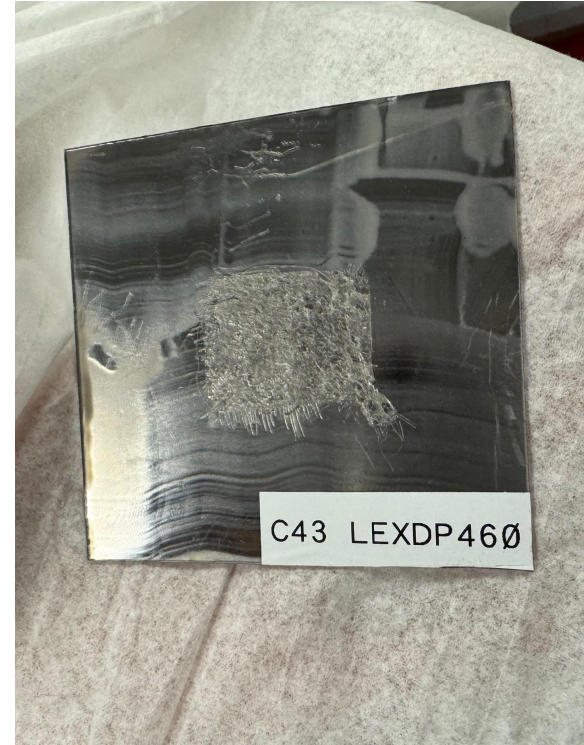
- After viewing all recent samples together at BNL we came to a better understanding about dark spots. They are **NOT exclusive to DP460**, Purdue substrates also show them.
- We previously stated 1 lexan piece also showed dark spots. After viewing this in person, the back of the lexan had epoxy on it (this was meant to be a transmission test). **NO other lexan shows dark spots in any test including coatings where other samples (non bare lexan) have dark spots.**
- **We are extremely confident, this dark spot is actually seeing epoxy under the lexan.** Purdue having a more uniform epoxy method makes the entire 7x7 sample look like a dark spot. This made identifying it earlier more difficult (but light spots can be seen on edges where there is little to no epoxy)

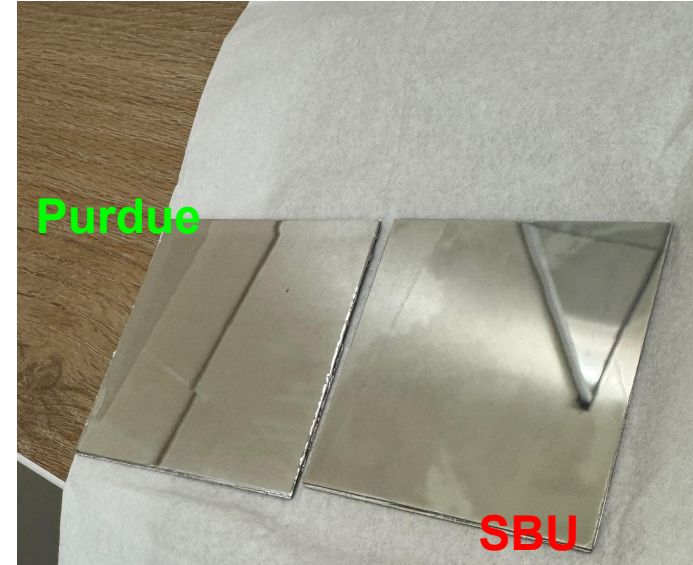
- We conclude (barring C43 LexDP460) that **lexan only does not have dark spots**. Light is transmitted through the reflective coating, and would typically be reflected back by the lexan layer, the thick epoxy instead absorbs a fraction of this light which has resulted in these frequent 85% coatings (testing dark spots vs light spots is on avg a loss of 4-5%).

- Aging of our last QC likely means we were not receiving an accurate reading, after replacing this crystal, we are aiming for the same relative number but it is not actually the same absolute value.

- We must simply coat slightly thicker, too much aluminum causes some interference issues with transmitted light, but if we can make the coating thick enough that the epoxy does not play a role, then recouping the lost reflectivity from the epoxy will make up for any fractional losses by adding too much aluminum. We can then optimize from there and return to our 90% reflectivity from coating #28.
