Understanding the Dark Spot on Mirrors

The End of SULI Program Summary

Preet Mann (SBU), Jan Vanek (BNL), Mahmodol Mojumder (SBU), Bishoy Dongwi (SBU), Yongxin Deng (BNL), Kong Tu (BNL/SBU)

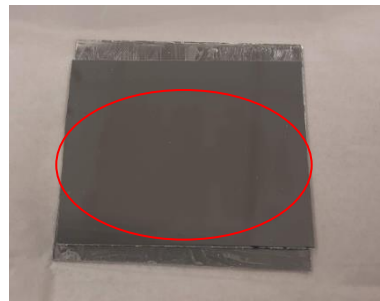
42 Mirror 4 DP460 dark spot

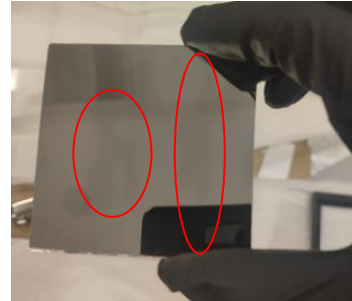
42 Mirror 5 DP460 dark spot

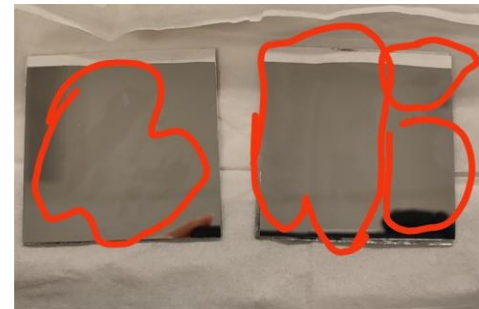
43 DP460 mirrors

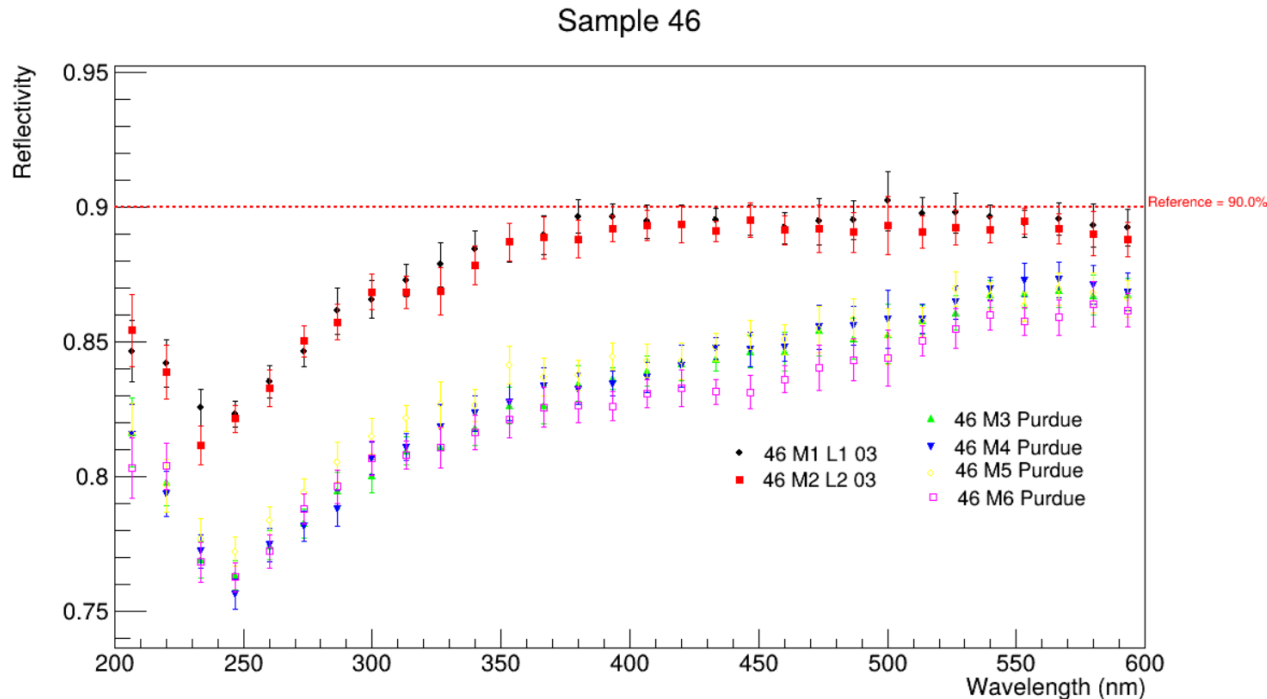
Example Coating 46:

- Lexan-only can reach 90%
- No visible Dark spots on two Lexan-only samples.
- Dark spots on Purdue's substrate
- With ~5–10% reflectivity drop for dark spots on Purdue's substrates.

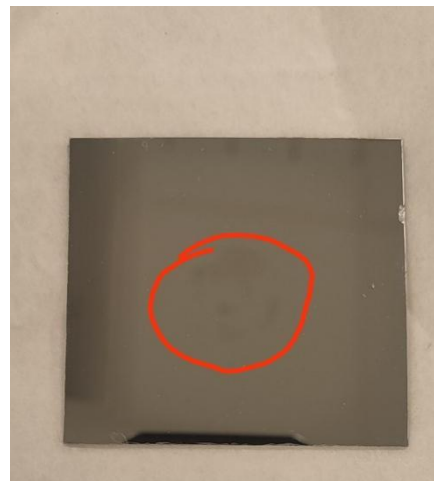
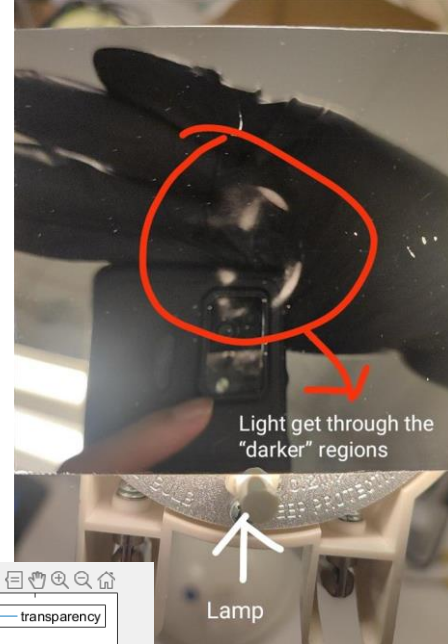
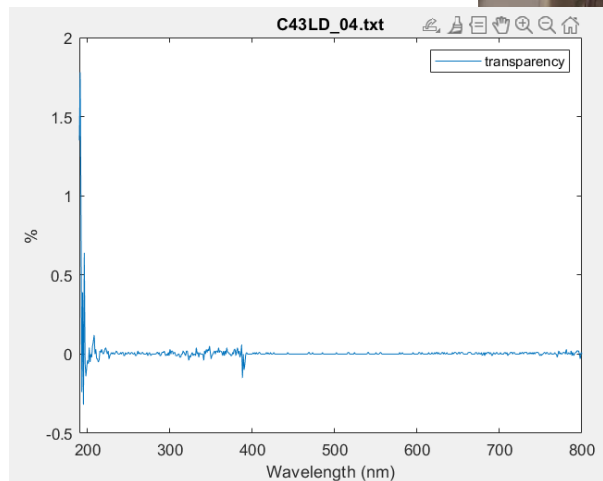
- Coating 43 is thinner than the normal coating: 4.4kA Cr, 10kA Al. Normal is ~4kA Cr, ~16kA Al.
- Dark spots at **mechanical mount** on the frame in vacuum chamber.
- Those dark spots seems like the **thinner coating**.
- However, the Monochromator shows **0 transparency** at dark spots.

- **Potential solution:** thicken the coating if coating is thinner at dark spots.
- Quantitatively verify “used of epoxy” dependency.
- Further verify “transparency” impacts.

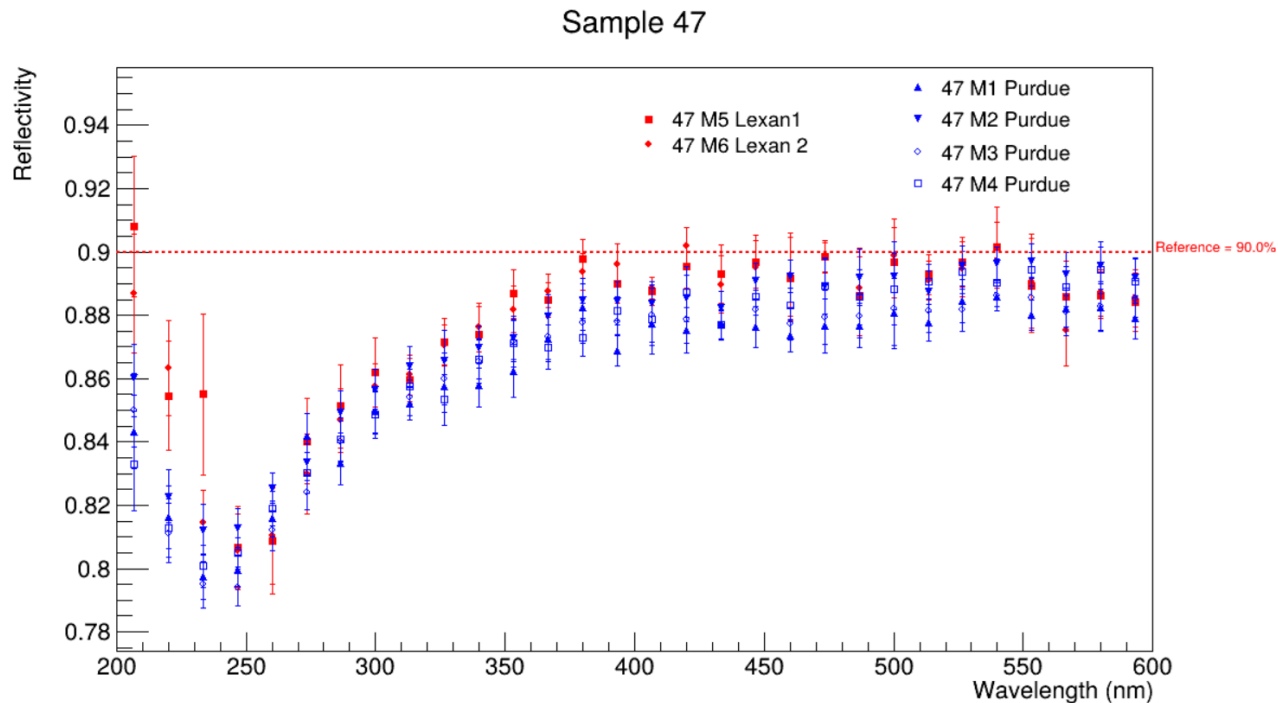
Coating 47 → testing potential solution by thickening the coating

- Lexan-only, no dark spots near 90%
- Purdue, no dark spots, with some contaminations, near 89%
- May be a good news that with thicker coating: Purdue's substrates(blue) have great improvement and almost catch up Lexan-only mirrors(red) with no visible dark spots and reflectivity split.

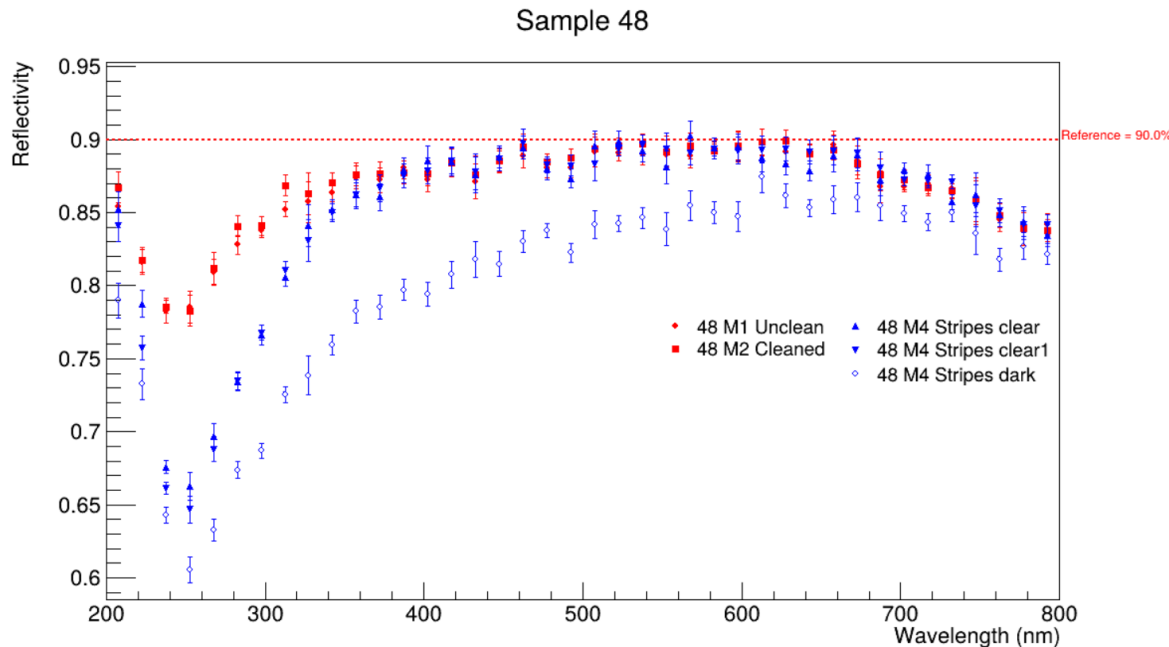
M4 “Stripes” mirror(blue) vs M1 & M2 reference (red)

With Lexan substrate but two stripes of DP460 epoxy on one side.

- Dark spots on epoxy stripes area only.
- Clear spots consistent with M1 & M2.
- ~5% reflectivity drop on dark spots. Also, dropping effect is weaker at higher wavelength

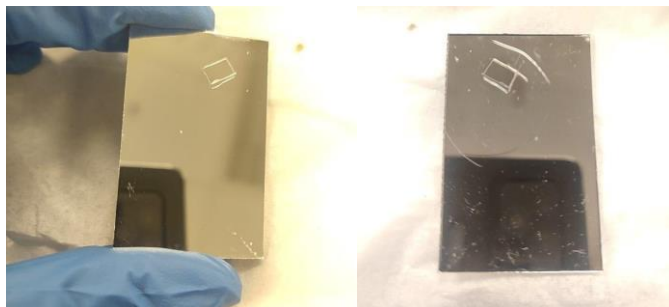
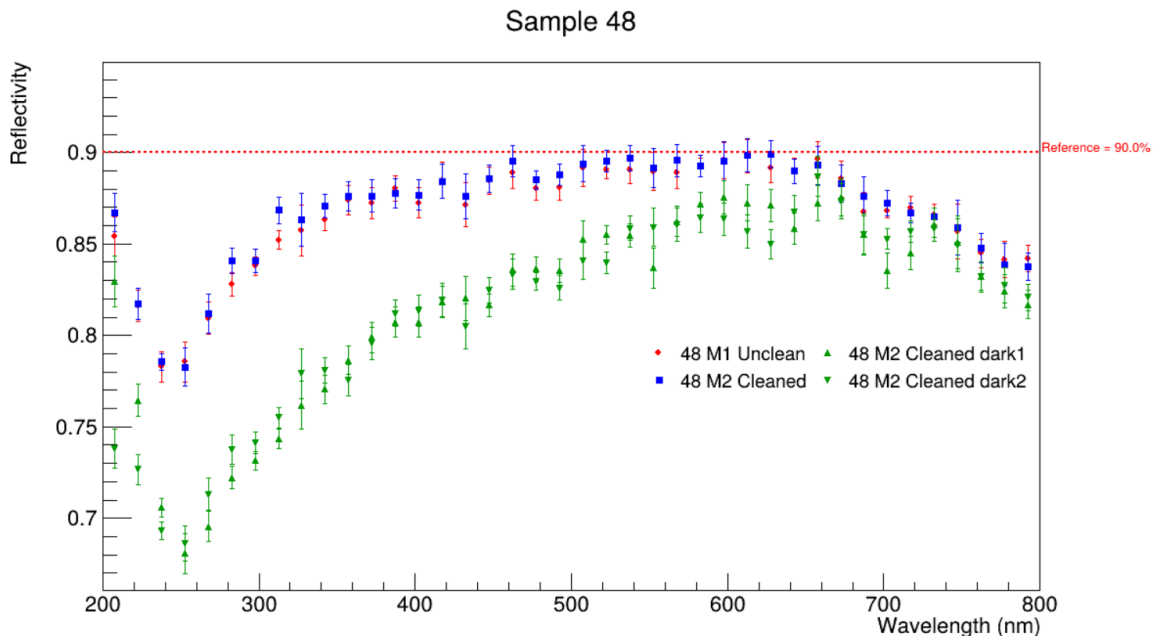
“Cleaned lexan-only” vs M1 & M2:

- Same dark spots at **mechanical mount**
- Maximum ~10% reflectivity drop.

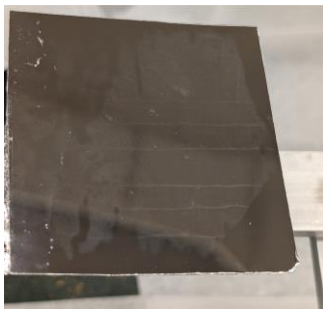
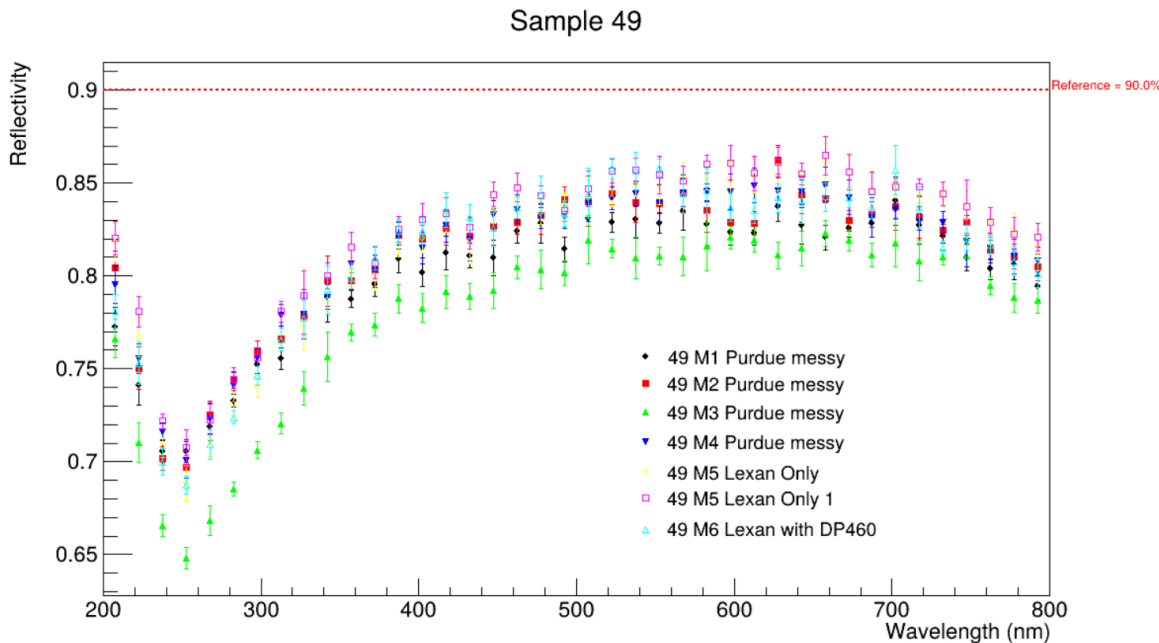
Coating 49(6kA Cr, 24kA Al, the thickest coating)

- Thickest coating
- No dark spot → similar in coating 47
- The contamination spots are no much different than Lexan-only but create some spread from 500 to 700 nm range.
- The M3(in green) is noticeably lower with worst contaminations.

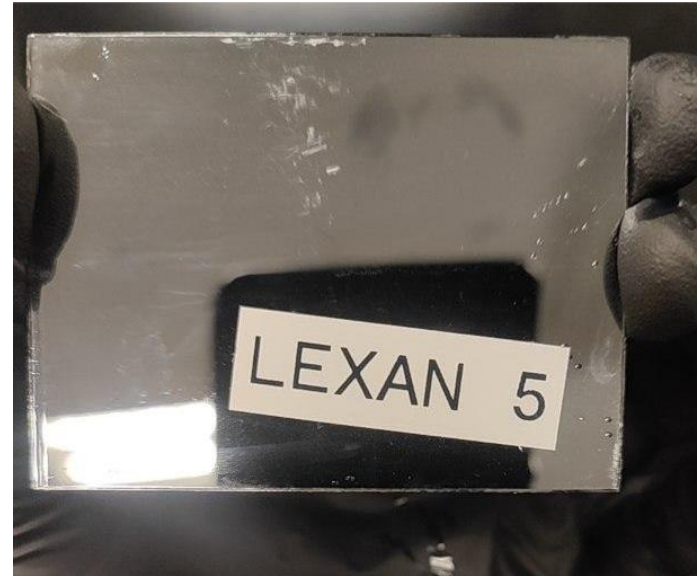
Same dark spots at mechanical mount.
