Visual Inspection Report

HRPPD #24

Returned from Repair (Visual inspection only – no HV or functional tests performed at this stage)

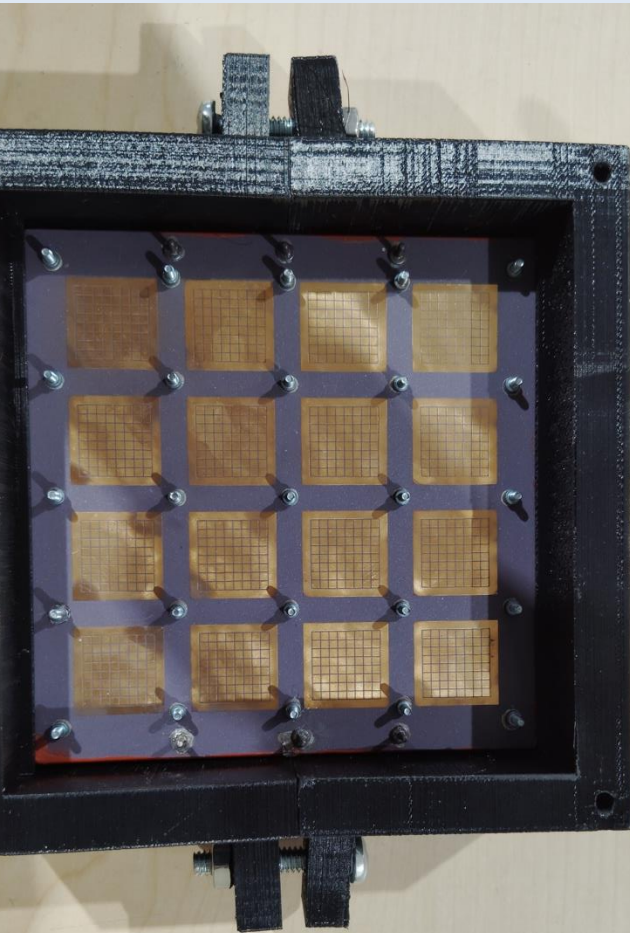
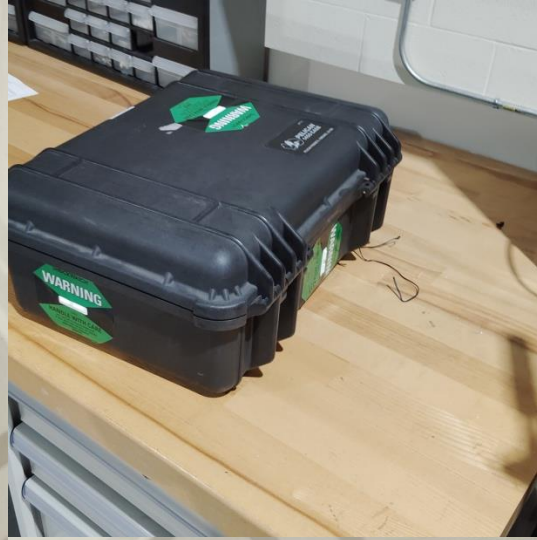
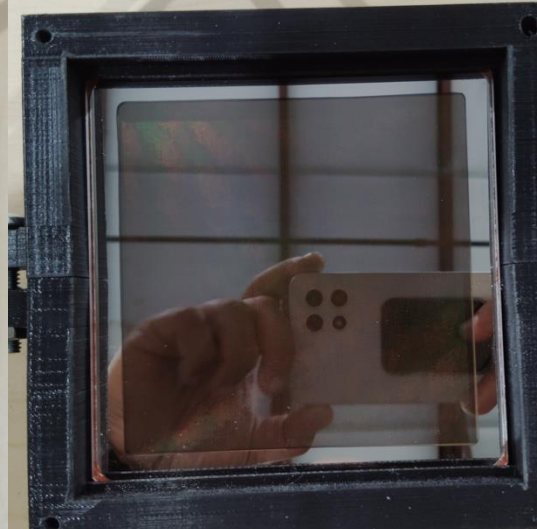
- The shipping box and attached shock sensors were intact, and no physical damage was observed during transport.
- The external body of the module can be considered mechanically stable and free of shipping-related issues.

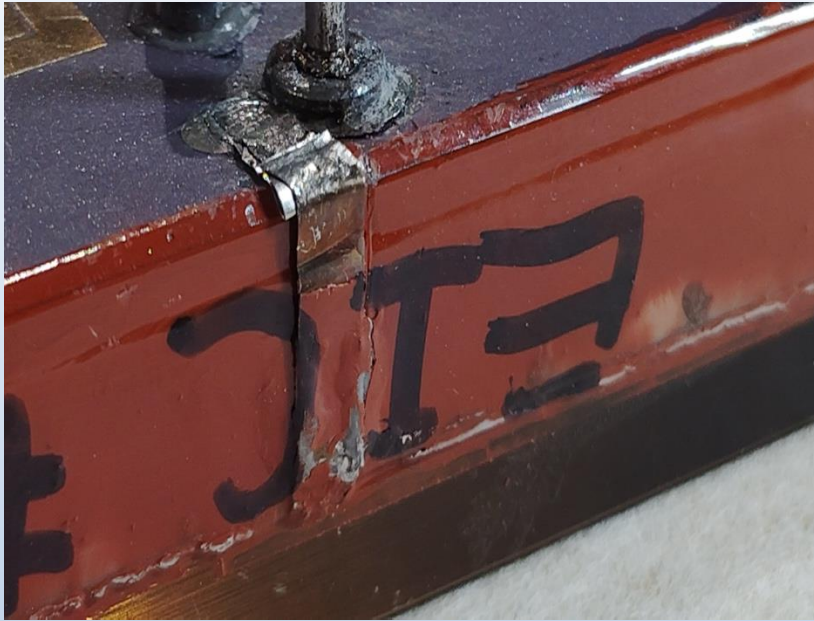
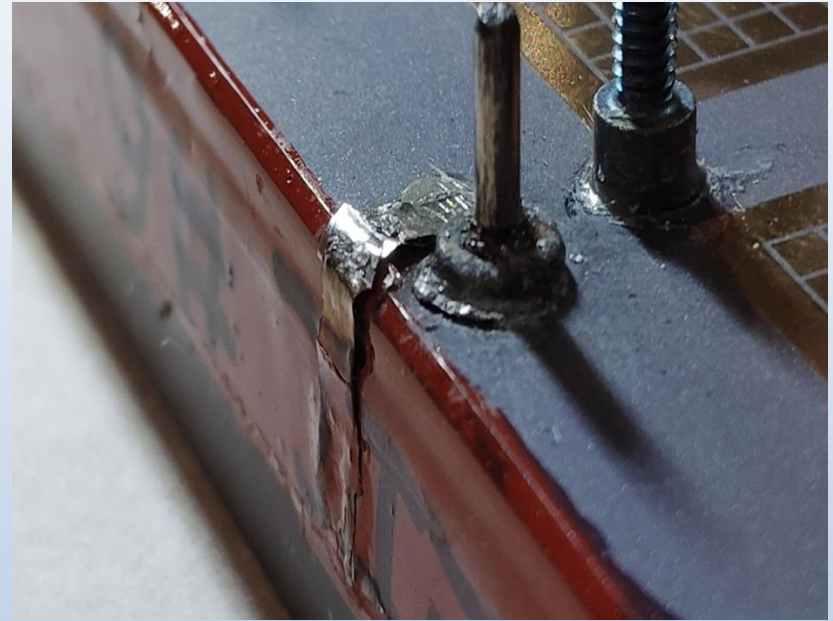
- The photocathode (PC) HV pin showed evidence of repair, but the quality of the rework appeared incomplete.
- Spot welding lacked uniformity, and several attachment points did not look fully bonded.

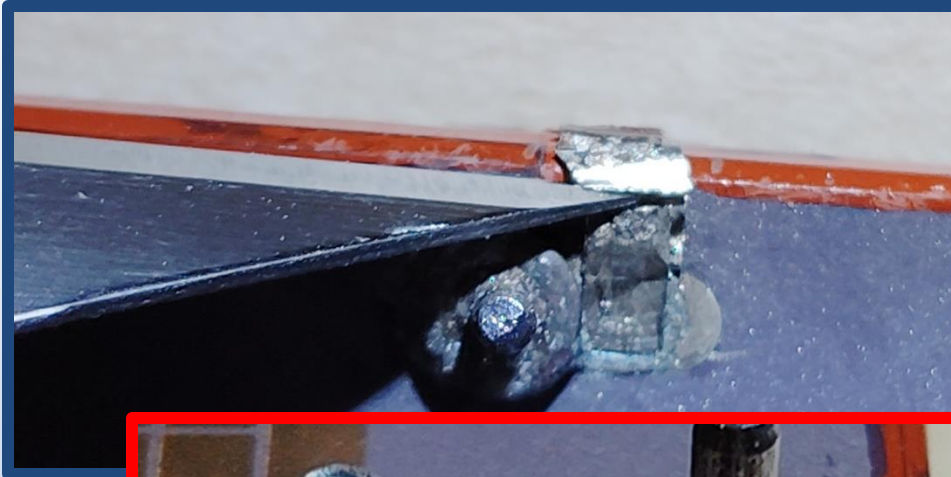
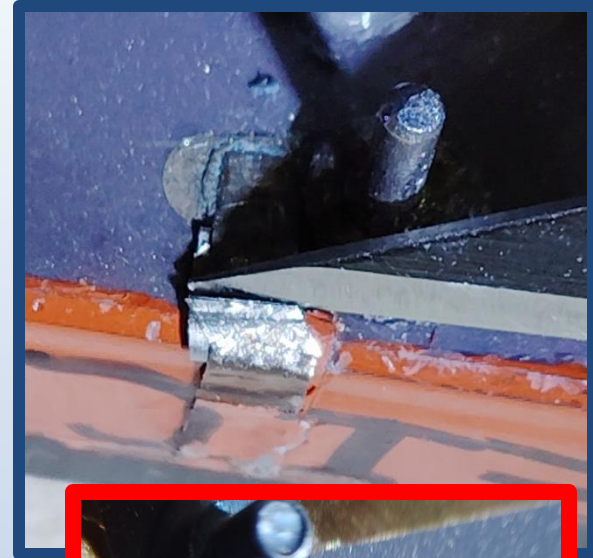
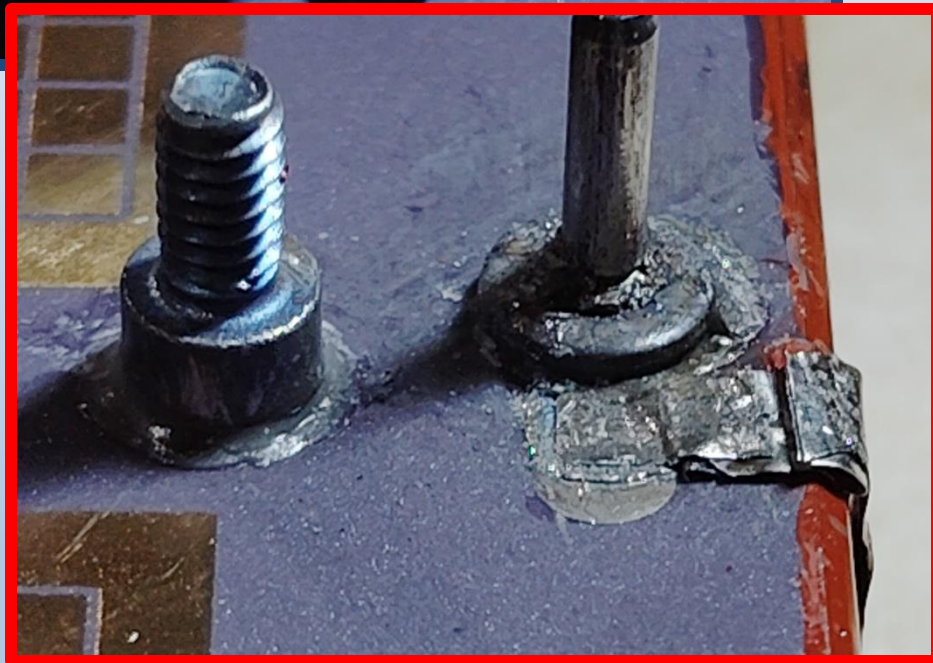
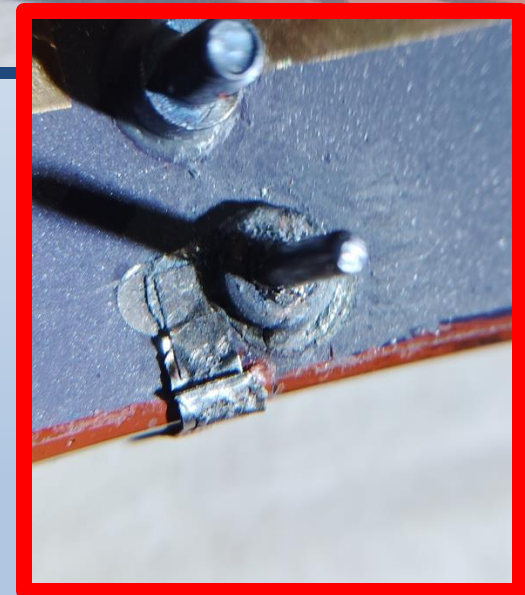
From pictures, one can clearly see loose ends on the HV stainless strip connector, raising concerns for sparking, micro-discharges, or future oxidation.

- To mitigate immediate risks, I applied Kapton tape to the HV connector strip to prevent any possible shorting with the PCB ground.
- The next step will be to install the HRPPD in the dark box and conduct initial operational tests to verify functionality.
- If the detector passes these initial checks, I will proceed with extended HV biasing and monitoring to evaluate long-term stability.

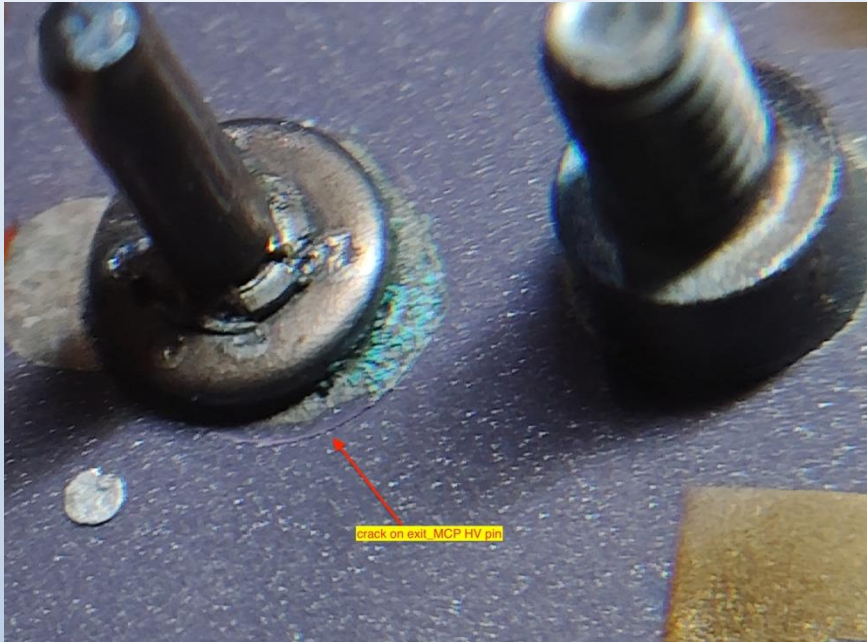
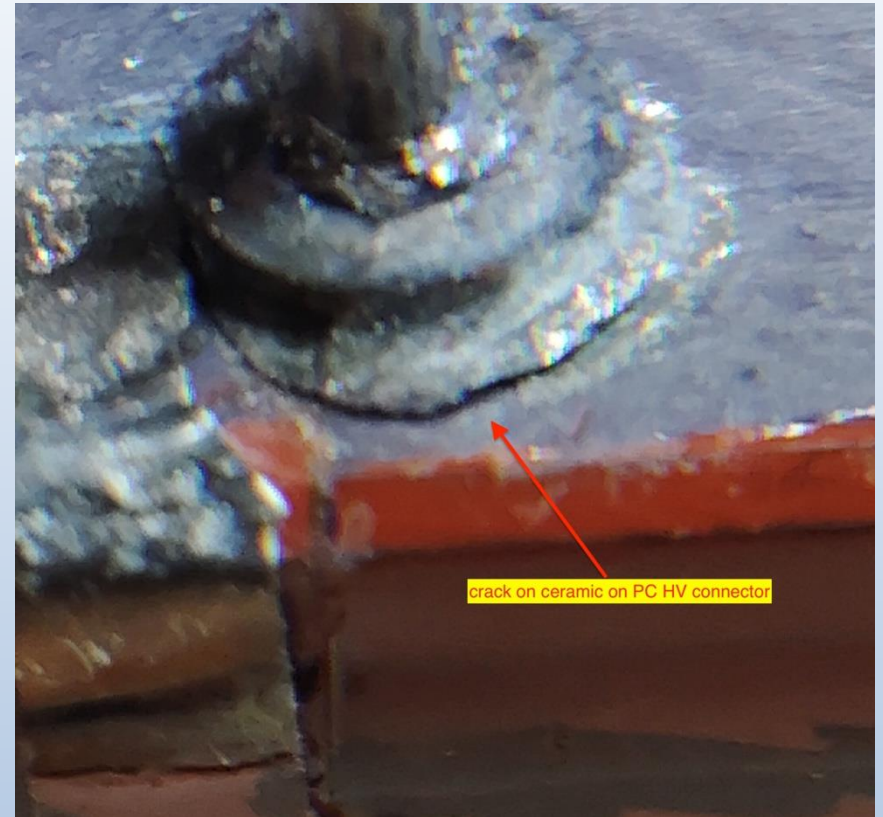
Cracks were observed at the interface between the ceramic body and both the exit_MCP and PC HV pins, introducing additional uncertainty regarding long-term performance.
