RHIC BPM SYSTEM APEX WORKSHOP 2010

October 19th 2010

BPM System Improvements

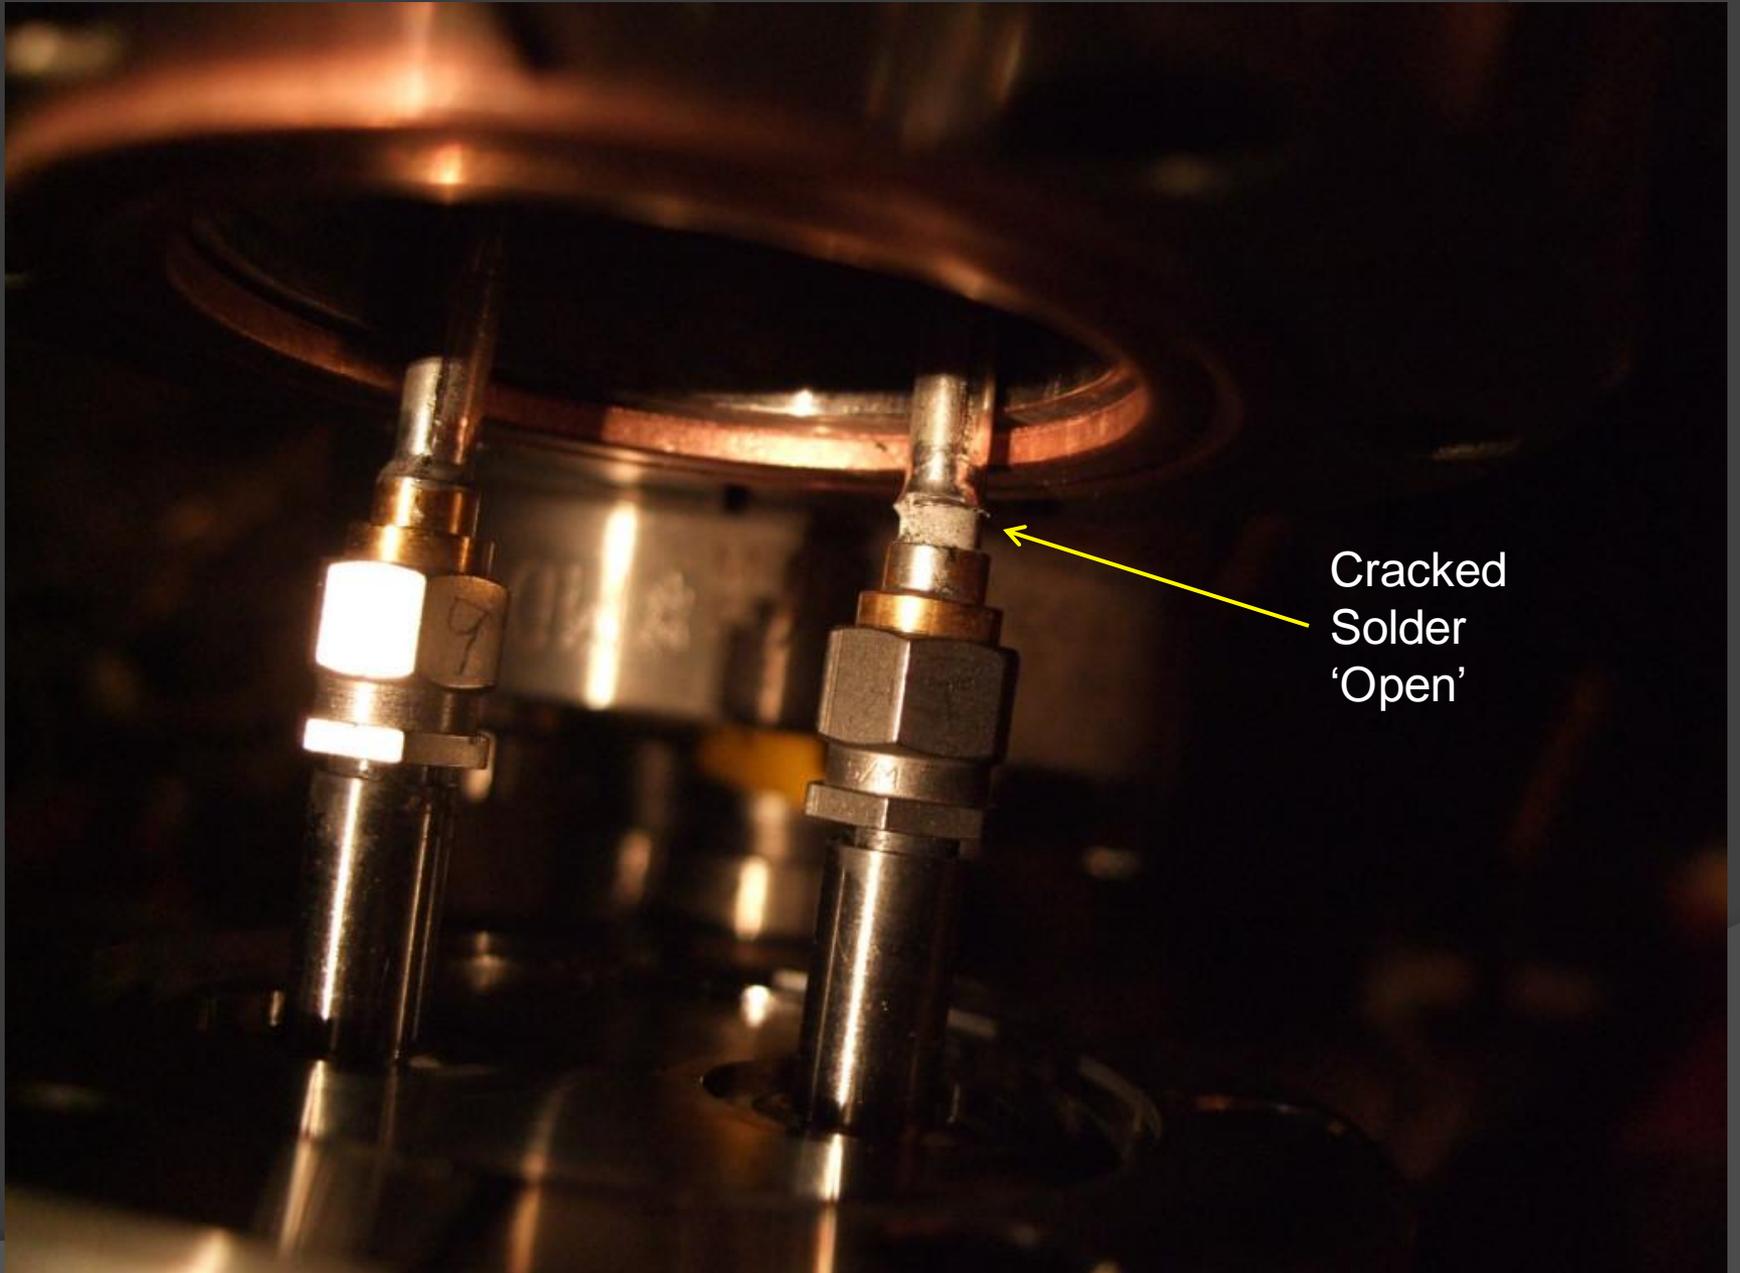
yo9-bh3

- ⦿ All 11 problem feedthroughs have been serviced
- ⦿ 'Open' Failure Mode
 - Most are old-style feedthrough
 - Those examined had 'cracked solder' – known problem
- ⦿ 'Shorted' Failure Mode
 - New-style feedthroughs affected
 - Solder overflow into connector caused short
 - Failure does not appear to be related to new style feedthrough

Cracked
Solder
'Open'

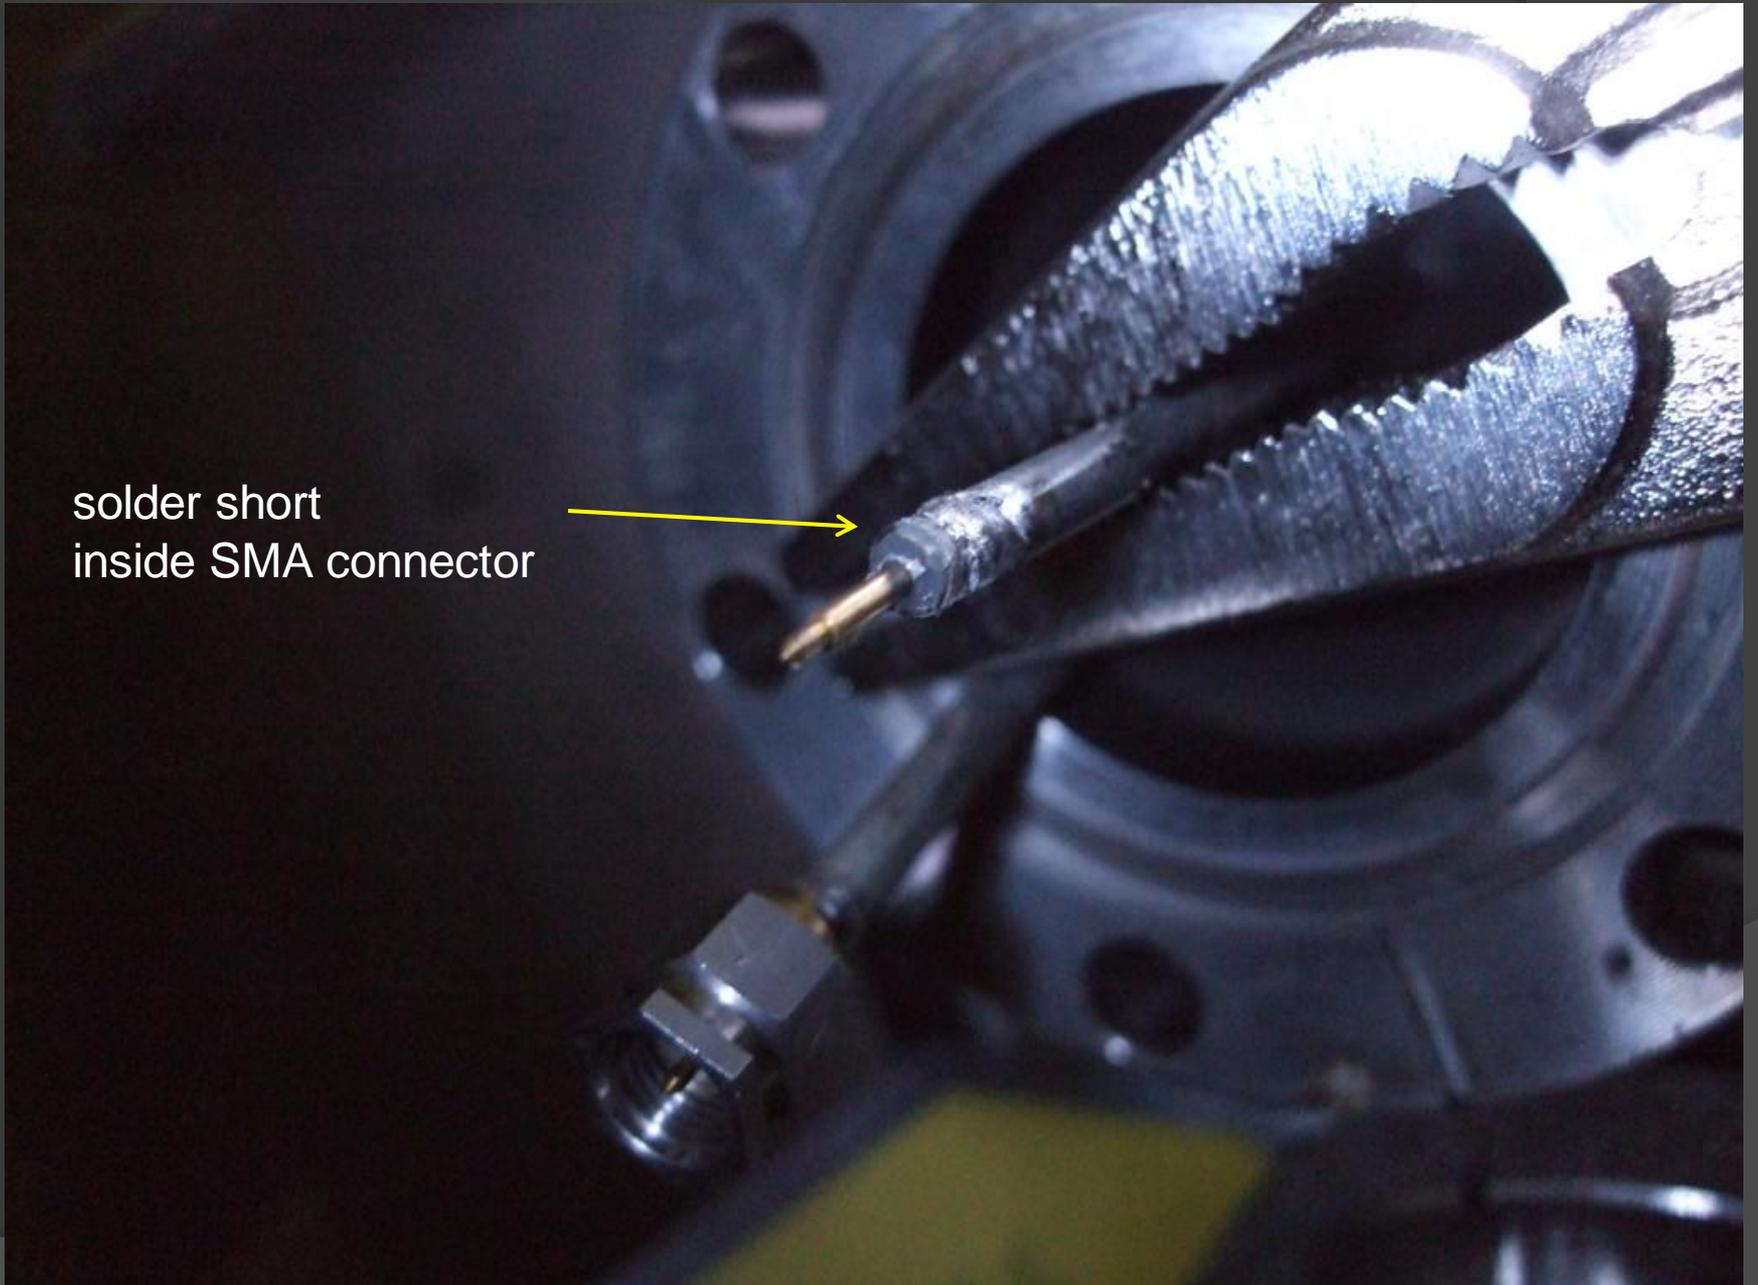
yi11-bh3

solder short
inside SMA connector
