EIC Roman Pots / AC-LGADIJCLab Progress Report

BNL-IJCLab-OMEGA Meeting - May 6th, 2021

- Progress report on activities related to an AC-LGAD (strips) sensor wire-bonded by BNL onto an ALTIROC1_V2 (PCB #30)
- **➢** Outlook

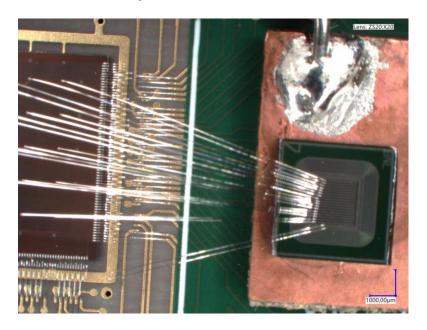
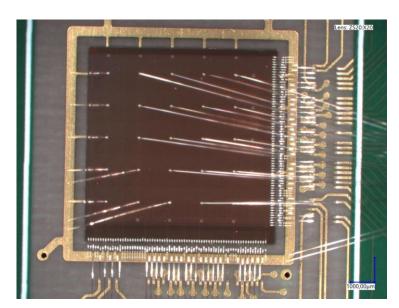
April 20th, 2021

- under microscope and multimeter measurements: no obvious short; 2 wires connected to the guard ring accidently damaged (1 unsoldered, 1 crooked)
- Attempt to use the Captinnov semi-automated probe station => requires a chuck adaptor or to use the manual one

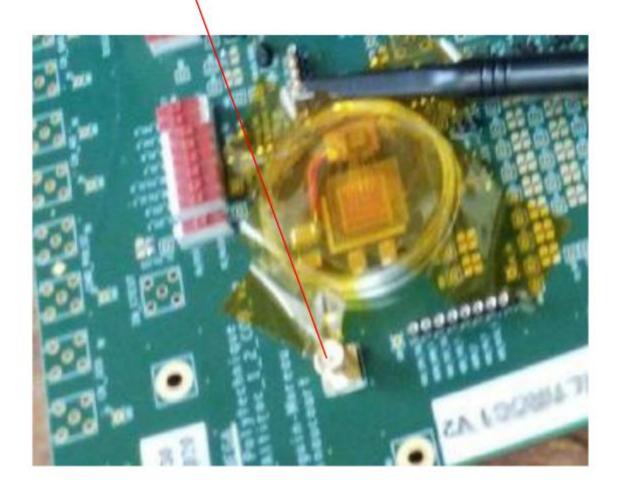
We measure impedance with ohm-meter between HV input and GND Measurement > 10Mohms

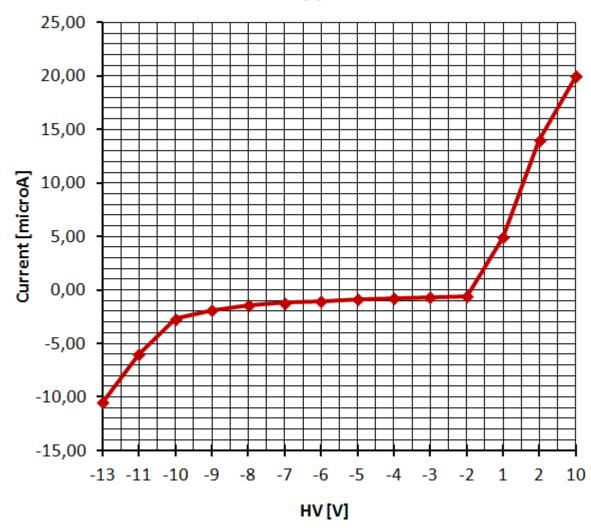
Current versus HV applied to AC-LGAD

First exploration: -10 μ A at -13V, current increasing with the HV applied

Suspecting a bad polarization of the AC-LGAD P zone

Observed leakage current too high

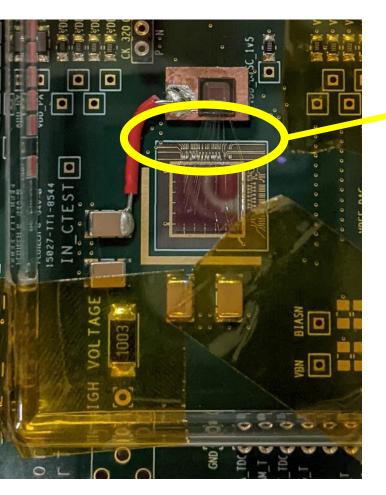
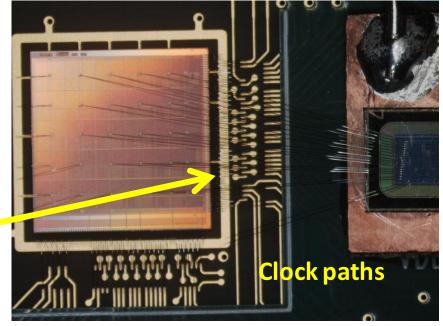
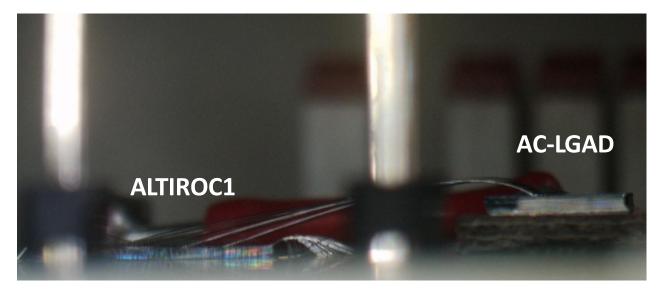
(ALTIROC1_V2 + AC-LGAD) Wire-bonding concerns (1/2)

How the AC-LGAD sensor is connected to HV copper plate? Conductor glue, adhesive tape?
