Improvements to the CeC Systems

CeC Experiment at RHIC CeC X Retreat

Jean Clifford Brutus August 16th,2021

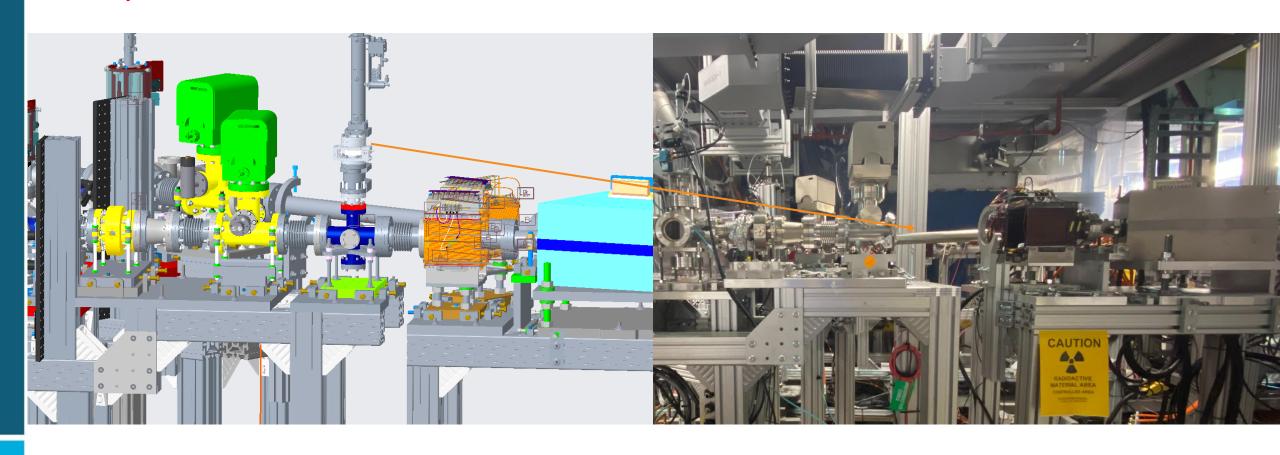
- Stand modification design completed
- Beamline vented and vacuum components removed
- BPM and ion pump relocated; survey to follow
- Delay from vendor for H/V Slit Custom cross 10/05/21

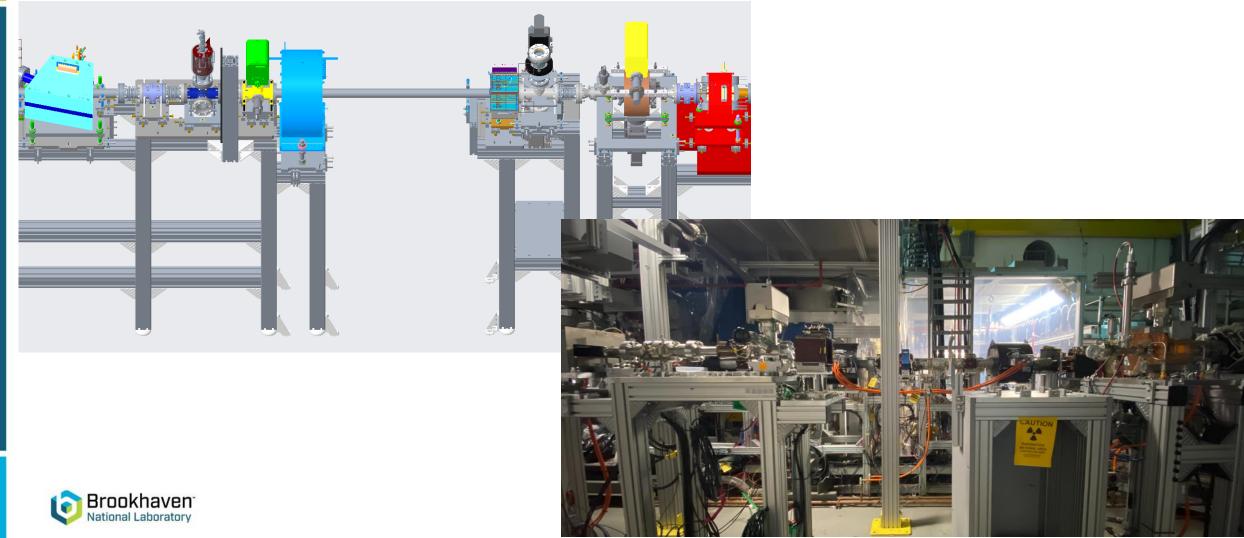
Profile Monitor and Solenoid

- Stand modification design completed
- Work in progress for relocation of H/V corrector and removal of Diamond detector stand
- Delay from vendor for profile monitor cross 10/05/21 fabrication of new cross in house as backup

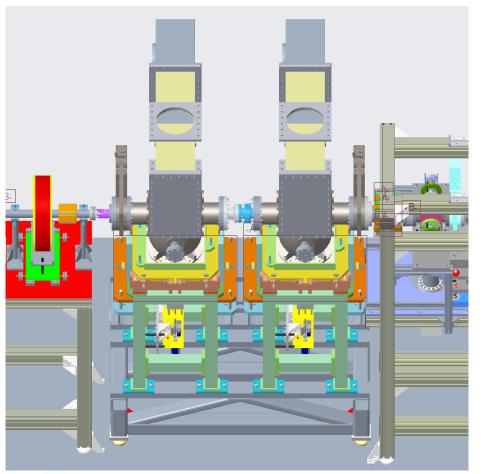
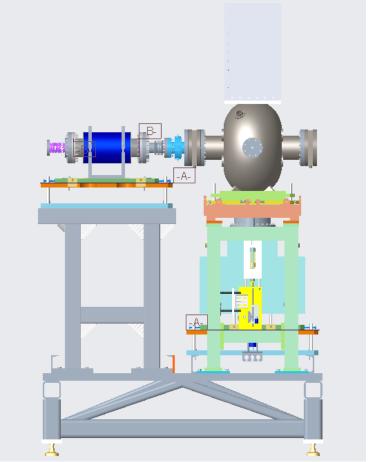
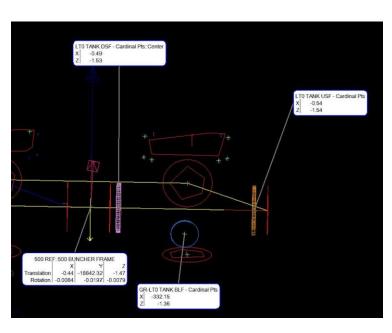
500 MHz Removal

- Design completed
- Design of coax reconfiguration completed
- Parts ordered and in house
- Single 500MHz surveyed: -1.5 mm axis; 0.02 degrees about Y axis

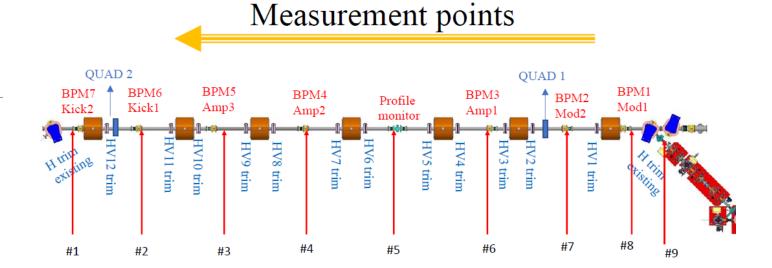
Stray fields studies in CeC section

- I used milliGauss meter today to investigate nature and values of strat magnetic fields in the CeC section
- Earth magnetic field :
 - Earth magnetic field was observed by walking along the CeC section with hand-held meter. Vertical component of the magnetic field has the same sign by varying from \sim +350 mGs at the start (sol 1) to \sim +500 mGs at the center and to \sim +250 mGs close to the of the CeC section (sol 7). Vertical component varyies from -150 mGs to about +100 mGs

- RHIC shell screens Earth magnetic field well with remaining components ~ 100 mGs
- Compensating dipole magnets generate magnetic fields \sim 2-4 Gs at length \sim 40 cm, e.g. angular kick \sim 1.8 3.6 mrad opposite to the main dipoles, i.e \sim 0.2-0.4% difference from the first dipole!

- The main finding from today the back-out blankets and especially connecting cables are highly magnetic, have strong residual fields. Since they are not uniform and asymmetric, they are likely responsible for problems we had with angles of solenoids axes and luck ore reproducibility. These blankets and cables need to be removed.

3D probe was placed ~ 5-6 cm above the IR axis.

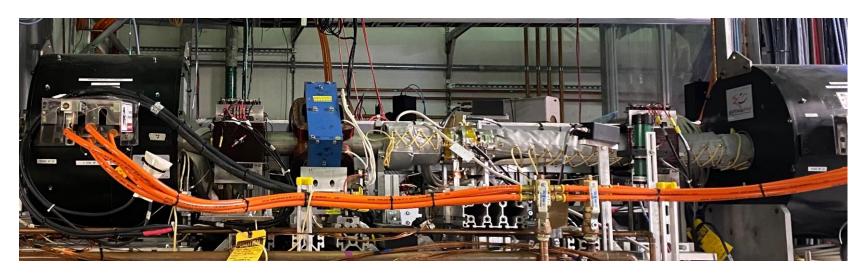
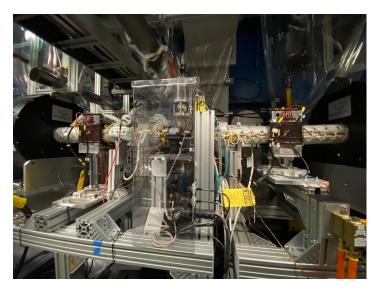
- Search for explanation for unusual kinks in e-beam trajectory discovered, that in contrast with specifications, heating blankets and their cables have significant amount of magnetic materials, which distort magnetic fields in the CeC section
- Heating Jackets and their cables are highly magnetic and have to be removed from the insides of the solenoids, trims, quads... and the rest of the CeC section.
- 7 correctors need to be taken apart to remove jackets
- When blankets are removed, we need to remeasure stray fields from the solenoids, dipoles and most importantly cables! Table shows that stray fields 1 m from solenoids are rather large for some of them and small for the others we need to understand the reason and check if there are cable loops?
