LArFCS Cryogenic System Progress

9/14/21

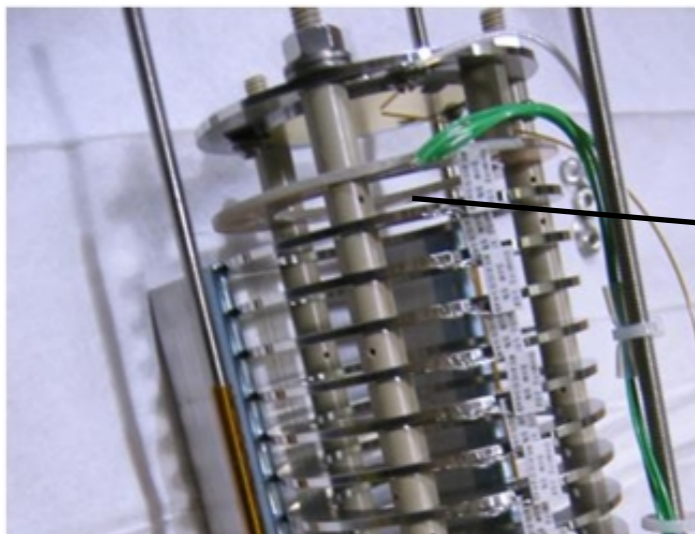
Original

- Refurbishment of our PrM stack completed
 - Missed resistors soldered to the stack
 - Broken wires found on cathode side grid
 - Replaced with the most recent honeycomb grid (Original grid is made in parallel wires)
 - Assembly complete, waiting for the test
 - Sending the Xenon lamp this week once it's available

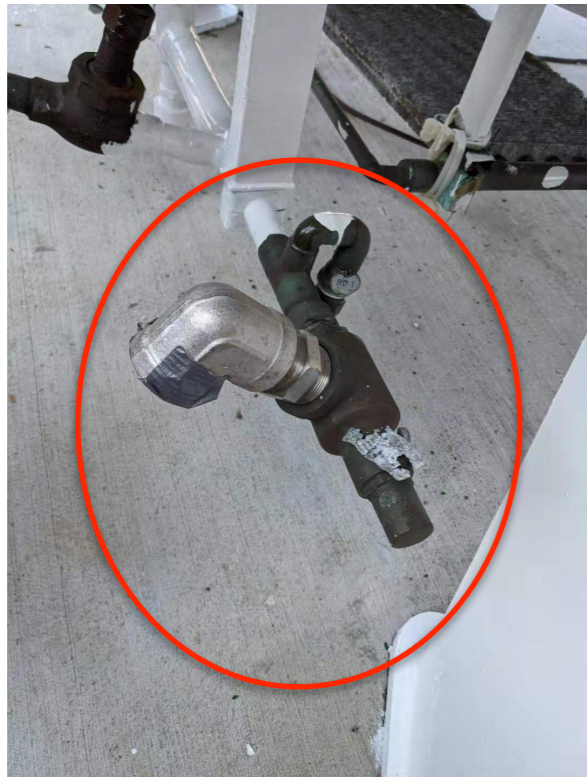
Ours

▸ Single pressure relief devices on the safety tree

- Recommendation: implement identical safety tree (burst disk+relief valve) on a three-way valve
- Worn label on the relief valve and burst disks

▸ Pressure relief tree solution

- They can do the installation for us
- Recommend to get the parts from Airgas with suggested specs
- CAD has facility to re-certificate the relief valve

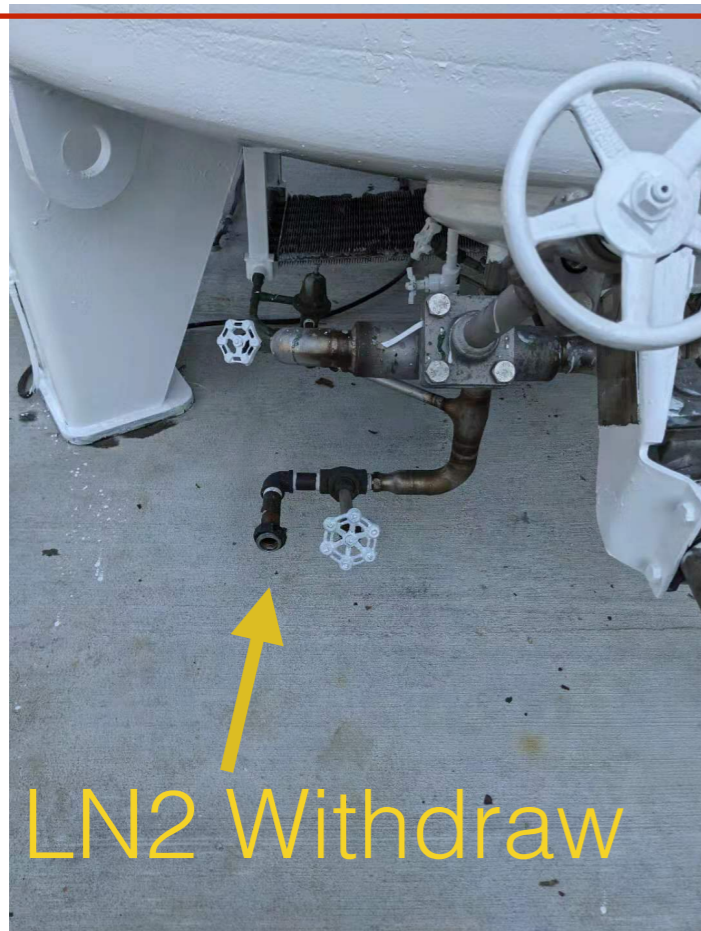
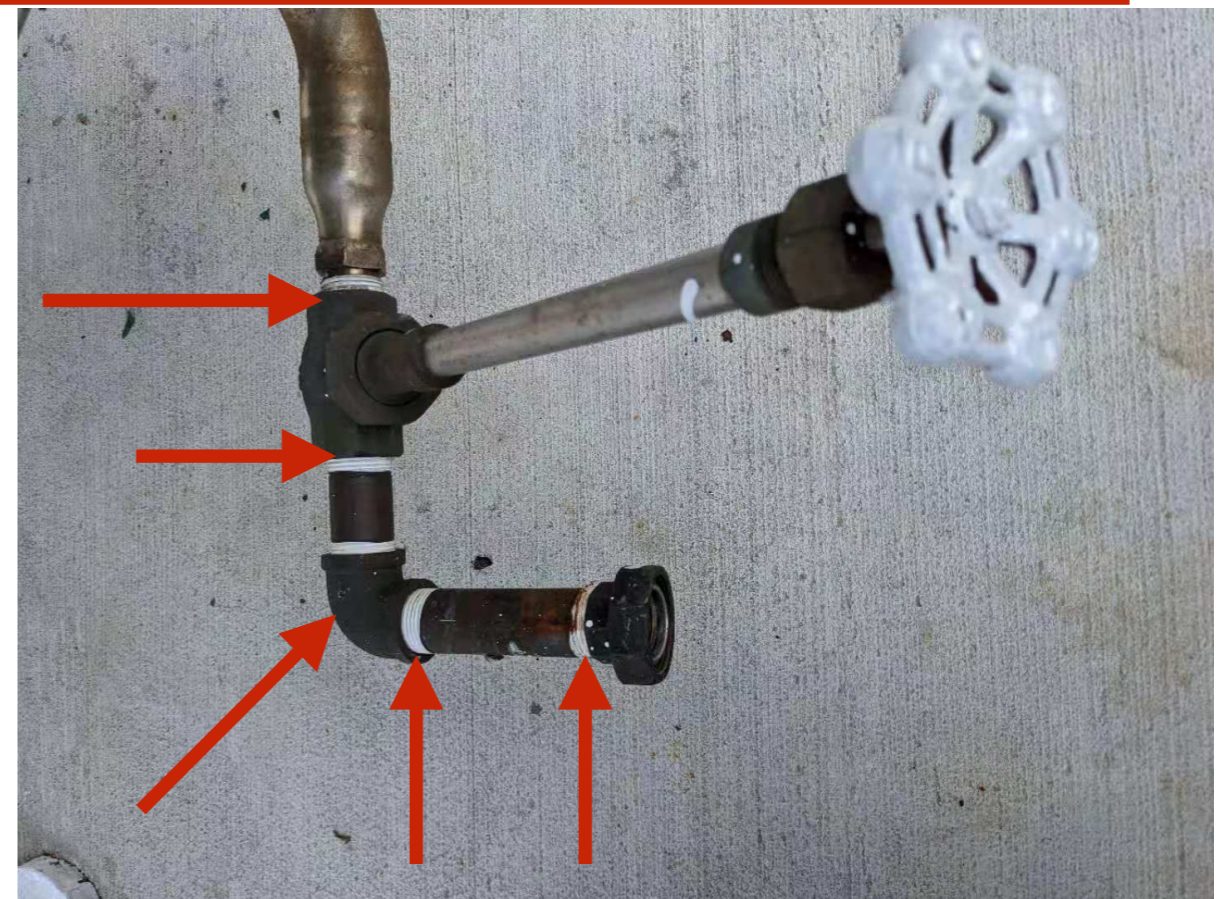
▸ non-cryogenic compatible materials used on the current plumbing

- Teflon tape and brass fittings found on the LN2 withdrawn, not suitable for cryogenics
- Requirements: Replacement with cryogenic compatible materials by cryo tech. (concurrent by Mike)

▸ LN2 output port issues resolution

- The current cryogenic valve with cryogenic brass body can be reused
- Just need to order Stainless Steel tubing with the right size, and fitting
- Sealing will be done with cryogenic tape or cryogenic paste

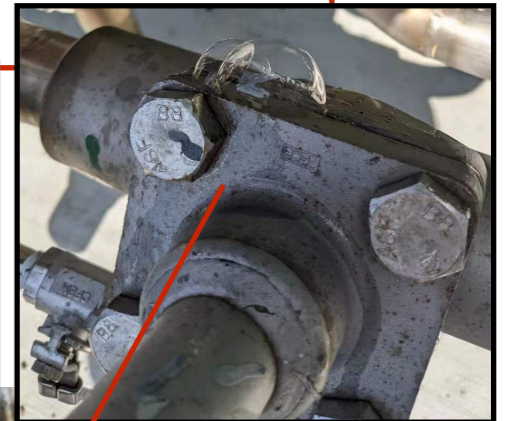
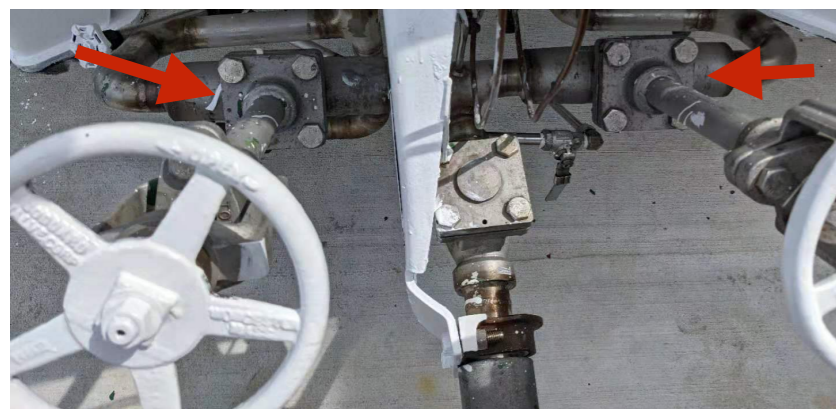
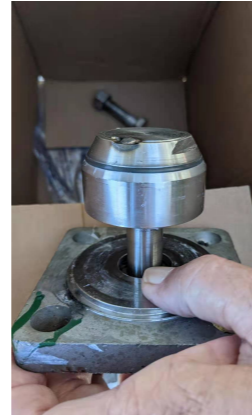
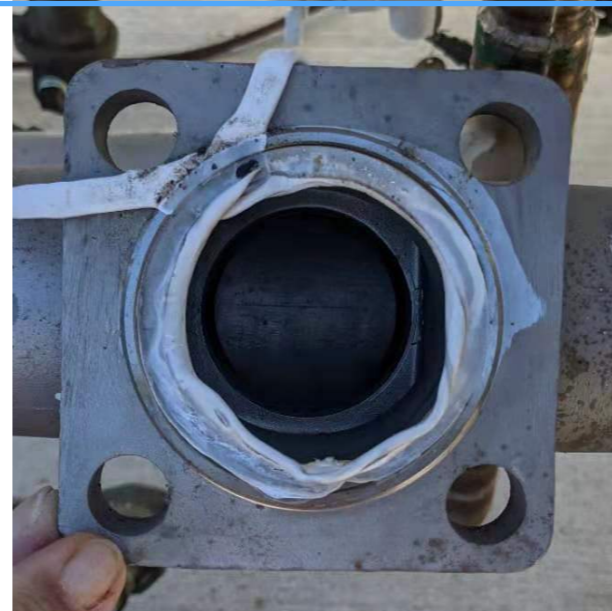
▸ Filling valves and free hanging gasket materials

- The leakage situation will usually be worse in cold
- Requirement: Fix by cryo tech. (concurred by Mike)

- Leakage is common on such valves
- The white strip hanging there is a part of previous sealing material
- The seal needs to be replaced
- Need to take apart the filling valves to check the seal

▸ Leakage on the filling valve resolution

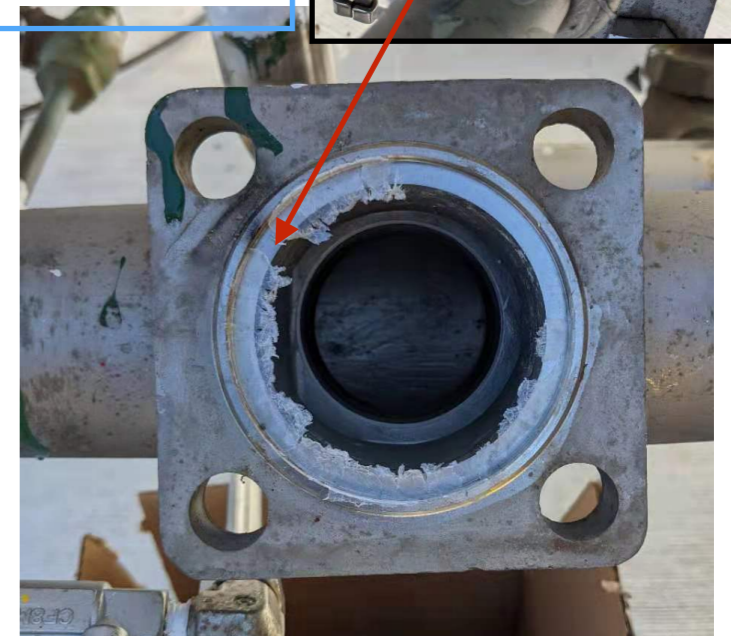
Left

- Opened on the two filling valves (We can open it, but needs cryo. expert to put it back)
- Right valve leaking badly does shows a gap on the sealing
- Confirming with the CAD experts for the materials they have in stock
