INTT Software: tasks for Day1 & Hardware related things

Takashi Hachiya
Nara Women's University

INTT software at INTT collaboration meeting

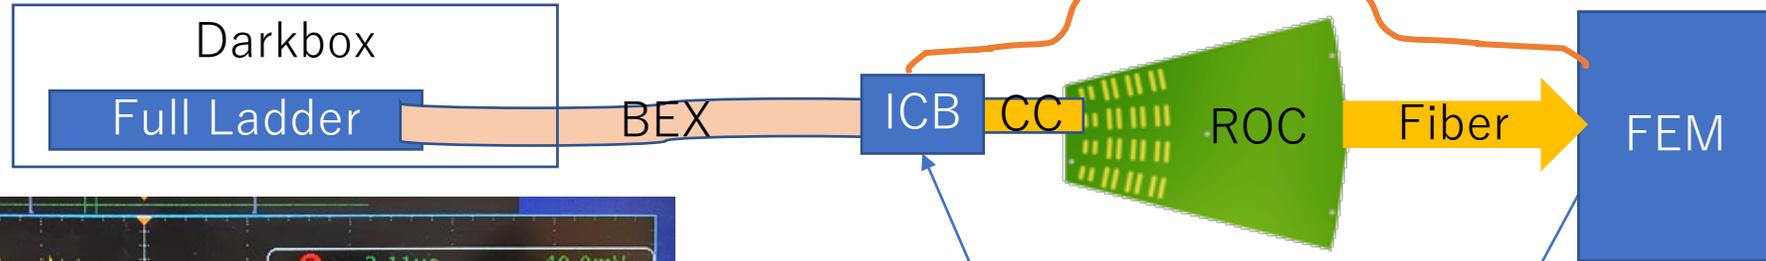
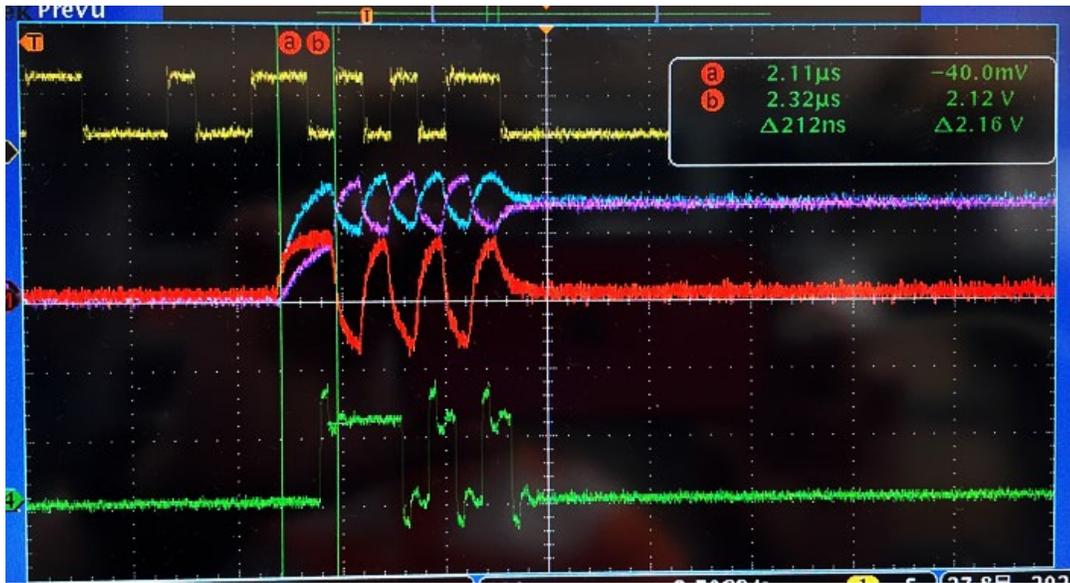
Checking signal by scope

- SC_IN: 10101011 Readback is little endian
- SC_OUT: 11010101 (agree w/ SC_IN)
- SC_OUT@FEM : 11101010 (different. 1 last bit missing)
- GUI:87 (01010111)

SC_IN = SC_OUT at ICB
 1 bit missing at FEM
 → The problem can happen at ROC

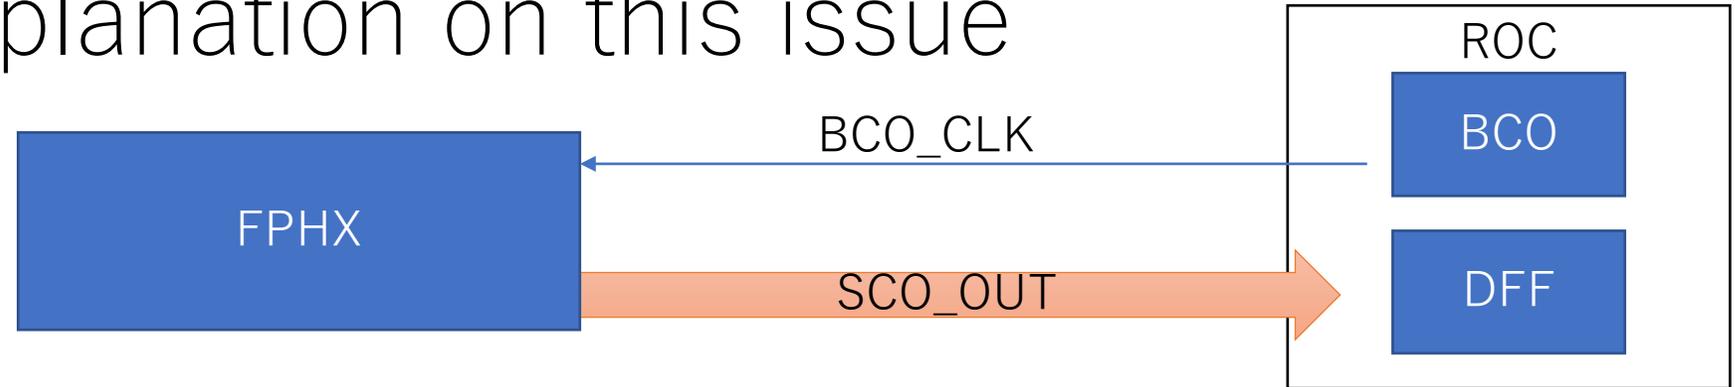
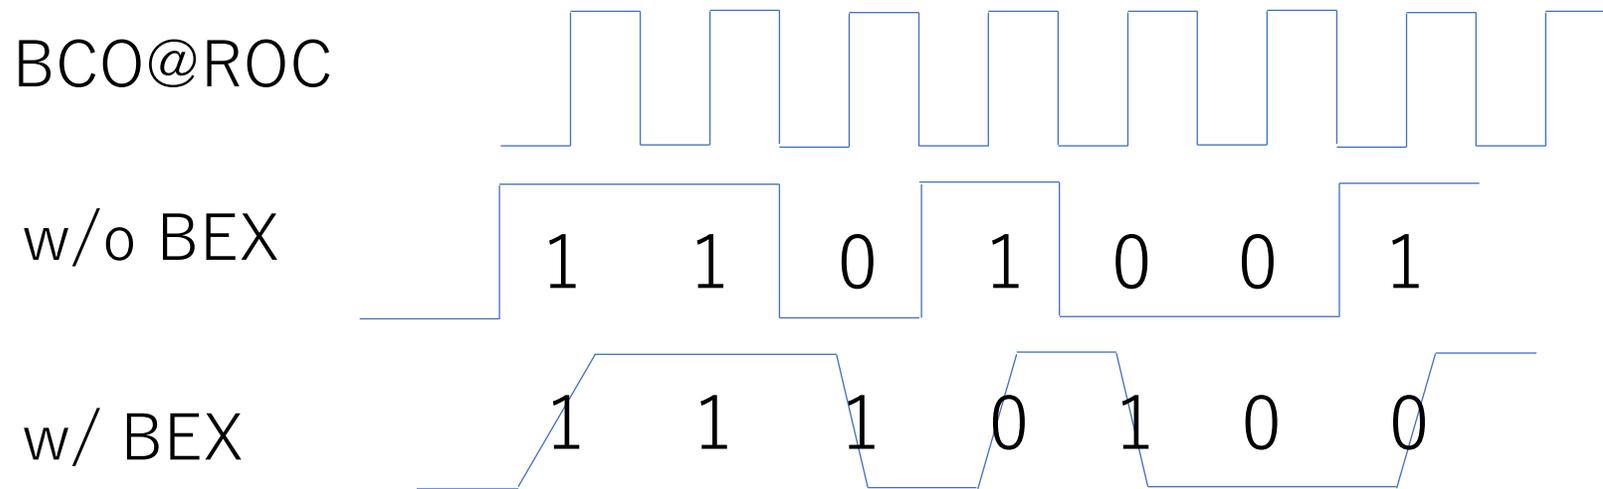
A possible explanation on this issue

- With bus-extender, the data timing is delayed ~20ns. The delay can cause the 1 bit shift issue.

- Delay 1 clock
 - Simple but not good for w/ BEX
- take 9 bit data instead of 8 bits.
 - First 8bits are good for BEX,
 - Last 8bits are good for BEX

- I would like to test this solution using a ROC for play

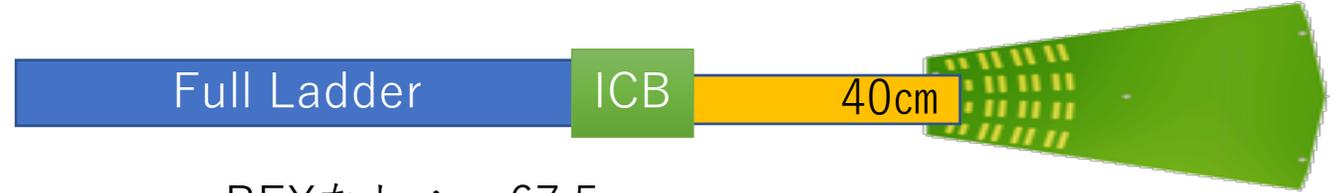
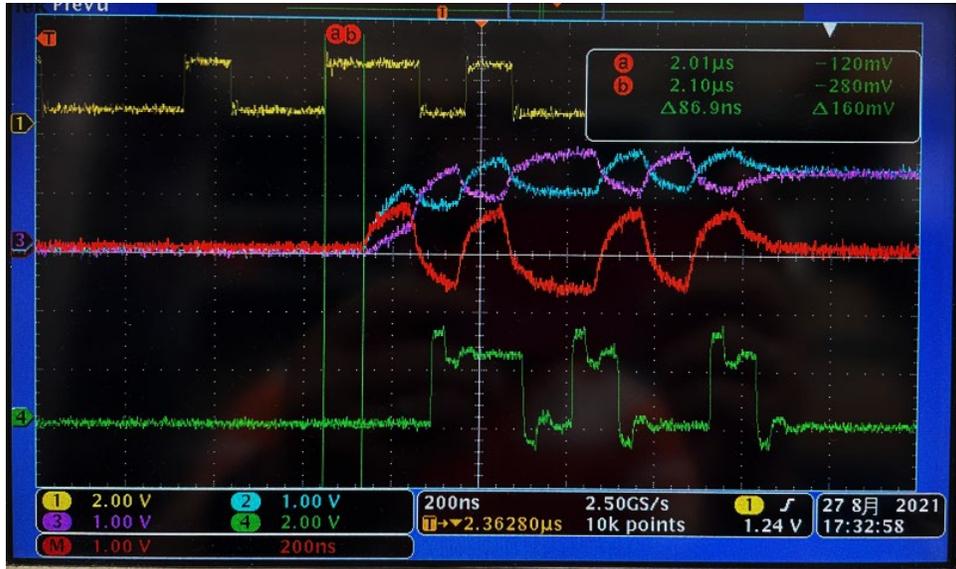
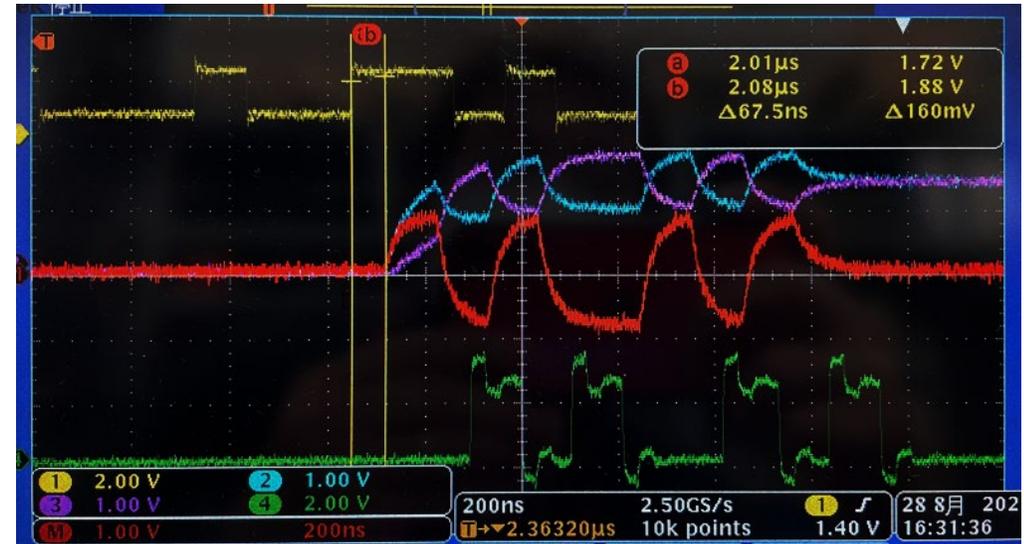
Readback信号の戻り時間

BEXあり： 86.9ns

BEXなし： 67.5ns

- 時間差： $86.9 - 67.5 = 19.4\text{ns}$ @ 130cm BEX
 - 130cm の往復でかかる時間： 13ns (20cm/1nsで換算)
 - BCOの鈍りで遅れていることも考えられる。

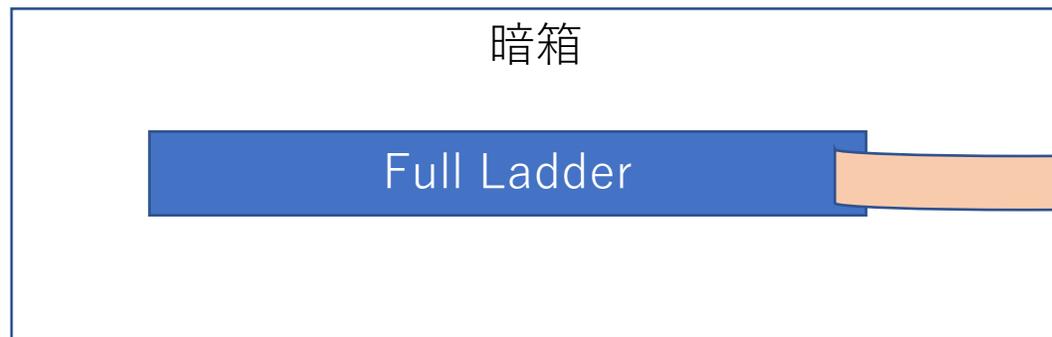
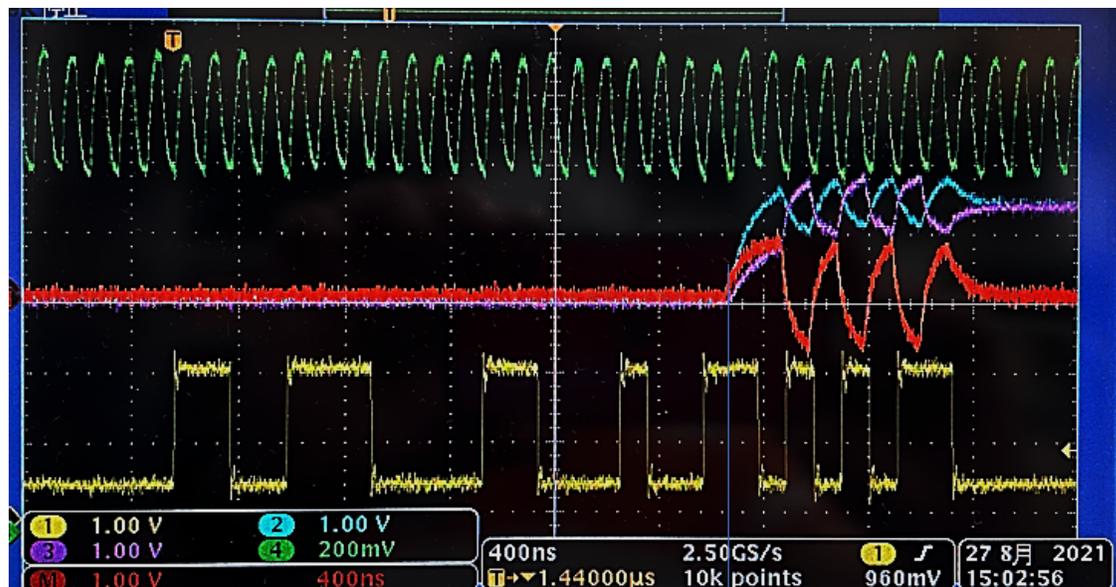
測定のセットアップ

- 入力：10101011
- 出力：11010101
 - 反転してでてくる。
- 入力と出力が一致している。

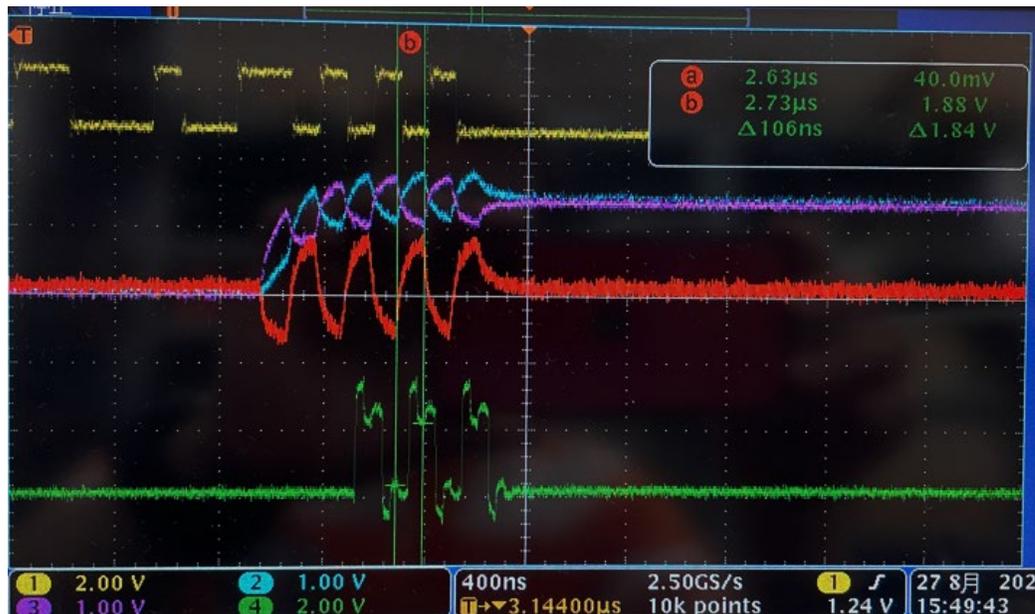
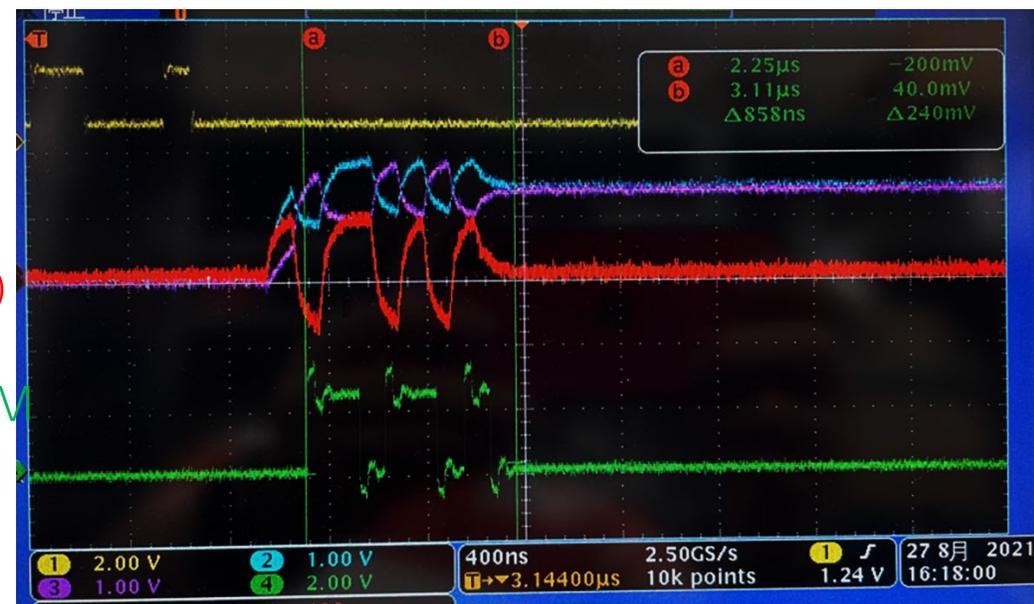
読み出しデータ

- SC_IN: 10101010
- SC_OUT: 01010101 (SC_INに一致)
- SC_OUT@FEM : 00101010
 - (違う。1ビットずれ+最初のビットが違う)
- GUI:84 (00101010)

- SC_IN: 173
- SC_OUT: 10110101 (SC_INに一致)
- SC_OUT@FEM : 11011010
 - (違う。1ビットずれ+最初のビットが違う)
- GUI:91 (00101010)

読み出しデータの1ビット目は、2ビット目といつも同じ

- ROC上で、FPHXデータの受信失敗
 - (距離が長い?ため、)データが遅れ、受信タイミングがずれてしまう
 - 典型的には1クロックおくれる
- 観測結果からこれが推測される
 - バスエクステンダを使ったときに起きる。
 - より下流(FEMなど) が原因とは考えにくい。
 - Readback波形の遅れ+なまりが原因と推測
