Evaporation #6 Set up

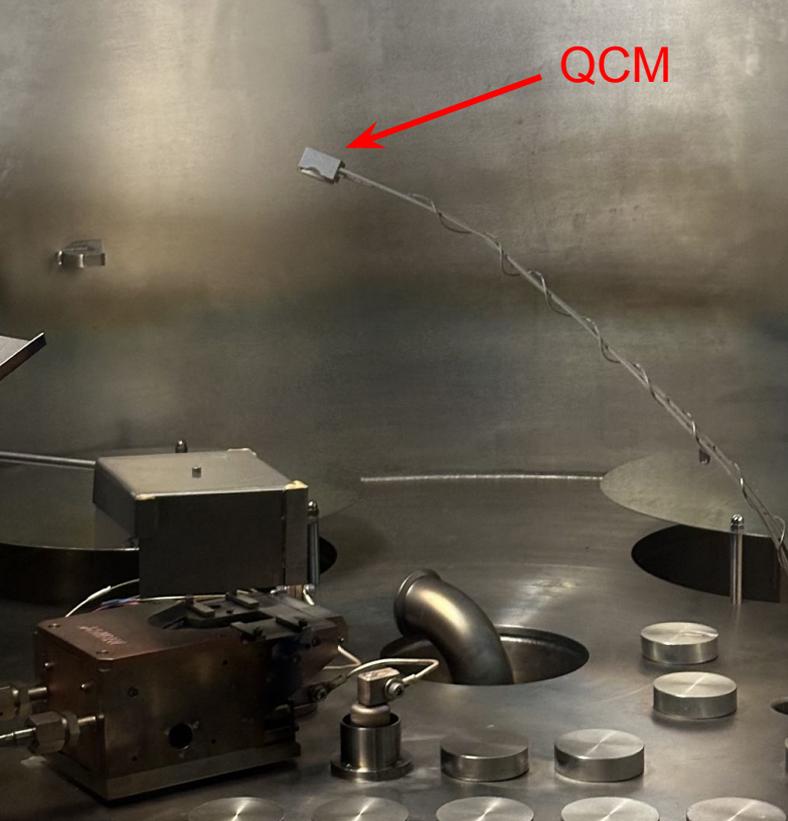
Unfortunately, this evaporation did not go as expected, as we began to coat the Cr we noticed 0.0 Ang/Sec and 0.0 kAng despite being at 40 mA (we would usually see ~10-20 Ang/Sec. We increased it to our peak cruising current of 70mA and yet again saw 0.0 despite the expected ~ 40 Ang/Sec. Notice that the time and frequency were still recorded, after checking to see that there truly was Cr in the crucible and visually seeing a coating form, we concluded that the quartz crystal microbalance was not adequately showing deposition data.

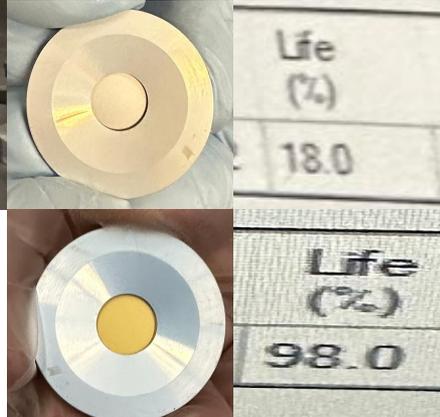
Quartz Crystal:

We attempted to coat some Al, in hopes that some data would be picked up but despite 200mA the issue persisted. At this point we ended the evaporation and left the chamber pumped down. I noticed after that the “Life %” of the QCM displayed as “1%”, after checking from older evaporations I found that the Life had been deteriorating steadily. We located a new quartz crystal and replaced the previous one. After checking the software, the Life now reports 98%.

Old Crystal

New Crystal

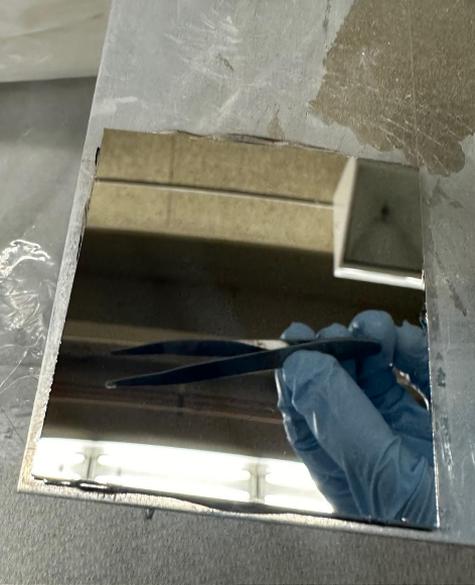
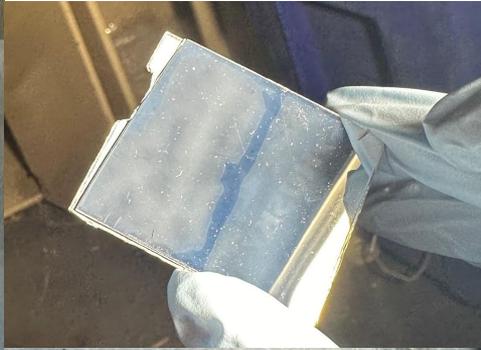
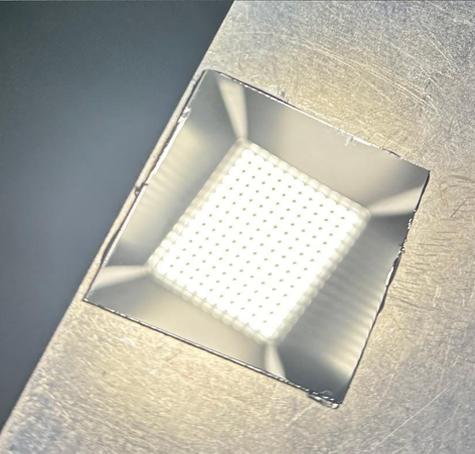
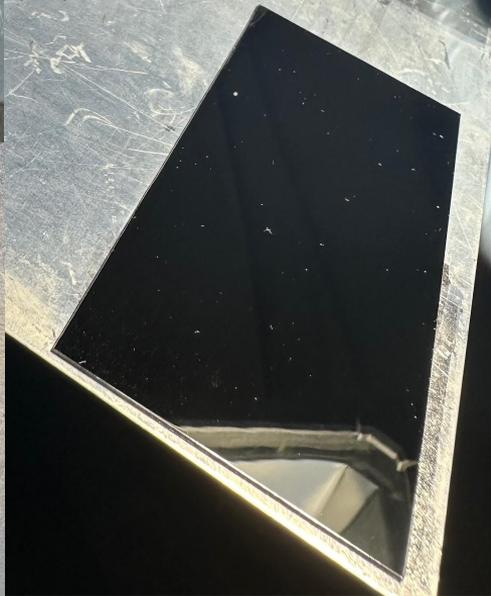
Coating Results:

The top right image is from Evaporation #5

Visually, the evaporation went well, when the mirrors are held up to light we cannot see through the coating as in evaporation #5, nor is the surface of the film “hazy”. The exact reason for this is still unknown to us, we suspect either the large quantity of chromium is responsible, or since these samples were left in the chamber (under vacuum) overnight that perhaps instantly flushing the system with nitrogen gas could be causing some unwanted haziness, we will attempt to replicate this evaporation next week using the time stamps and currents that are recorded in order to acquire data and test whether leaving samples in the chamber prevents the haziness.
