sPHENIX INTT

Dummy sensor placing error

First real module assembly in Taiwan

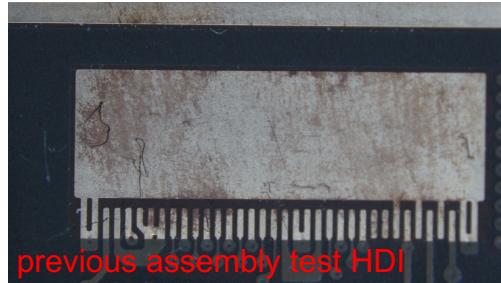
oxidation rust appears

Cleaned by eraser

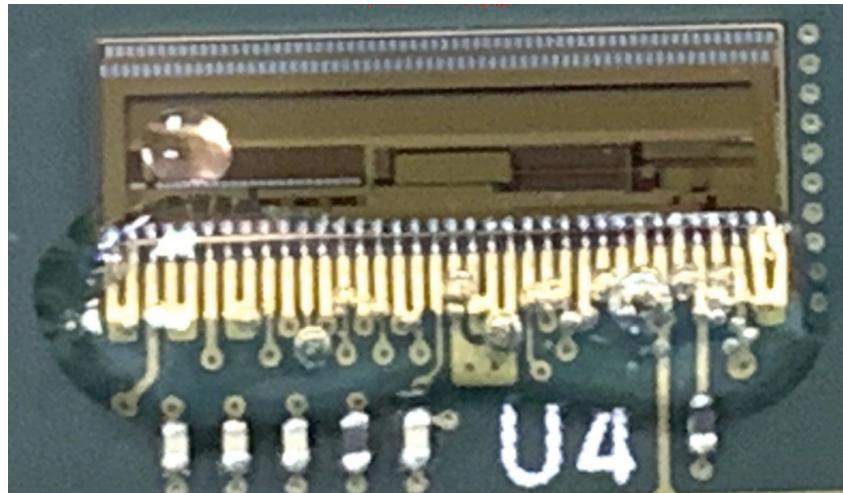
2020/05/22

The sylgard 186 spreads during 3 days curing

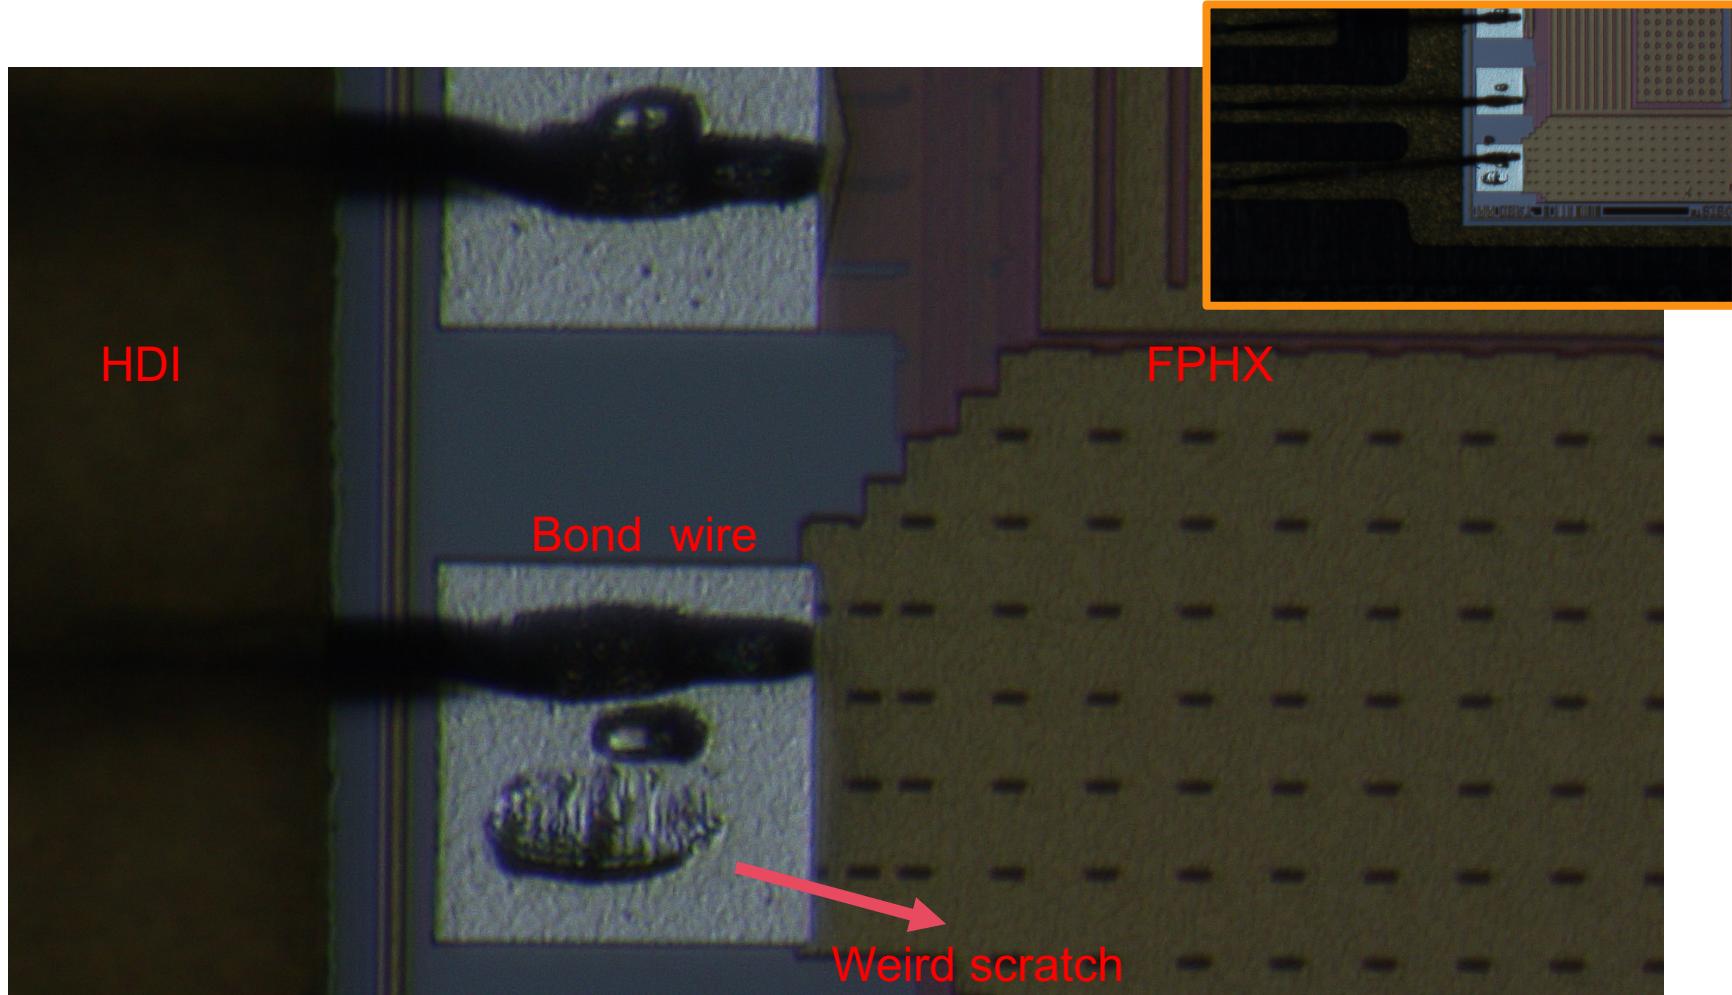
A weird damage on FPHX

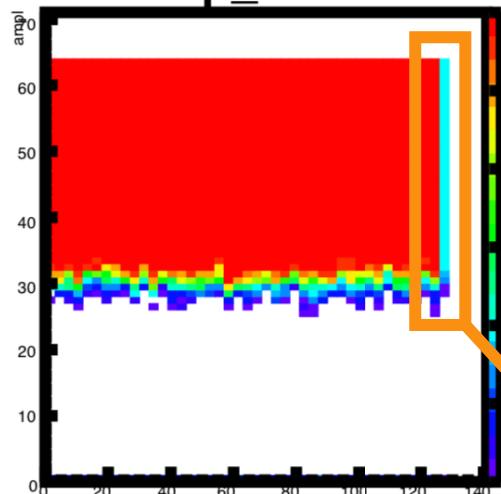
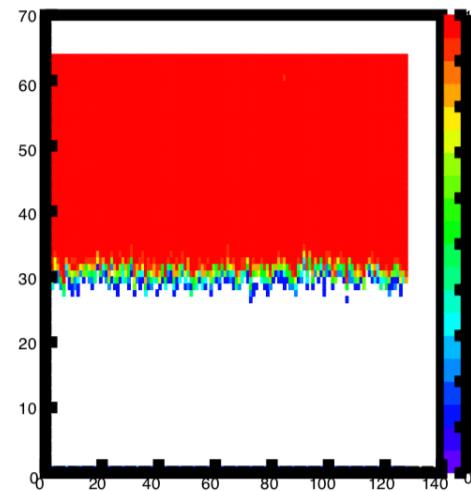
chip_id=8

Unfunctional channel 128?

Change the bin width

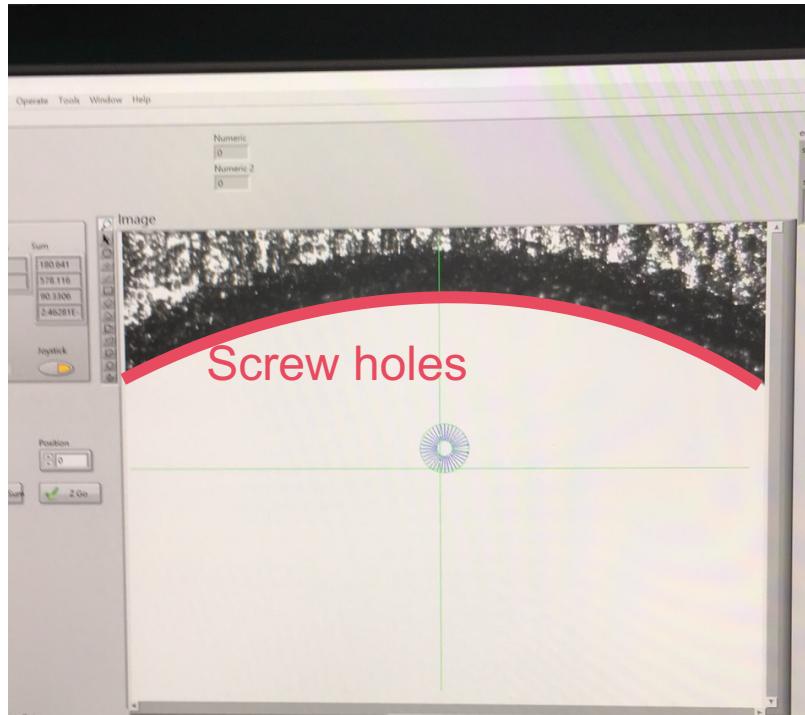
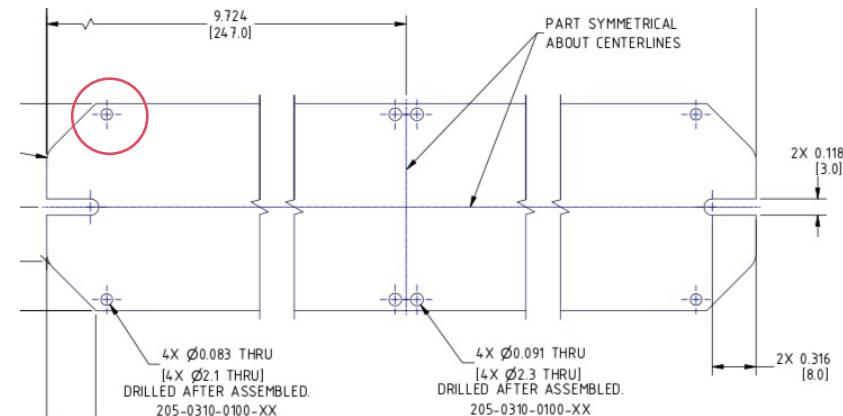
- No alignment holes on stave

We try to use the screw holes as alignment holes, it is too big

Is it possible to add the alignment marks on stave ?

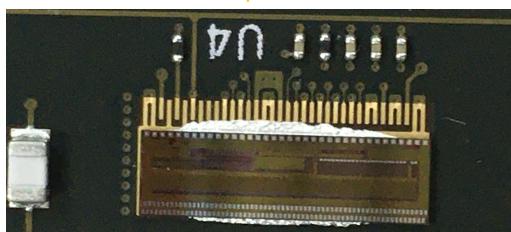
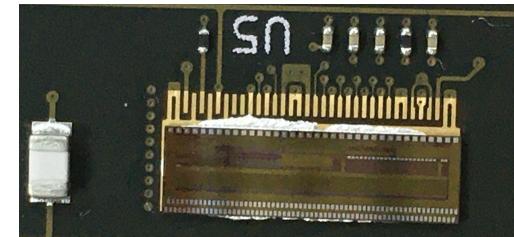
The leakage of glue is too much

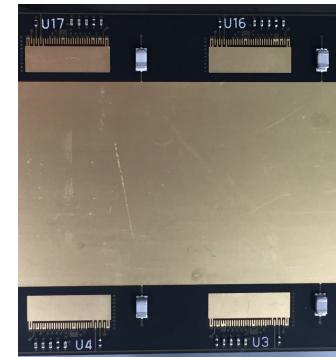
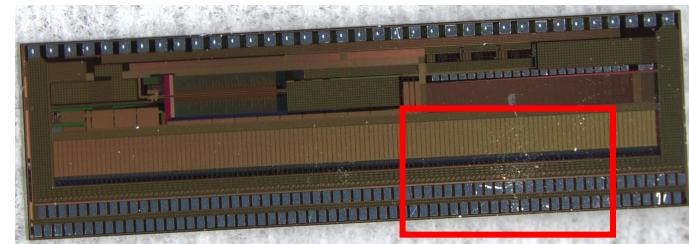
The HDI looks ok, 10 chips is considered to be bad
Cheng Wei, Shih (NCU HEP, Taiwan)

Remove all chips
Clean the HDI
