# SPHENIX INTT

## - Weekly Report

2021/6/9

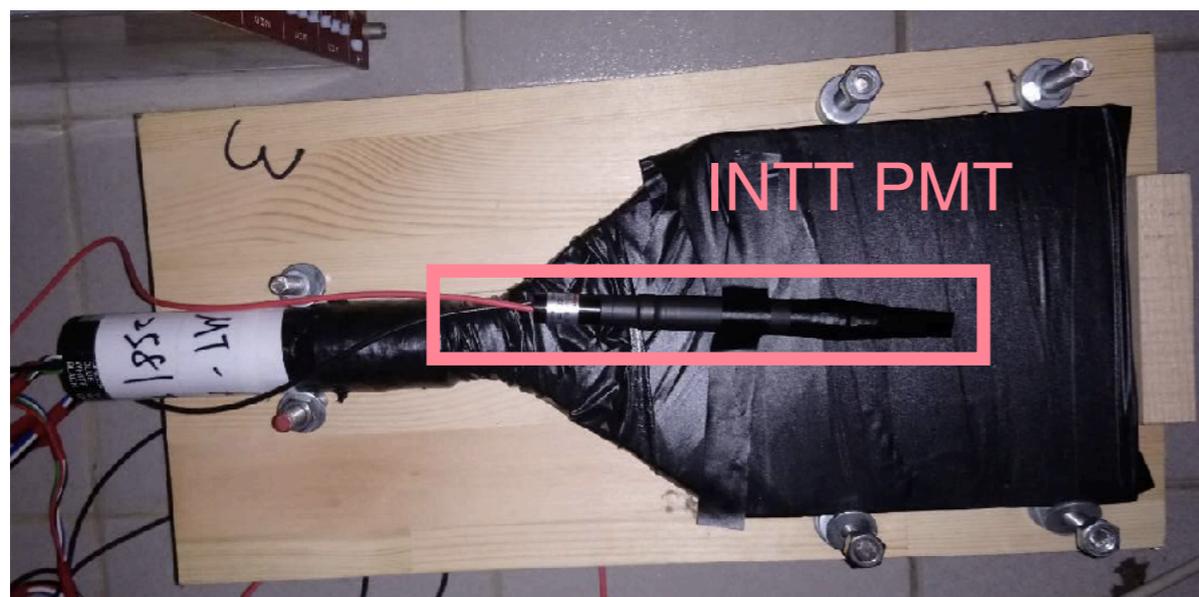
- Cosmic test is performed for supply voltage, threshold cut study
  - NWU Supply voltage : -1100V
  - Test voltage : -750 V to -1200V

@ 10th floor

2 PMT+scintillator overlaps

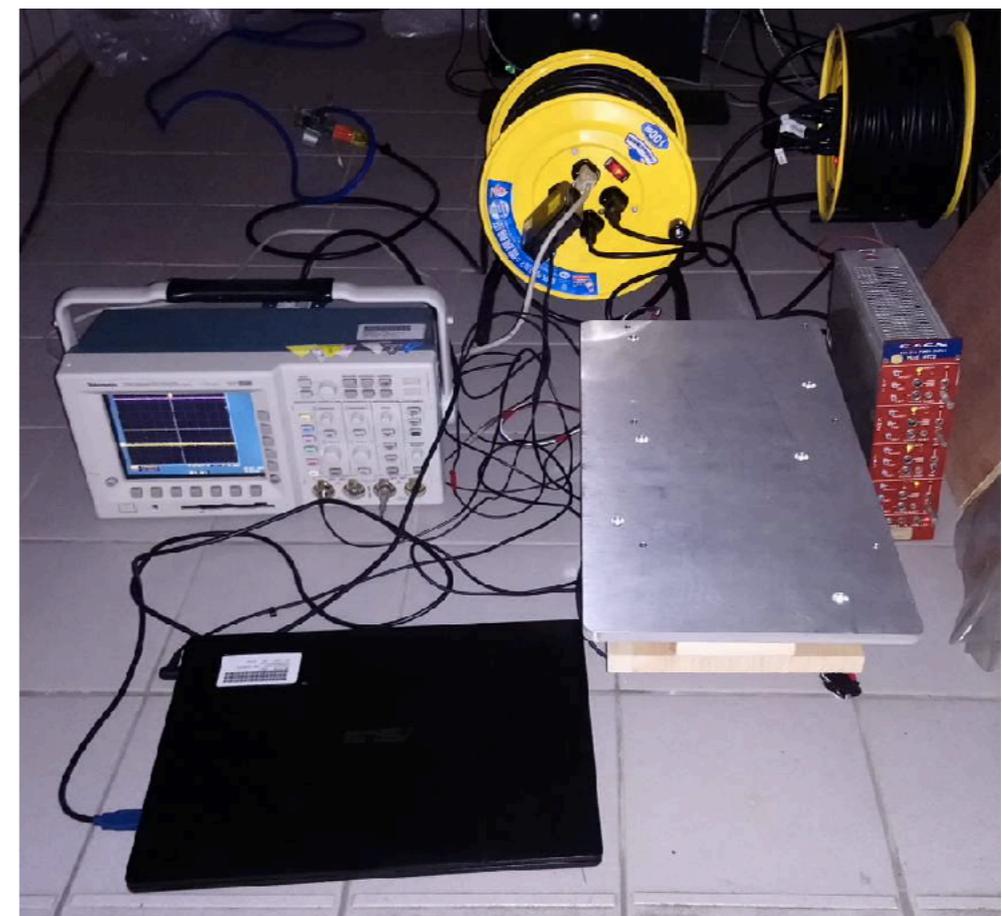
INTT PMT scintillator size  $\sim 1 \text{ cm}^2$

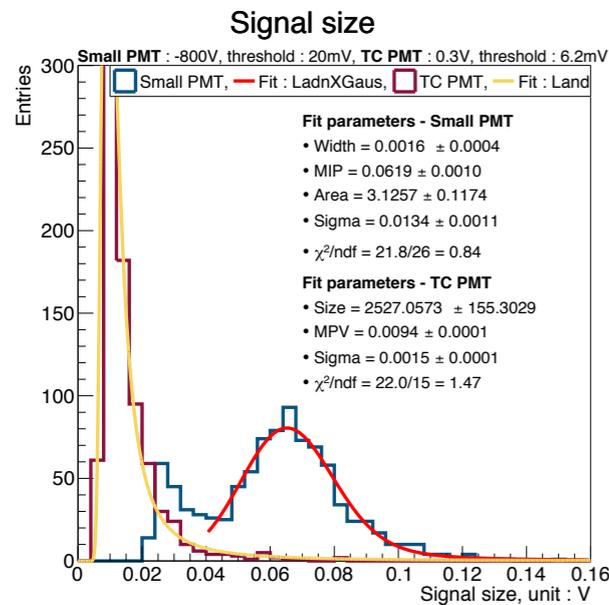
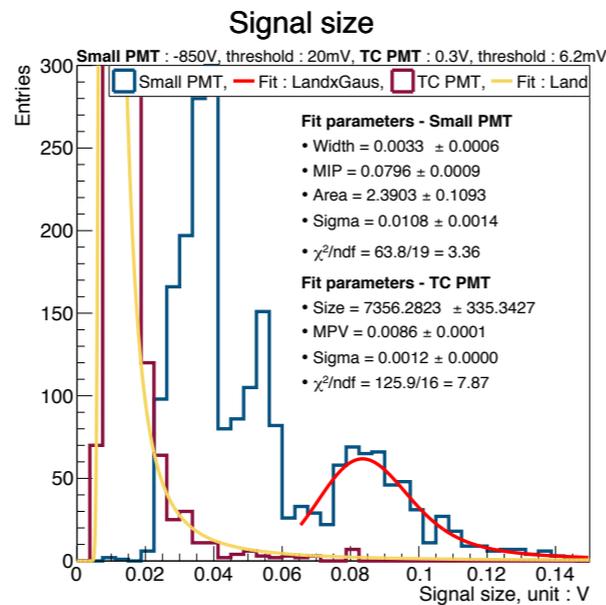
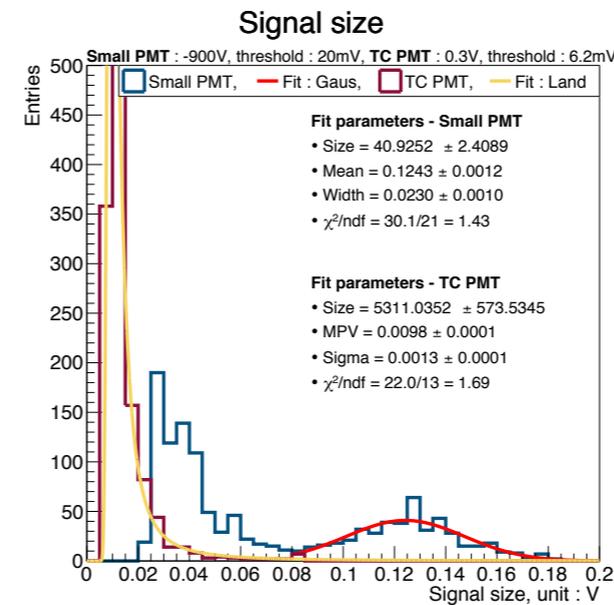
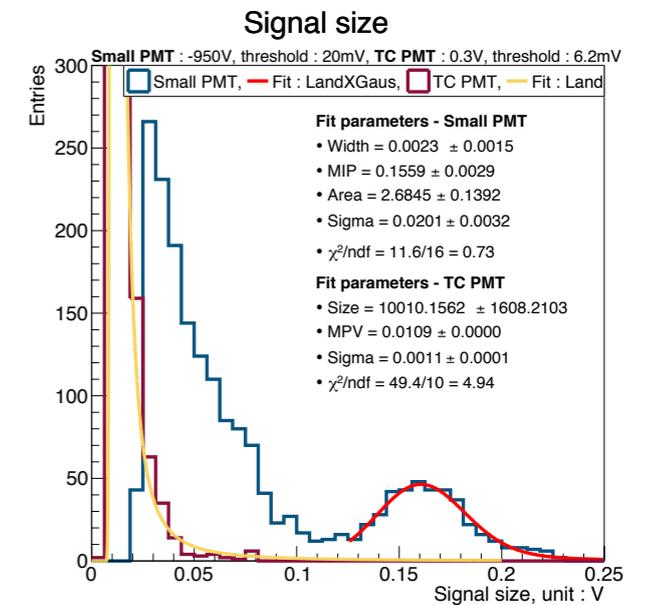
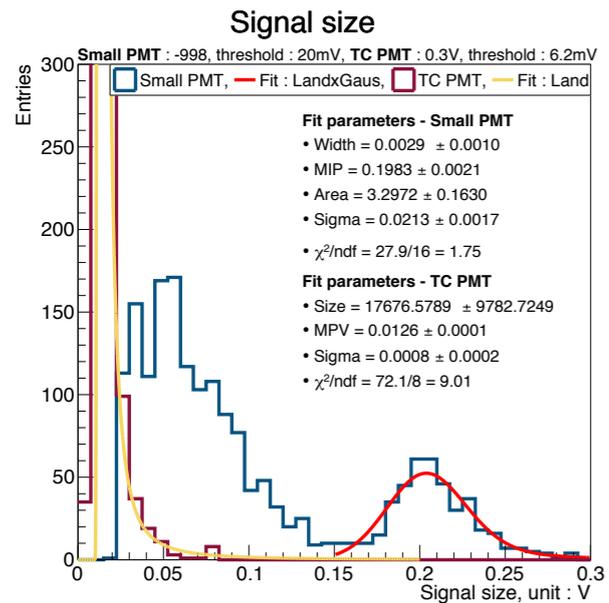
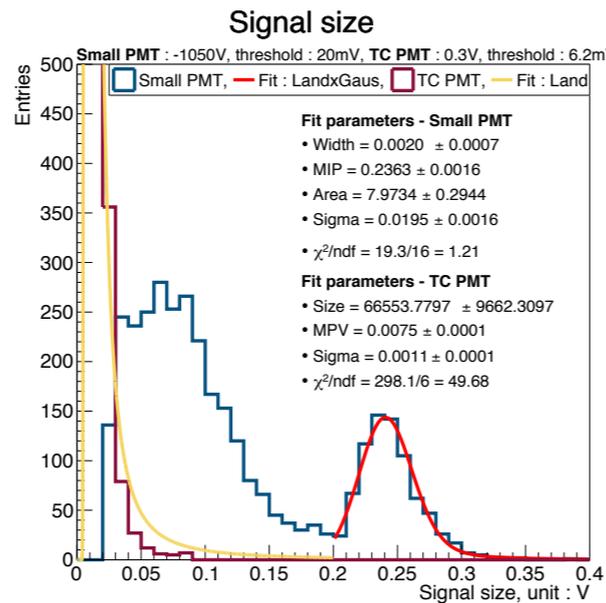
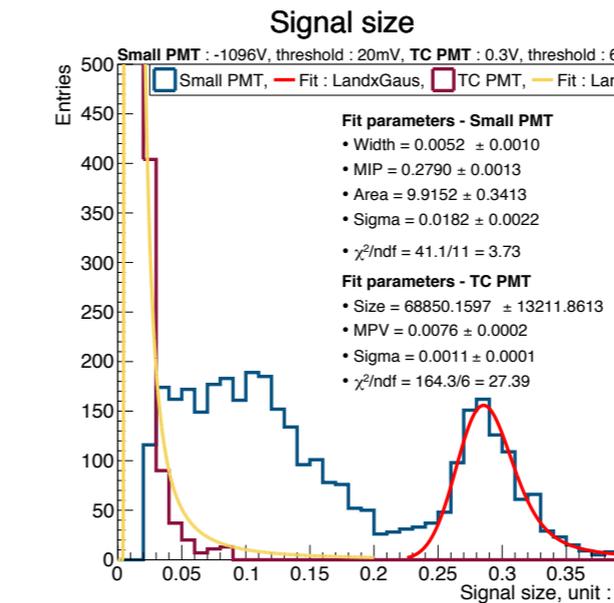
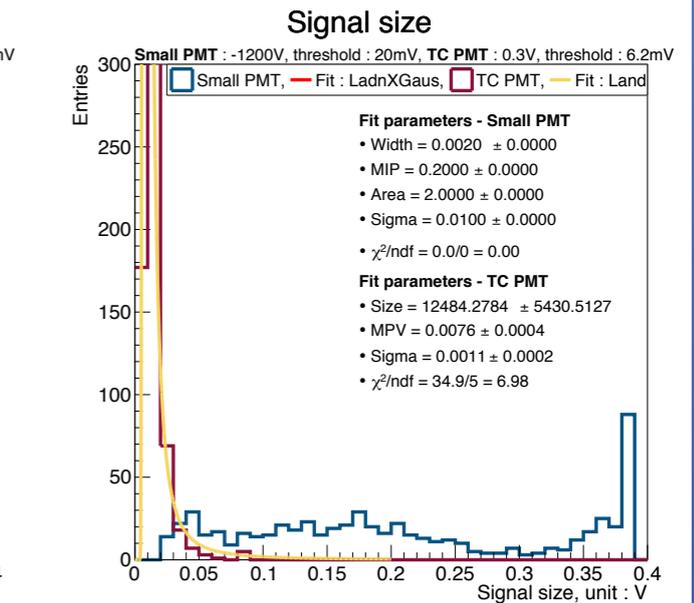
Threshold cut on oscilloscope : 20mV. **Without** noise cut

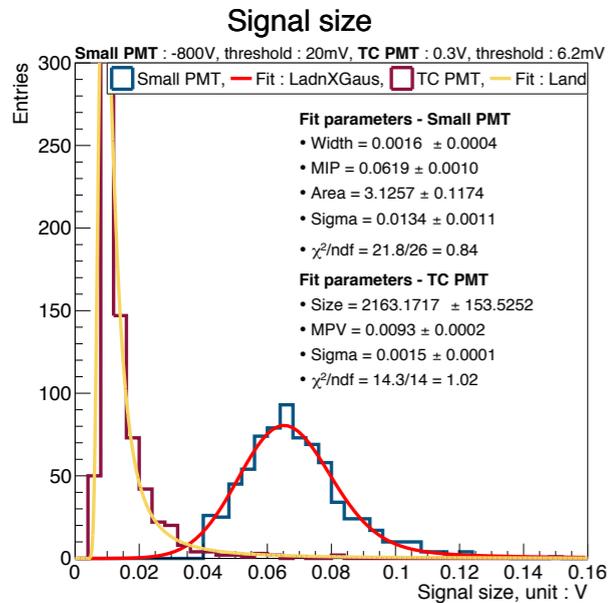
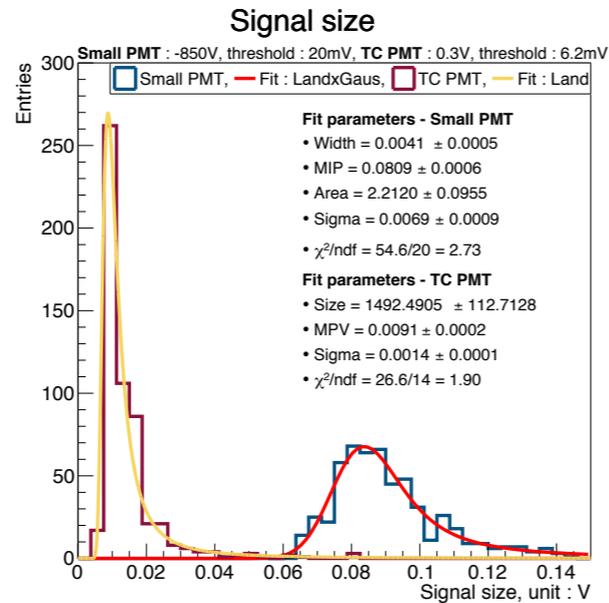
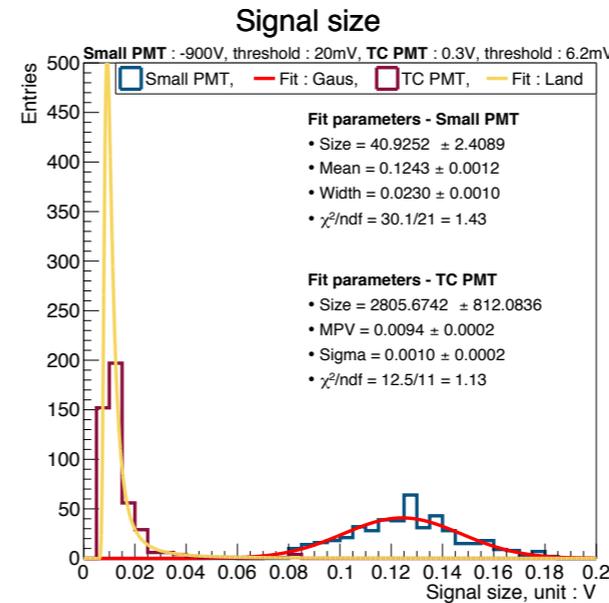
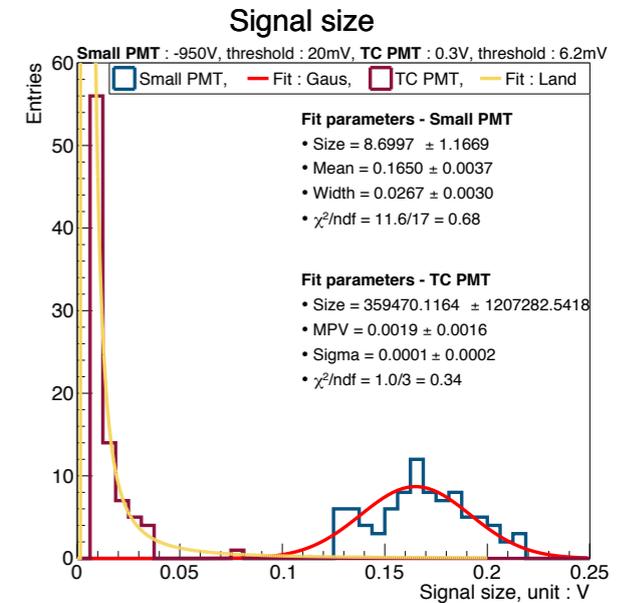
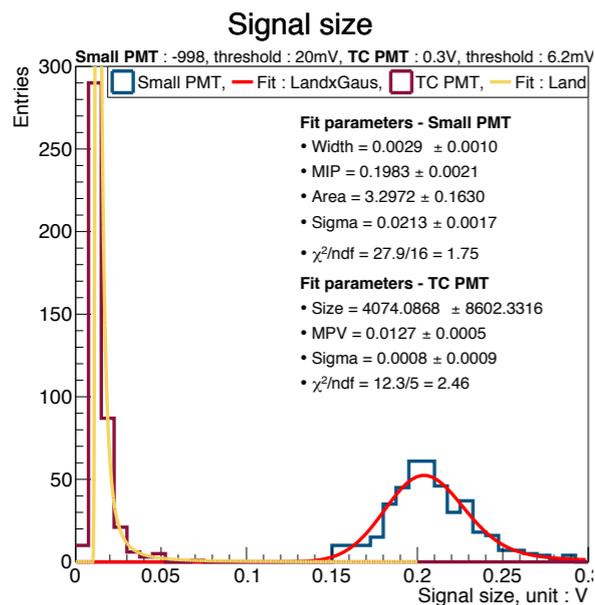
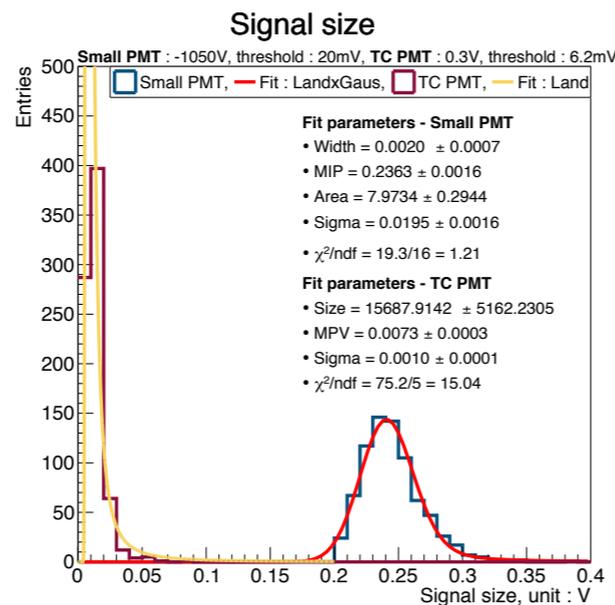
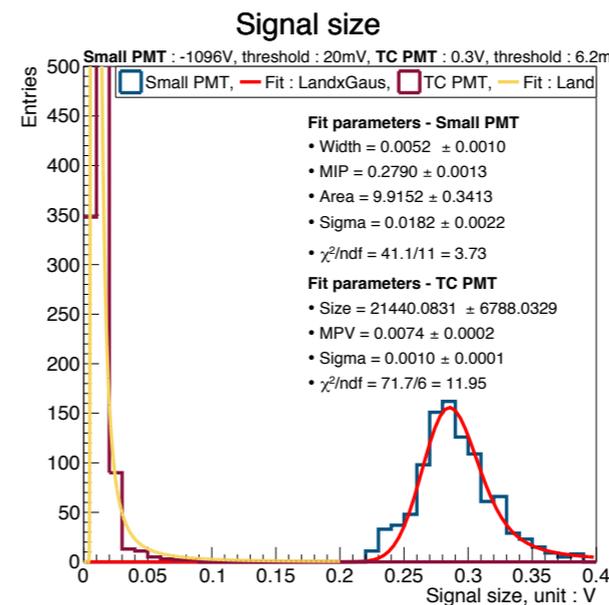
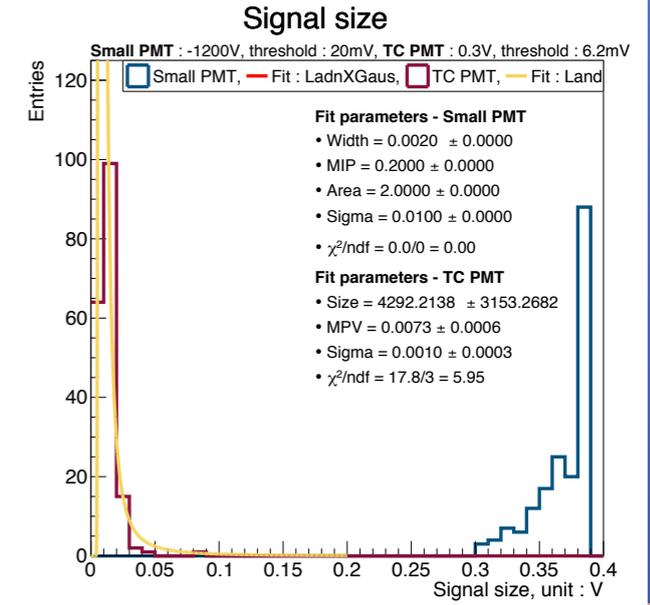
Threshold cut on oscilloscope : 20mV. **With** noise cut

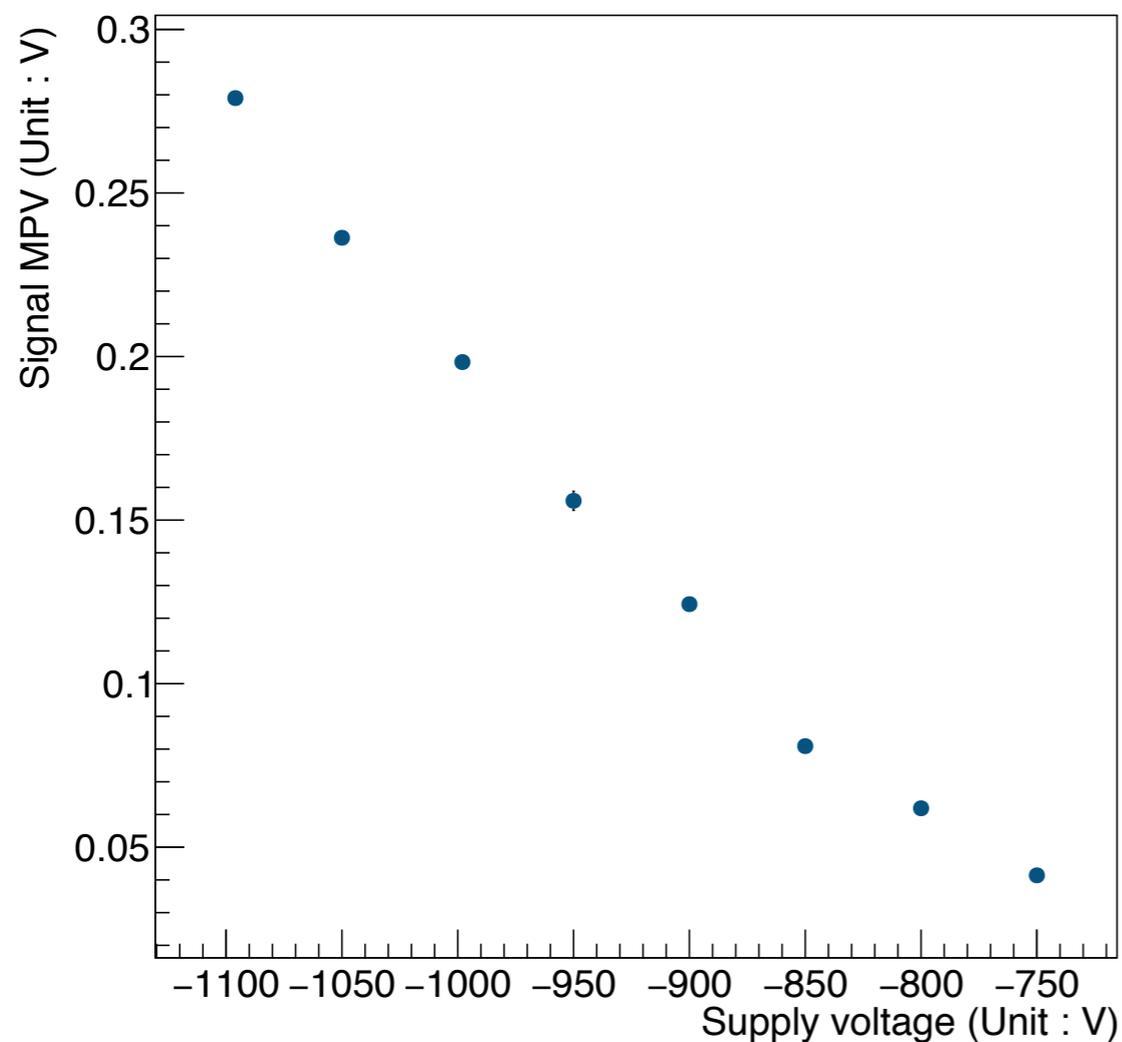
Signal MPV vs supply voltage

- Level 3 warning is extended to 6/28
- The PMT test is finished,
  - Supply voltage -1000V, threshold cut 0.15 V is good for use.
- We applied DP460 on 2 staves this week.
  - We will keep applying DP460 on staves.
  - Twist test results : 3 / 4 sides good.
  - Question : Would 0.8 N\*m be too strong ?

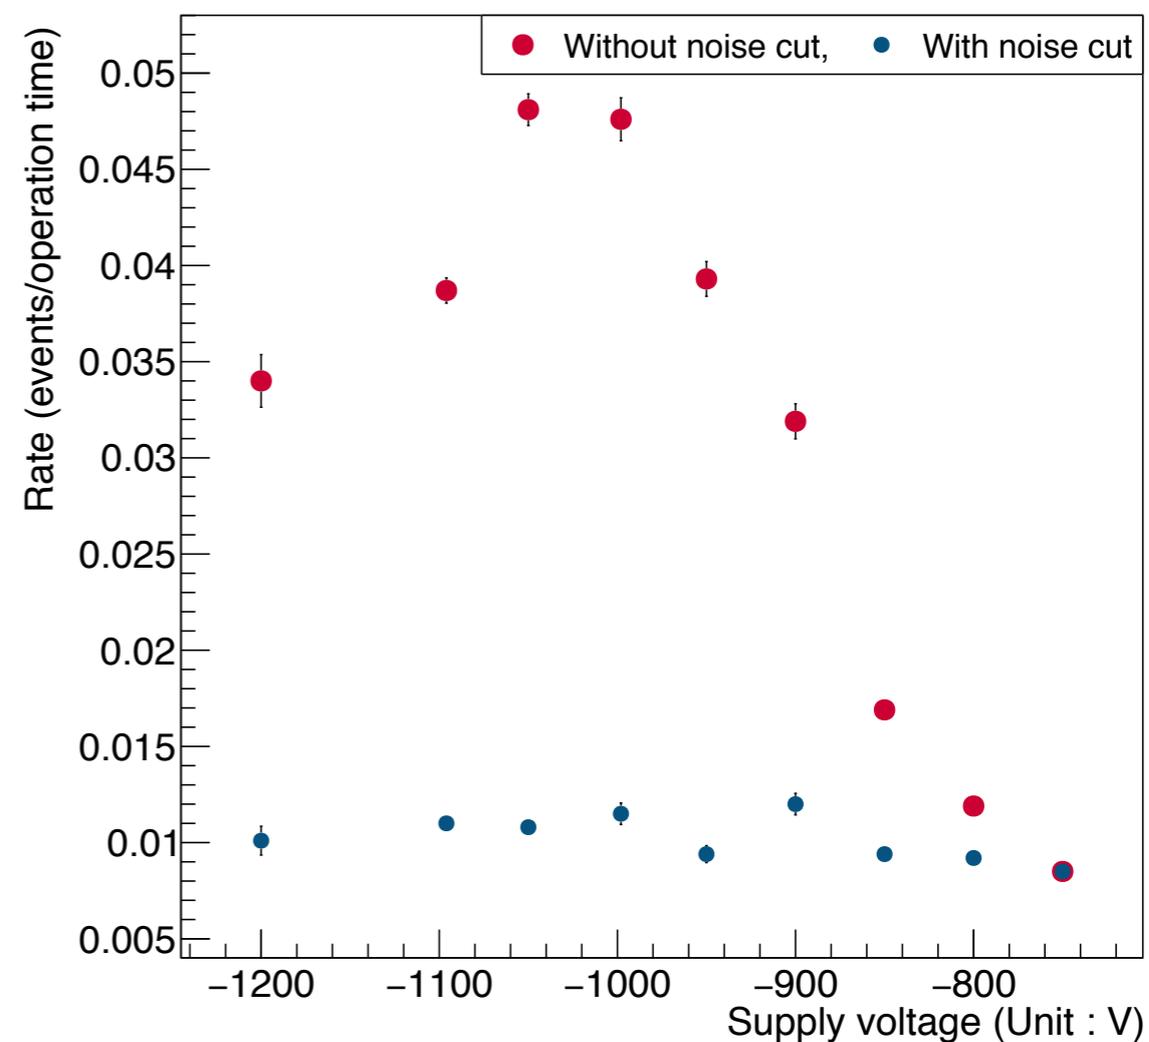
Event rate vs supply voltage

After applying noise cut, the event rate is stable at  $\sim 0.01$

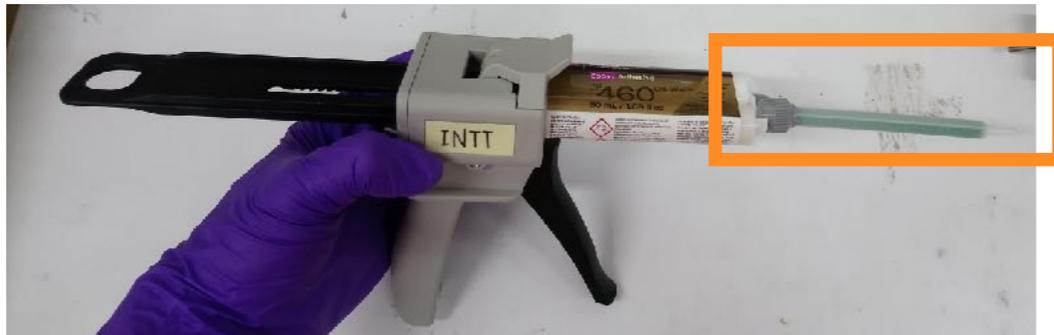
Glue gun with mixing nozzle

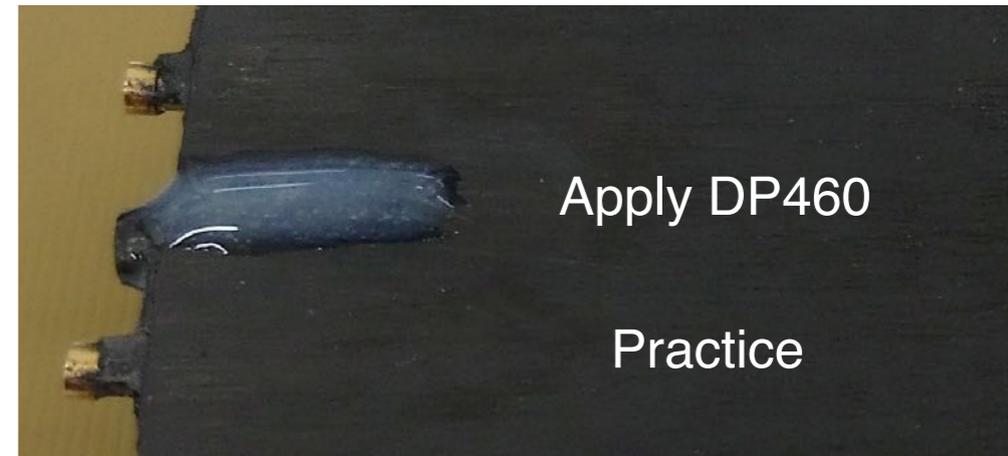
Clean the surface by acetone before applying glue

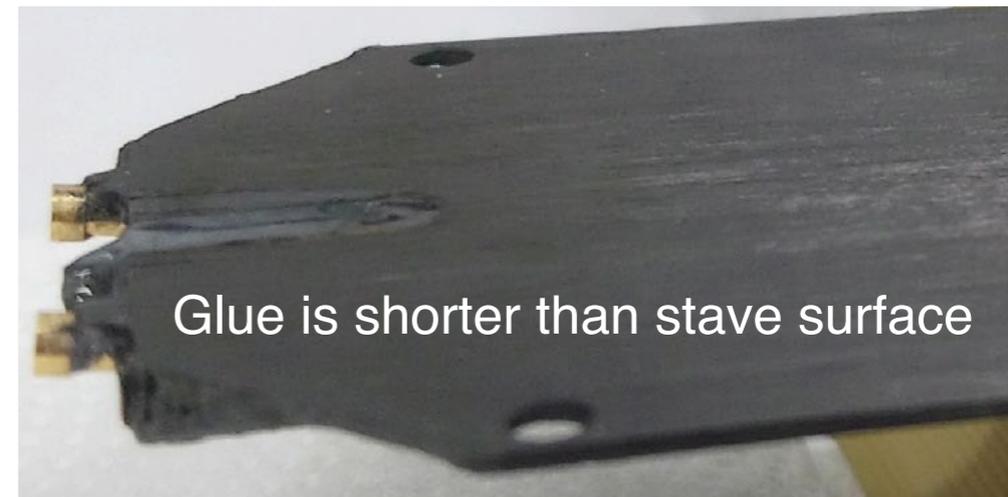
Blade for removing surface glue

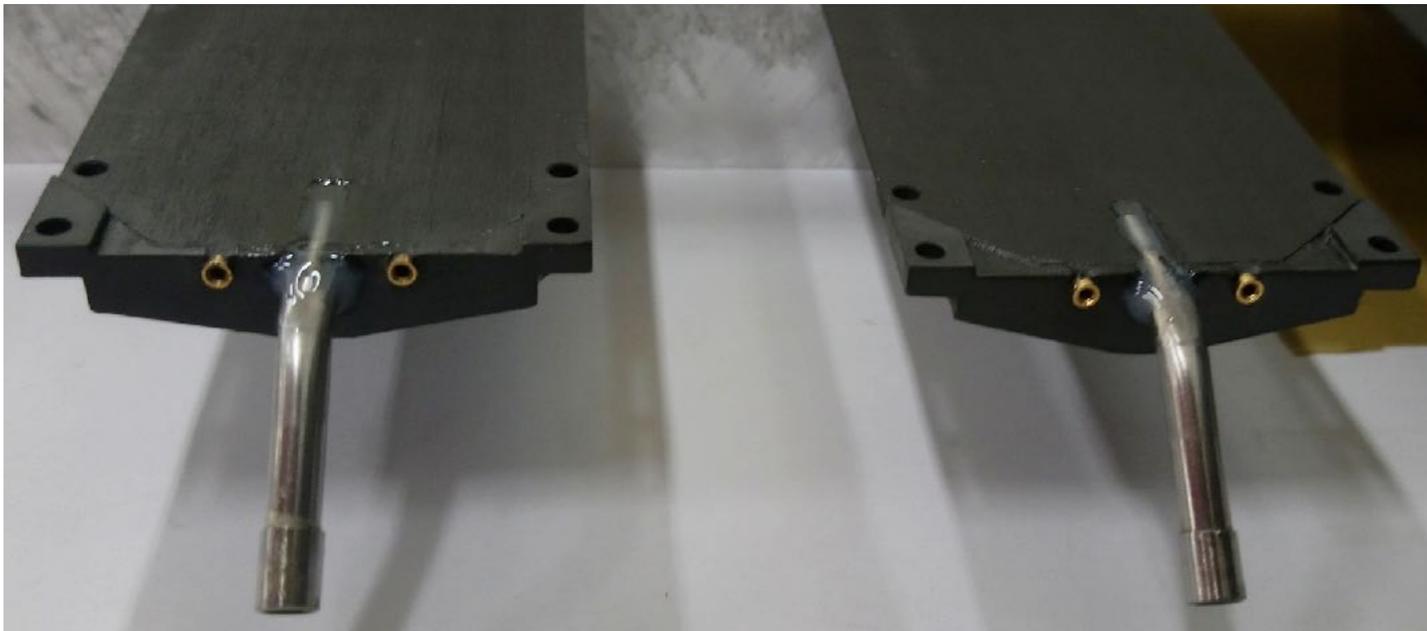
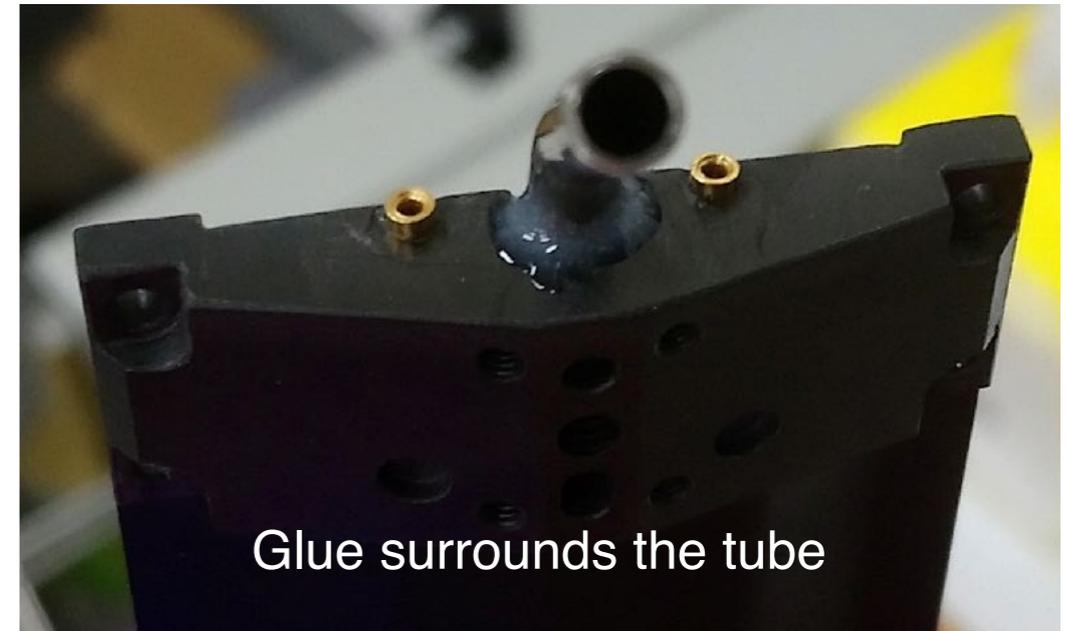
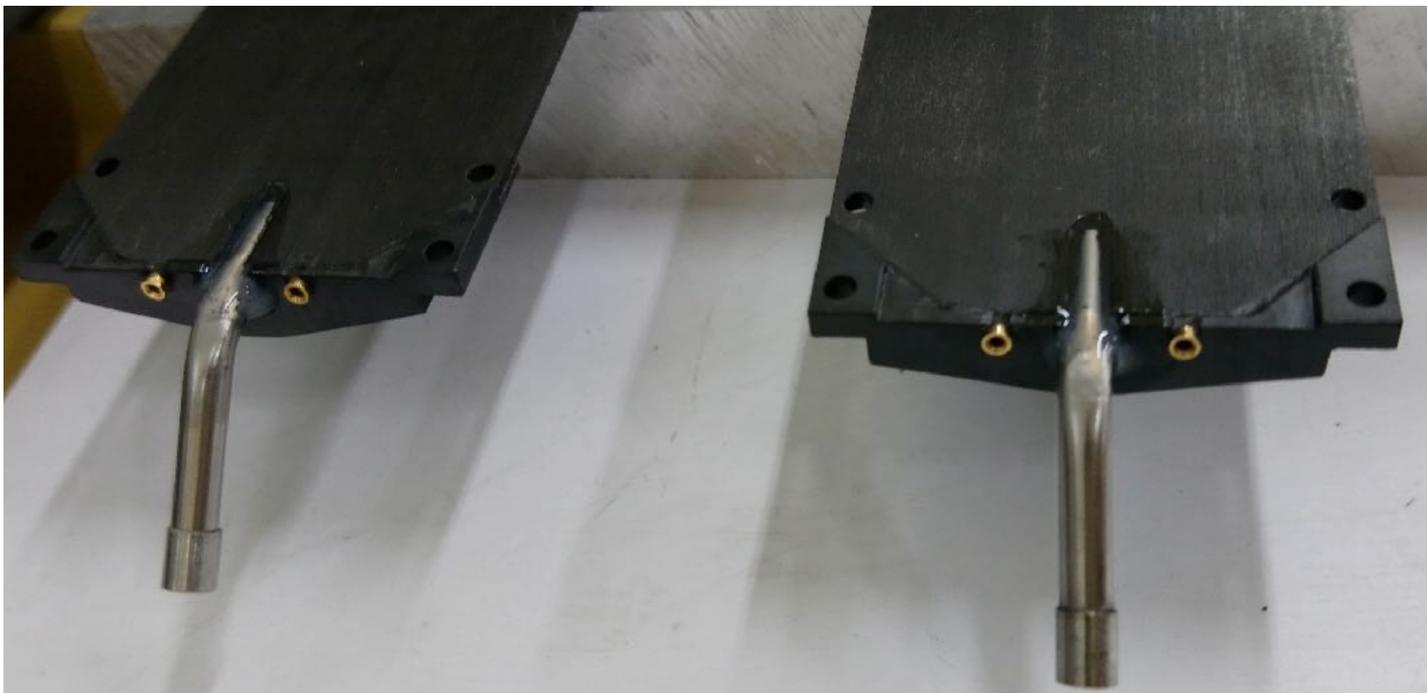
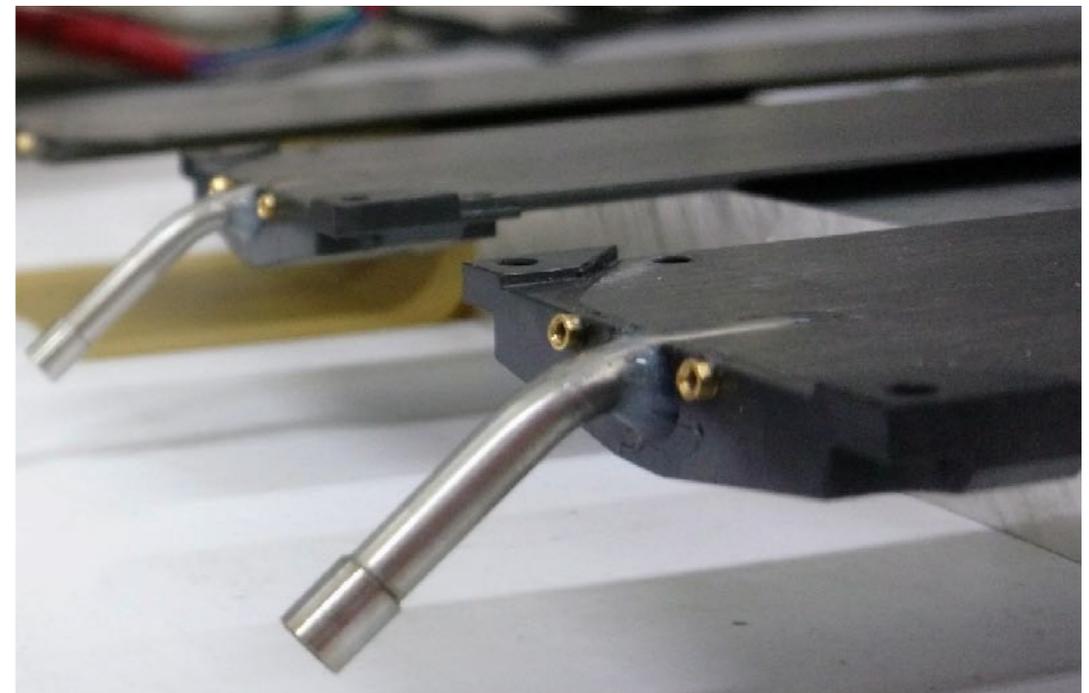
- First try with 2 staves

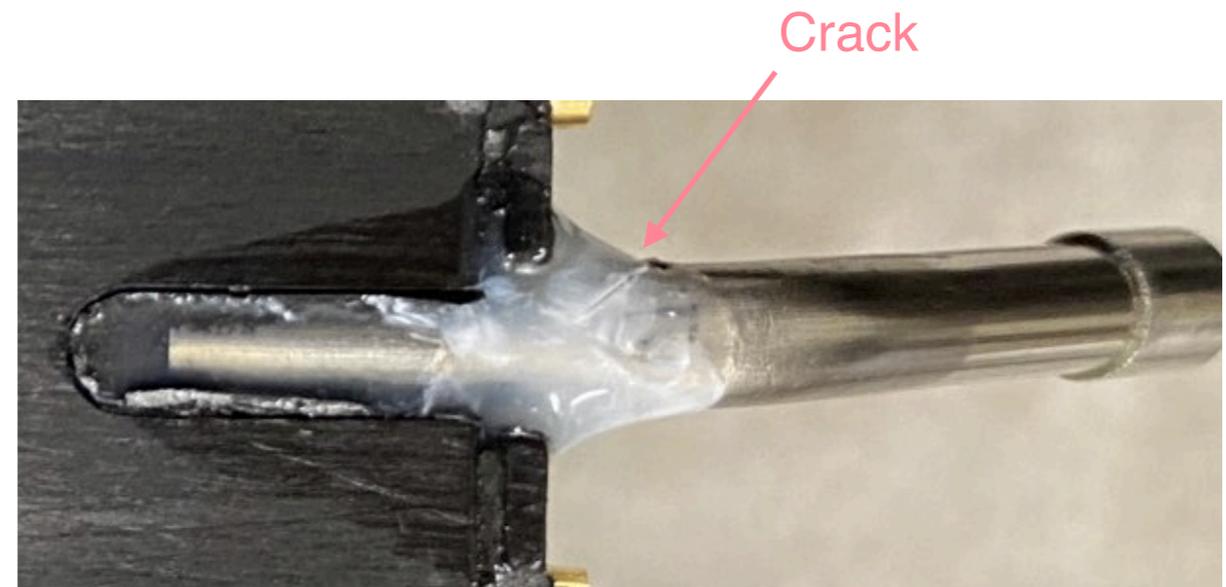
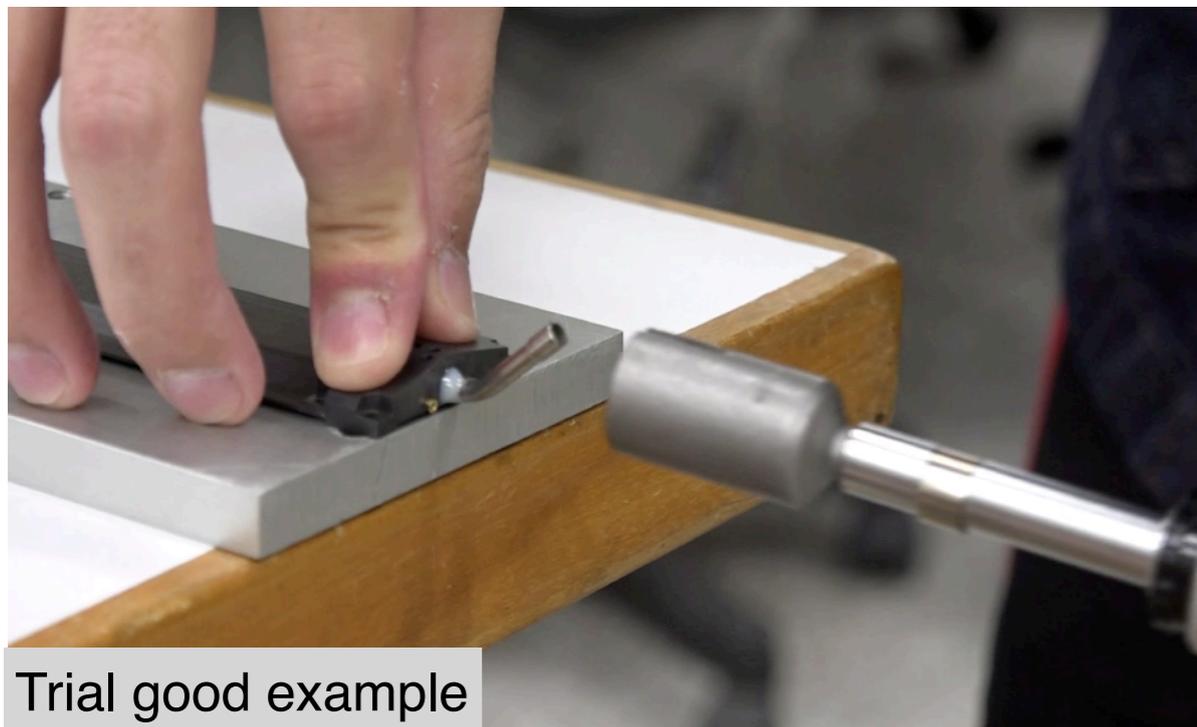
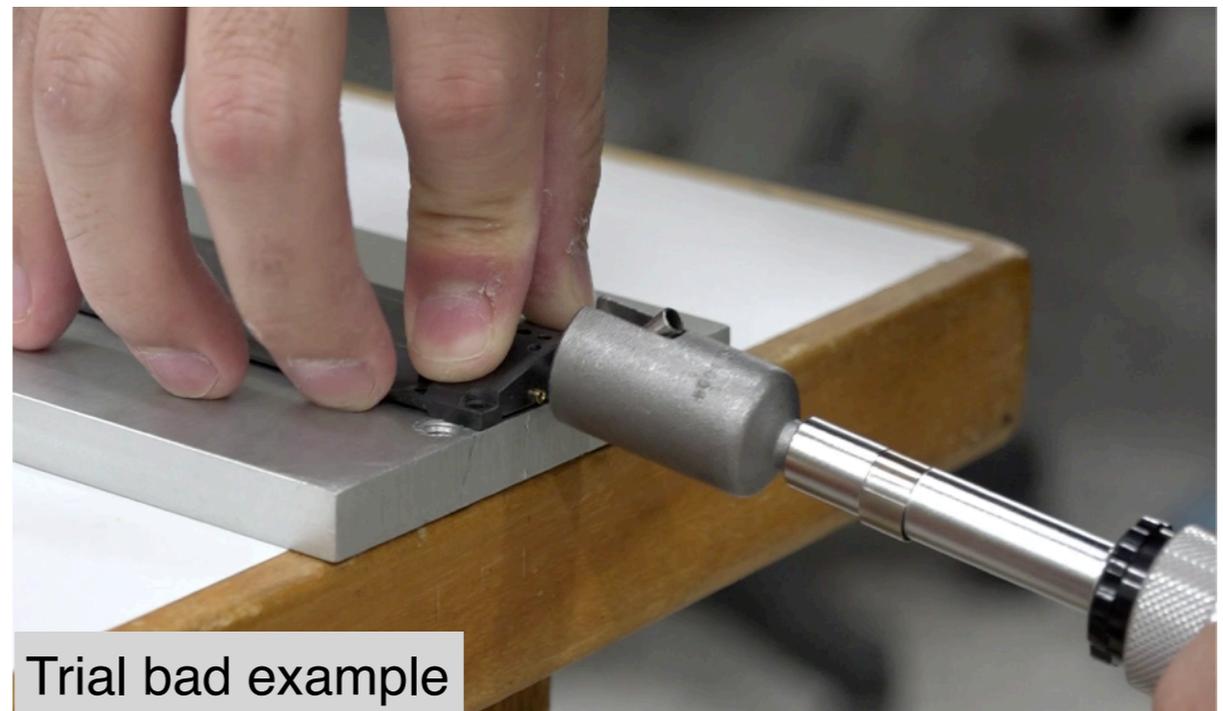
- Twist test : 24 hours after glue application.
- Torque : 0.8 N\*m
- Test with 2 staves :
  - 02-0083 : both sides good
  - 01-0074 : one side bad

The crack is on DP460  
Would 0.8 N\*m be too strong ?

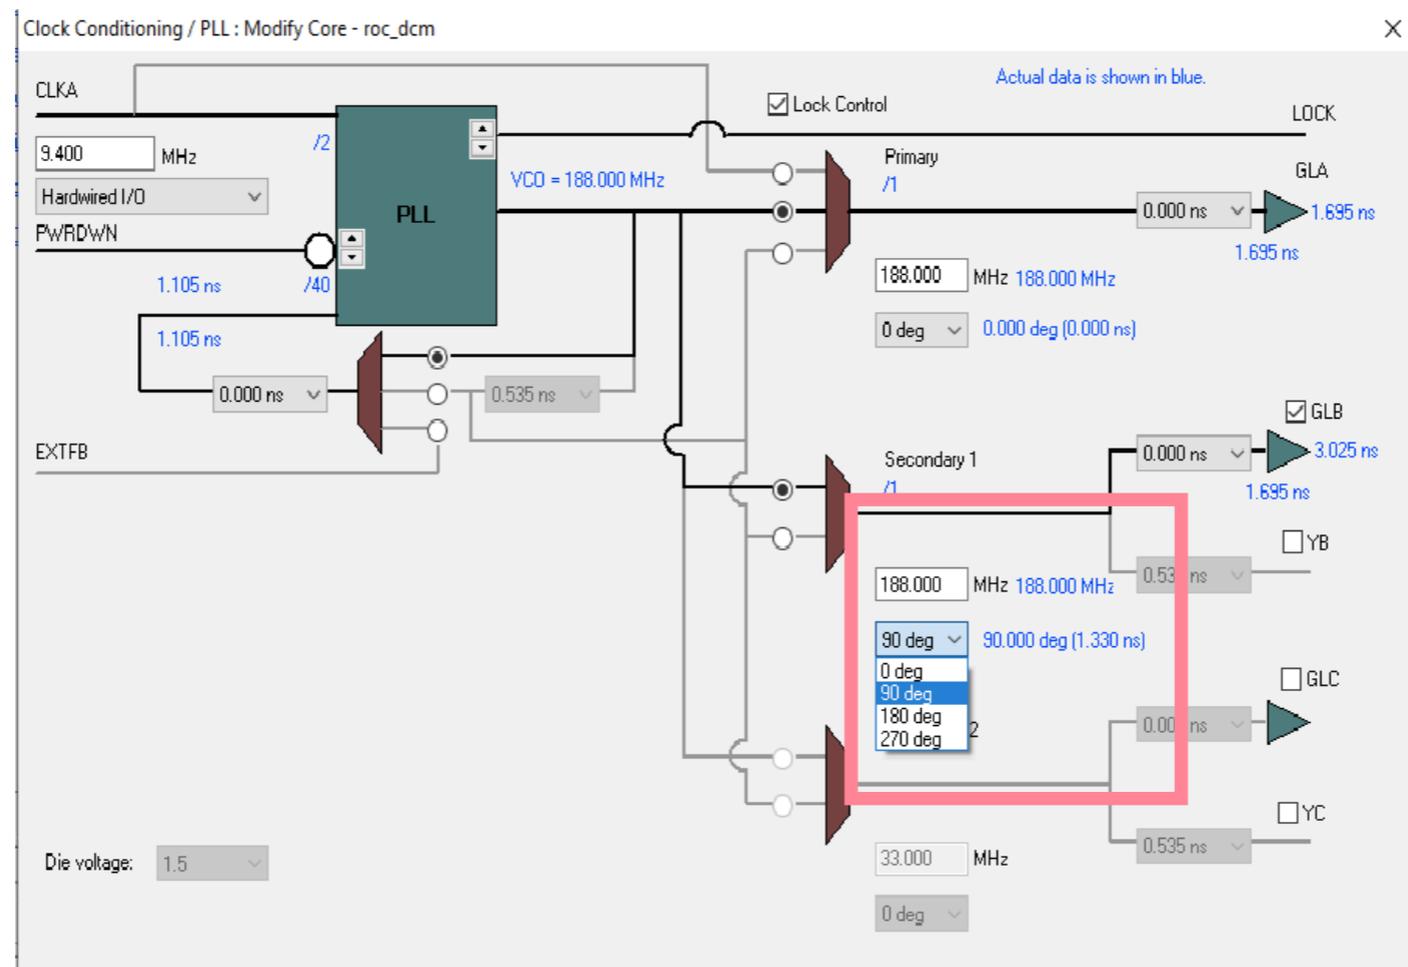
- We modified CLK90 to CLK180 & CLK270.
- The code has sent to NWU.
- License for IDE 9.1 is not free, price : 1000 USD for 1 year.
  - IDE version we are using now : 11.9

- We will try to apply the DP460 in NCU.
- The PMT and Motor are almost ready for test stand
- To do list :
  - We will change the clock phase by the GUI, and send the code to NWU for testing.
  - Concern : if FPGA fails to work, it is dead. We don't have solution to recover it (we don't know the original code version in FPGA ).
- We may have to compile the code with different IDE
- Test the PMT with different supply voltage

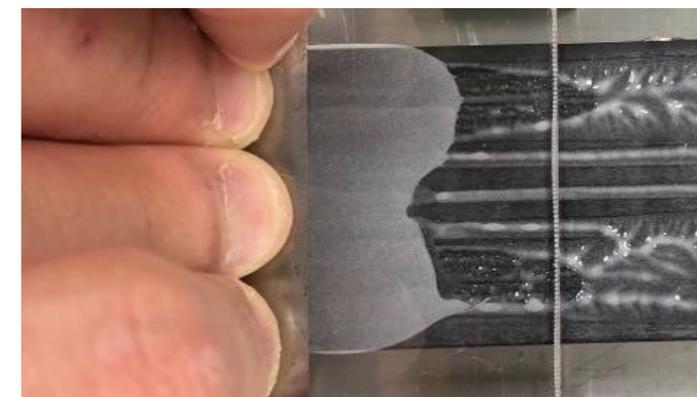
60 um SS plate in between

- Ladder glue issue
  - According to previous test, glue spreads well.
- To do
  - Test glue spread with full size acrylic plate.
  - Tune the gantry glue deposit parameters (more rings).
  - Optional : glue mask for applying glue (the same as BNL).

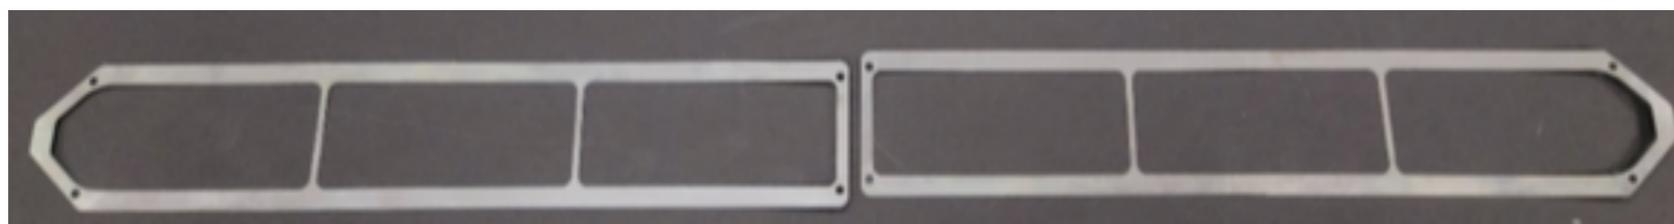
Thickness : 50um  
Glue mask from BNL
