## The INTT Readout Electronic Review

# Electronics Readout Performance

Takashi Hachiya,

July 28<sup>th</sup>, 2021

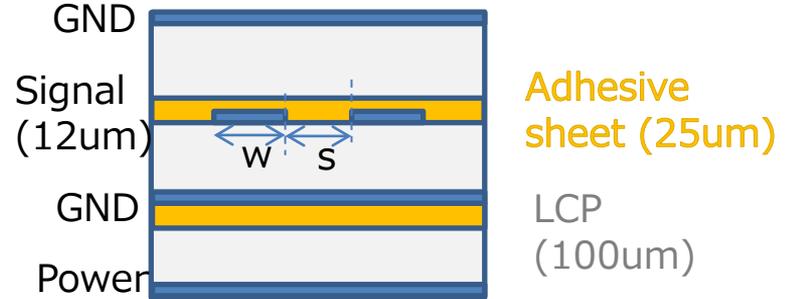
- Cable design (prototype)
  - Dimension (L x W): 120 x 5 cm<sup>2</sup>
  - 4 layers (signal , 2xGND, PWR)
  - Lines : 62 lines (Line and space : 130 & 130 um)
  - $Z_{diff}$  : 100 $\Omega$  by strip line structure
    - Signal layer is sandwiched by GND layers
  - **Liquid Crystal Polymer (LCP) as substrate**
    - Relatively new material for FPC
    - Less signal loss due to low di-electric constant & tan( $\delta$ )
    - Thick LCP available for  $Z_{diff}$  : 100um
  - **The design is decided based on EM-field simulation**

4 layers laminated by the adhesive sheet

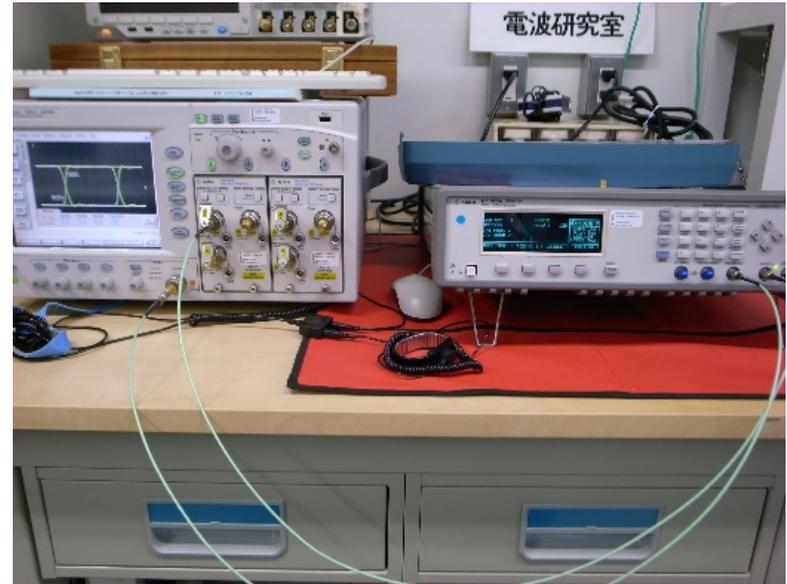
Test bench to study properties of the single Bus-Extender

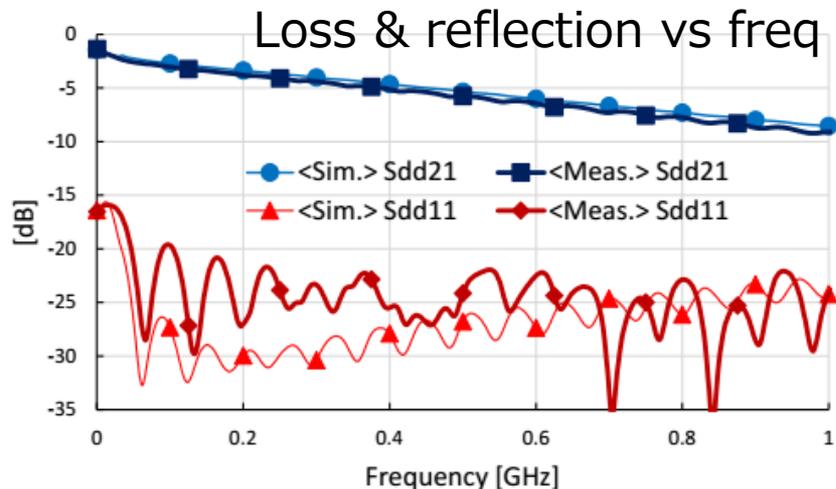
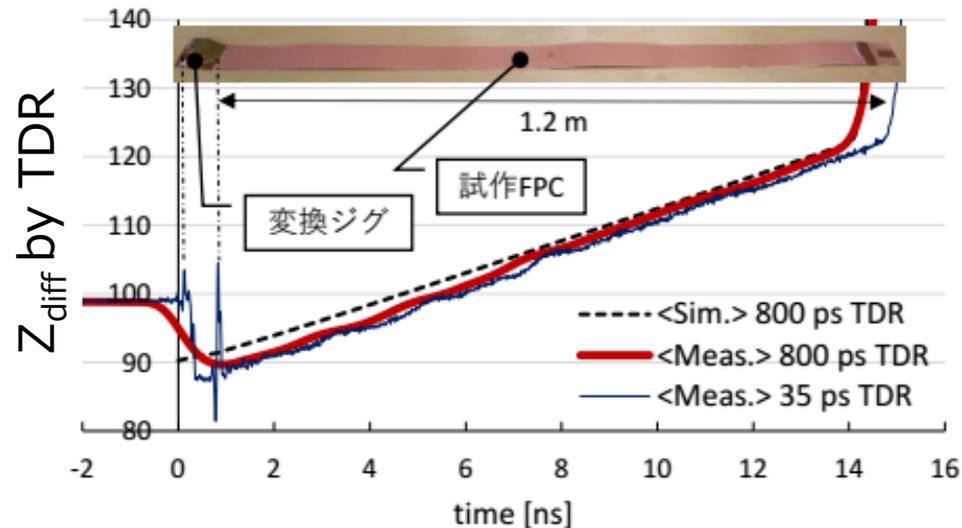
# Bus Extender Electrical Performance 1.2m

- Freq. dependence(s-parameter)
  - **Signal loss** : ~30%、
  - **Reflection**: < 10%

- Z<sub>diff</sub> by TDR
  - Z ~ 90Ω (slight smaller than 100Ω)

Data is consistent with the EM field simulation

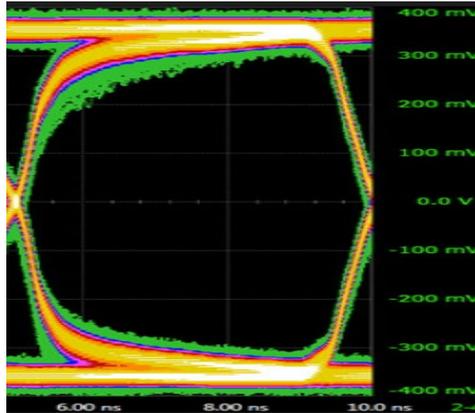
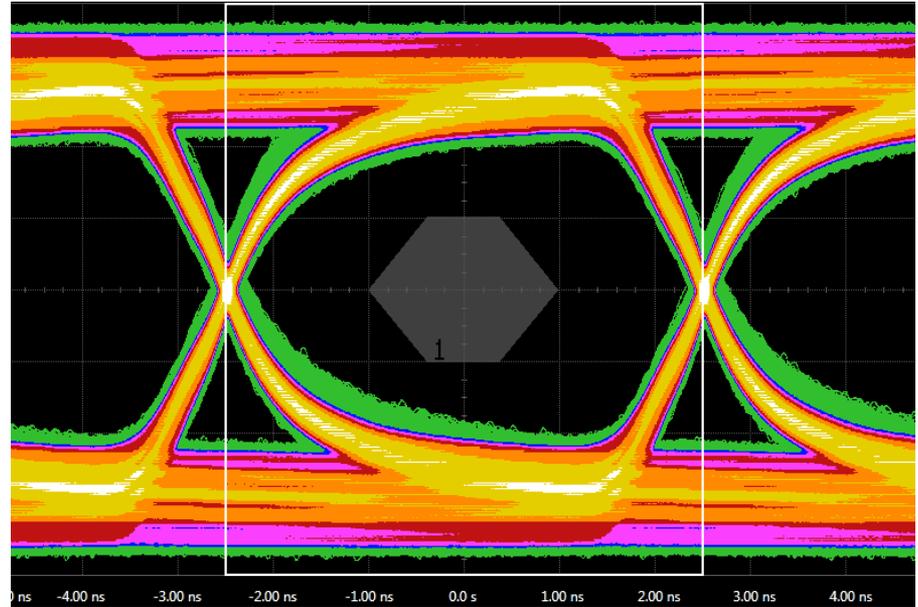
# Eye diagram

Input : 200Mbps pseudo-random pulse with 500 ps rising time,

- The signal pulse is clearly separated from the mask
  - Pulse get distorted due to larger signal loss of hi-freq. component

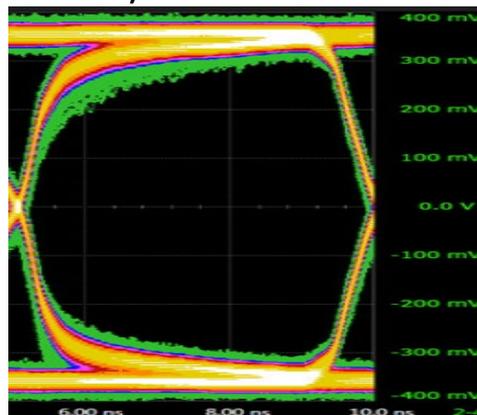
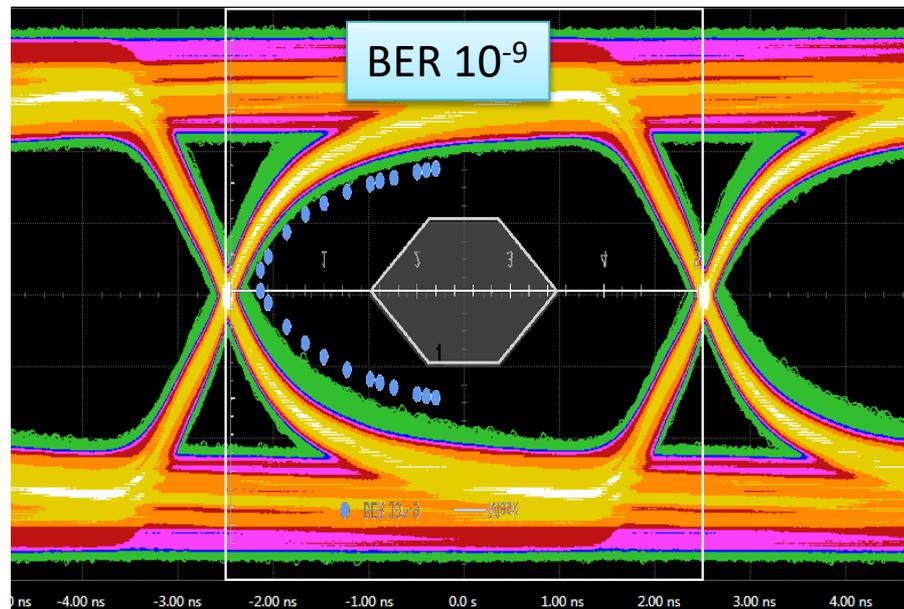
# Eye diagram

Input : 200Mbps pseudo-random pulse with 500 ps rising time,

- The signal pulse is clearly separated from the mask
  - Pulse get distorted due to larger signal loss of hi-freq. component
  - Bit error rate <math>< 10^{-9}</math>

The performance of bus-extender is good enough for INTT

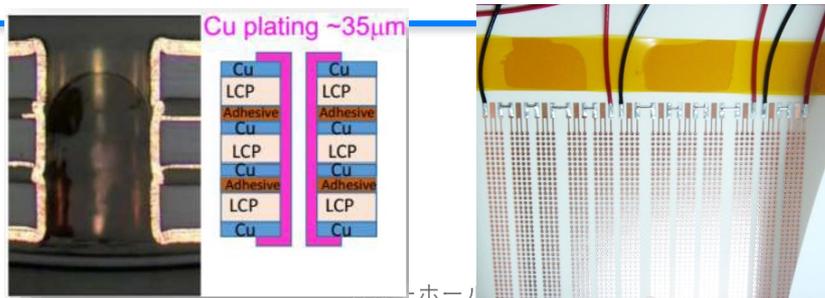
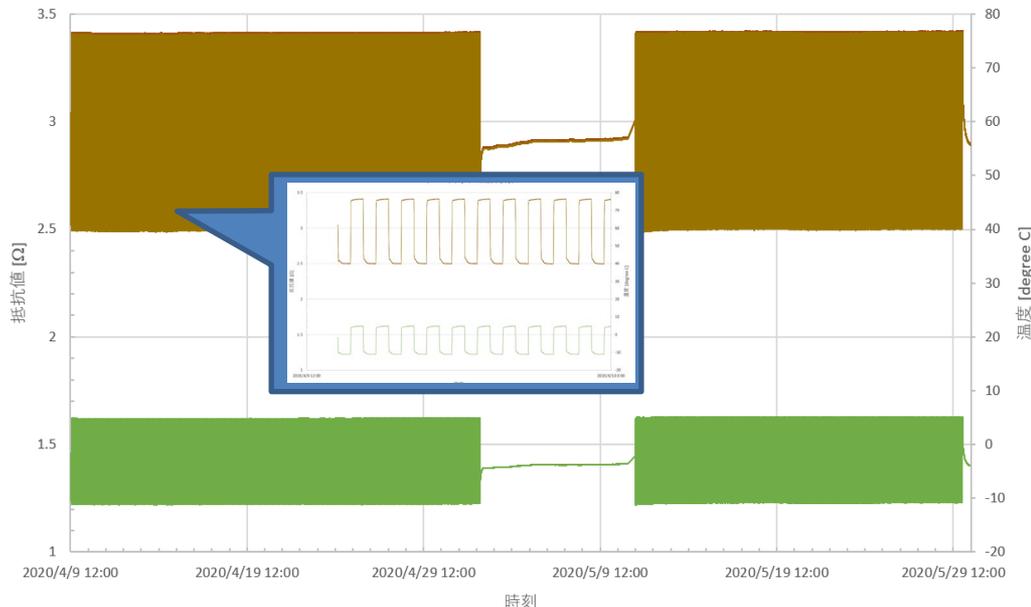
# Aging Test

- Keep healthy at least 3 year operation
- Mechanical stress by temperate
  - LCP is expanded and shrunk
  - Thru-hole could be damaged.
- Temperature cycle
  - -15 (30min.) ~ 75°C (30min.) with 1~2min. transition.
  - 1000 cycles (40 days)
- Test FPC sample
  - 4 layers, same as bus extender
  - 400, 1000, 1000 thru-holes are daisy chained and its resistance monitored .
- Results
  - Resistances changed with temperature
  - All FPC samples are healthy after 1000 cycles.

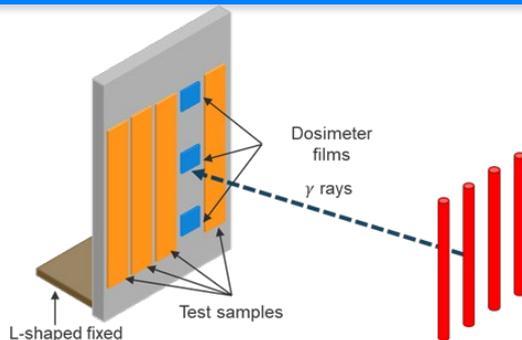
- Radiation hardness tested
  - Keep healthy for at least three years of operation.
  - Investigate the radiation hardness since the Bus-extender is produced with advanced materials, LCP and adhesive sheet.

- FPC samples are exposed by strong Gamma source ( $^{60}\text{Co}$ ) @ QST Japan
  - Radiation dose: 5kGy, 500kGy, 1000k Gy

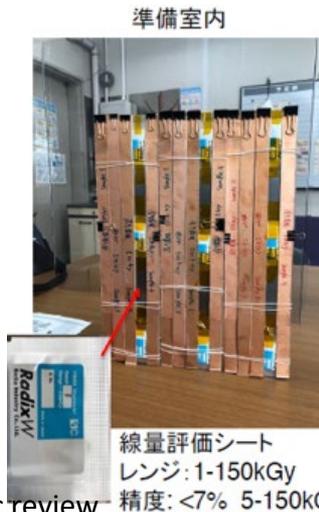
After exposure, the samples look oxidized by ozone ( $\text{O}_3$ ) 9

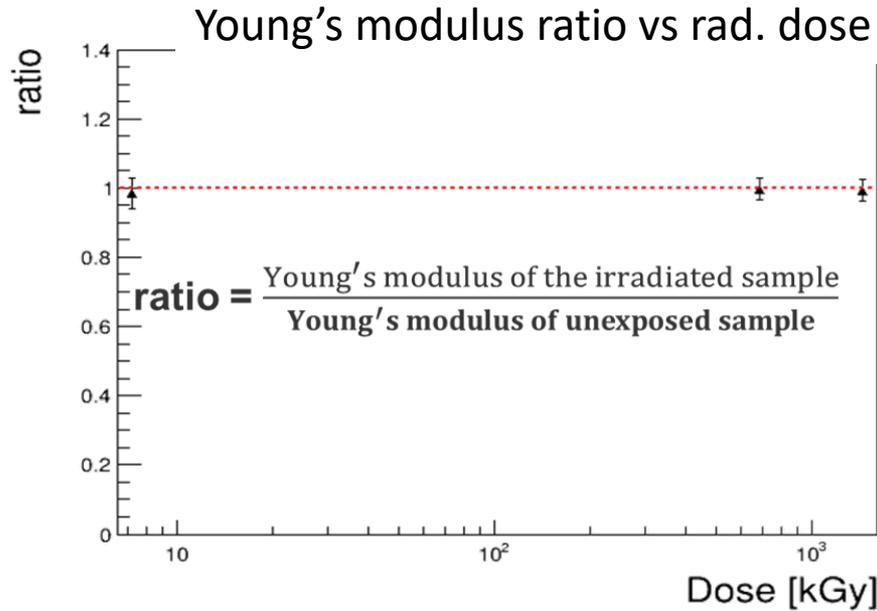
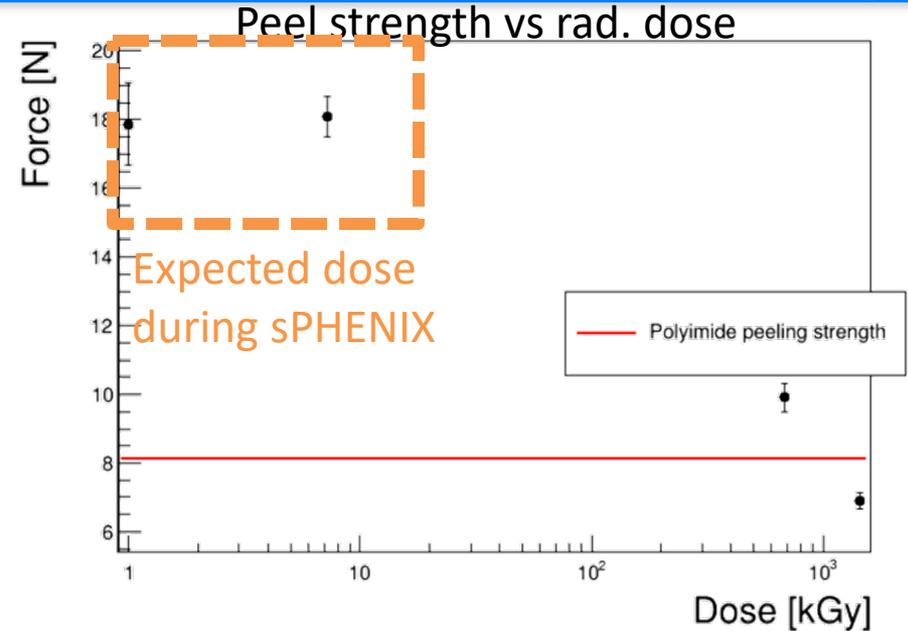
- Young's modulus: No change within 7% uncertainties by radiation exposure
- Peel strength : No change for sPHENIX data taking and get smaller clearly for the higher exposure.

**Radiation hardness of Bus extender is good enough for sPHENIX**

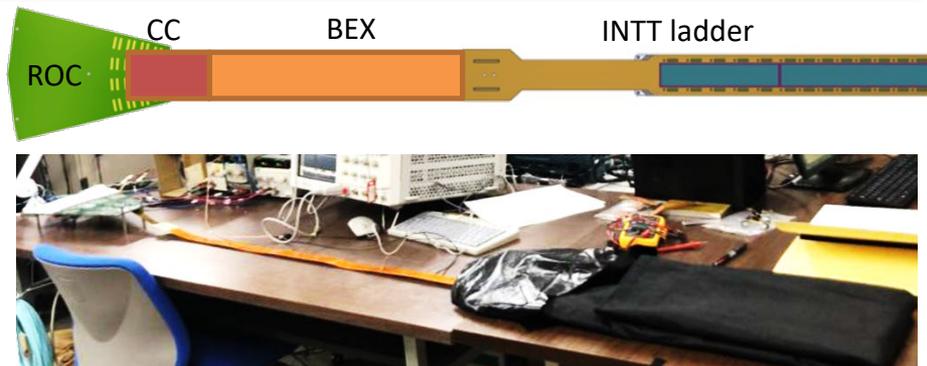
- Eye diagram w/ BE in the readout chain
- Data transmission sometimes failed w/ BE
  - Distortion and attenuation is consistent w/ the self BE performance
  - HDI make additional distortion.
- Larger (8mA) LVDS current recovers the transmission successfully
  - FPHX chip has a capability to change LVDS current from 1 – 8 mA

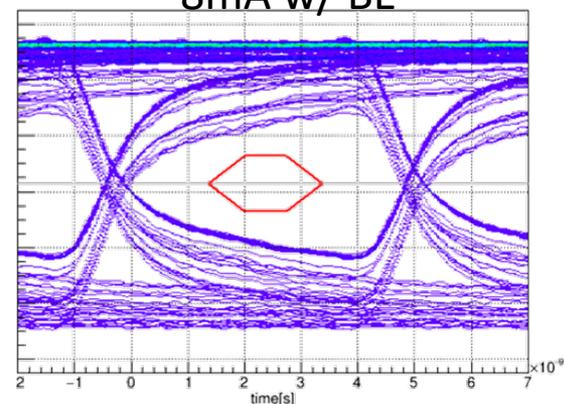
8mA w/ BE

Recovered by large LVDS current

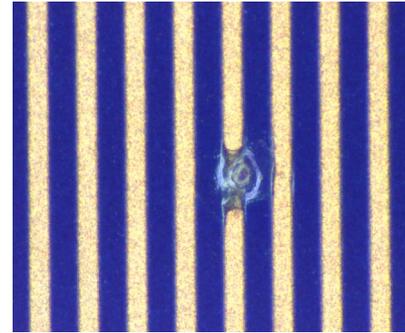
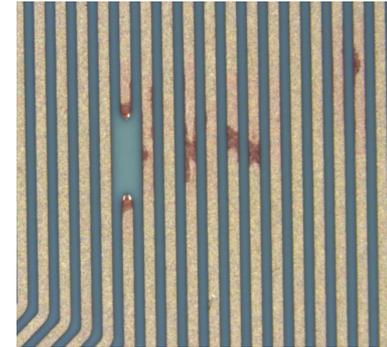
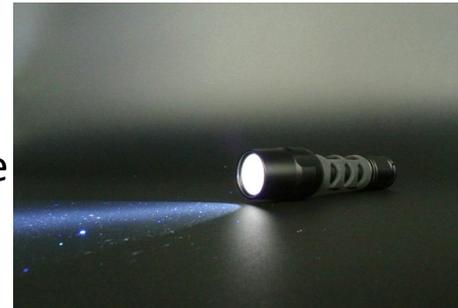
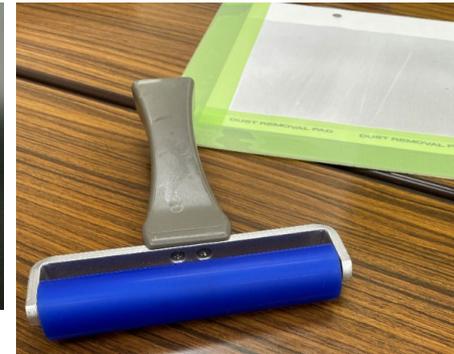
- Improving the yield rate is necessary
  - Current good yield rate was ~20~30%
  - Production parameters are best tuned
    - Pressure to make multi-layer & make thru-hole
- Inspected/discussed the production procedure with manufacturers
  - Contamination of small dusts is major cause when producing the FPC
- New procedures to remove the dust as much as possible
  - UV lights to look for remaining dust
  - Silicon roller to remove dust
- Check the continuity before laminating multiple layers
- Expect to be improved to good yield rate ~80%

Short line by mis-exposure    Open line by mis-etching

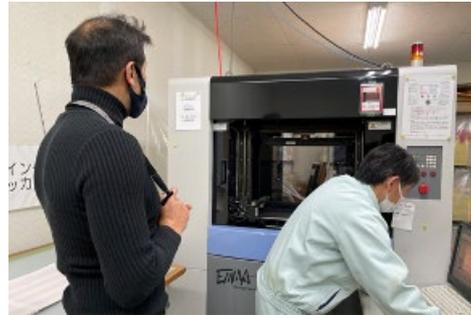
Yield rate improved dramatically

Flying probe tester  
The INTT Readout Electronic review

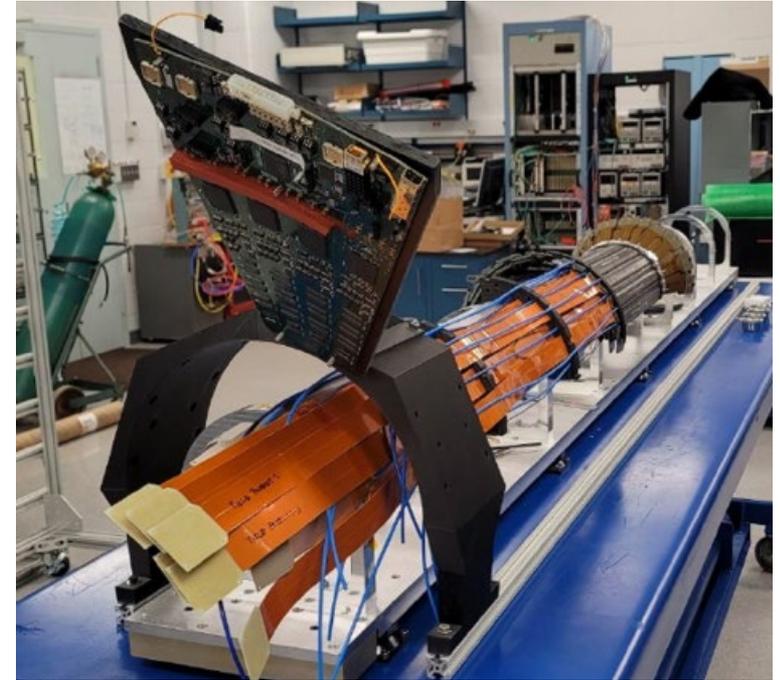
- Barrel assembly is in progress
  - Checking the interfere of the ladders
  - Adjust the length of the bus extender.
  - Optimized the shape of the conversion cables

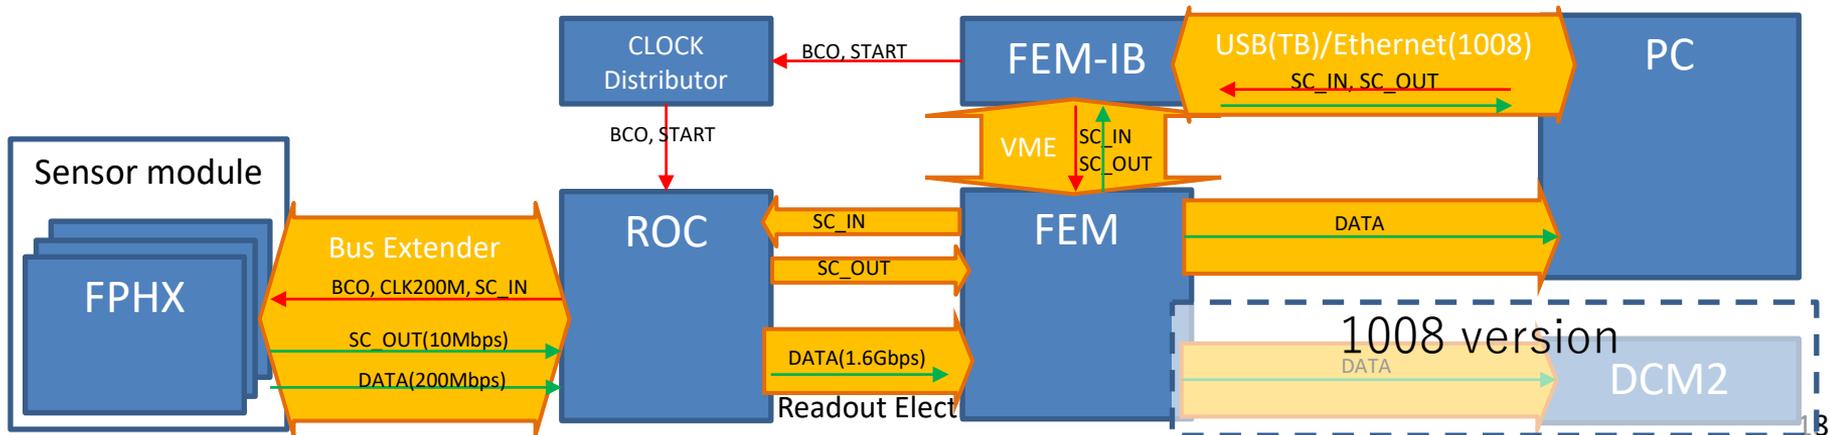
- Full Readout Chain
  - 20 bit /hit is generated at FPHX and sent to ROC w/ 200 Mbps
- SlowControl
  - Send the control command to FPHX and the readout electronics (FEM, FEMIB, ROC) w/ 10 Mbps
  - The SC commands set thresholds in FPHX, Channel masks, flash memory
    - Flash memory expected to be used for the initial values
- Readbacker
  - Useful to see the ladder condition remotely

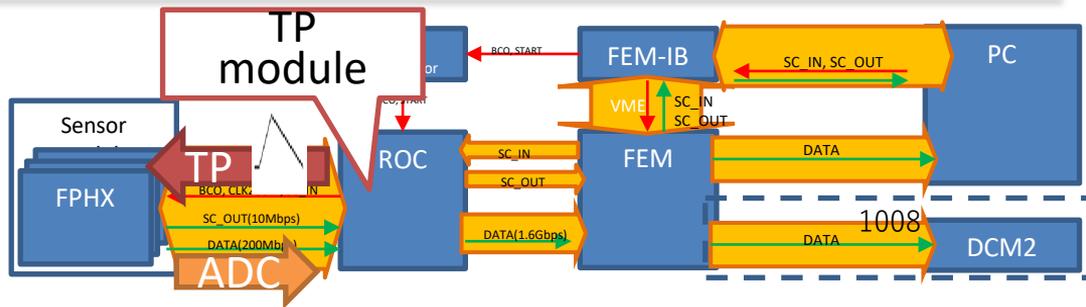
- TP module built-in at ROC
  - 10 TP / ch with amplitude of 0-63
- Useful to see ch-by-ch response
  - ADC threshold clearly seen
  - Linearity between ADC (output) vs amplitude (input)
  - Nhits/ch by TP should be 350

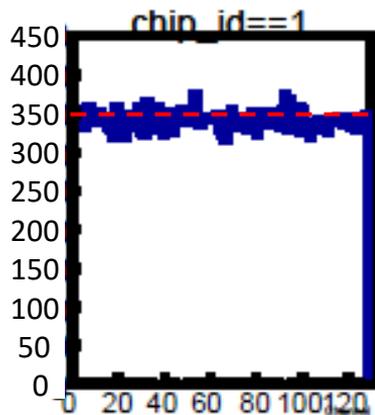
GOOD

- GOOD:  $\langle N \rangle \sim 350$
- Fine :  $\langle N \rangle \sim 300$
- Low Entry :  $\langle N \rangle \sim < 250$
- Lost Channels :

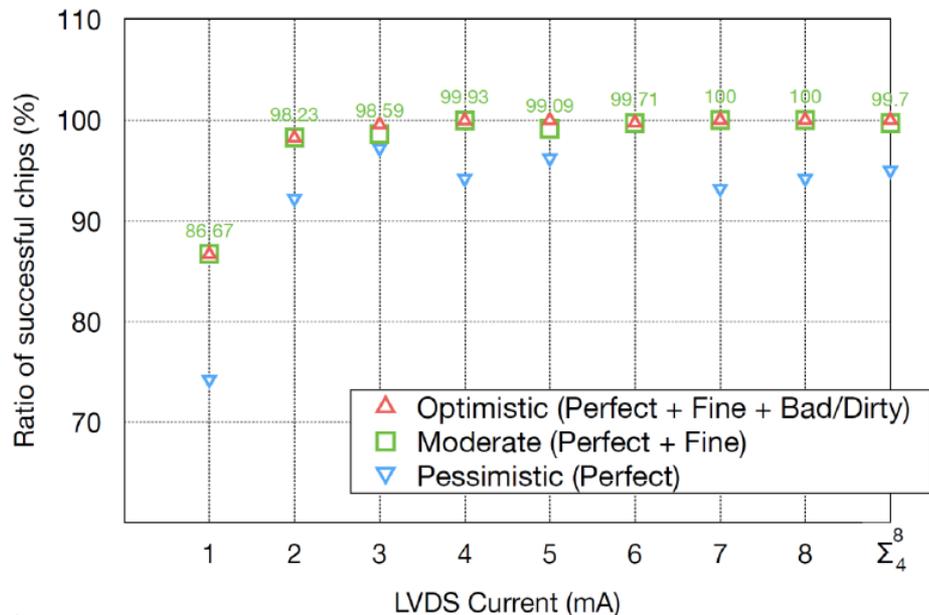
Ratio of successful chips (ROC SW5, C3)

- Add bus-extender to the data path
- Results
  - Ratio increase w/ LVDS currents

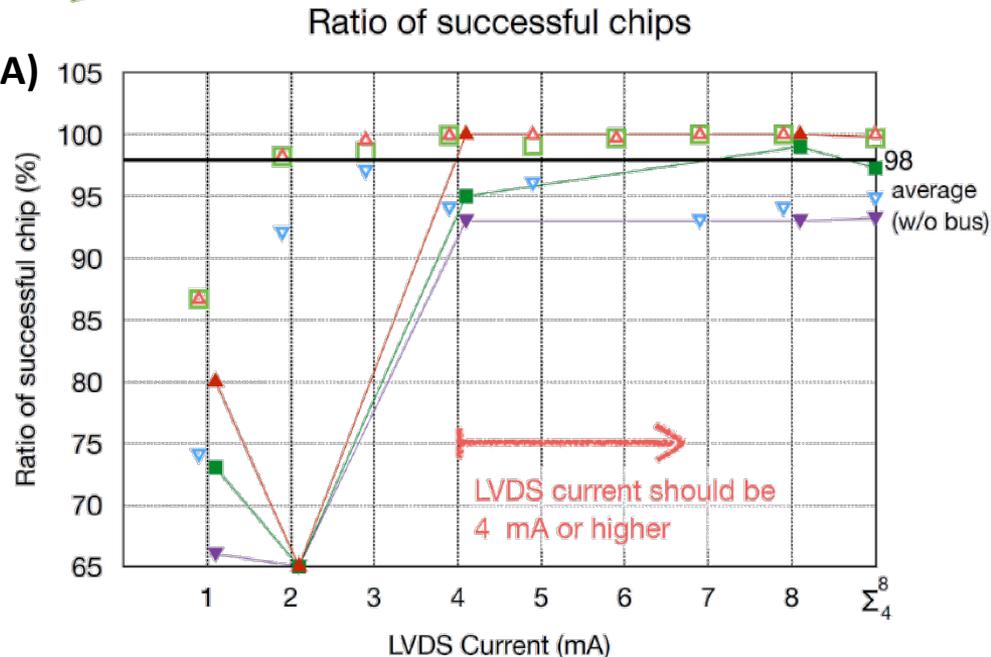
Ratio of successful chips (ROC SW5, C3)

- Add bus-extender to the data path
- Results
  - Ratio increase w/ LVDS currents
  - Ratio ~ 100% at LVDS  $\geq 4\text{mA}$  (FVTX = 2mA)

2 different ports at ROC

Data transmission w/ Bus-Extender successful

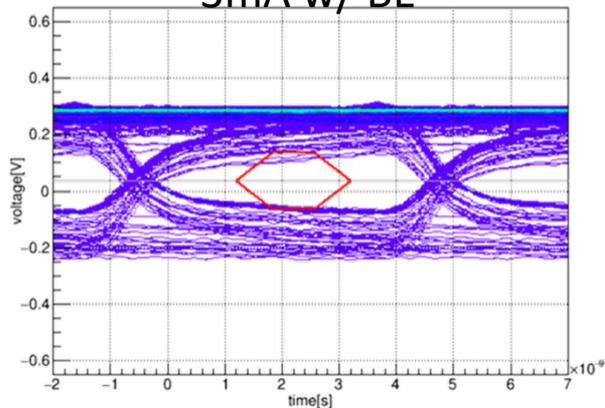
3mA w/ BE

- Tested that SC initialize the registers for each FPHX
- Example: LVDS current changed to 3, 5, 8mA

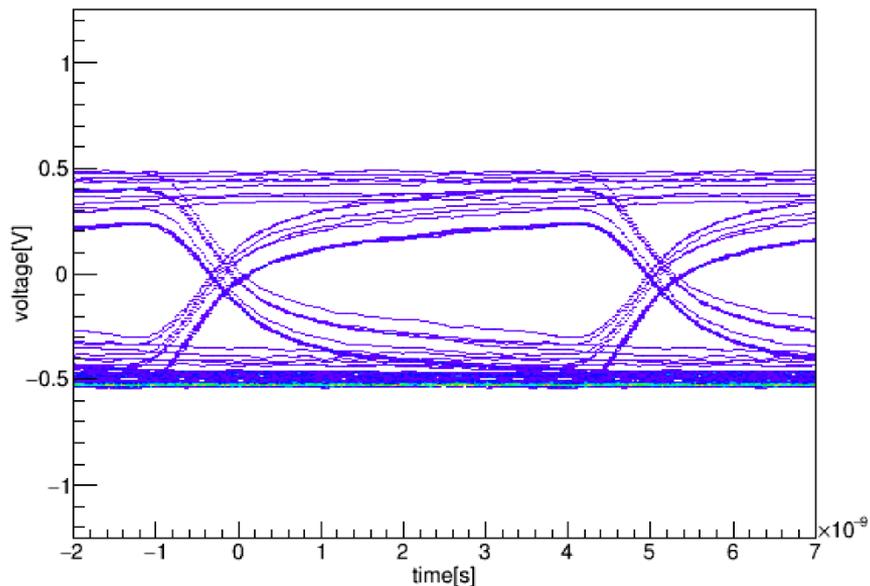
Before

All ROC regulators were replaced from 2.5V to 3.0V to compensate the voltage drop

- LVDS signal heights matches 8mA setting after the regulator upgrade
  - 8mA setting  $\rightarrow$  0.5V : Power was not enough to drive 8mA before the upgrade

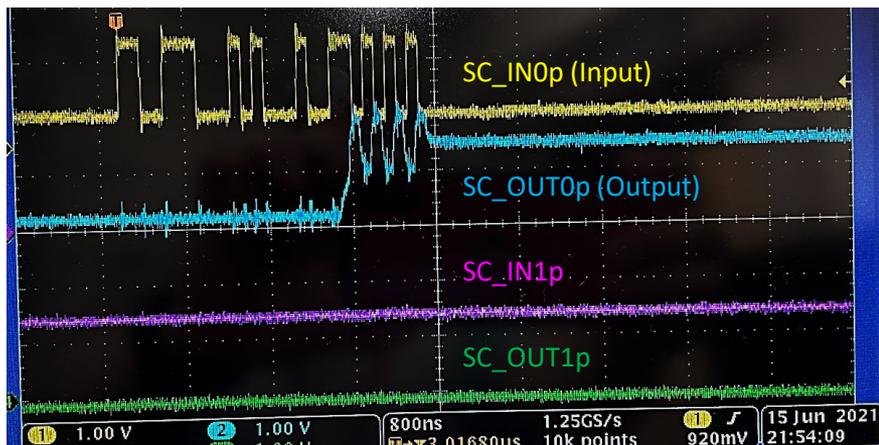
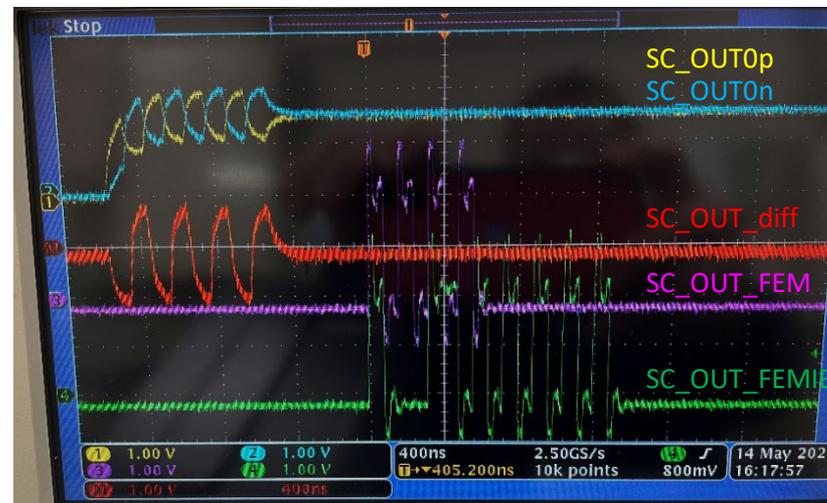
- Send the SC command to the chip.
  - SC commands and Readback values are monitored on the interception board
- Readback signal reach to FEM-IB
  - Transmitted from FPHX to FEM-IB via ROC and FEM.
  - Header (b\_10001101) added at FEM

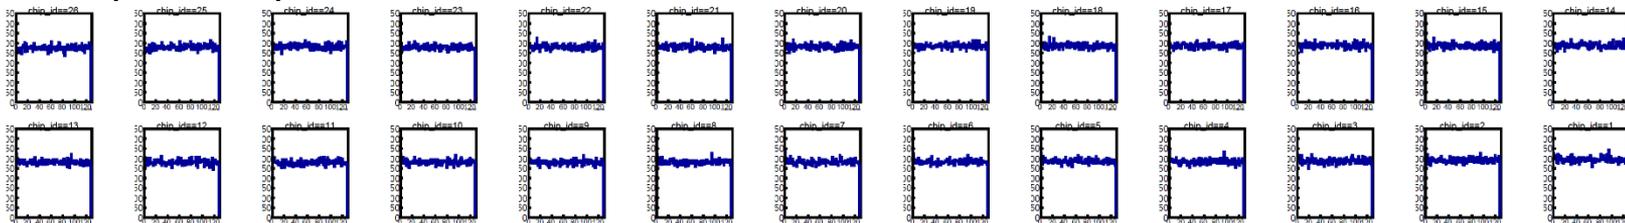
Fine (N < 300)

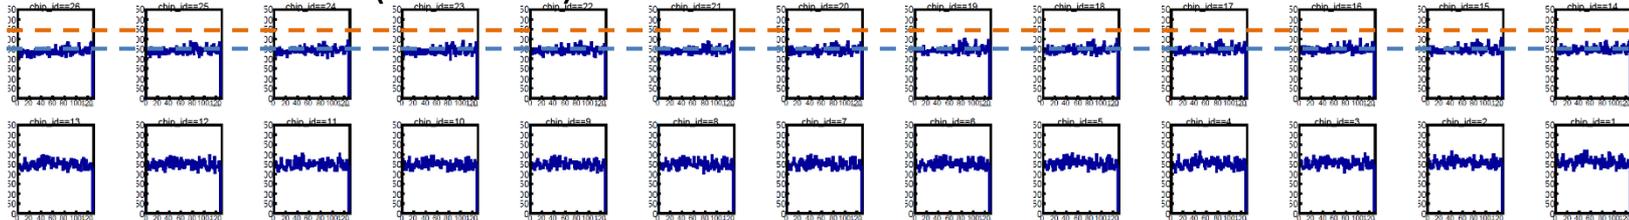
BAD1: less entries (N ~< 250)

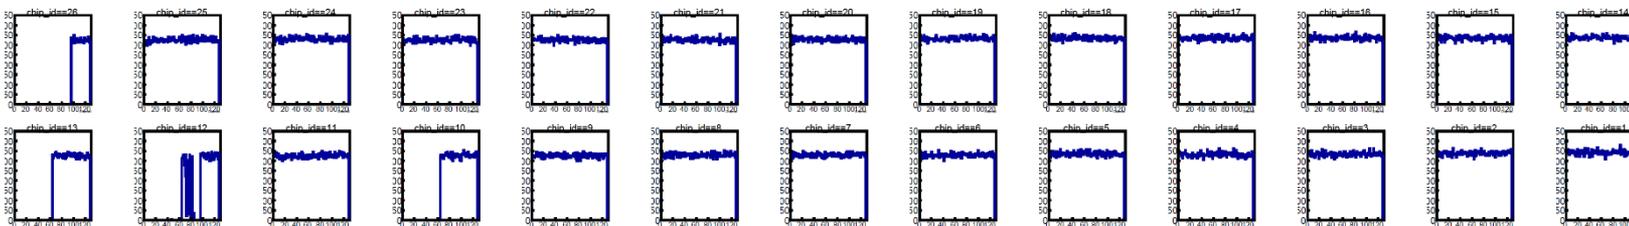
BAD2: Lost channels

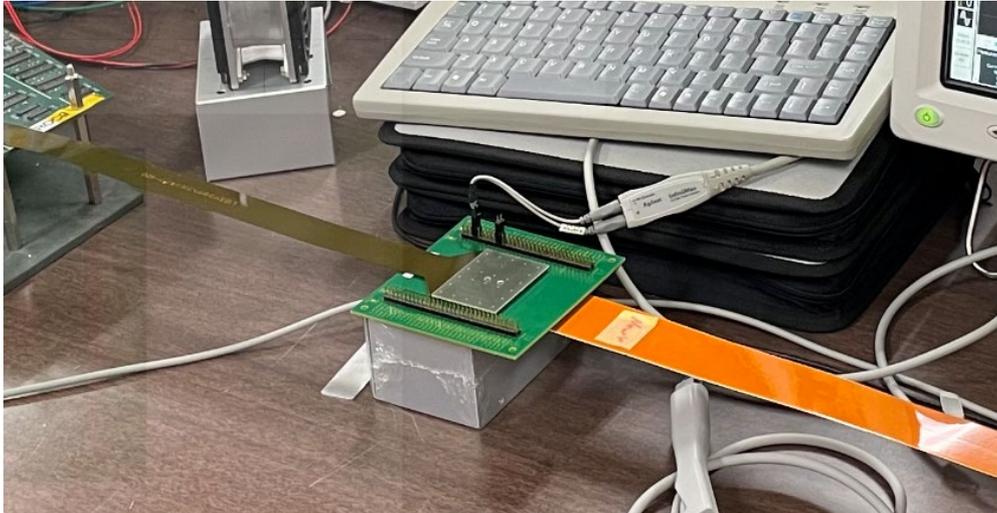
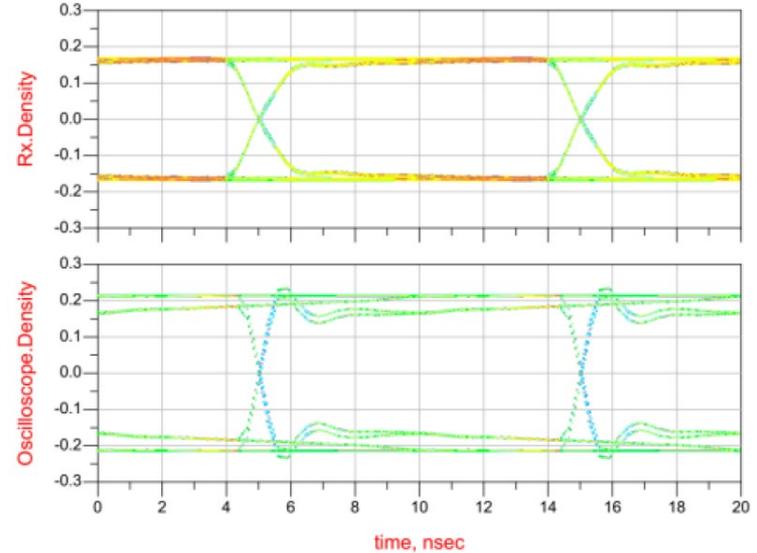
- The interception board is designed to measure the signal pulse of data transmitting between the ladder and ROC.
  - Useful for debugging and QA
- The side effect by the interception board is a distortion of the pulse

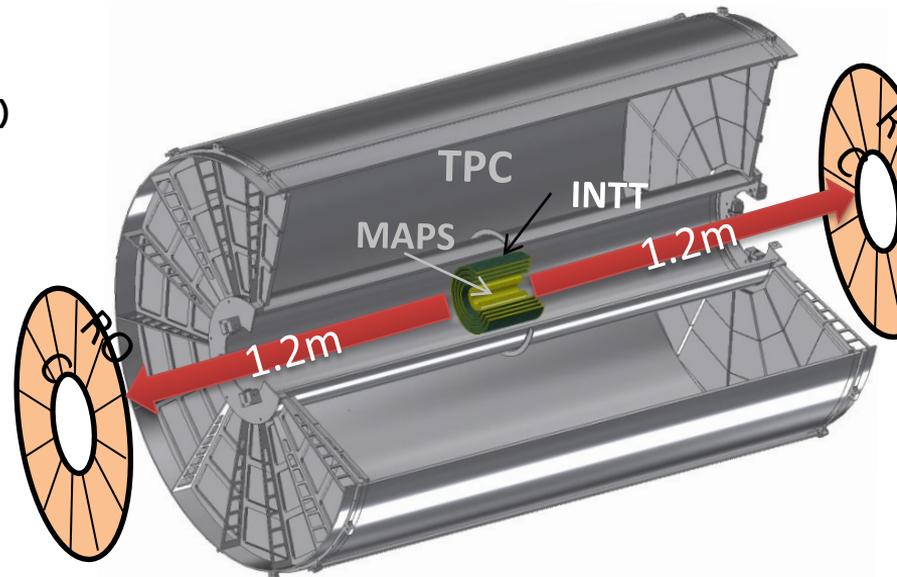
- Long  $\sim 120\text{cm}$
- Dense = 62 pairs of the signal line (and power/GND)
- High speed = 200 Mbps LVDS ( $Z_{\text{diff}}=100\Omega$ )
- Tight space  $\sim 5\text{cm}$  and curving path
- (re)use the FVTX ROC

- Develop the cable based on the FPC technology
  - Flexible and can be micro-fabricated
- Very long FPC is challenging
  - No fabrication machine for 120cm FPC
  - Large signal loss by 120cm during the signal transmission
  - Keep line & space precisely for whole length
    - Make the circuit open/short easily if the line width is fluctuated

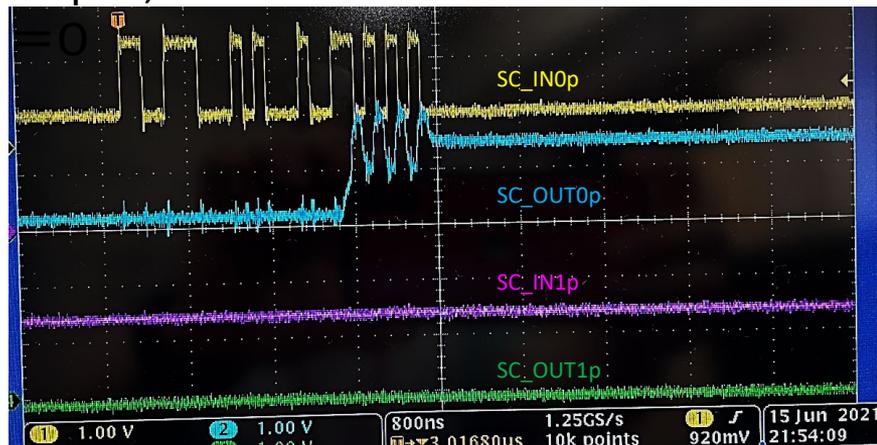
Chip=2, Side

- Send the SC command to the chip of interest.
  - SC commands and Readback values are monitored on the IC board
- The test is successful

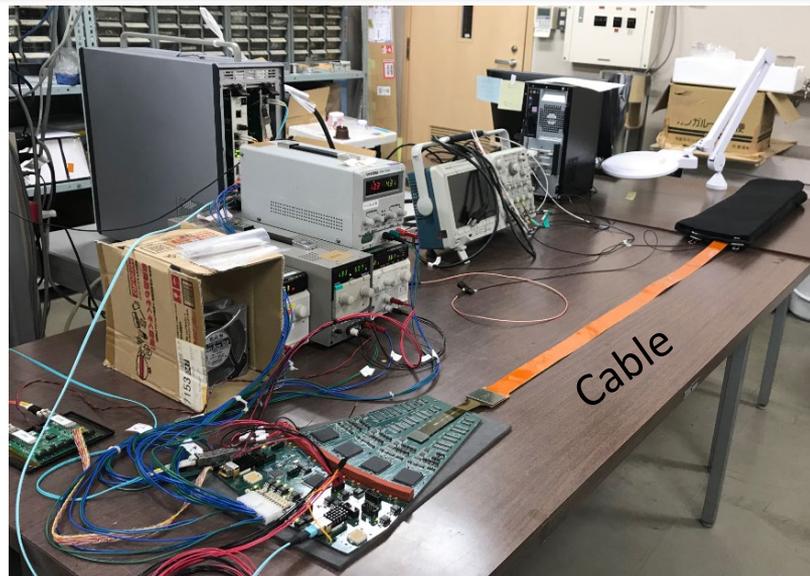
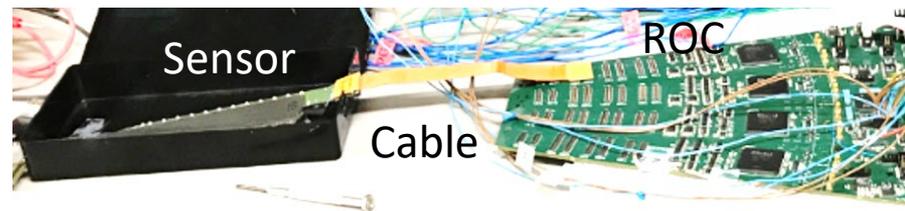
- BEX for INTT is much longer than that for FVTX
  - LCP used for small signal loss
- Technically challenging
  - Small signal loss
  - Stable Zdiff for the length

FVTX	INTT
Length	10~30 cm	<b>120cm</b>
Layer	7	4
Signal	62 pairs (LVDS)	62 pairs
Power	V-a, V-d, GND	V-a, V-d, GND
Substrate	Polyimide	<b>LCP</b>
Impedance	50	50
