# LArFCS Cryogenic System Progress

8/24/21

# LArFCS Construction

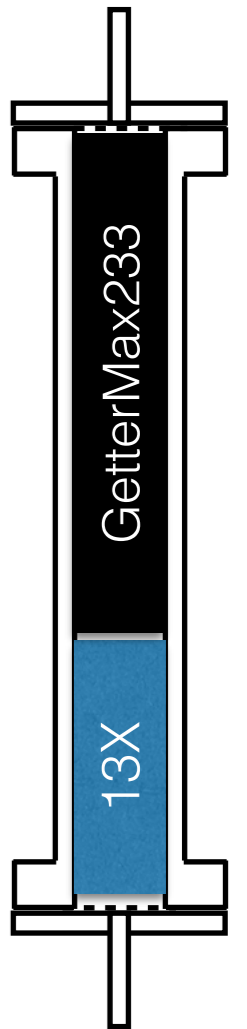
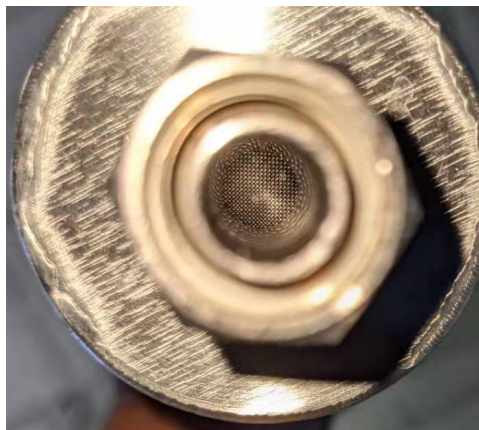
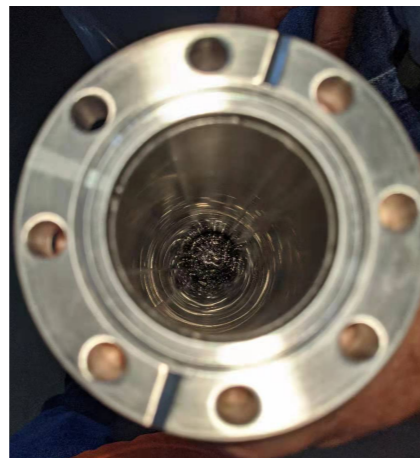
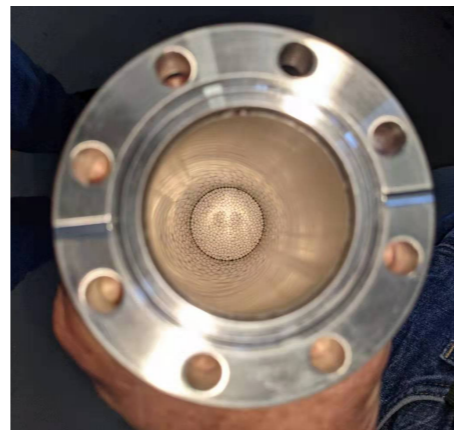
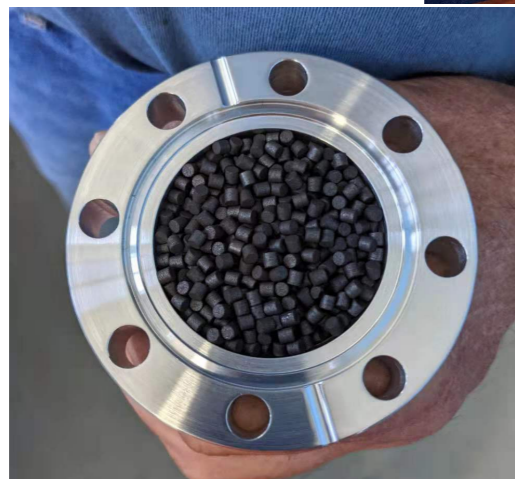
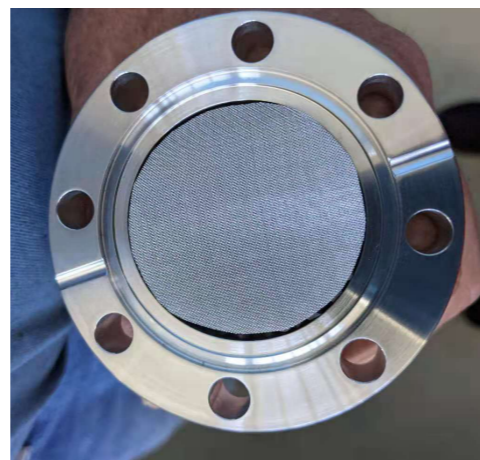
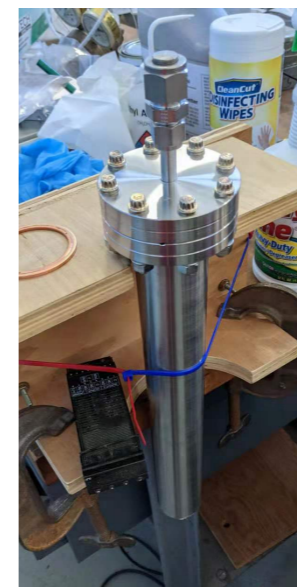
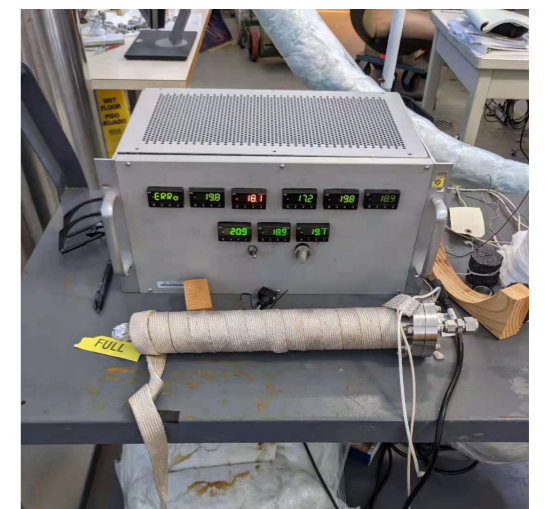
## ▸ LArFCS purifier assembly

- Cylinder filled with the scrubber materials
  - ~220ml, 180g 13X molecular sieve
  - ~440ml, 561g GetterMax 233 O<sub>2</sub> Oil contamination on the mesh accidentally found
  - Capped with mesh at the top and bottom to hold the materials
  - Materials containment works well, no leakage with vigorous vibration
  - Reactivation system installation in progress

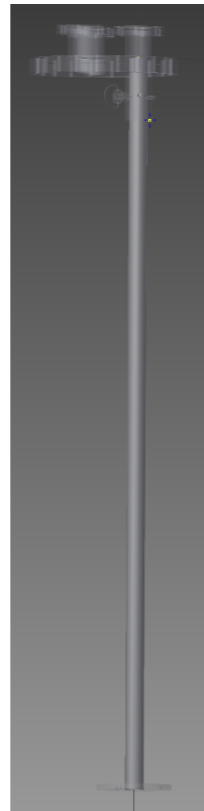
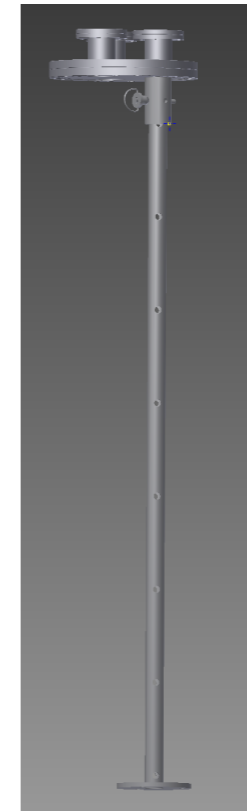
## ▸ PrM mounting structure

- KHV finished the top flange
- Started to fabricated mounting structure below the top flange
- Minor modification on the tube design with 3/8" venting holes added

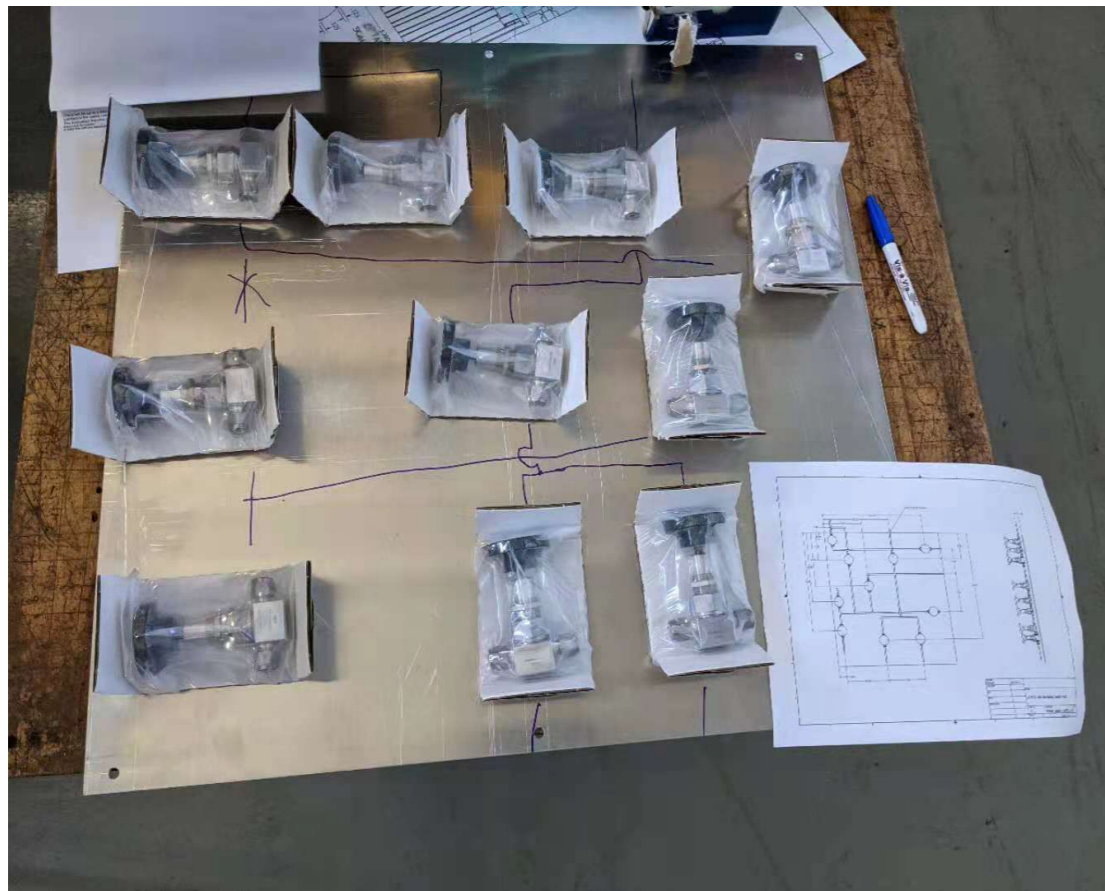
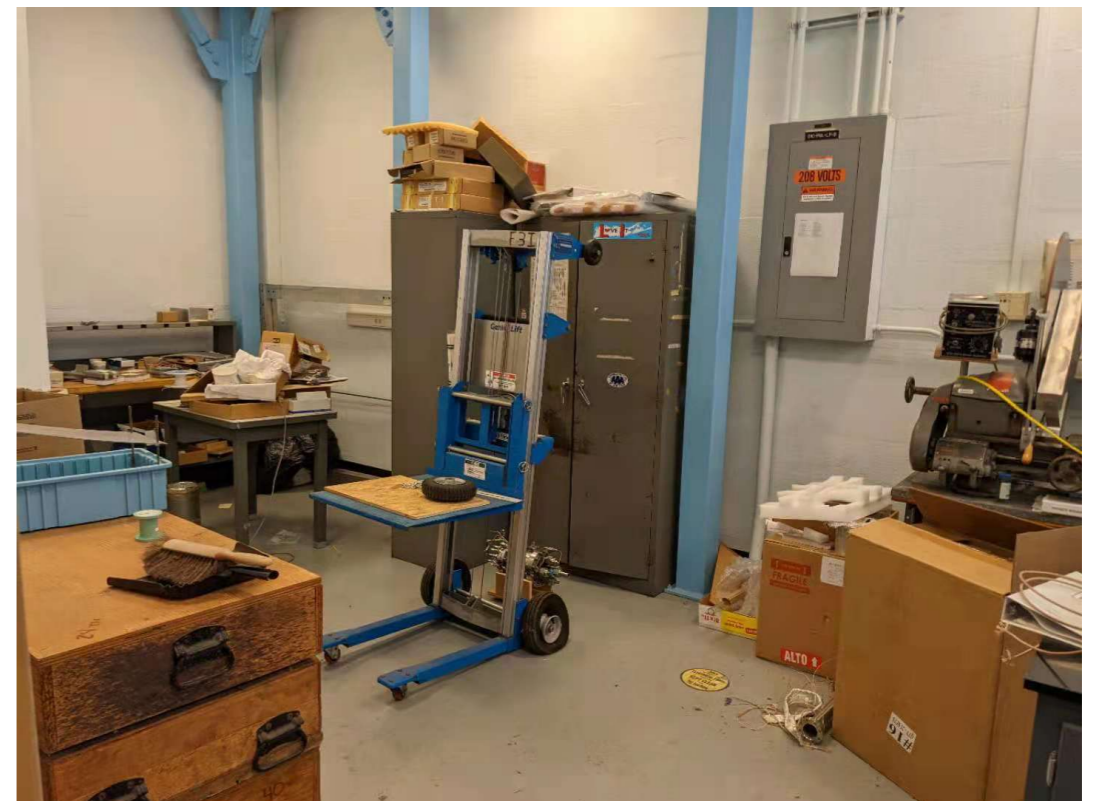
## ▶ Gas panel assembly

- Went through a mocking-up arrangement on the panel with Russ
- Minor modifications on the assembly design to optimize the assembly
- Plan to finish the panel this week

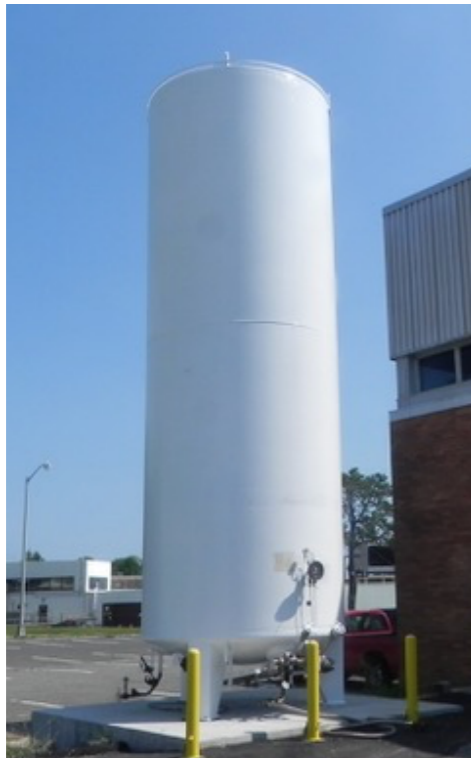
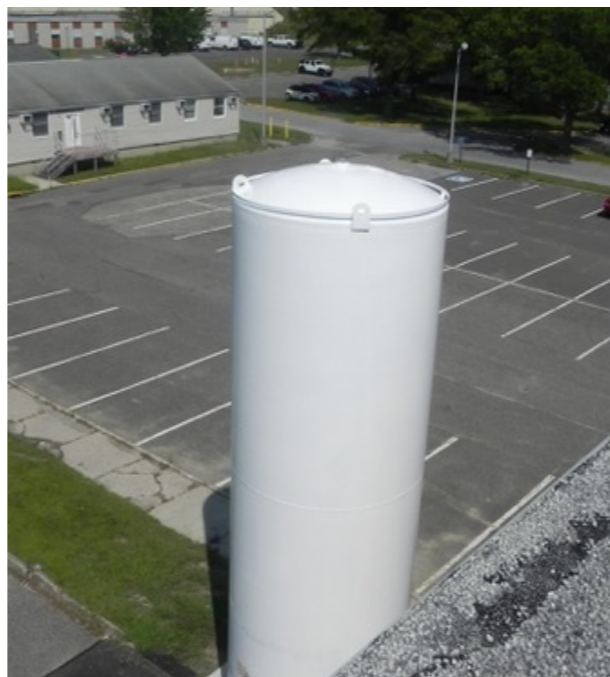
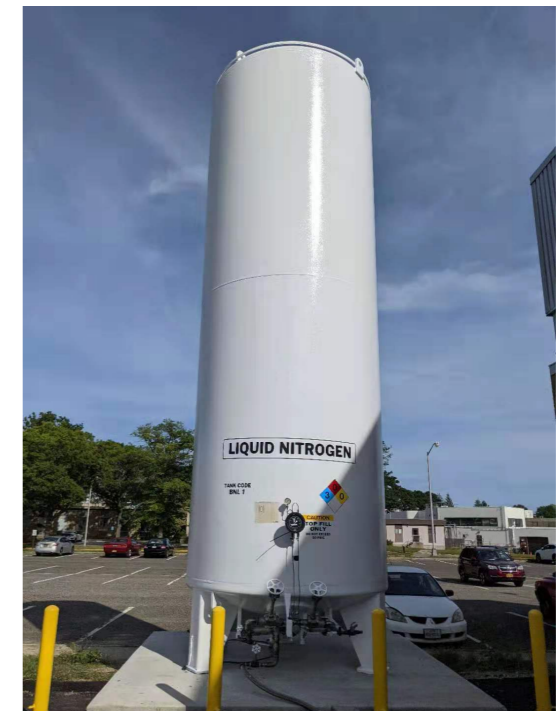
## ► The painting job is done

- *"The last (and only) green dewar has disappeared. I have look on sites for years, and that was the ONLY dark green dewar I found in the whole world."*  
—Mike Gaffney
- Significant surface temperature reduction observed measured by IR thermometer
  - After the painting, With 90°F outdoor temperature, Building 510 roof temperature at 146°F
  - The tank had a uniform temperature of 120°F, with less than 5° difference between the middle and top. The Building 510 High Bay roof was recorded at 146°F.
  - When it is in Green, with 90°F outdoor temperature, the tank average temperature was 165°F and the tank top was 225°F.
- Re-labeling done before the hurricane, now Tank Code BNL 1
- Safety approved for test LN2 filling once the site survey by the vendor is done
- Still waiting for the scheduling of site survey by Airgas
