# LArFCS PrM Test at UC Irvine

# PrM test at UCI

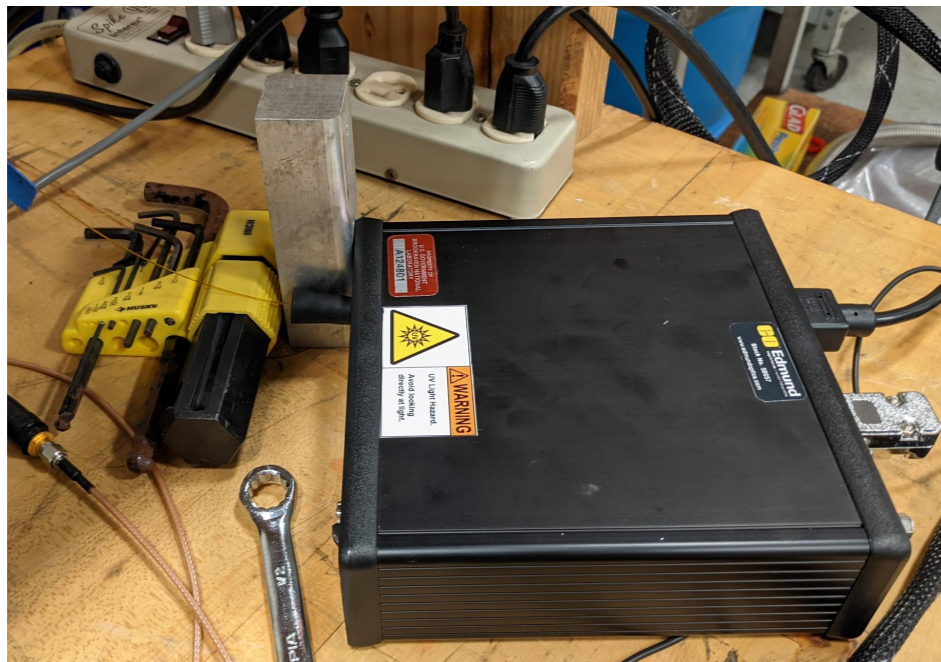
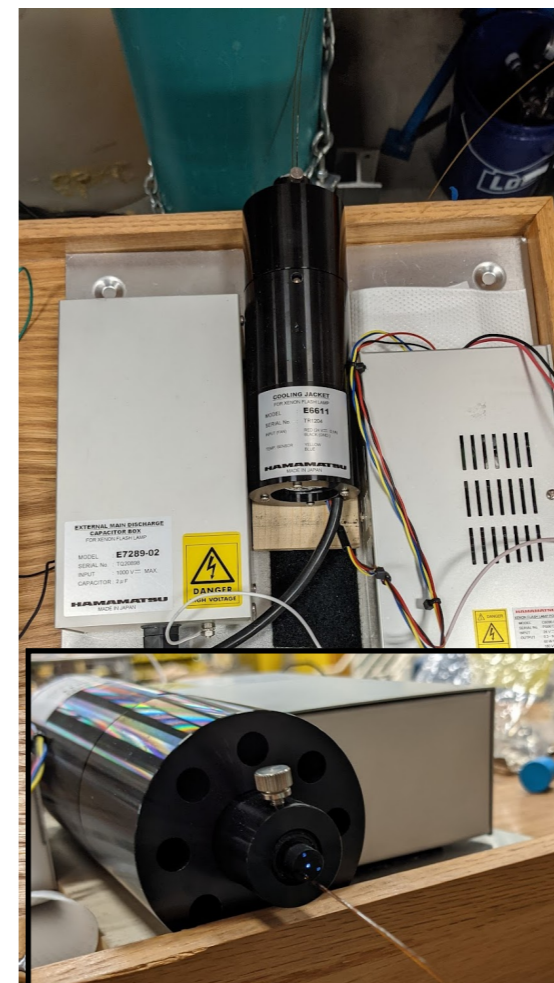
## ► Light Sources

- Hamamatsu Xe Lamp and our Xe Lamp used in the test
- Hamamatsu lamp light intensity is extremely high that the fiber needs to be pulled out a bit to avoid saturation
- A rubber plug is used to adjust fiber positioning to achieve the maximum intensity
  - With adjustment, the signal amplitude can be comparable to Hamamatsu Xe Lamp

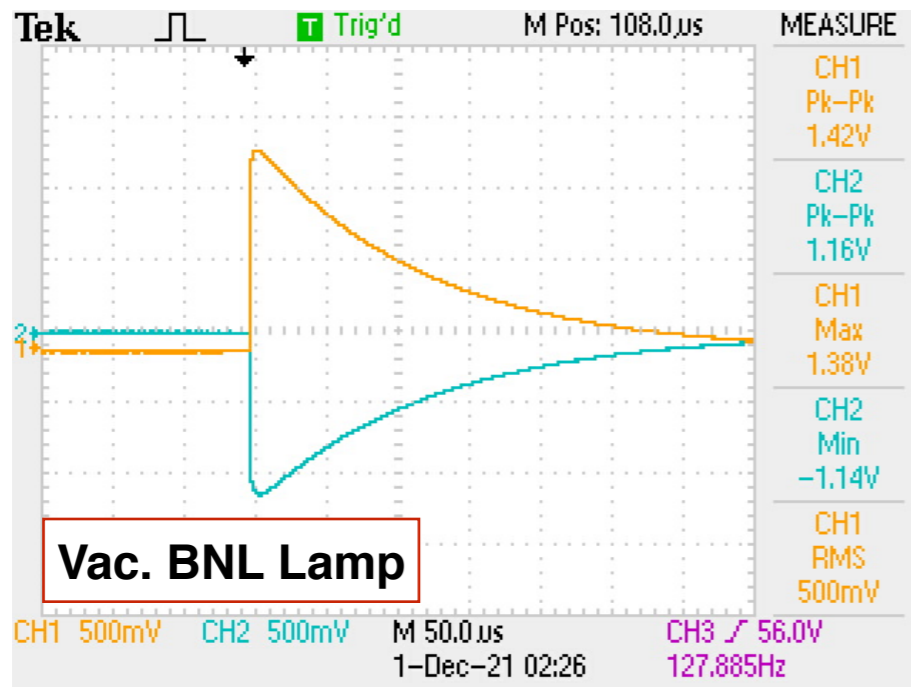
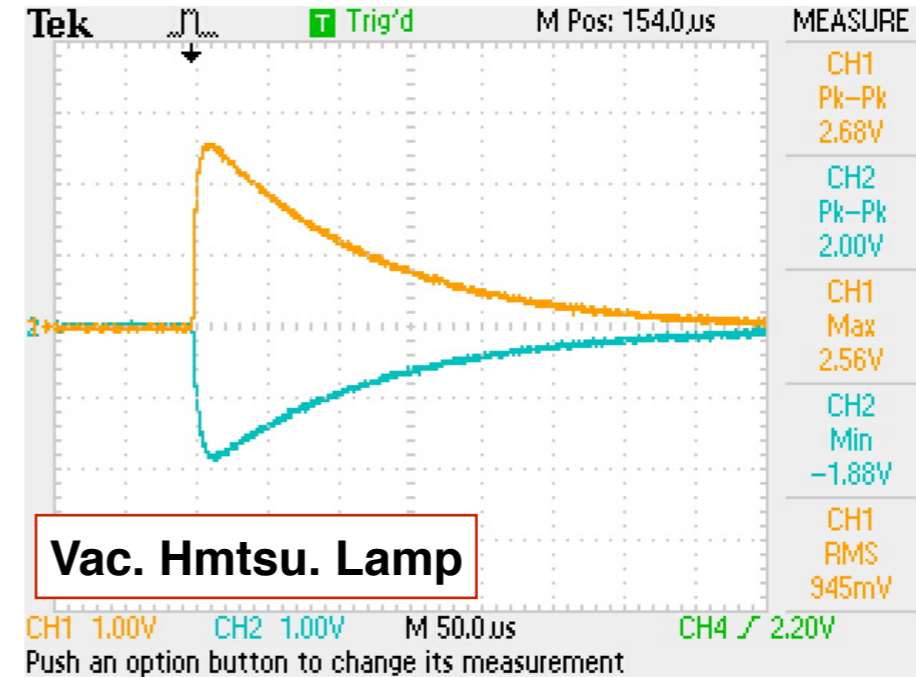
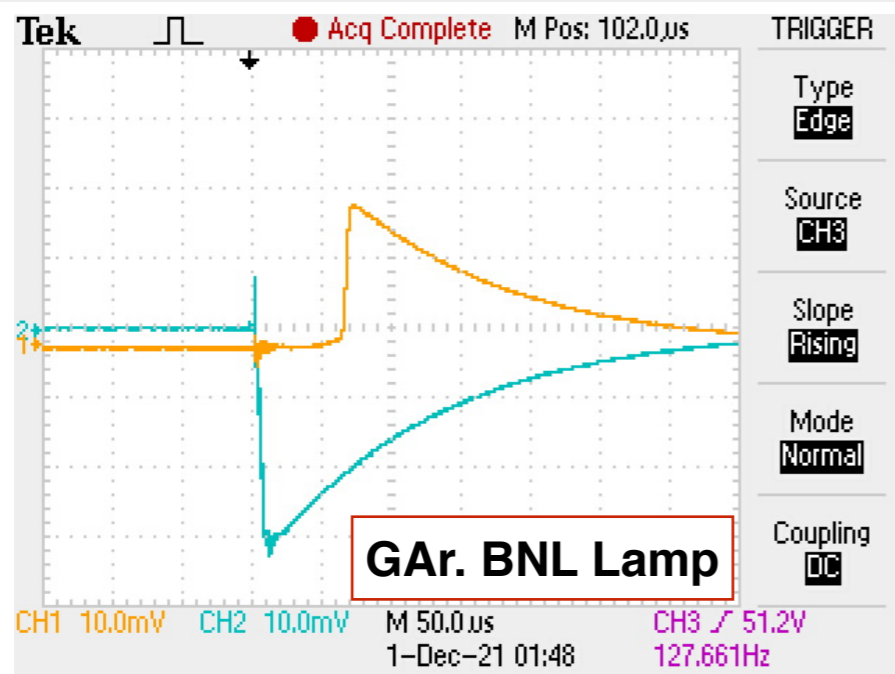
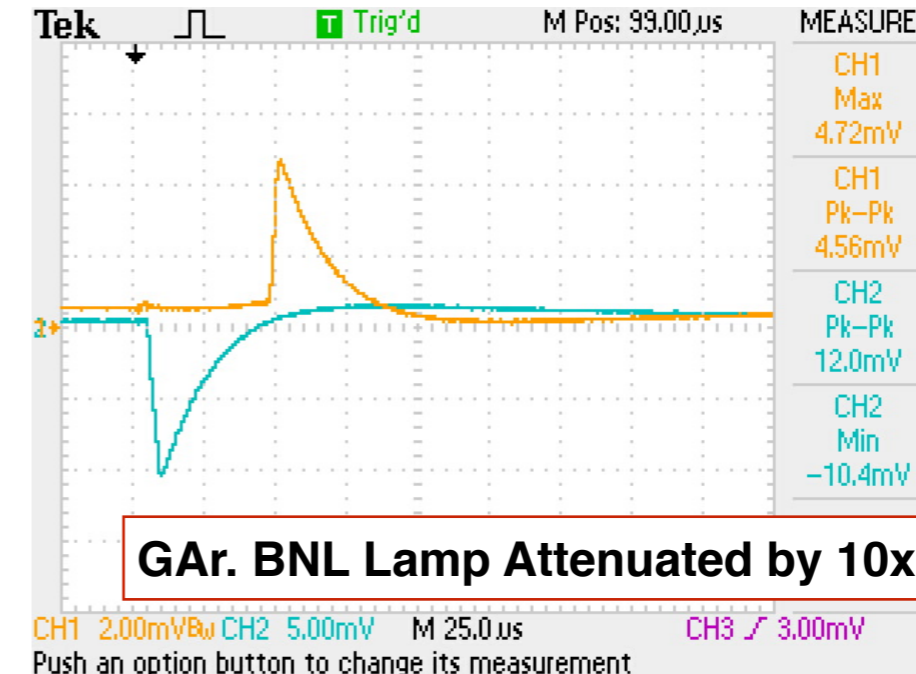
## ► Practice test at the beginning

- Starting with PrM in Vac and charged with GAr to 1 bar
- GAr signal still visible with 10x attenuation
- There is noise issue with our electronics that UCI box with lowest noise was used

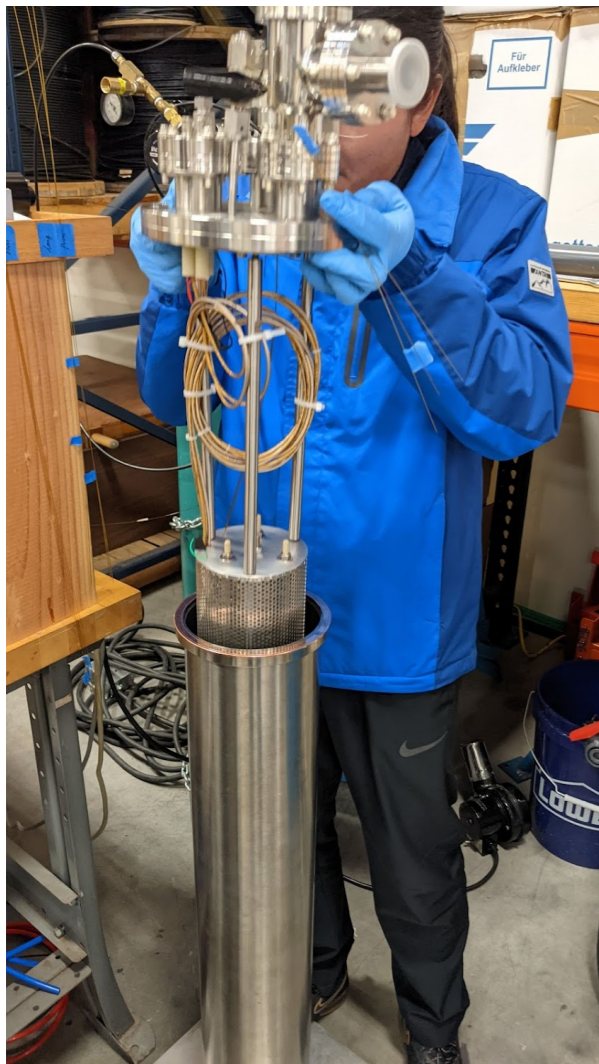
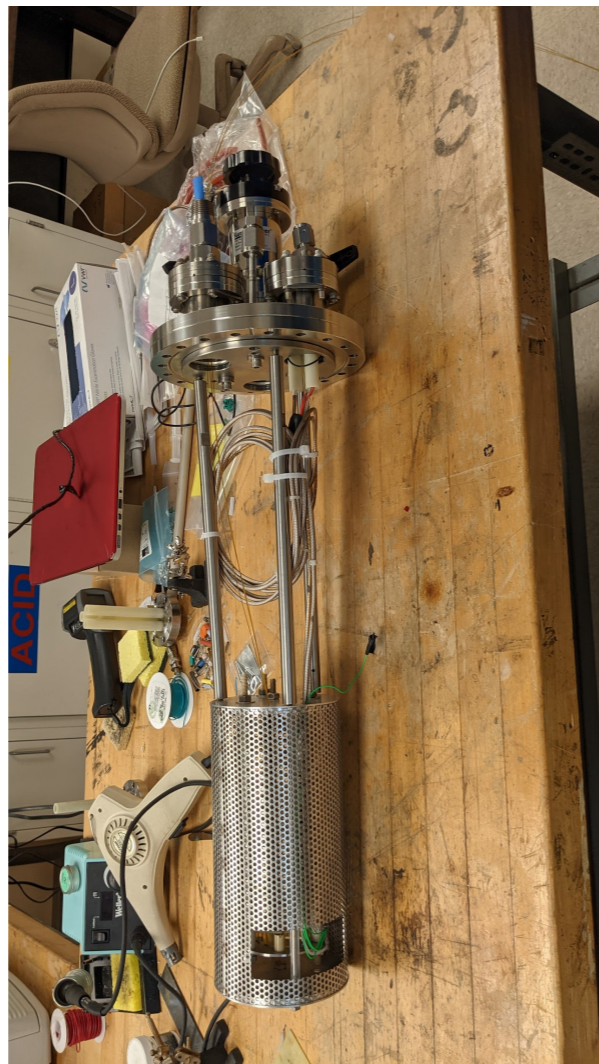
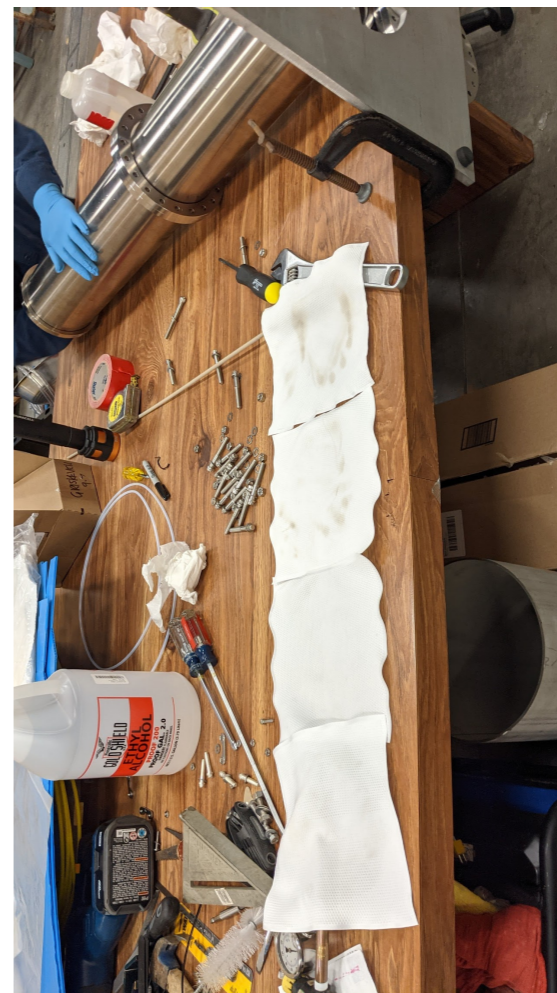
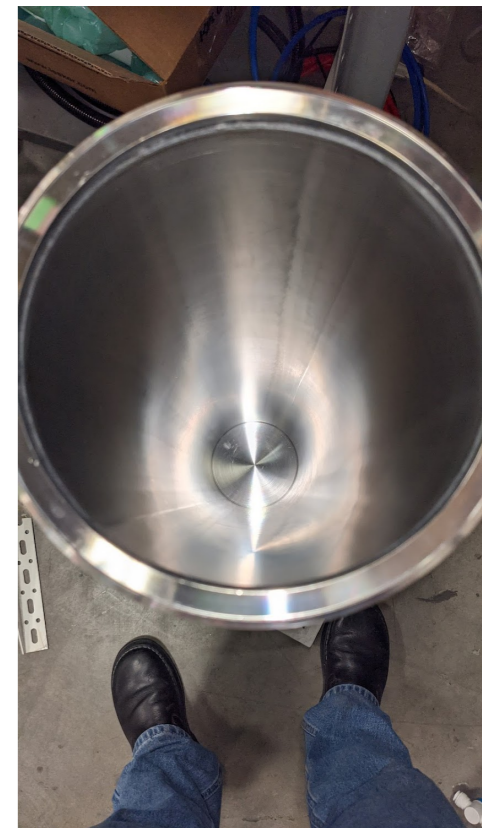
- ▶ **System opening for re-assembly**
  - The system was opened after initial test for re-assembly
  - The test chamber was found to be pretty dirty with oil on the surface that we thoroughly cleaned it up

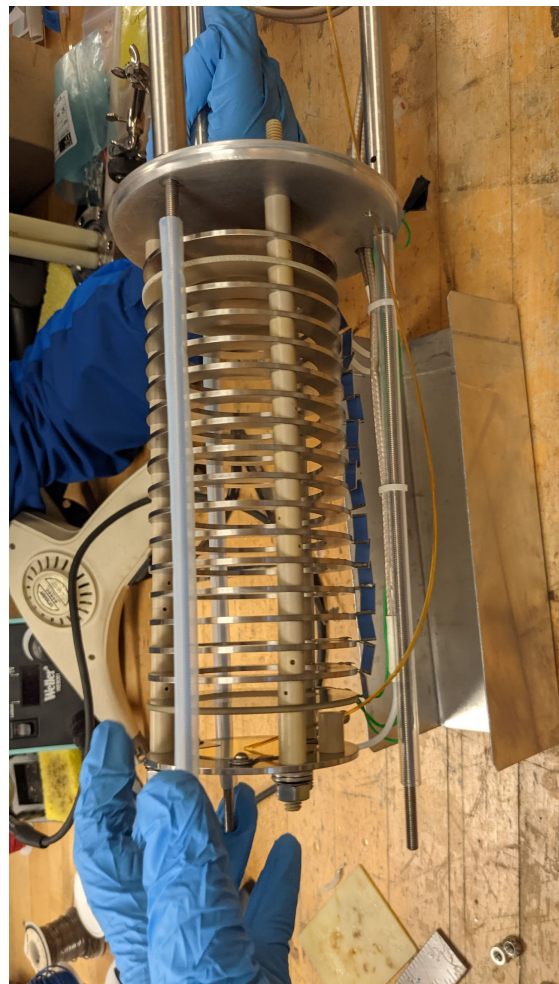
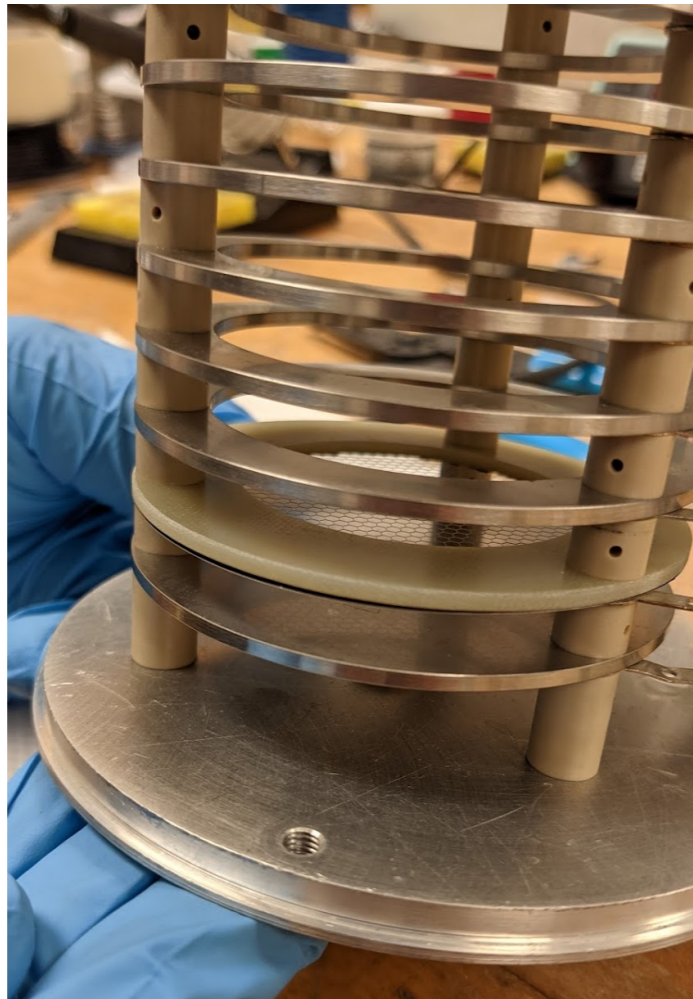
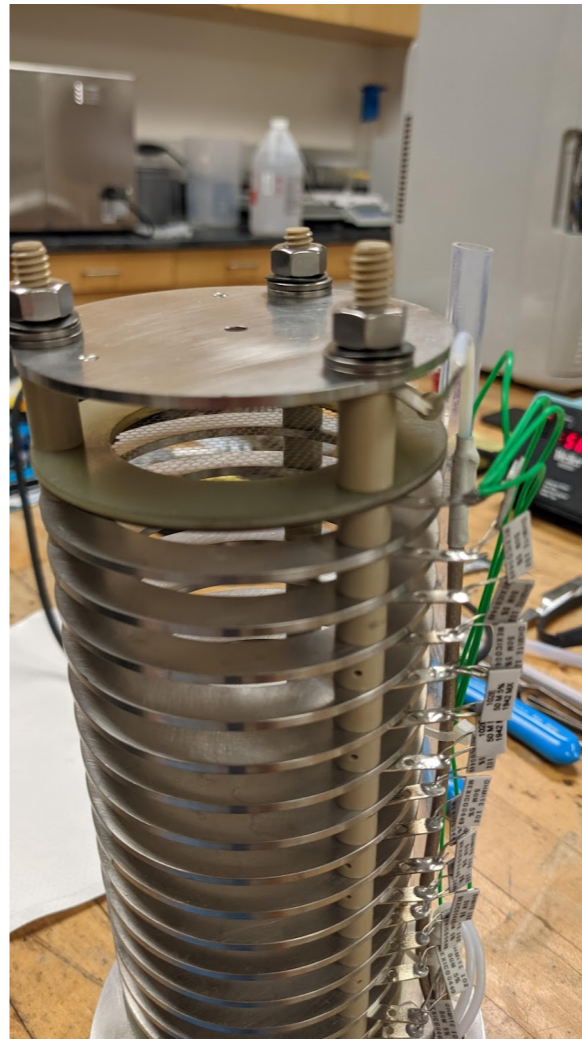
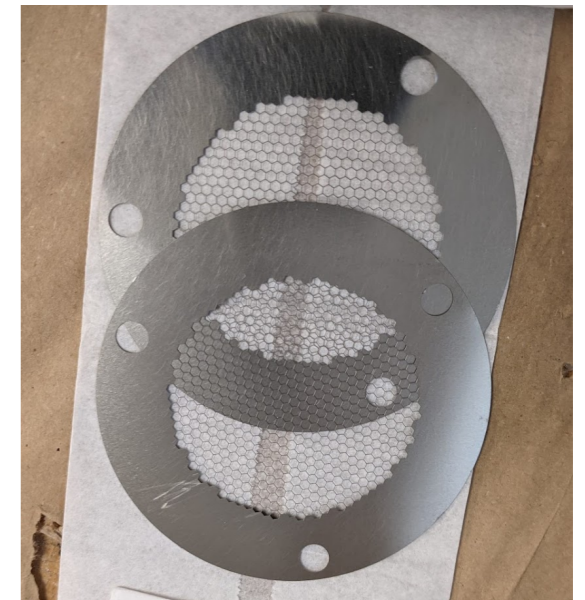
## ► PrM Anode Grid Replacement

- The cathode grid was previously replaced due to broken wire
- The anode grid was replaced to the honeycomb grid this time
- All the cable and fiber connections need to be disconnected during the process

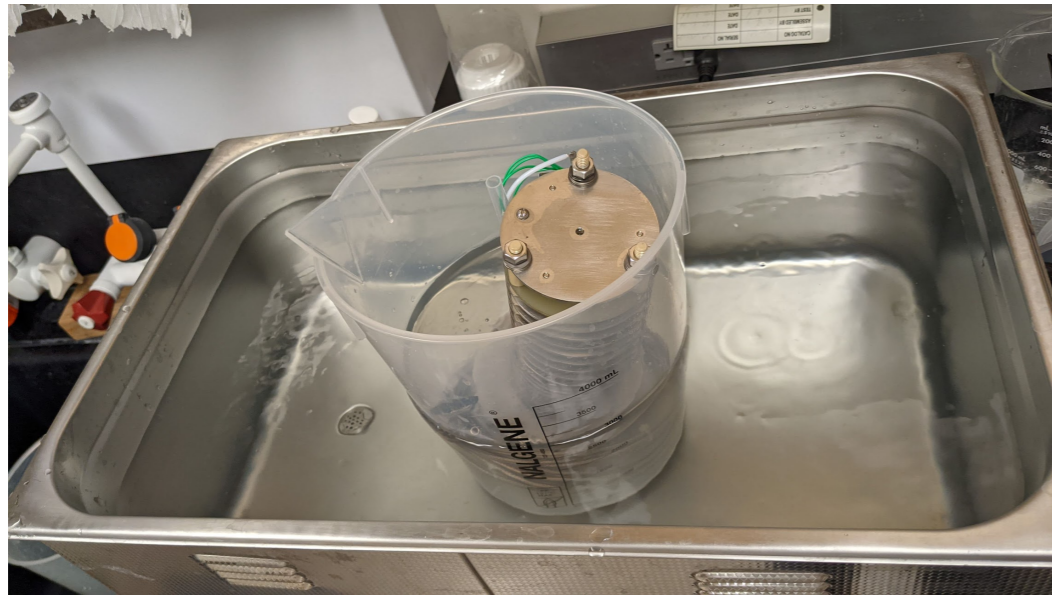
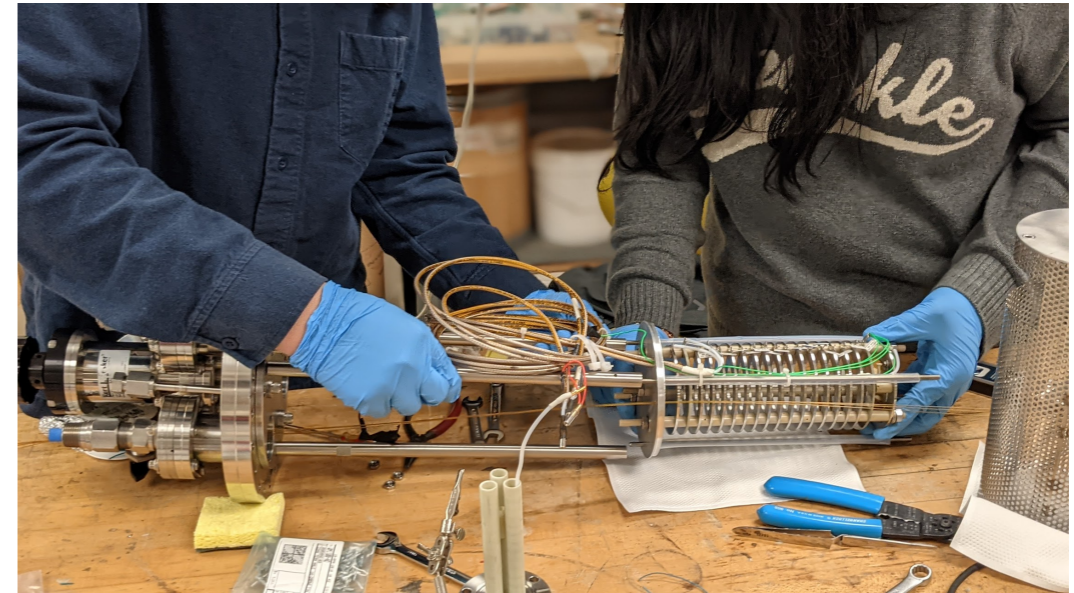
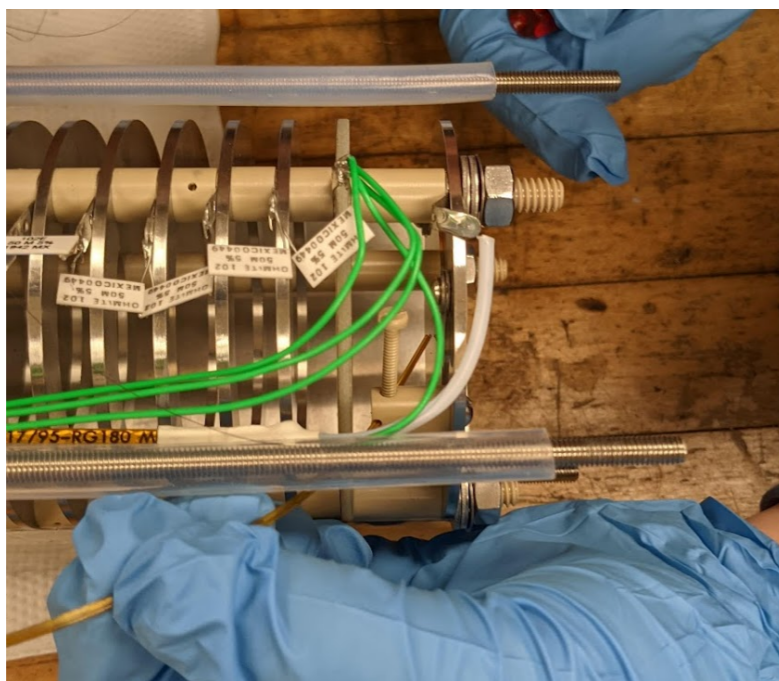
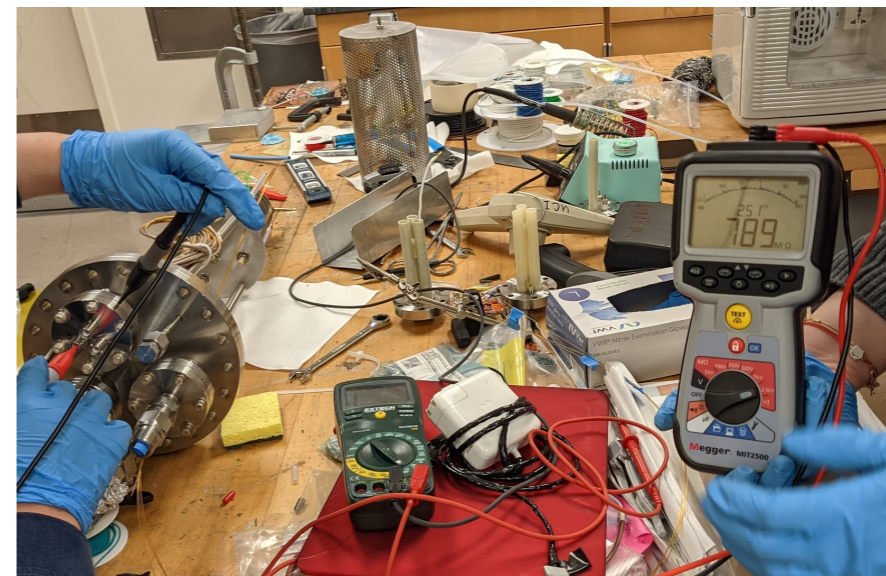
## ► PrM assembly

- The PrM stack was cleaned and assembled
- Went through the testing procedures to ensure the continuity of the connection
- Fiber positioning needs fine adjustment

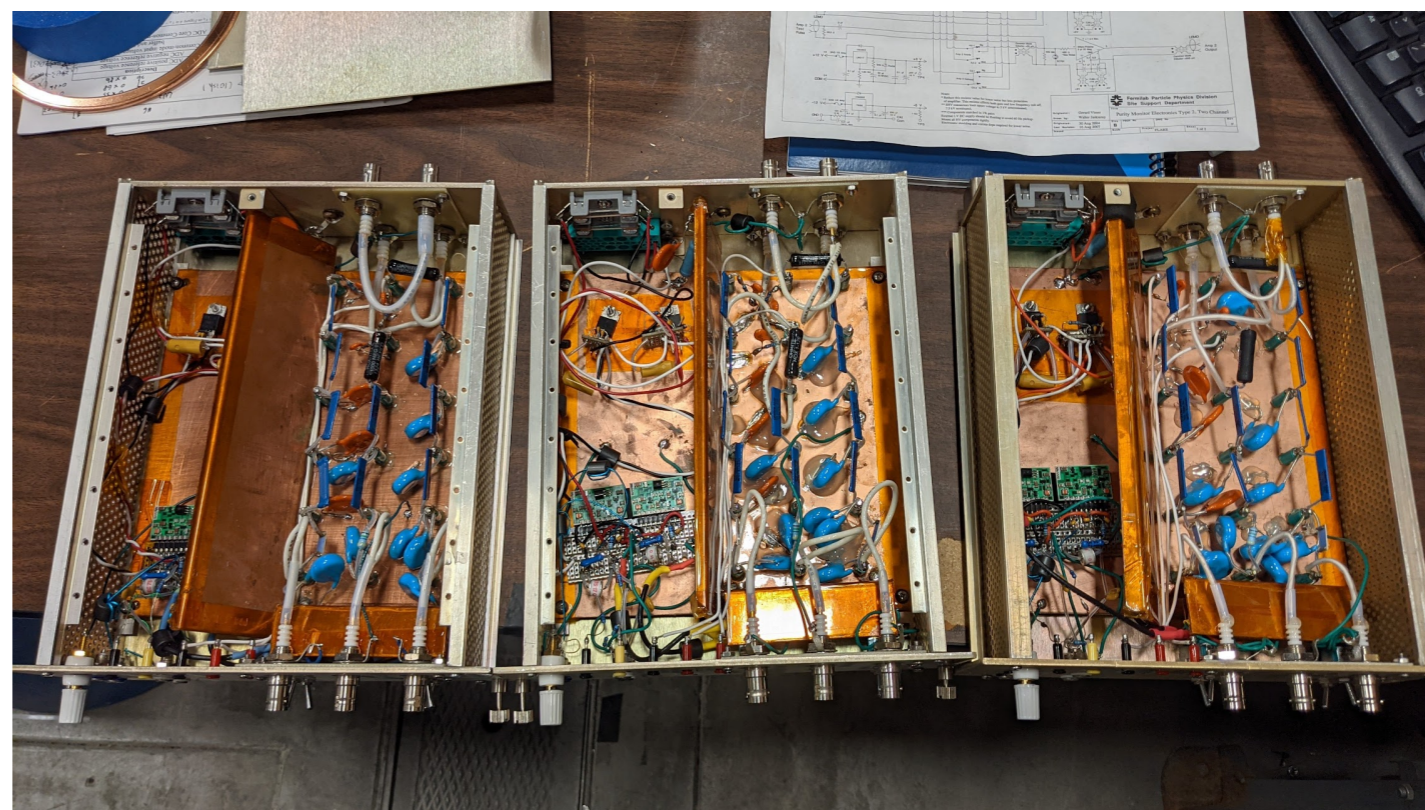
## ► PrM Electronics Box

- There are multiple electronics in the lab following the Fermilab design
- Performance differs slightly in terms of noise and baseline stability
- We used one of the UCI's with the best performance
- The assembly work was assigned to single person
- Our box was built by one of Jianming's student
- There were noise and baseline jumping issues and finally fixed by tied down signal cables to the base copper plate
- Our box is similar to UCI's best electronics box now

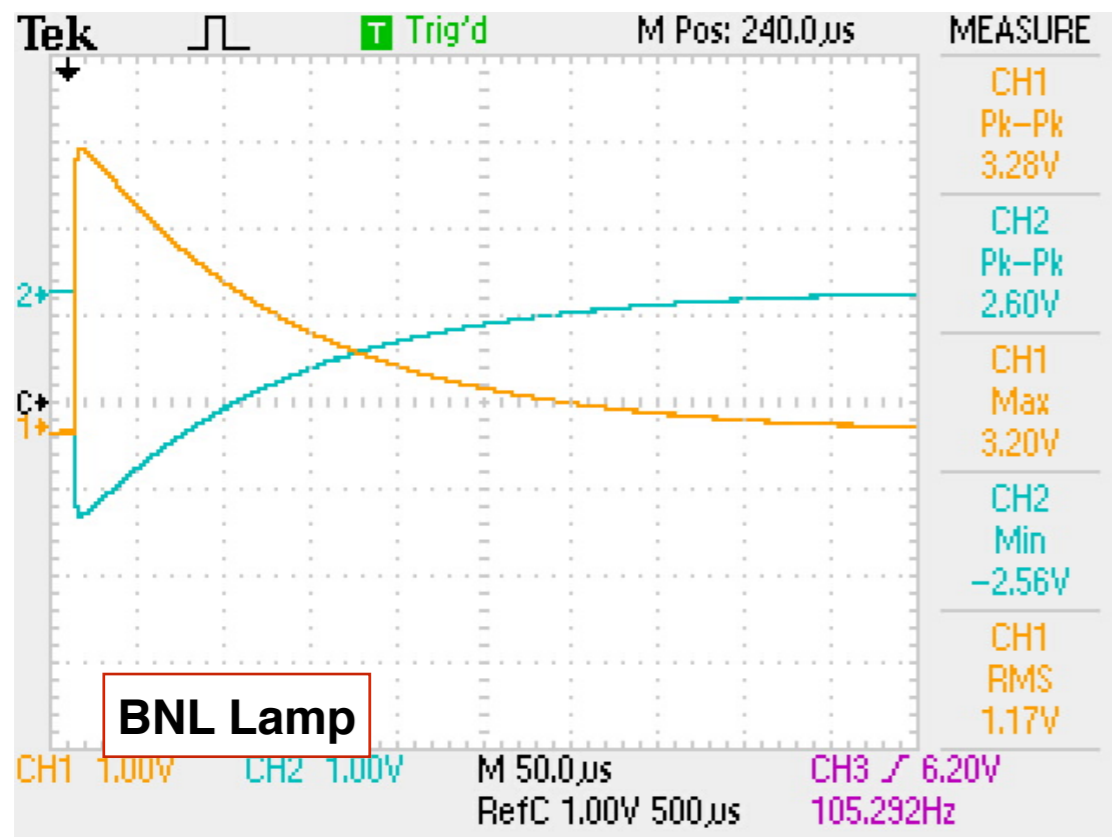
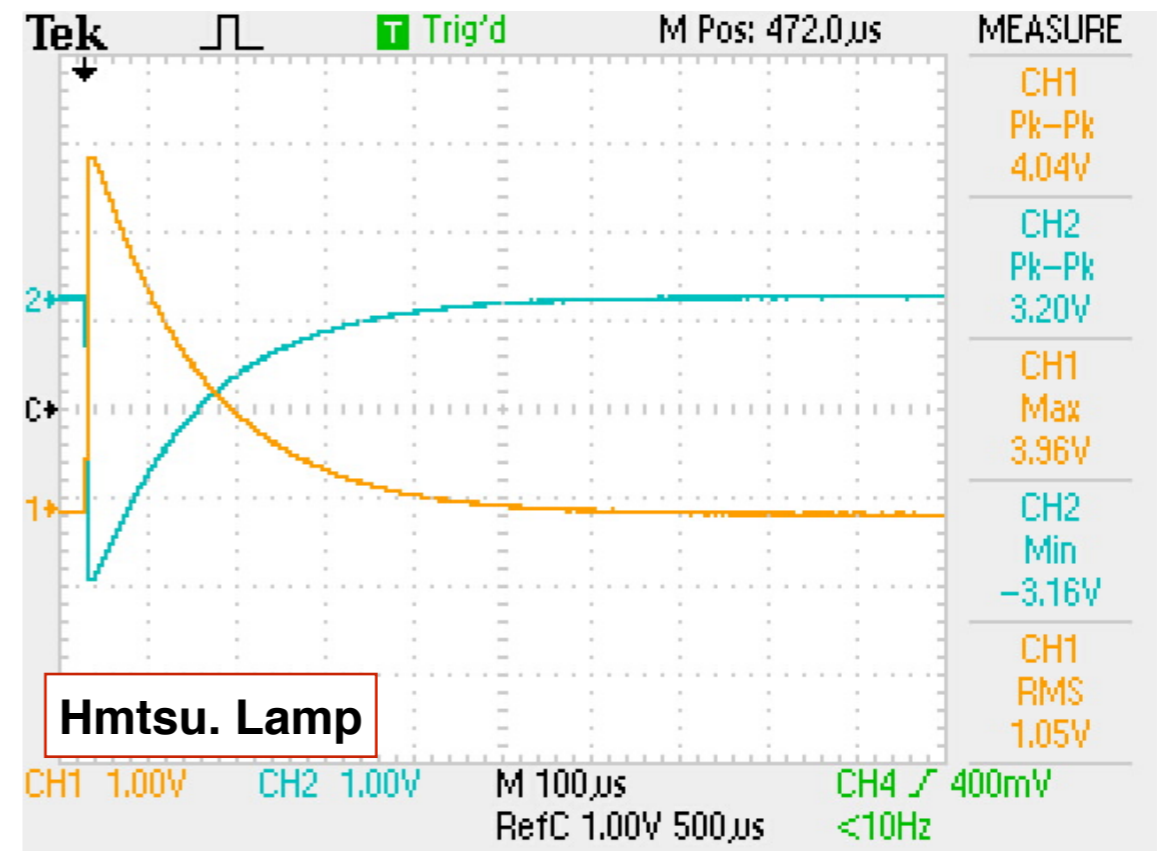
## ► Baseline measurement Our PrM

- Vac. with BNL box with different light sources
- Hmstsu. lamp adjusted to the same amplitude
- Our light source could be used in LAr measurement

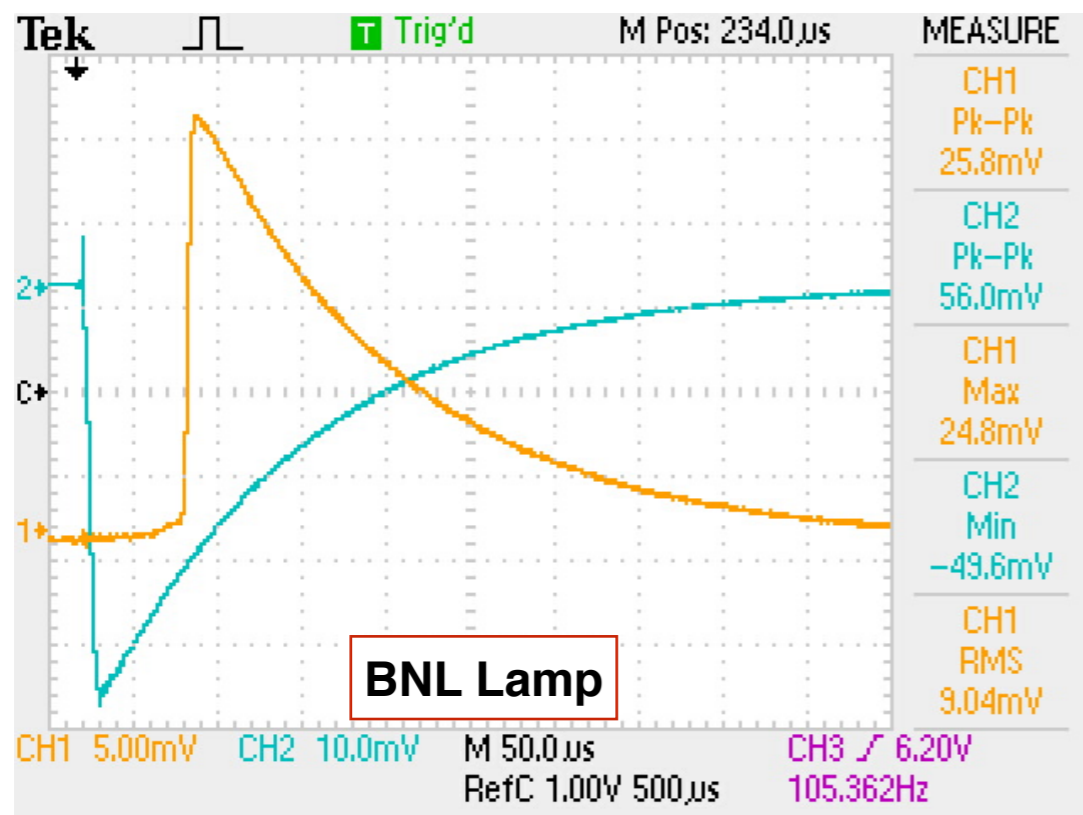
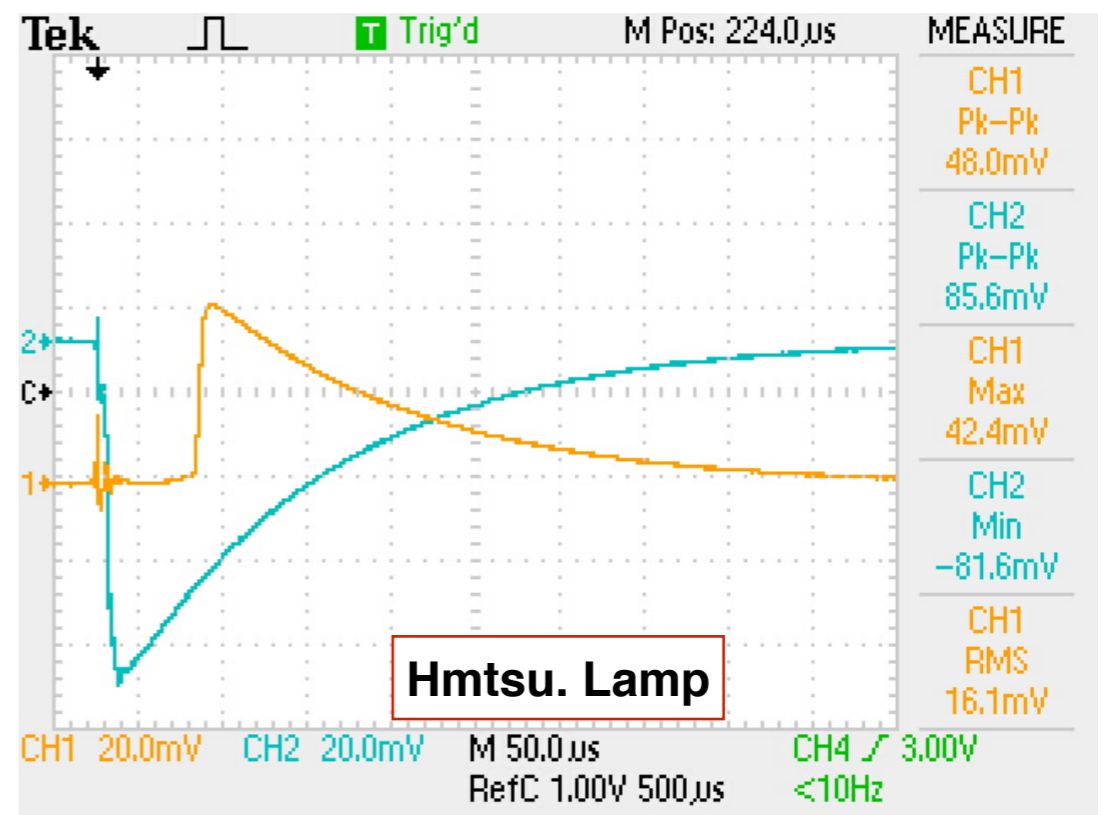
## ► Baseline measurement Our PrM

- GAr@1bar with BNL box with different light sources

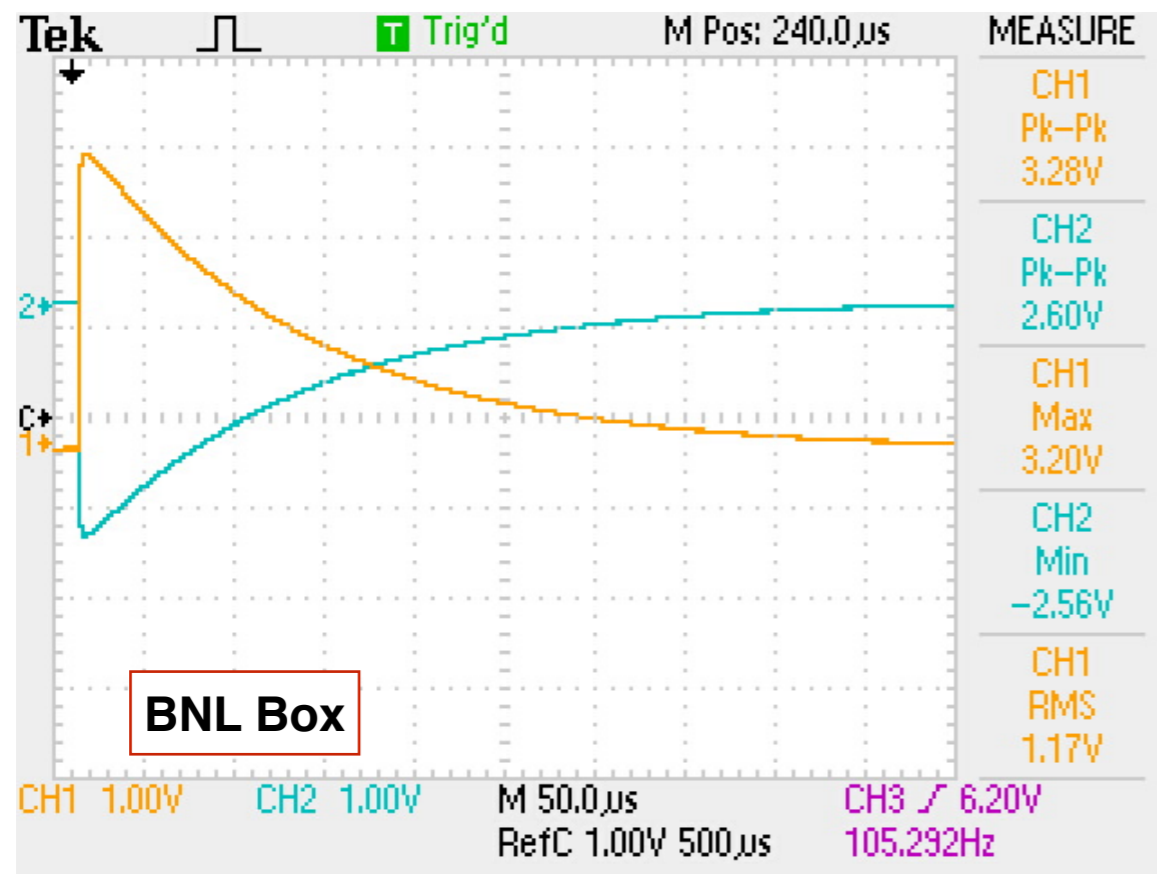
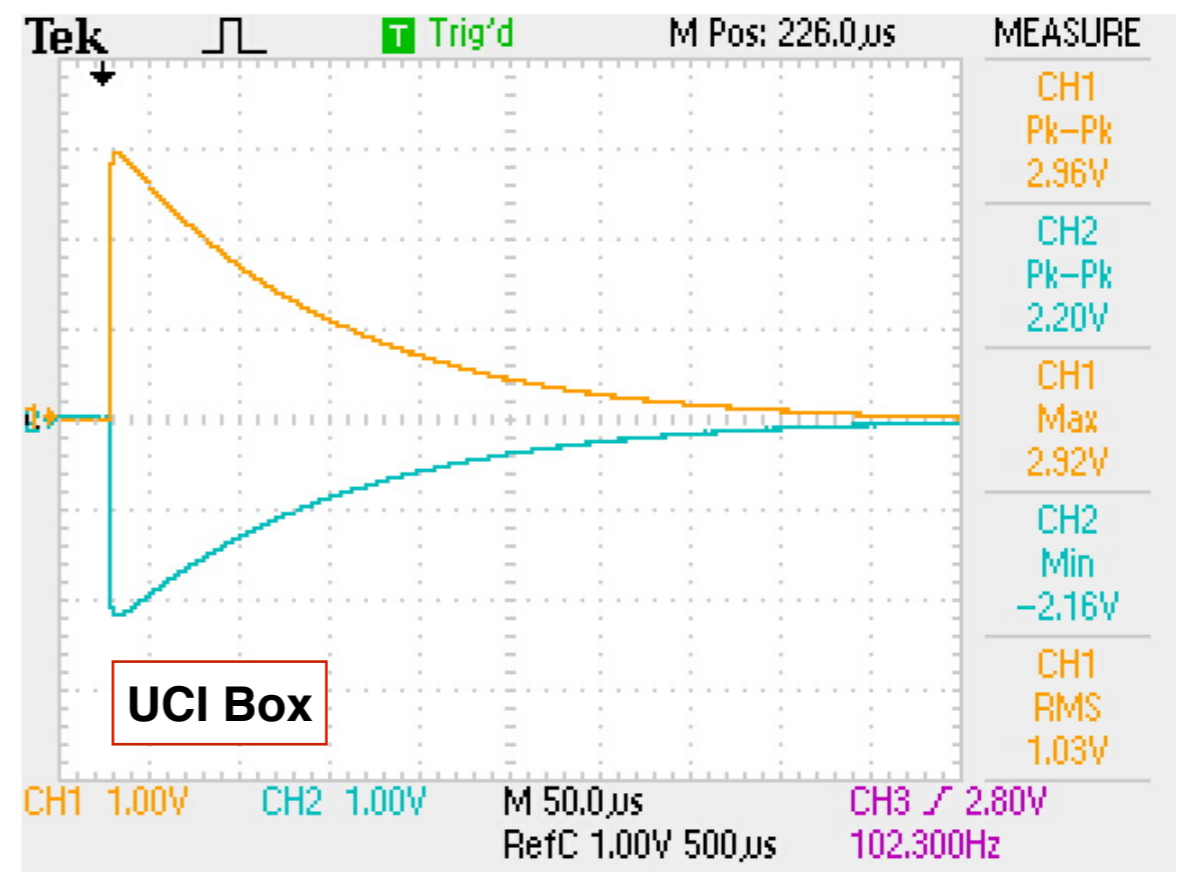
## ► Baseline measurement Our PrM

- BNL electronics box Vs. UCI electronics

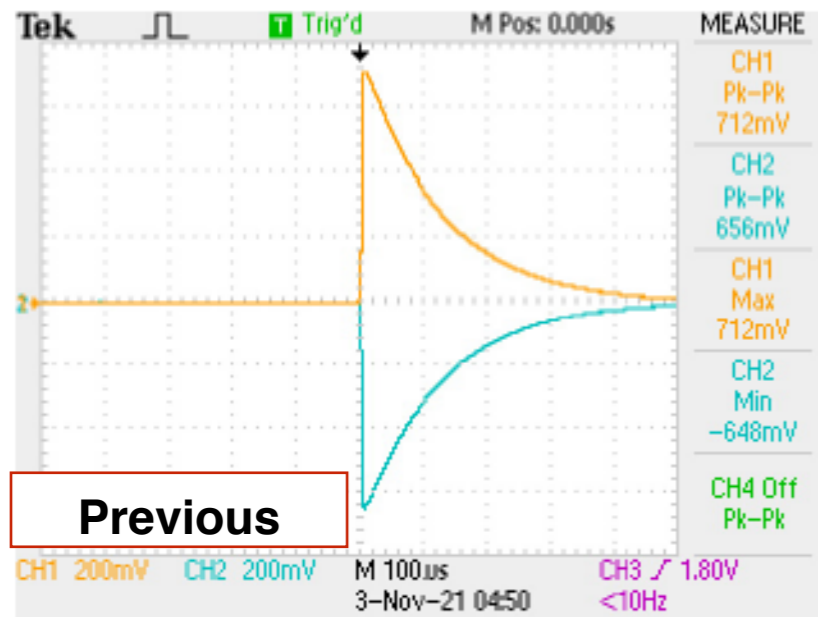
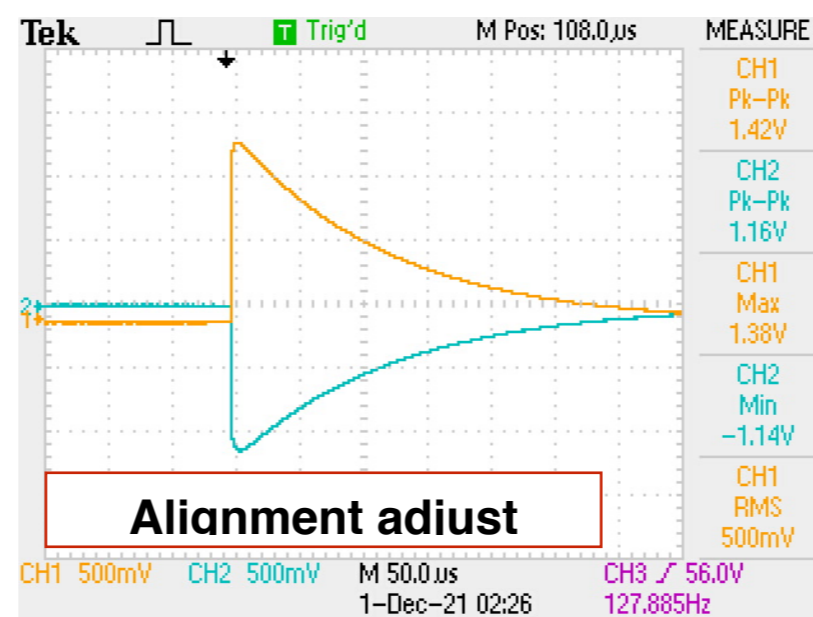
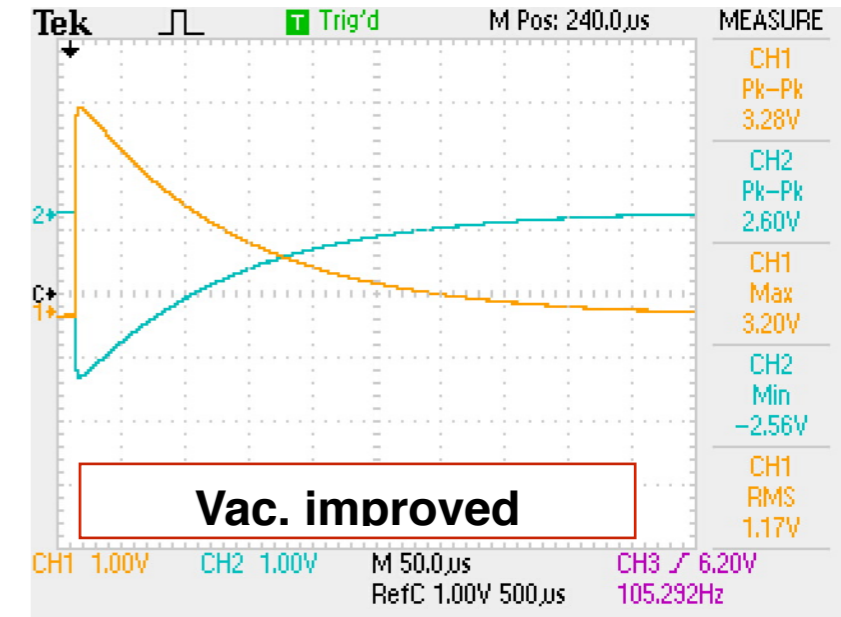
## ► Signal improvement with BNL lamp

- The signal starting at  $\sim 180\text{mV}$  in Vac with old cathode
- After replacement of the cathode With improvement on the alignment and Vac. quality, signal amplitude increased by 1 order of magnitude in vacuum
- Our light source could be used in LAr

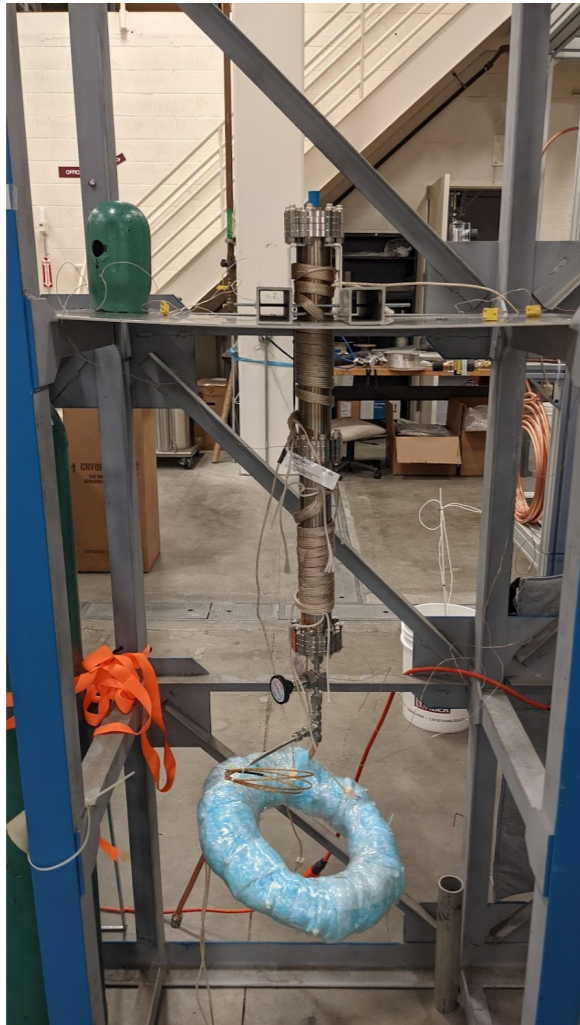
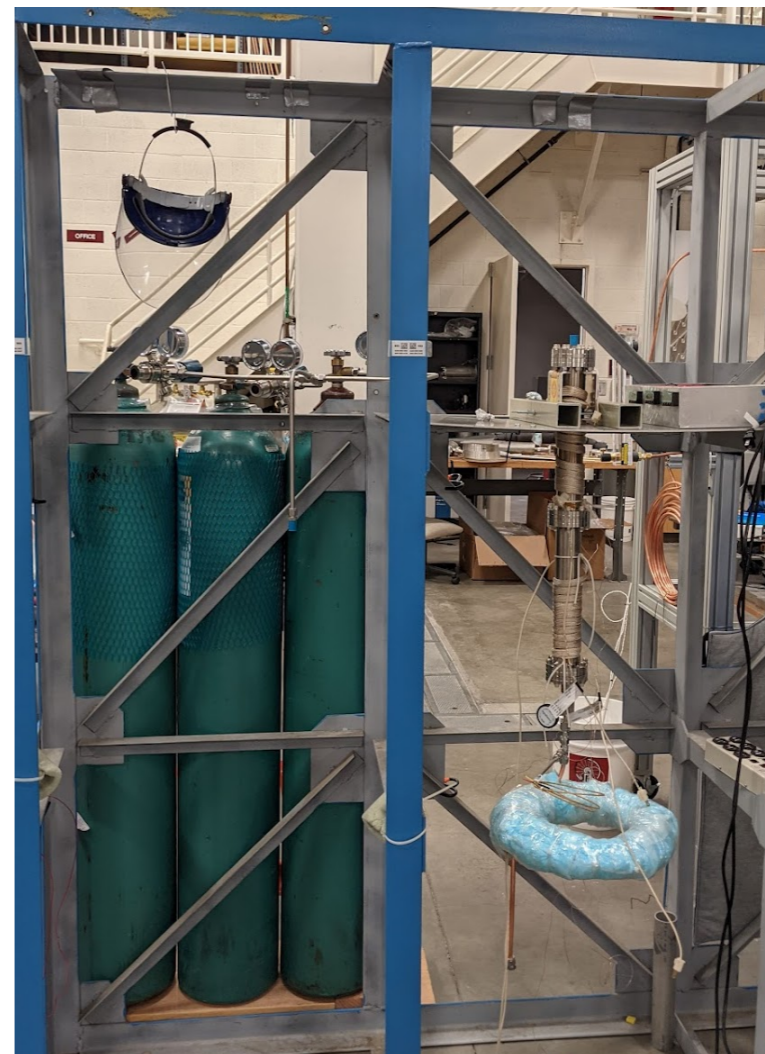
# UCI purification system

- ▶ **Construction of the controlling activation system**
  - It is for PrM test in LAr
  - The adapted the in design of our inline filter
  - I helped with installation and plumbing
  - Scrubber materials has not been filled yet
