NE5 Fiber Latch Solution

Itaru Nakagawa

RIKEN/RBRC

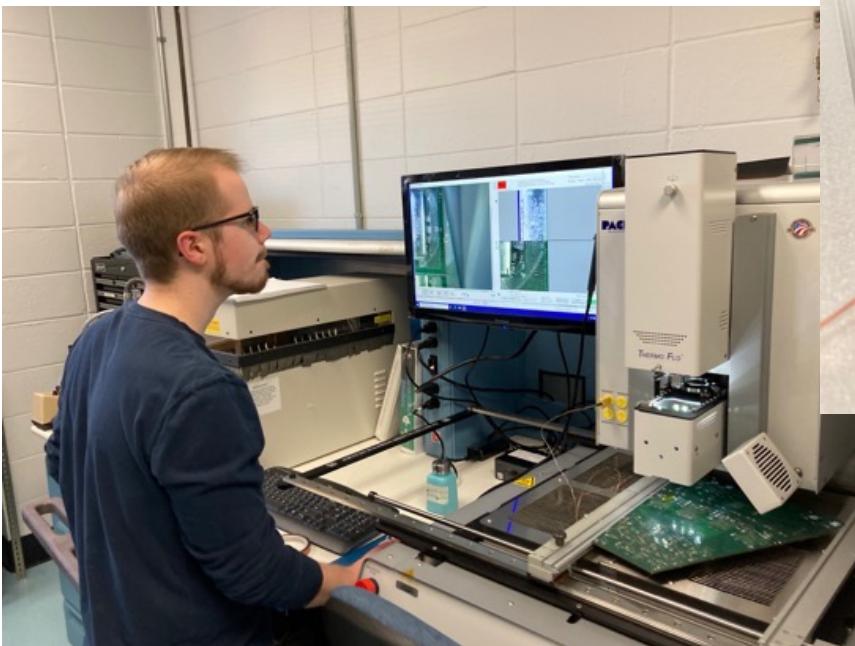
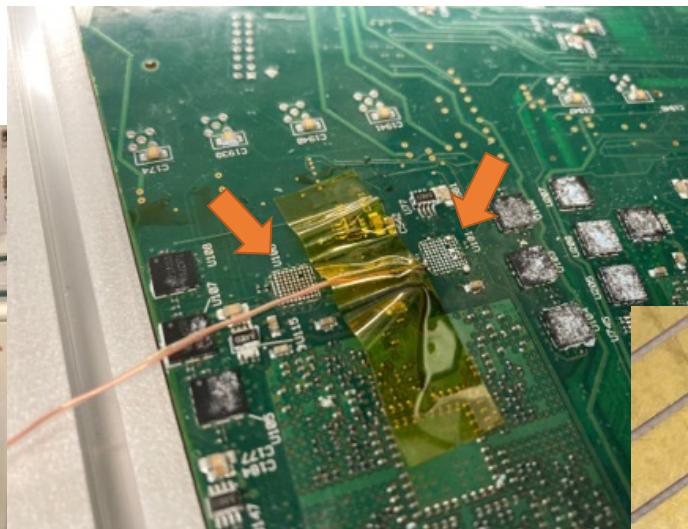
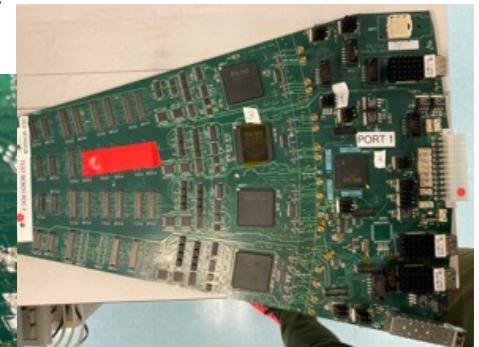
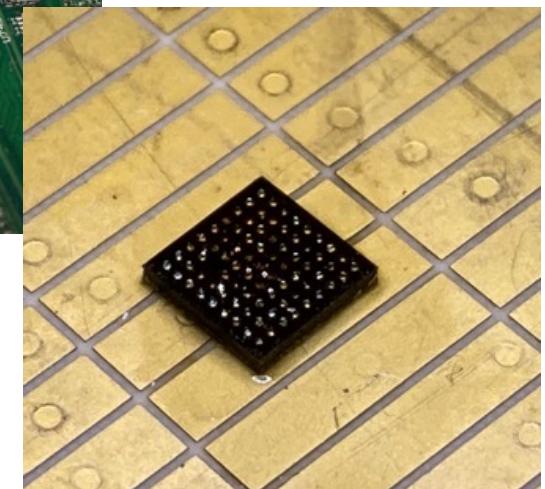
Removal of TLK2711 from “Old ROC”

TLK2711 removal from “the old ROC” the version BCO cable input is incompatible with production version

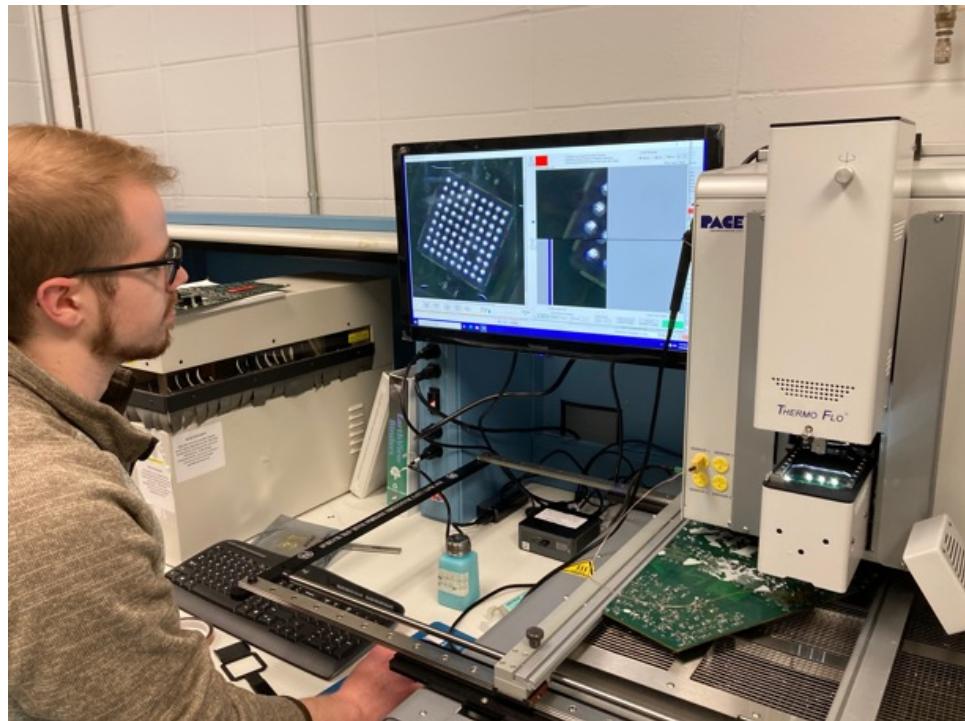
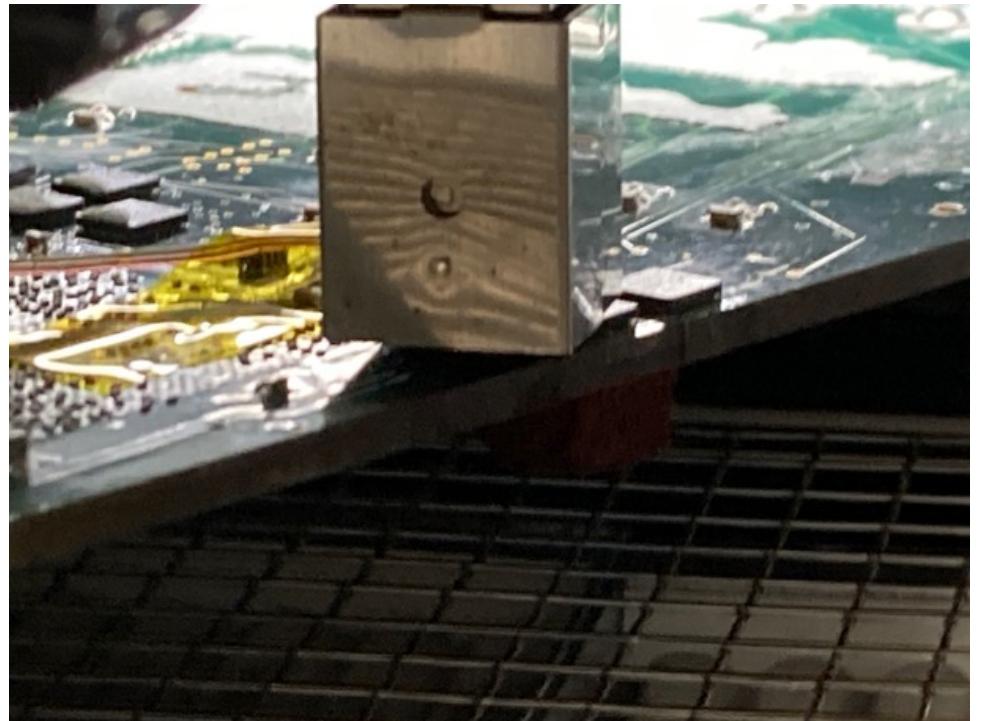
Implementation of TLK2711 on NE5

After removal of bad TLK2711s from NE5, implement TLK2711 took out from the “old ROC”.

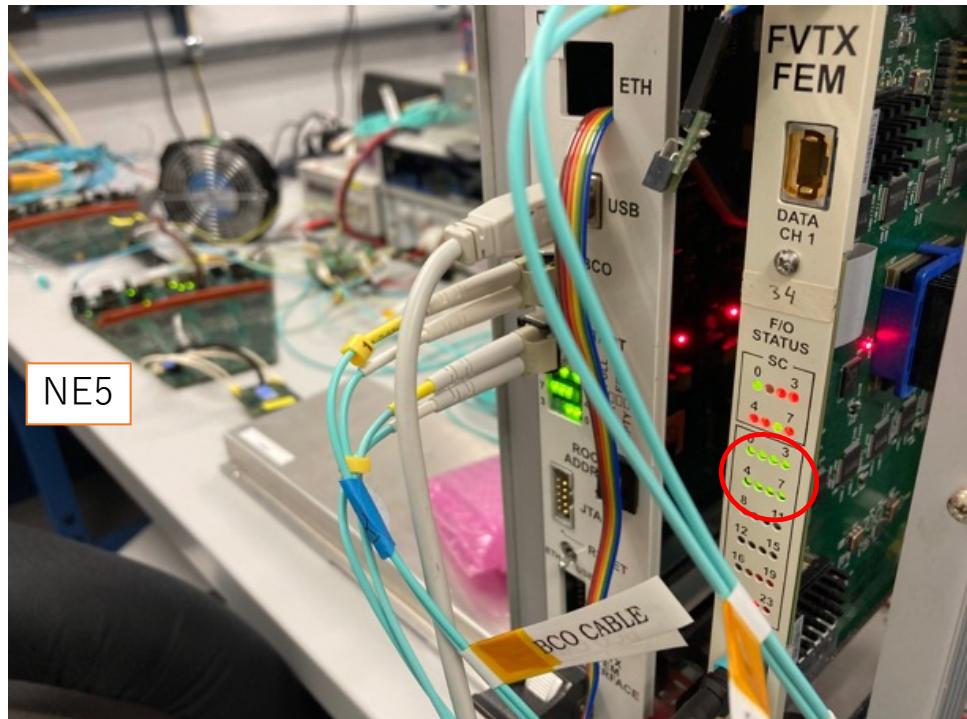
After TLK replacement

- The fiber latches firmly. Repeated at least 5 times and no latch failure.
- The calibration result looks healthy.
- NE5 has been promoted to be class-1

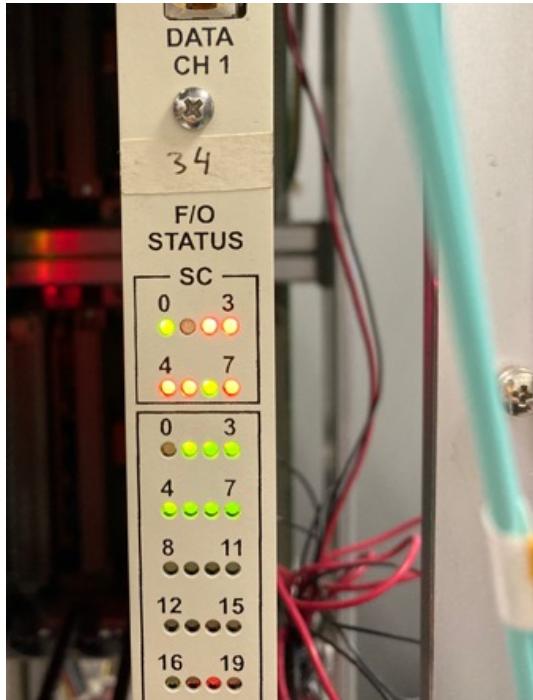
Column-A

- U107 & U108 (A3), U403 & U404 (D1)
- The result is that A3 and D1 data fiber now latches (confirmed 5 times in a row)
- A2 data fiber won't latch. Turned out it has been overlooked in the database.

The conclusion is that consistent with SE5 TLK2711 replacement result. The TLK2711 replacement is the cause of fiber latch issue.

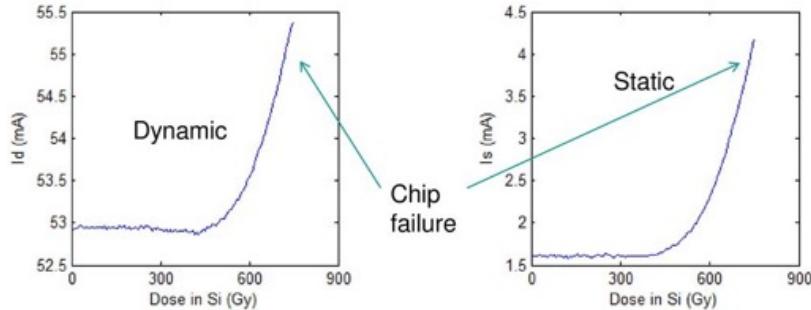
Sample no. 1: Analog Current Trend

- Moderate dynamic current increase from 53 mA to 55 mA
- Power down current increment from 1.6 to 4.2 mA, more than 300%

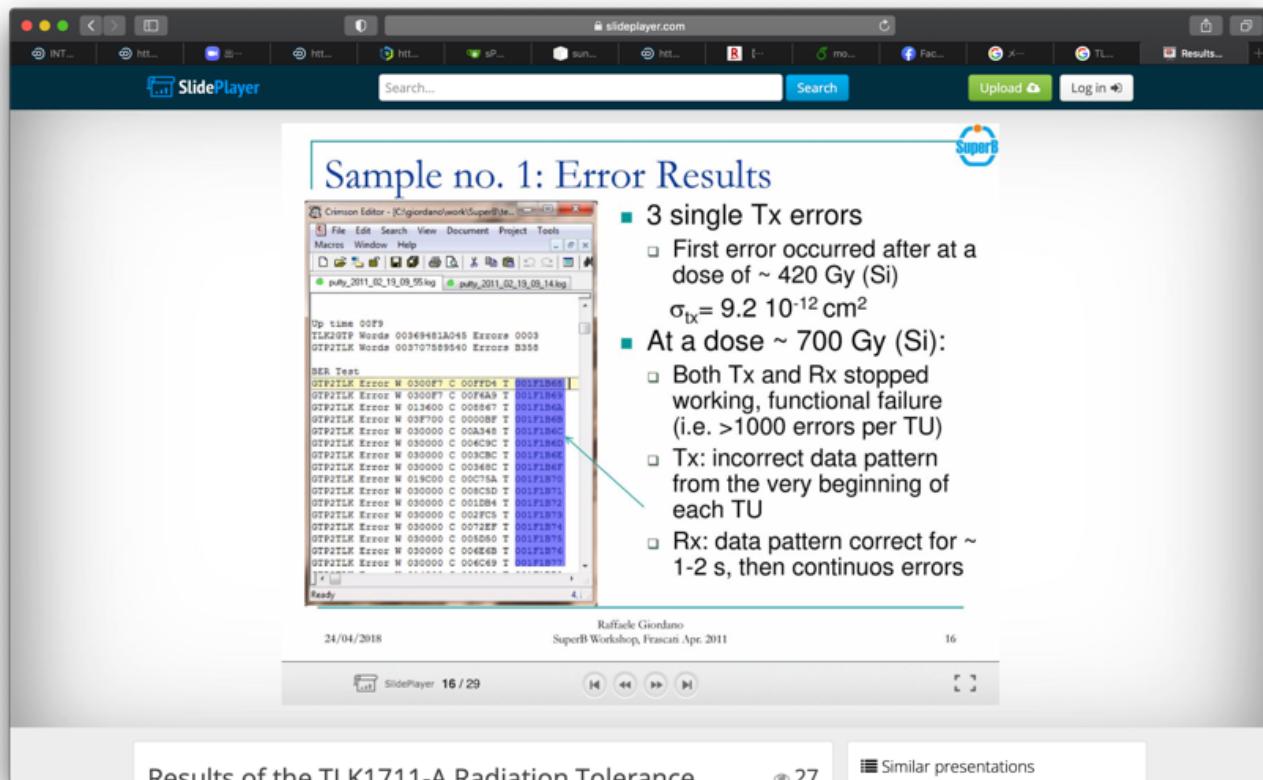
Sample no. 1: Error Results

- 3 single Tx errors
 - First error occurred after a dose of ~ 420 Gy (Si)
 $\sigma_{tx} = 9.2 \cdot 10^{-12} \text{ cm}^2$
- At a dose ~ 700 Gy (Si):
 - Both Tx and Rx stopped working, functional failure (i.e. >1000 errors per TU)
 - Tx: incorrect data pattern from the very beginning of each TU
 - Rx: data pattern correct for $\sim 1-2$ s, then continuous errors

TLK starts to output "wrong pattern" after certain exposure to radiation. This explains wrong comma word detection but no jitter or deformation of eye diagram.

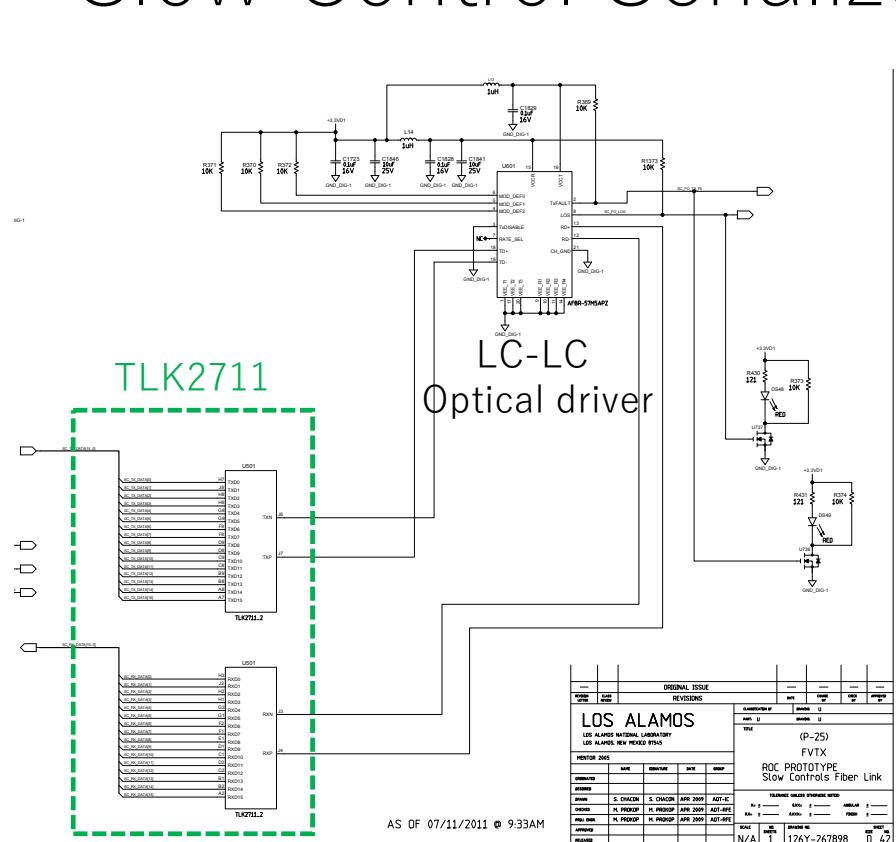
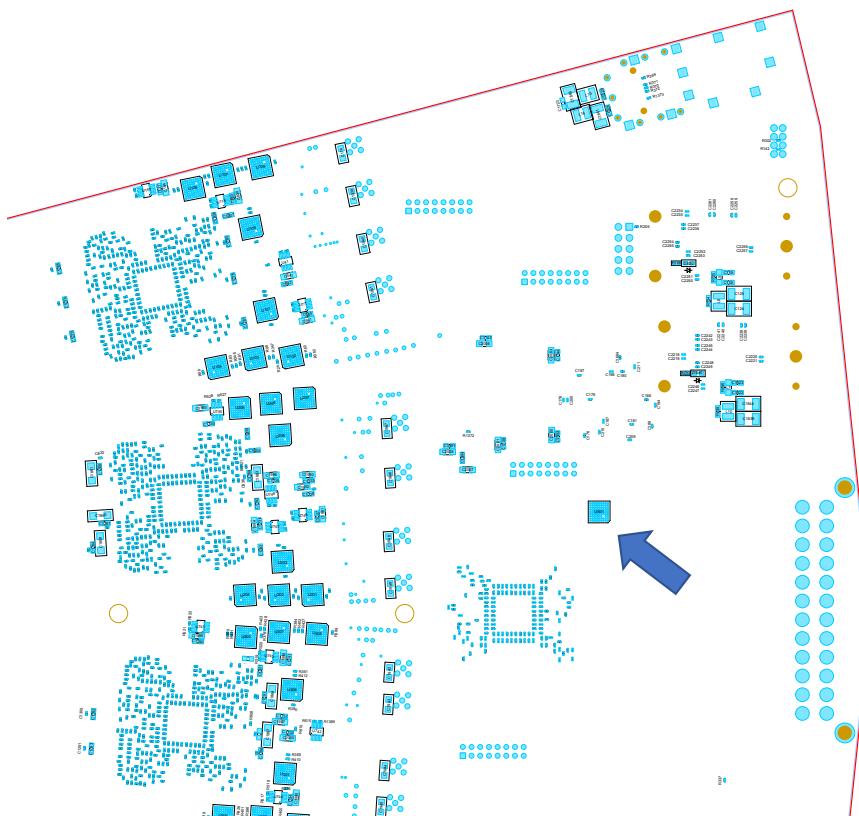
Slow Control Serializer

1 TLK2711 per slow control of a given ROC board.

- 30 new TLK chips are to be shipped to BNL in December.
- Slow Control TLKs of Class-1 ROCs are to be replaced by new ones in BNL instrumentation division.
- According to Joe, the estimated replacement time is one hour per 1 TLK chip and the risk is low.

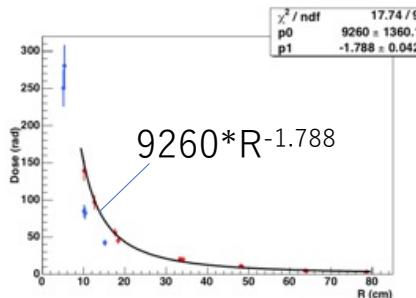
Fig. 15. Red points: TLD radiation measurements versus their distance R from the beam line and fit to the function $p_0 * R^{p_1}$. Blue points: TLDs placed on the nose cone, scaled to the same **luminosity** as the red points, versus their distance R from the beam line

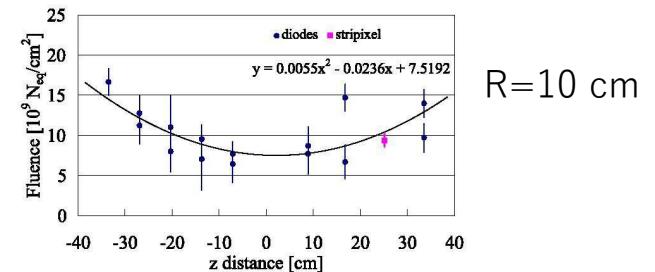
Fig. 17. Fluence of irradiated stripixel sensor and diodes at $R=10 \text{ cm}$ in PHENIX IR.

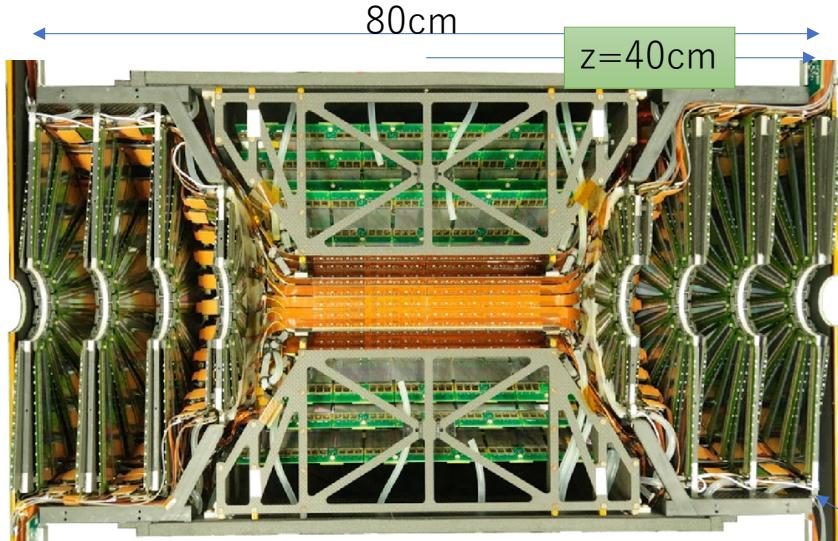
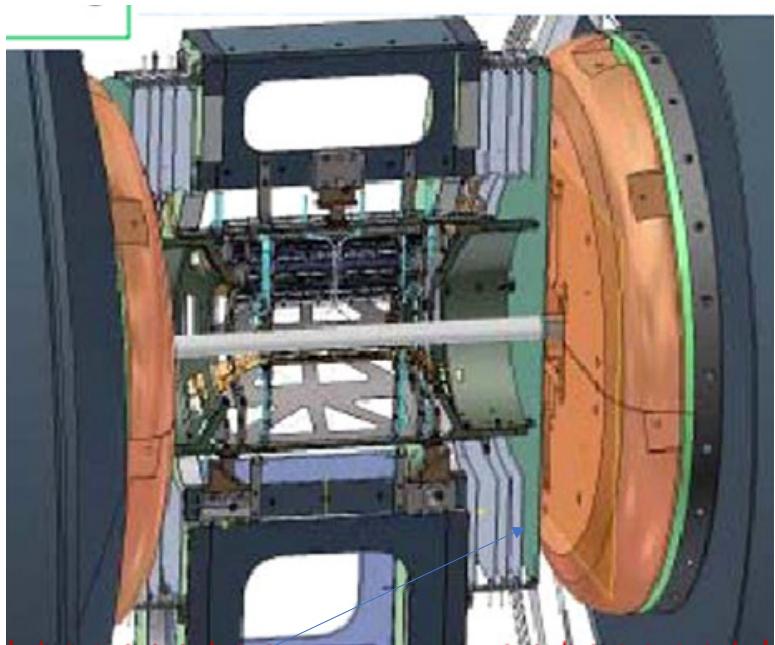
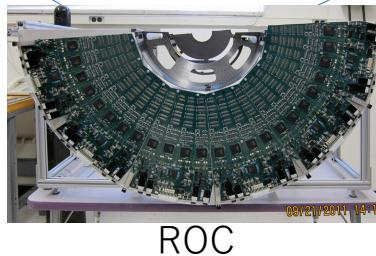
FVTX ROC Layout

Fig. 20. A completed half-detector, with the VTX barrels in the center, and the two FVTX endcaps on either end. The overall length is 80 cm.

$R = 40\text{cm}$
 $z = 40\text{cm}$
 $\eta = 0.88$

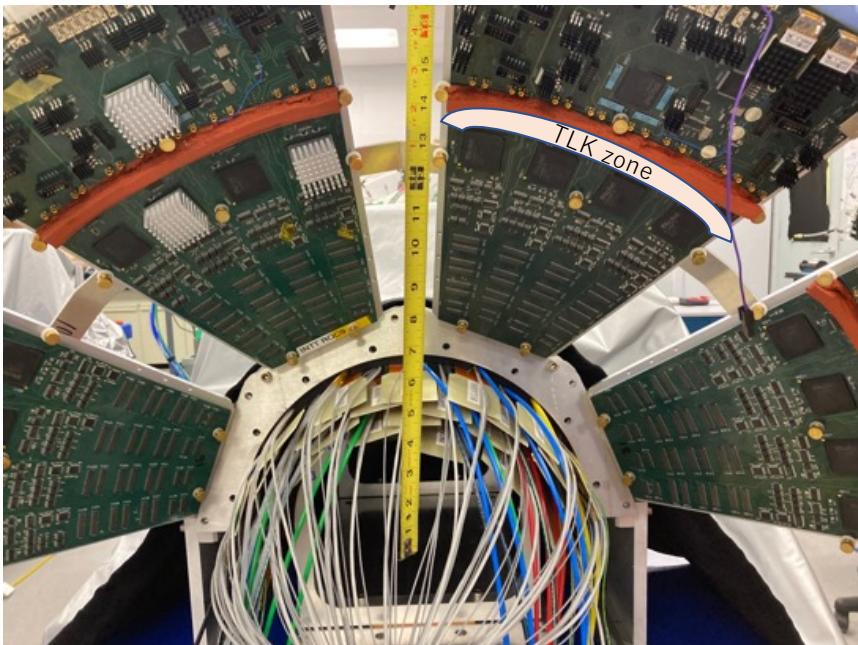
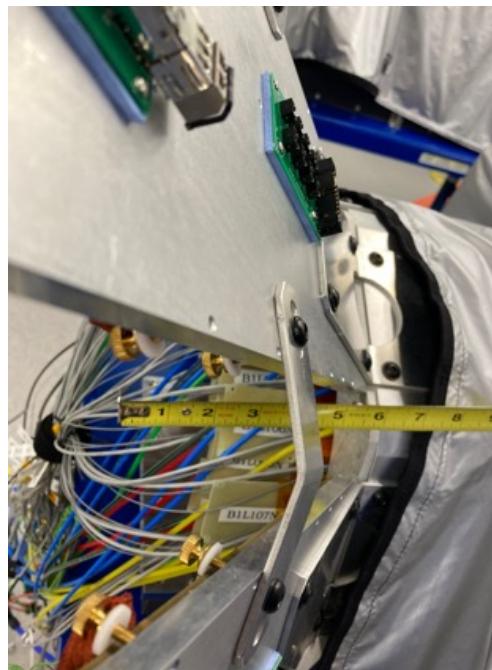
Location of TLK chips for INTT

$$\begin{aligned} z &= 40\text{cm(HDI)} + 110\text{cm(BEX)} + 7.6\text{cm (ROC)} \\ &= 157.6\text{cm} \\ \eta &= 4.5 \end{aligned}$$
