Cylindrical µRWELL Detector Prototype Development

ePIC MPGD-DSC Workfest
Florida Institute of Technology
Pietro Iapozzuto , Marcus Hohlmann
July 25 2024

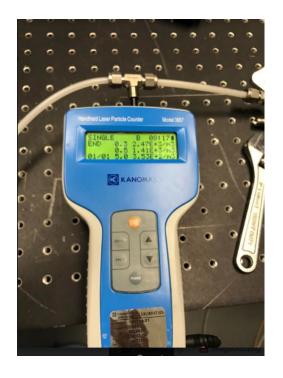
Gas line schematic and particle counts

Nitrogen Gas Tank
Regulator

Sum Dust
filter

Flow Meter
filter

Acrylic Box

- Tested Nitrogen Line at various points with particle counter
- Added two dust filters to see if results improved
- Will Repeat Measurements with Co2

Kanomax location	Dust Counts/m^3 (.3um, .5um, 5um)
After regulator	(1.96E, 6.06E4, 3.7E3)
After flow meter	(1.51E3, 7.06E2, 1.59E3)
Before acrylic box	(2.47E3, 1.71E3, 3.53E2)
After acrylic box	(2.48E3, 1.41E3, 1.77E2)
T
