# Status of 1004B Valve Box / Ring Repair

3 Oct 2023

# 1004B "Valve Box" Failure Timeline

# Repair Status, Helium Breach in 1004B valve box

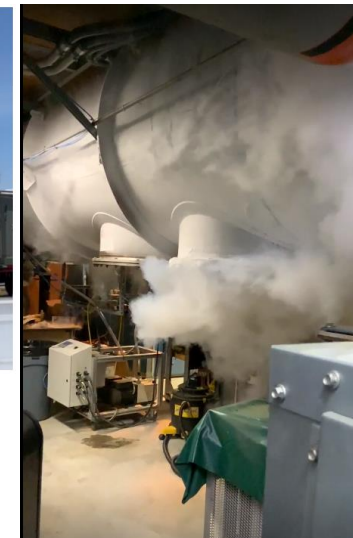
1004B Valve Box

Helium leak

- Repairs are underway
  - the replacement upper flange has been ordered through BNL Central Shops,
  - the interconnect tube is on hand,
  - a bottom adapter ring drawing to be fabricated in Central shops is in process, and
  - quotes have been received for the replacement bellows.
- All parts for this repair are expected before the end of October.

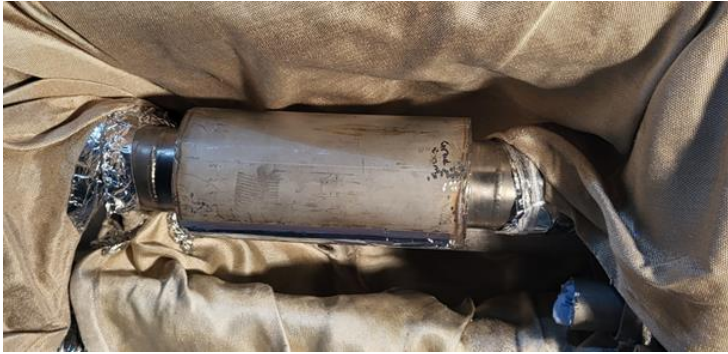
Splice can (#1) before opening

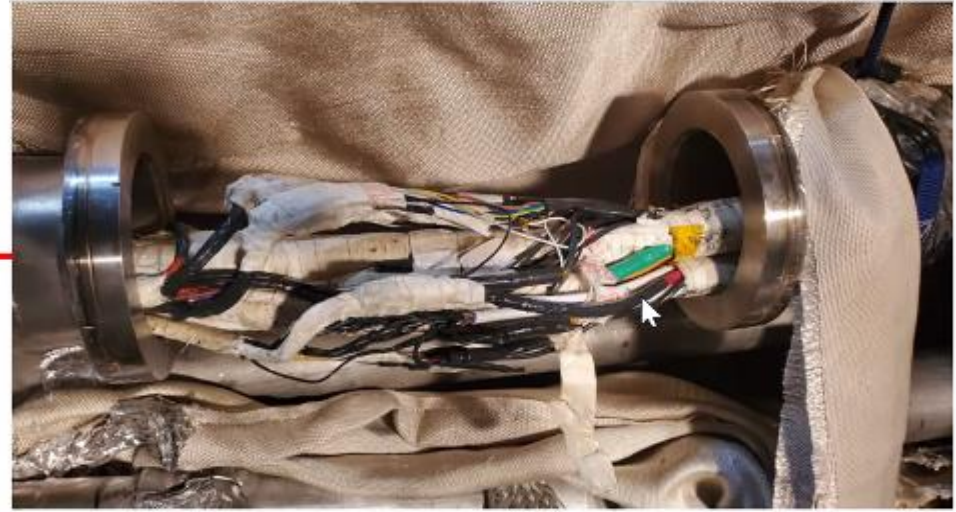
Splice can #1 after opening (no trouble found)

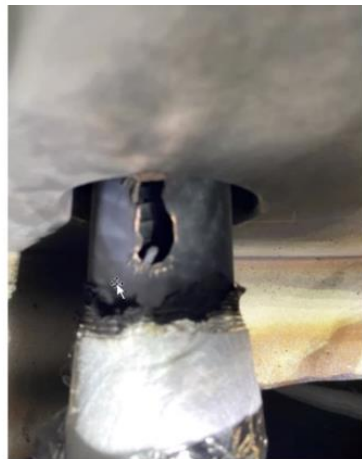
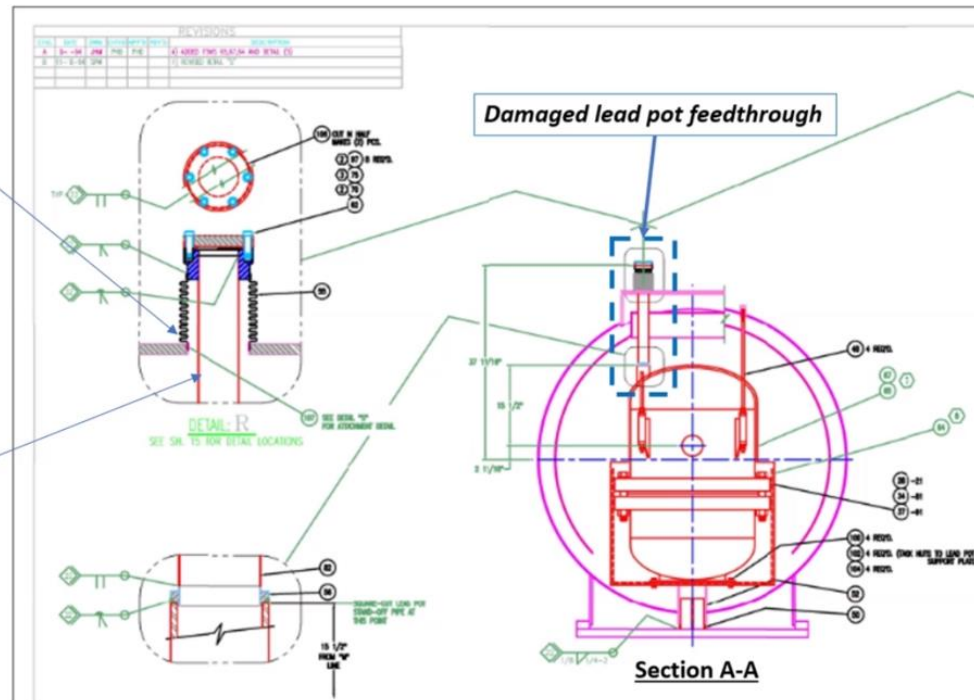
Bellows rupture

Feedthrough tube rupture

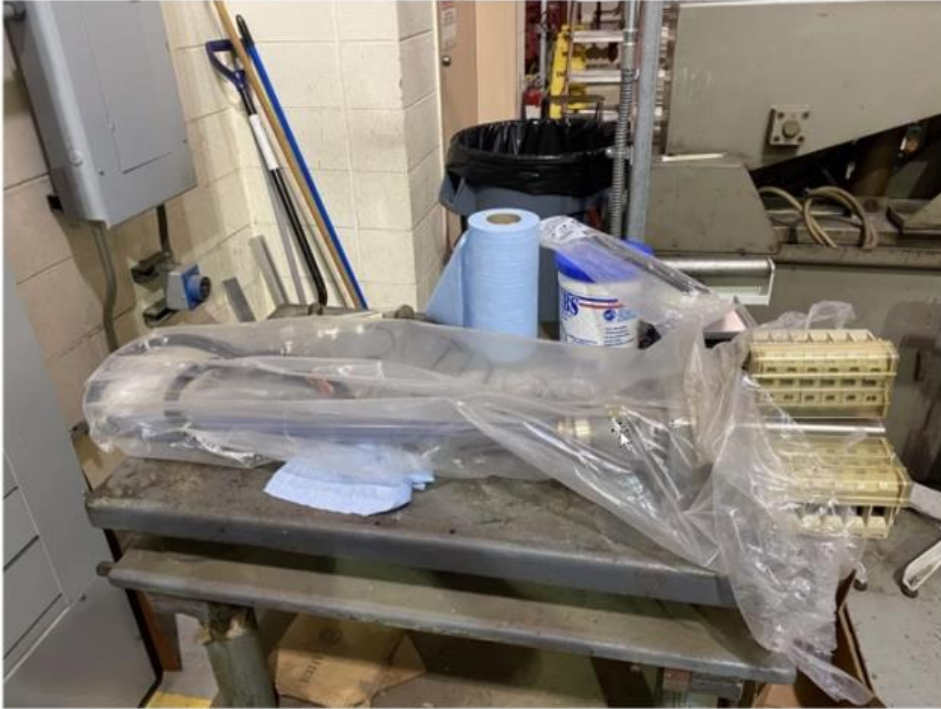
- Spare lead assembly under test
  - passed vacuum leak checks
  - electrical and pressure tests underway

Spare 150 A current lead

- ✓ In parallel, continuity checks of the superconducting cable distribution system between the 1004B valve box and magnets in the RHIC tunnel are also underway. Completed (10/23/23) and tested good.
- ✓ The spare lead assembly for the damaged 12-conductor cold-to-warm and gas-cooled current lead in the lead pot inside the 1004B valve box was successfully high-pressure tested and high-potted and is ready for installation.

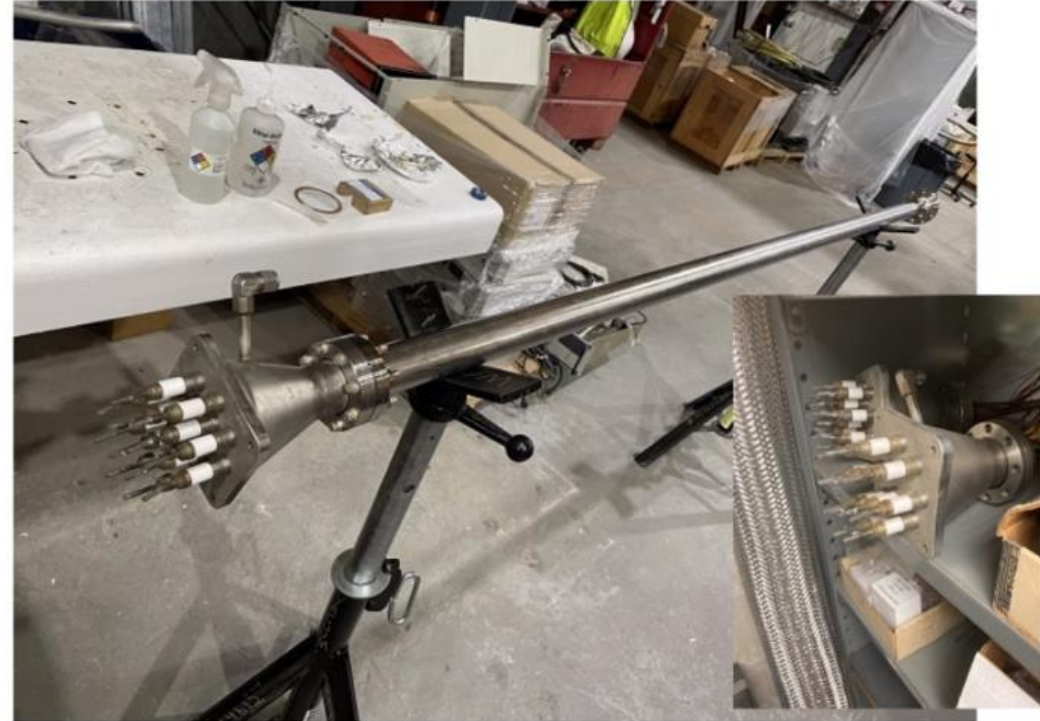
Vacuum test setup (using another, partially-built current lead)

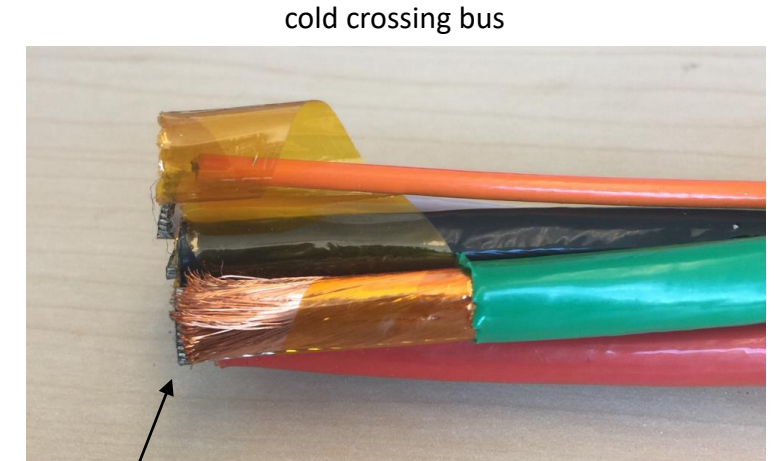
- the cold crossing bus to the 4 o’clock DX magnet.
  - Further measurements indicate there is a ground somewhere between the 4DX and 4D0 Magnet.
- The splice box at the D0 magnet has been opened and the return bus has been isolated. Measurements suggested a ground either in a short section of cold crossing bus or the DX magnet, or in the cold crossing bus between the DX magnet and the valve box.

cold crossing bus

flat superconducting  
cable (hard to see)

Added 10/3/23: Once the damaged splice joints were opened, repeat measurement showed > MOhm resistance which makes sense, retrospectively: per Jon Sandberg, Chief Electrical Engineer, the unexplained low (40 Ohm) resistance measured earlier was an artifact of the cables being shorted together in the splice can together with the residual soot.

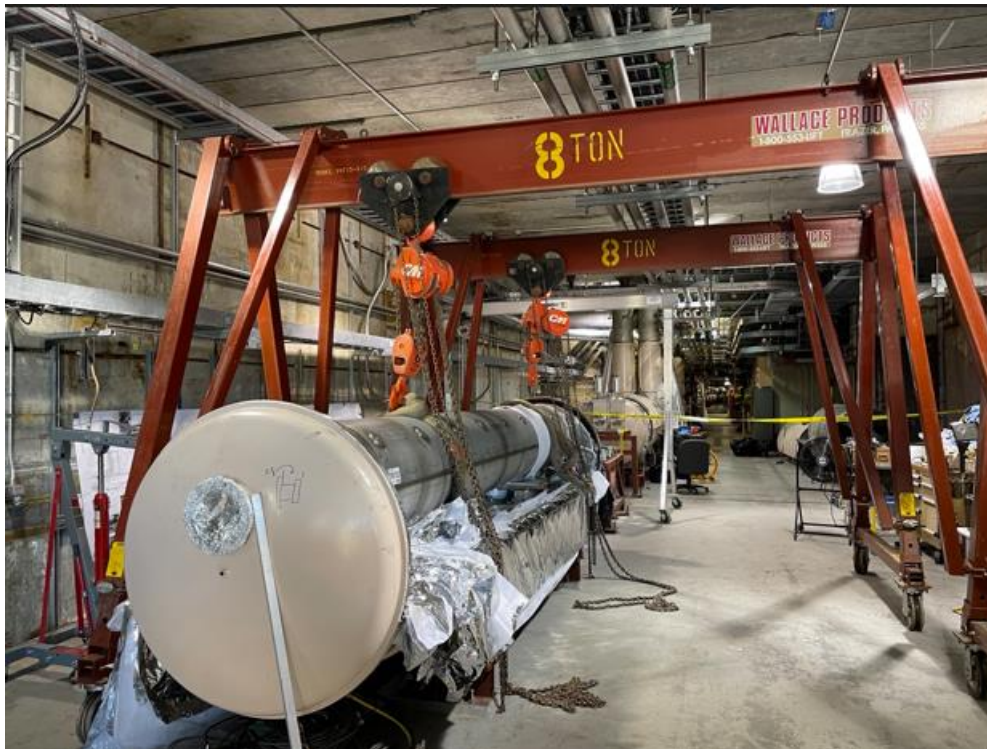
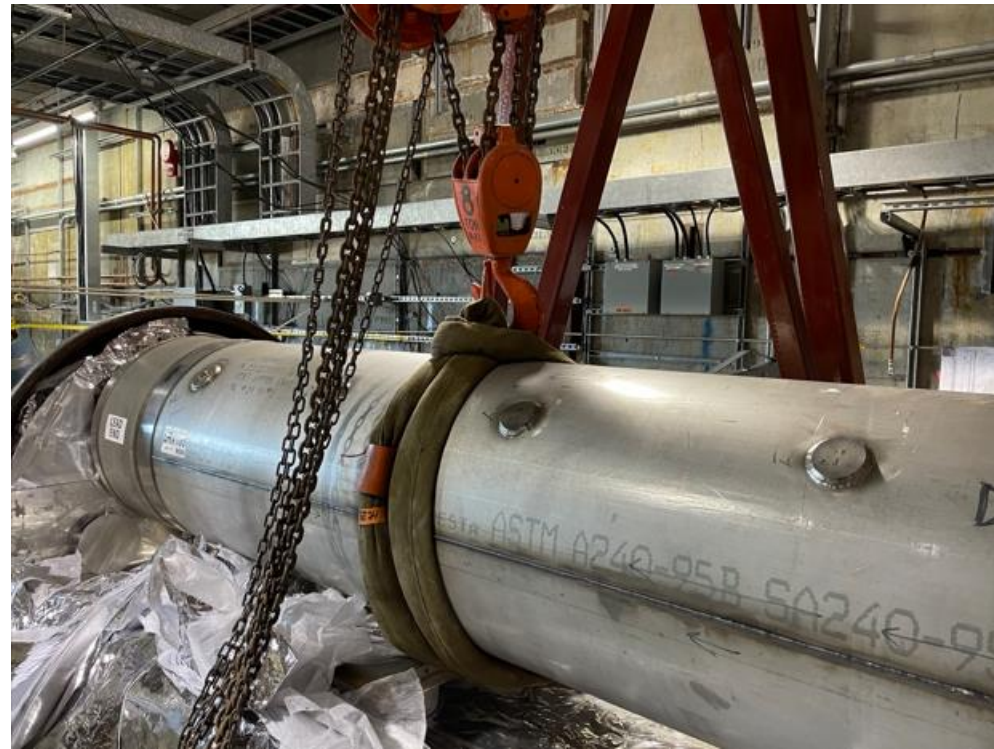
DX magnet in tunnel prior to removal (IR 4 region)

- Update on RHIC/1004B valve box: The DX magnet was removed from the cryostat and, last Friday, transported to a repair area set up in Bldg. 912 where also the spare DX magnet and a DX magnet prototype were brought from storage. Inspection of the DX magnet is foreseen this week following removal of the DX magnet's very large end-volume cylinders. Both spares were tested during RHIC construction however end connections and splices to the Cold Crossing Bus (which contains the superconducting cables) leads will need to be made. A couple of staff from the Magnet Division, who worked on the DX magnets 25 years ago, will also support preparation of the DX magnet for operation. Electrical testing performed last week of the rest of the superconducting cable distribution system indicated no other damage beyond this DX magnet. A schedule for completion is contingent on inspection of the DX magnet.

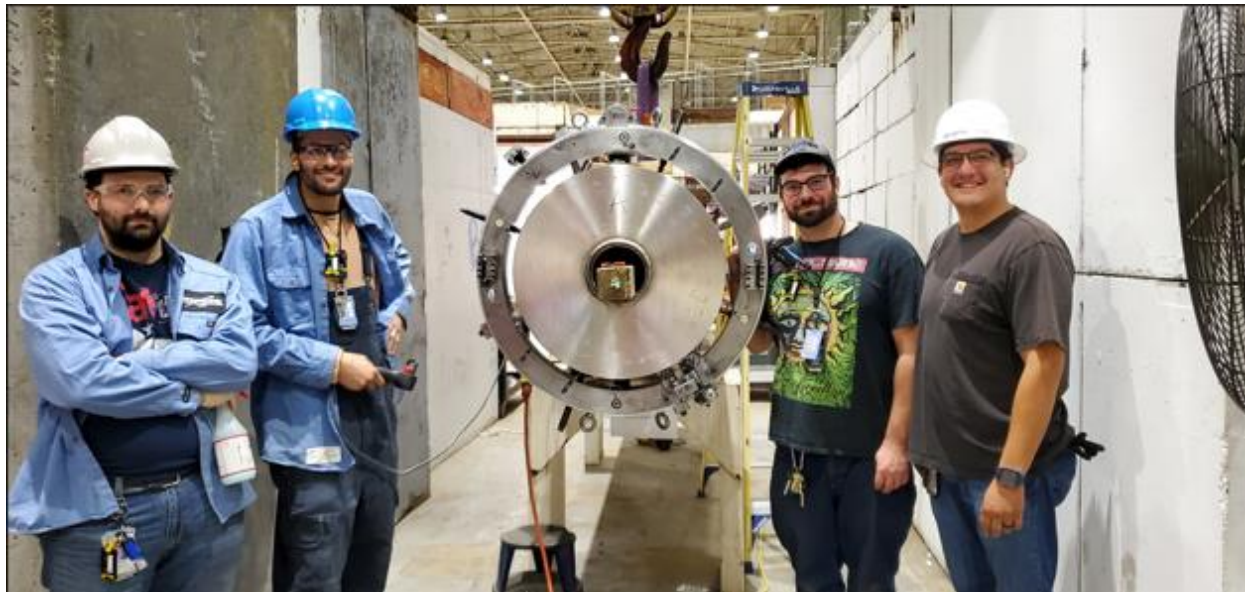
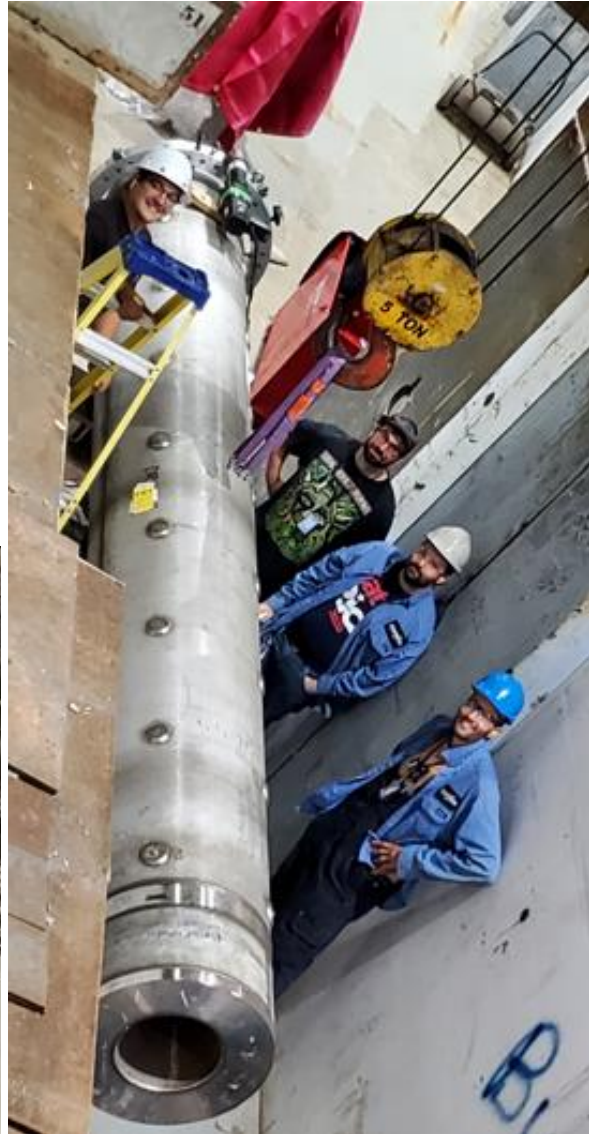
- Update on RHIC/1004B valve box: The DX magnet was opened on one end and revealed upon visual inspection no damage. In the upcoming weeks efforts will concentrate on developing the spare DX magnet into an operational spare for installation.

DX magnet in building 912

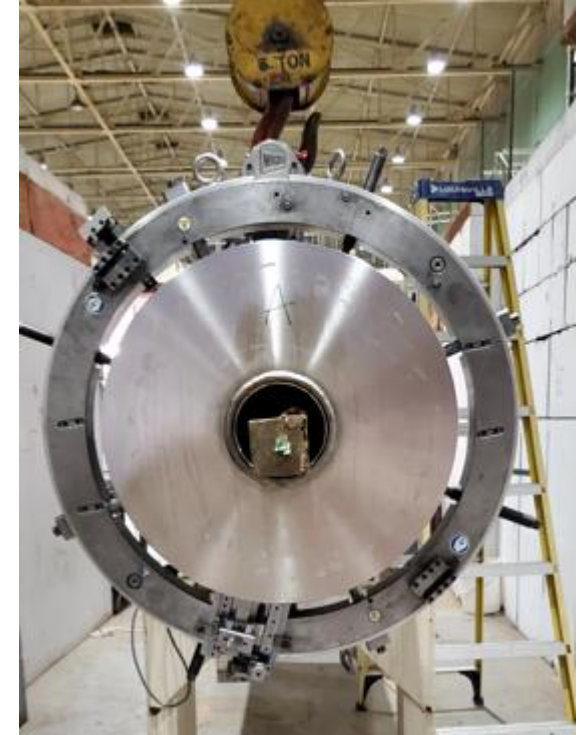
Pipe cutter (WACHS) used to grind off DX magnet end caps

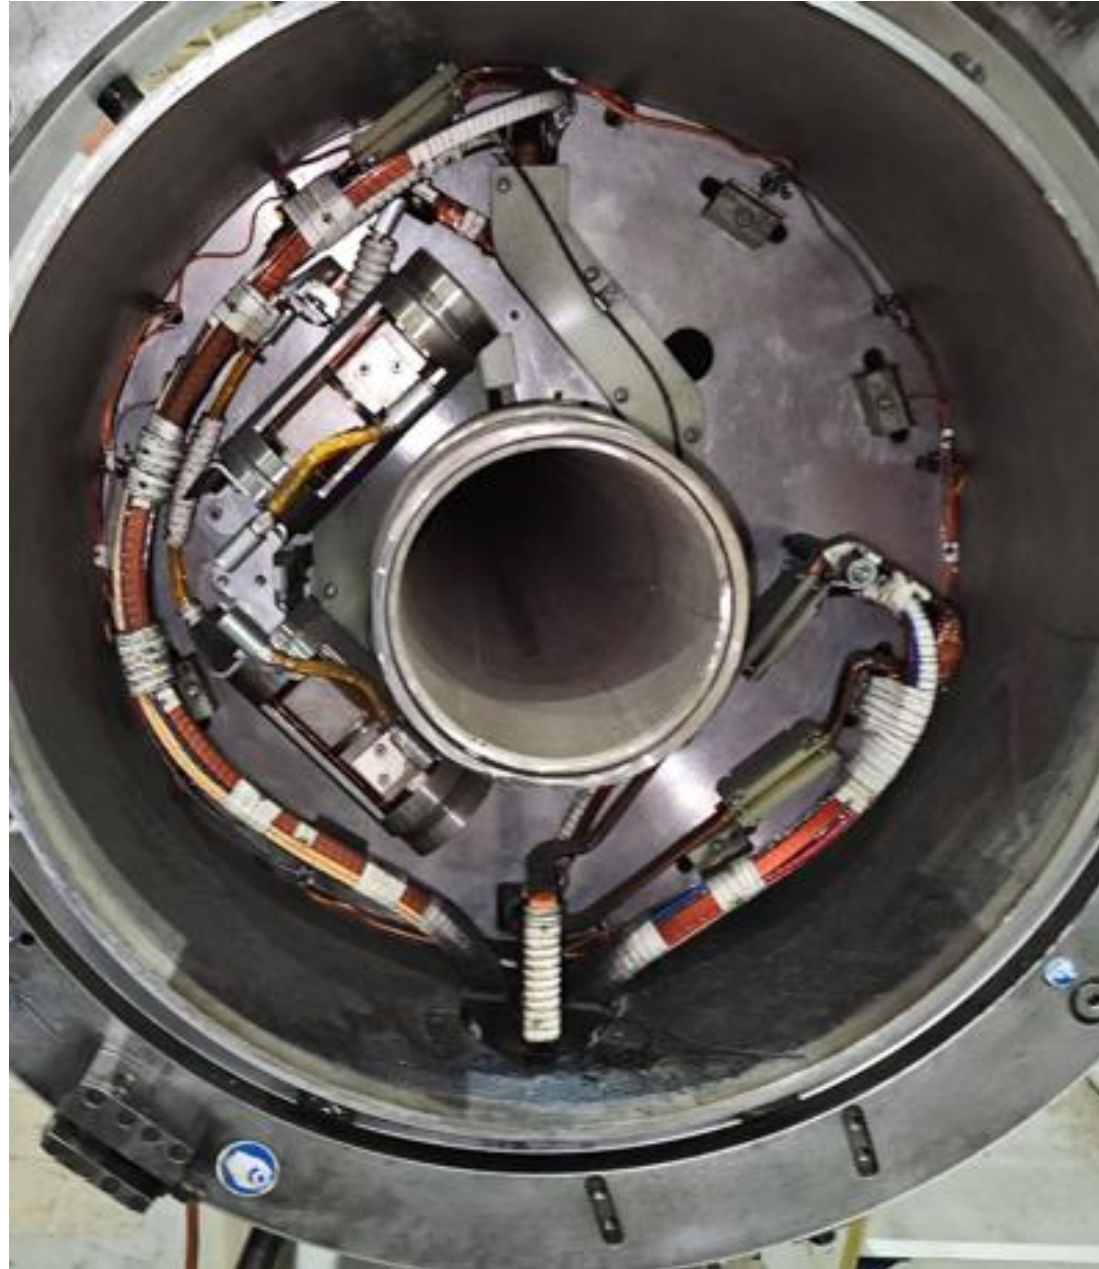
DX magnet after removal of end cap

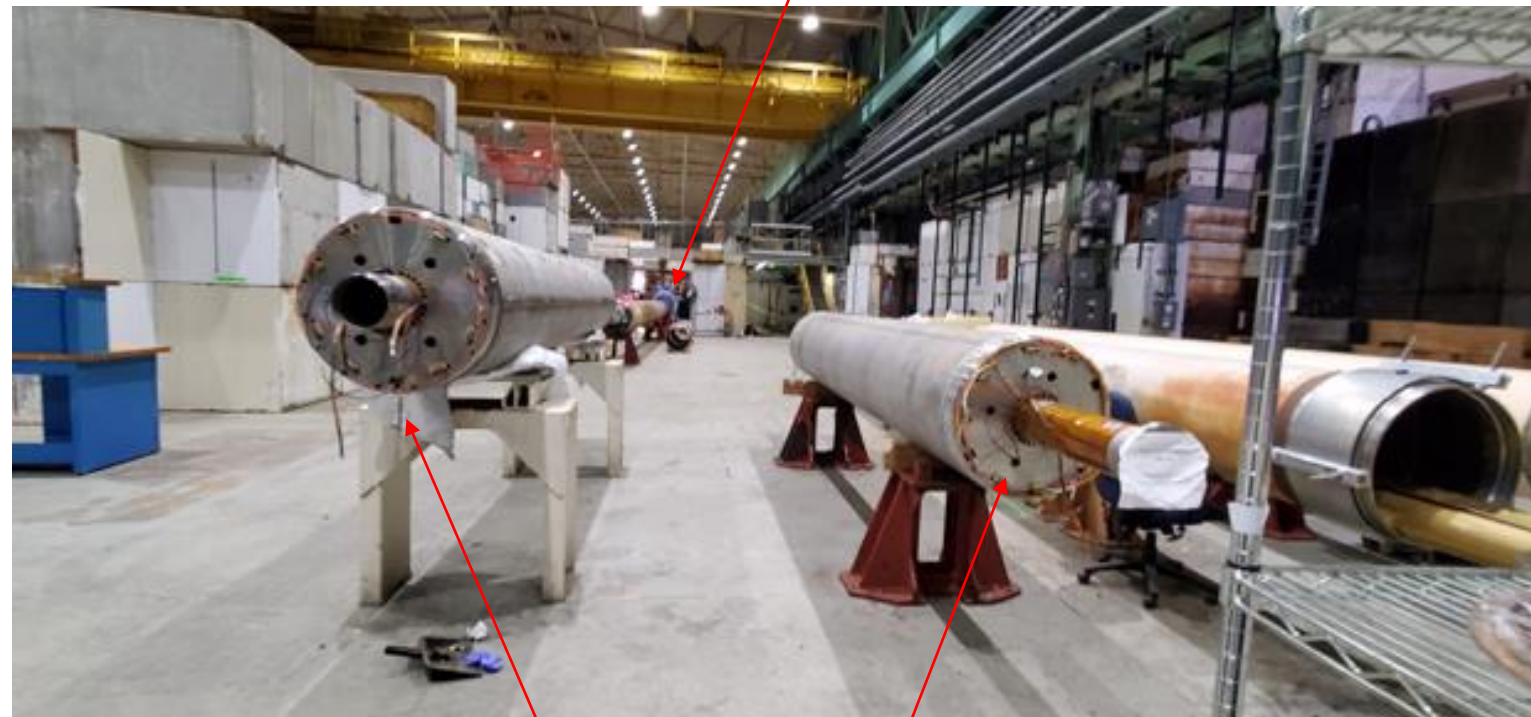
DX magnet from ring tunnel

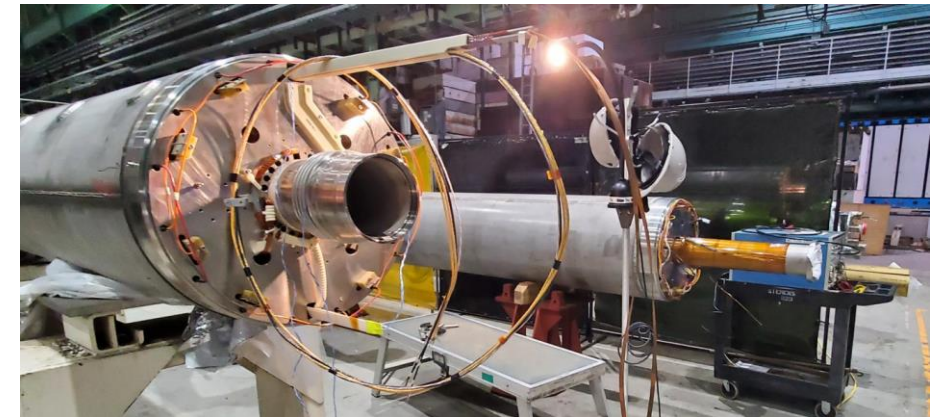
DX magnet spare and DX magnet prototype

- Update on RHIC/1004B valve box: Work is well underway to prepare the spare DX magnet for installation into RHIC. Resistance measurements were taken showing consistency between the relocated DX magnet and its spare. Welding, leak checks, and other mechanical preparation work on the spare DX magnet are underway and should be completed by the middle of this week. Wiring and installation work, supported by the Magnet Division, will then commence.

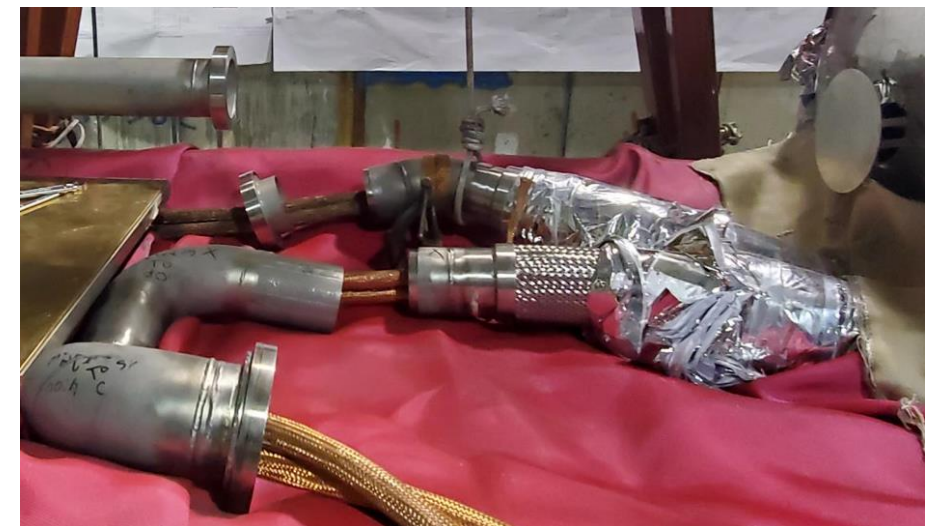
Select DX-magnet Cold Crossing Bus cables replaced in tunnel

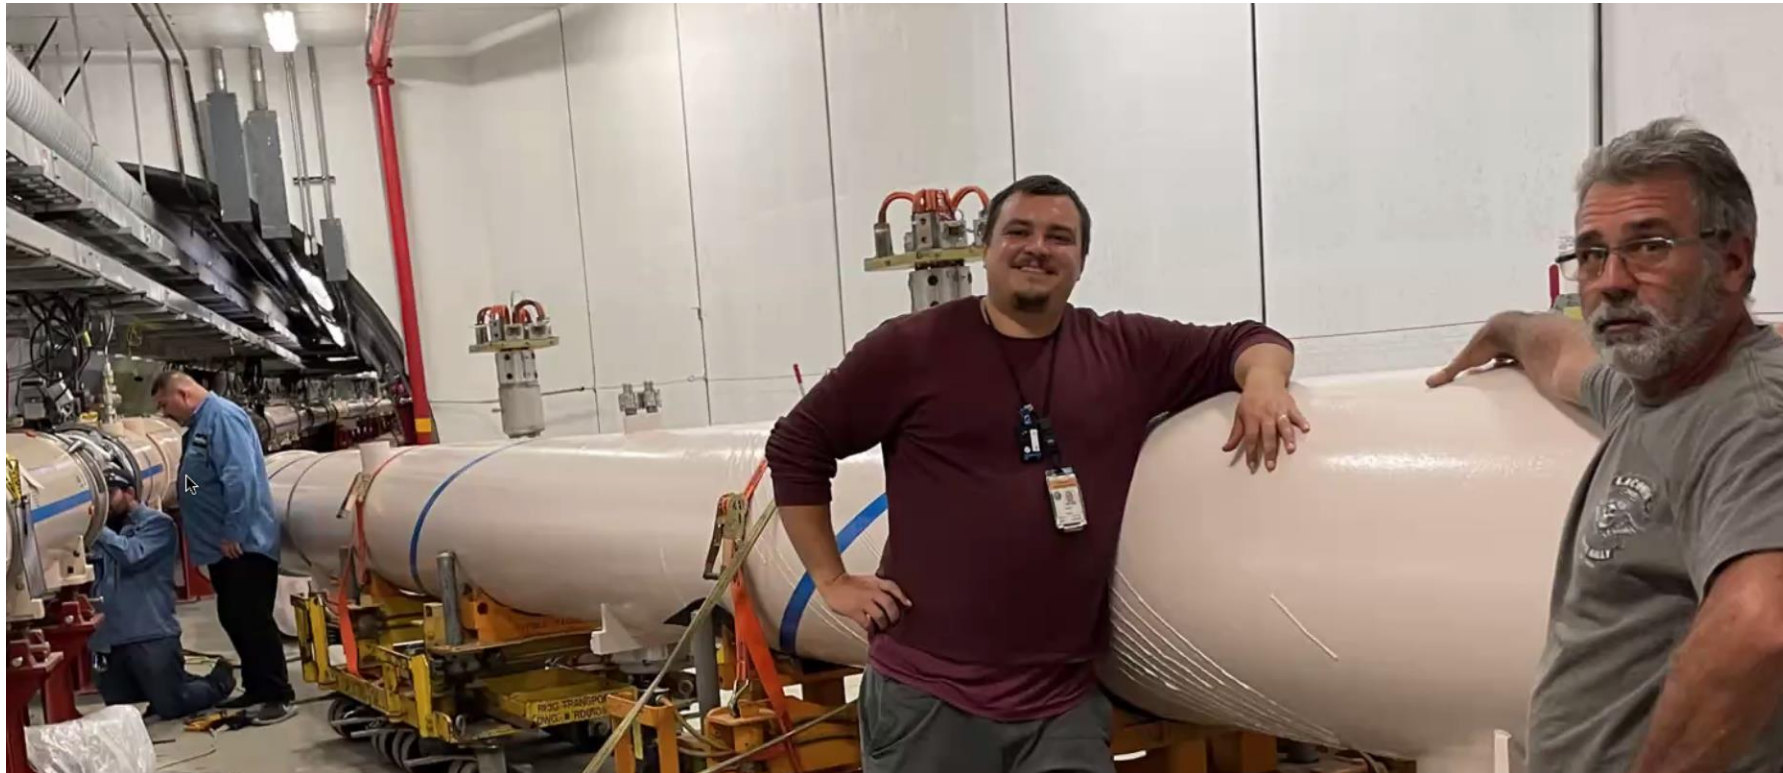
Dummy magnet and snake in RHIC tunnel prior to removal/installation/survey (IR8 region)

- Update on RHIC Blue Ring Siberian Snake magnet reinstatement: The repaired Blue Ring Siberian Snake magnet was installed and surveyed in the RHIC tunnel last week. Welding of the end volumes started last Friday and will continue this week together with soldering of the splice joints. Following that, the snake will be hi-potted, then pressure-tested. Mass spectroscopy measurements in the Helium lines will be made next, then the magnet shield will be installed and the insulating vacuum will be welded closed. Pumpdown of the insulating vacuum is foreseen early November with completion by mid-November. Leveraging off of the opening of the RHIC vacuum for the snake installation, the long-awaited removal of a RHIC quench diode to inform EIC planning was completed and a spare diode (Type I diode with inverting fixture) was installed and hi-potted. Welding of the diode's end volumes and remaining diode-related work is on track for completion this week

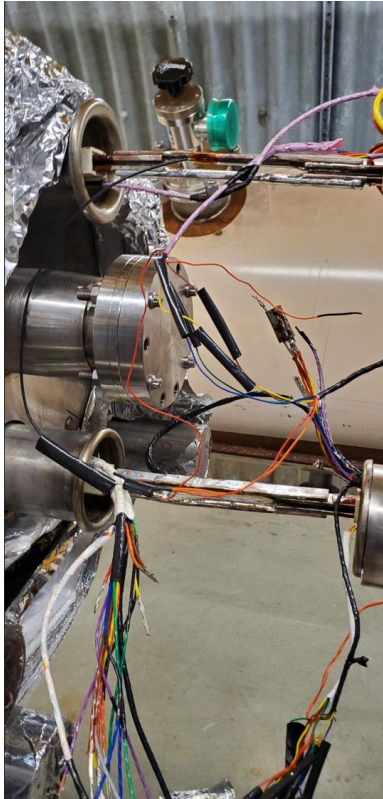
splicing of SC cables in snake

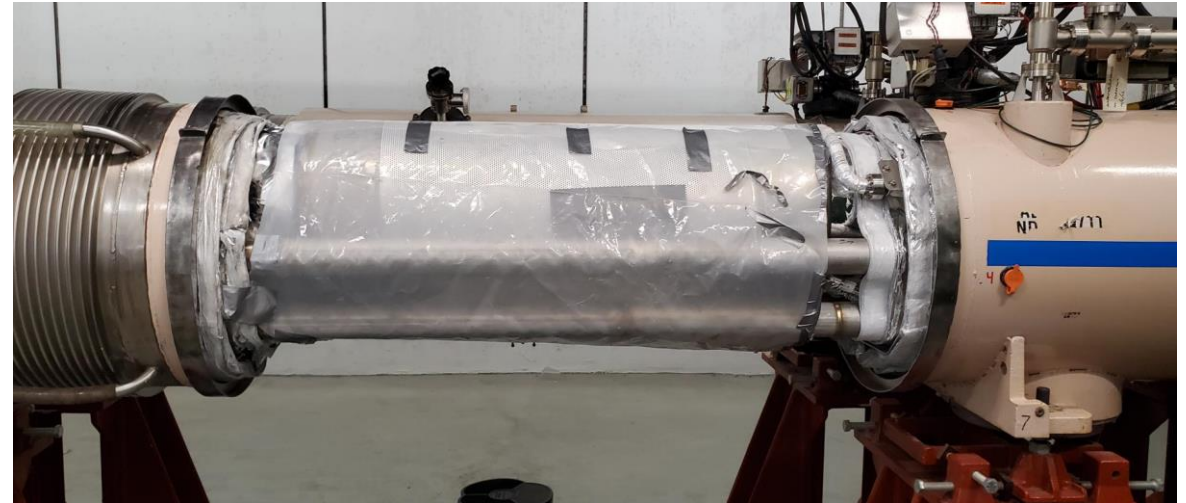
## RHIC diode installed

- ✓ Leveraging off of the opening of the RHIC vacuum for the snake installation, the long-awaited removal of a RHIC quench diode to inform EIC planning was completed and a spare diode (Type I diode with inverting fixture) was installed and hi-potted.
