Valve Box Repair Mechanical Engineering

Russell Feder for the 1004B valve box repair engineering team

1004B Blue Valve Box

1004B Blue Valve Box Repair

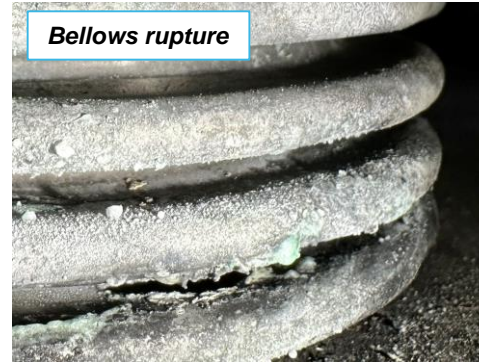
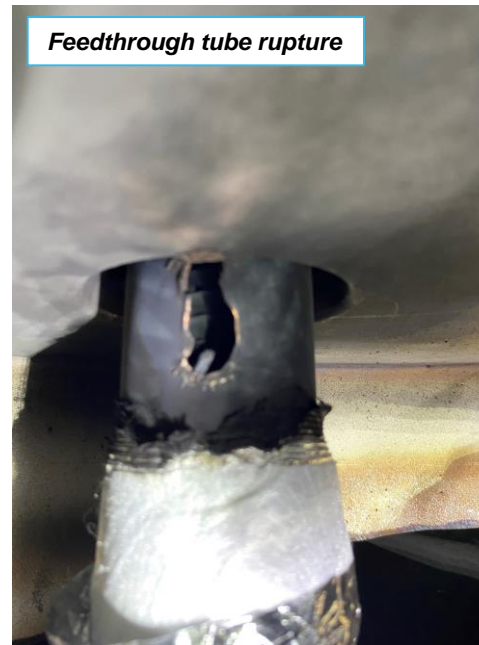
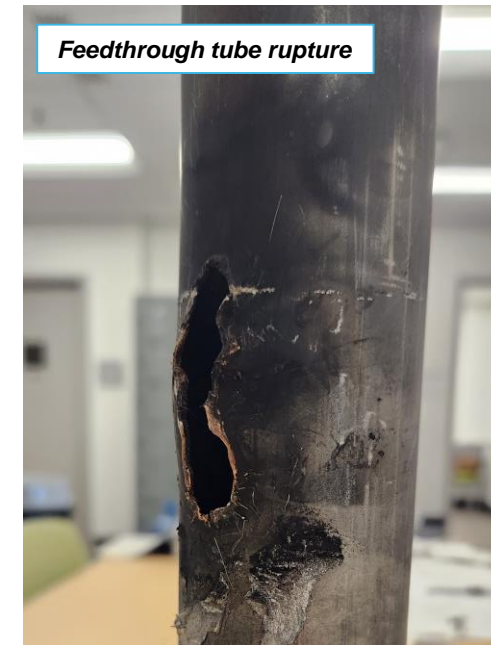
Lead pot "A" "TBD" feedthrough piping damage

This feedthrough is part of the M-line pressure boundary and the valve box pressure boundary

For more information on the causal analysis and electrical events that lead to this damage
→ Talks coming up next by Jon Sandberg, Chaofeng Mi, and John Escalier

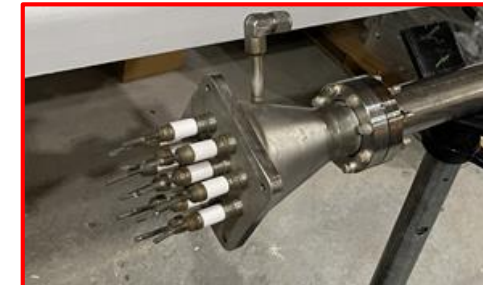
Pressure test of the repaired feedthrough
Tested to 8 atm, ~120 psi

- Operating Pressure: 58 psi (4 bar)
- Spare 12X150 Current Lead and Repaired M-line Test pressure: 120 psi (8 bar)
- But...By design, M-line reliefs are set to 250 psi (17.2 bar)
- Only have one 12x150 spare → Protect fragile ceramic feedthroughs
- Need to reconcile this → Get written approval for variation before March, 2024 restart

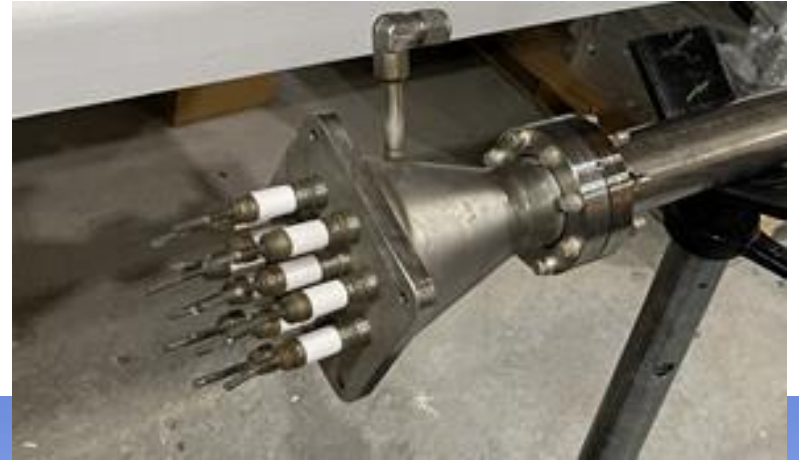
Lead Pot and 12X150 current lead FEA

- Use FEA to verify performance of the lead pot and feedthrough design, and new interface welding flange
- Lead pots are suspended from inside of valve box with 1/4" threaded rod. The gravity load is shared by threaded rod, feedthrough bellows, and M-line pipe stiffness. Not enough detail in this model to demonstrate all of that.
- Did not include contraction from 300K to 4K, assumed everything modeled is at the same temperature

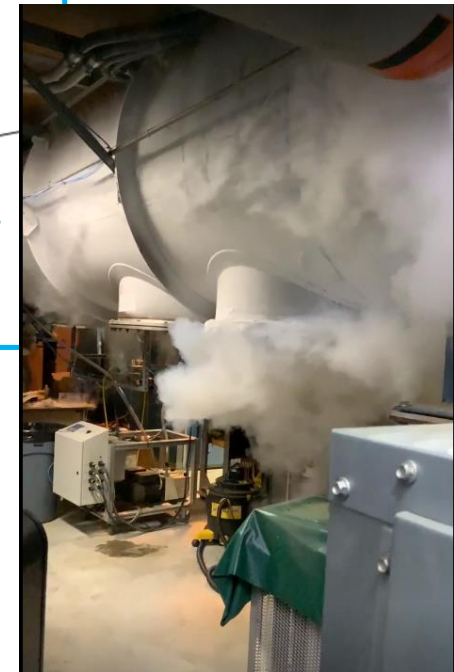
Valve box insulating vacuum relief valve worked as designed

- *Verified lift valve performance by dismantling and measuring properties in the Cryo shop*

Spring constant [lbs/inch]	85.0
Pre-Load force [lbs]	95.6
Relief set point [PSIG]	1.8
Required Pressure to fully open valve [PSIG]	1.9
Installed relief valve dia [Inch]	6.4
Maximum Pressure buildup in Valve box [PSIG]	3.7
Relief Pressure [PSIA]	18.4

Shown upside down sitting on bench in Cryo shop
