Spare DX Magnet Preparation and Installation

- DX and D0
- Splice cans damage
- DX end wiring
- DRX103 removal and inspection
- DRX114 spare preparation, steps and status
- Final steps
 - DRX Magnetic Measurement
 - DRX114 Installation and Testing
 - DRX103 Testing and Repair

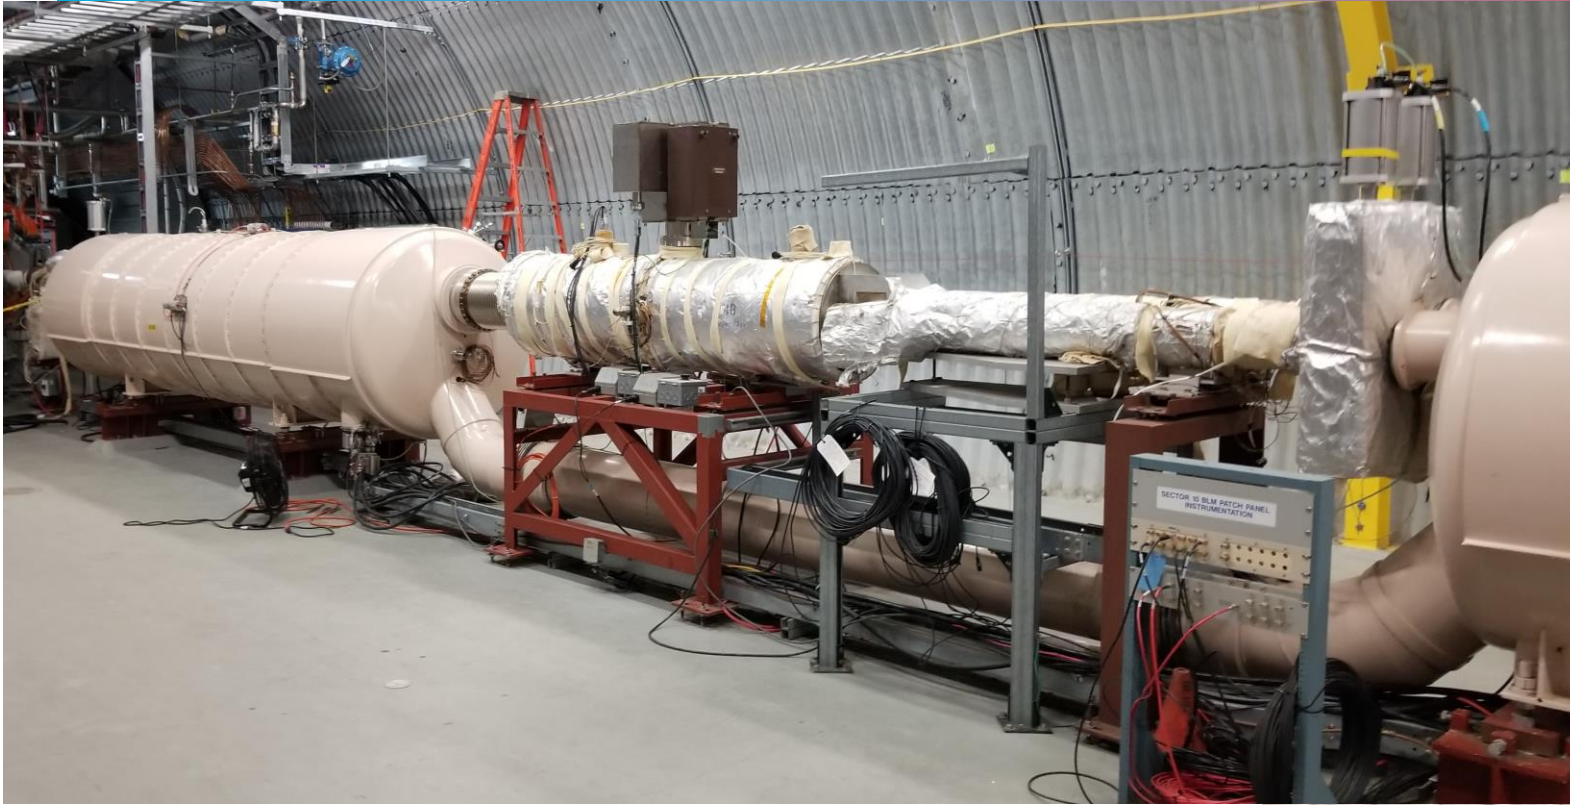
DX Magnet Assembly

DX above

D0 & Triplet Cryostat to the right.

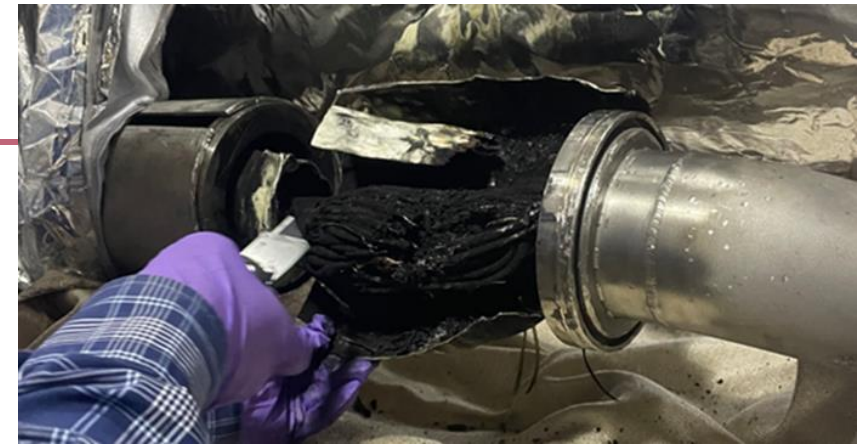
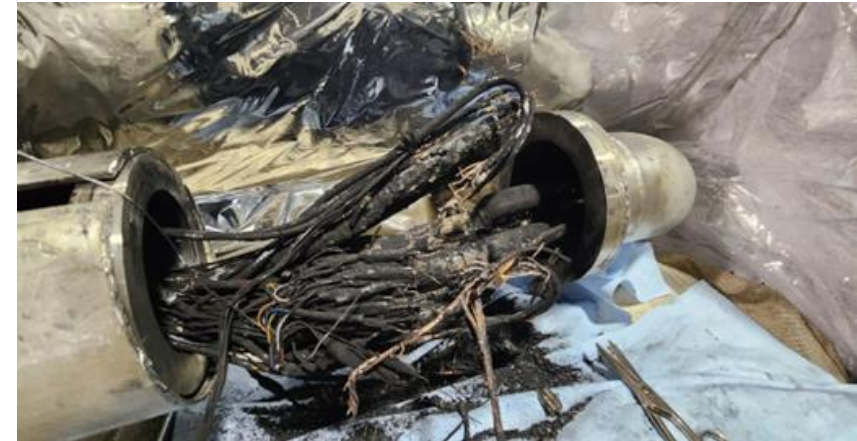
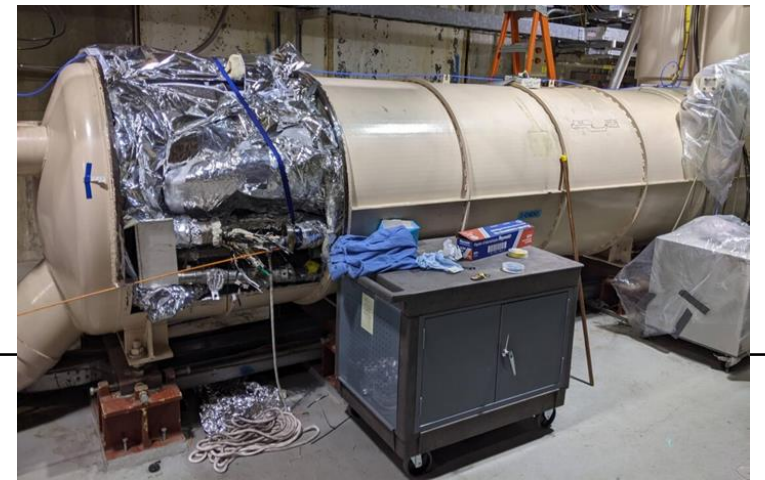
Splice Failures

1. Where is the problem – in the lead pots or the tunnel?
2. Opened valve box and lead pot first found the damage.
3. Problem in CCB? DX? D0? Beyond.
4. First CCB splice access and opened between DX and D0. CCB to D0 “lead end”. (SC4)
5. Problem DX to VB side.
6. 2nd splice access CCB to DX “non-lead end” (SC3). Damage
7. 3rd splice access CCB to DX “lead end” (SC2). Damage
8. 4th splice access CCB to CCB valve box (SC1). No Damage
9. The CCB to D0 lead end splice has been completely disassembled for CCB replacement (SC4). This allowed detailed inspection and testing of the D0 – no issues.

1. The DX magnets end connections/end volumes are bit accessible when it is installed in the cryostat. It has to be removed and repaired elsewhere.
2. There is a full DRX114 DX spare magnet assembly that was successfully vertically cold tested and trained to operating current. **(25 years ago)**
3. The DRX114 was inspected and tested warm. It was stored well.
4. The warm magnetic measurement of the DRX114 is being repeated after the wiring is complete.
5. The spare was not wired to a left or right configuration.
6. All necessary wiring for the spare was found and the technician who wired the DX and the DX engineer are still in the Superconducting Magnet Division – they provided full support.
7. Damage to the DRX103 magnet was not apparent; but, **unknown**. (140 Turns, 6300A)
8. The DRX103 would require additional time to repair due to removal of old damaged bus.

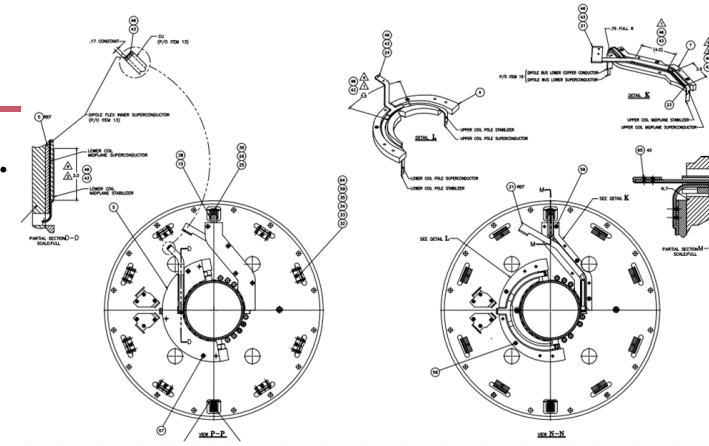
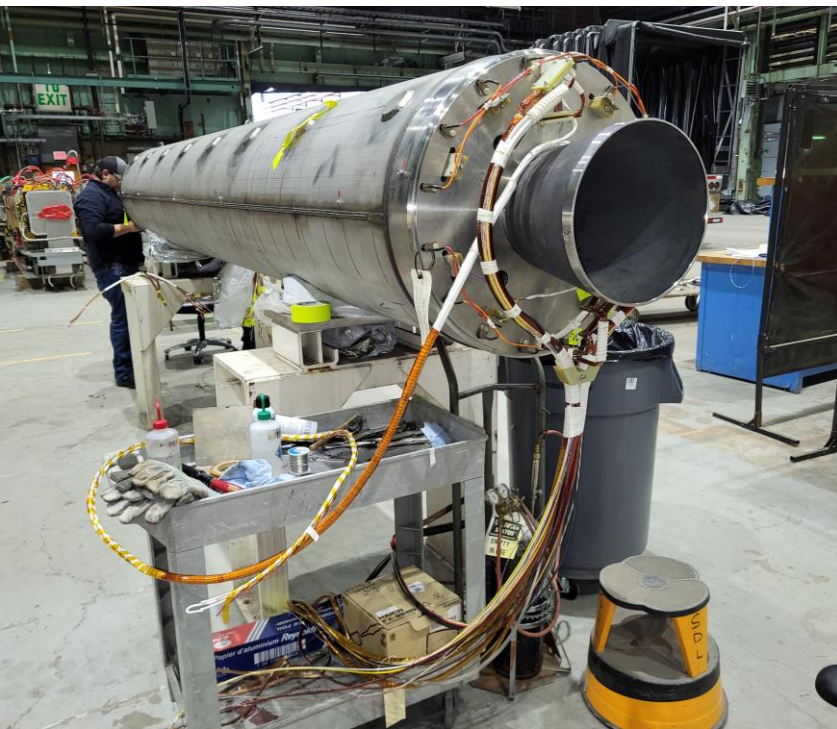
DX and D0 lead end wiring

- The DX uses cable connections for magnet to CCB interconnects on both ends.
- The RHIC arcs use hard bus magnet to magnet interconnects.
- The D0 uses cable connections for magnet to CCB interconnect on one end.
- 2 out of 3 magnet cable to CCB connections failed.
- Number 3 was opened, inspected, and found to be OK.
- The CCB to CCB connection between the failed DX connections and the valve box was opened for inspection and found to be OK.

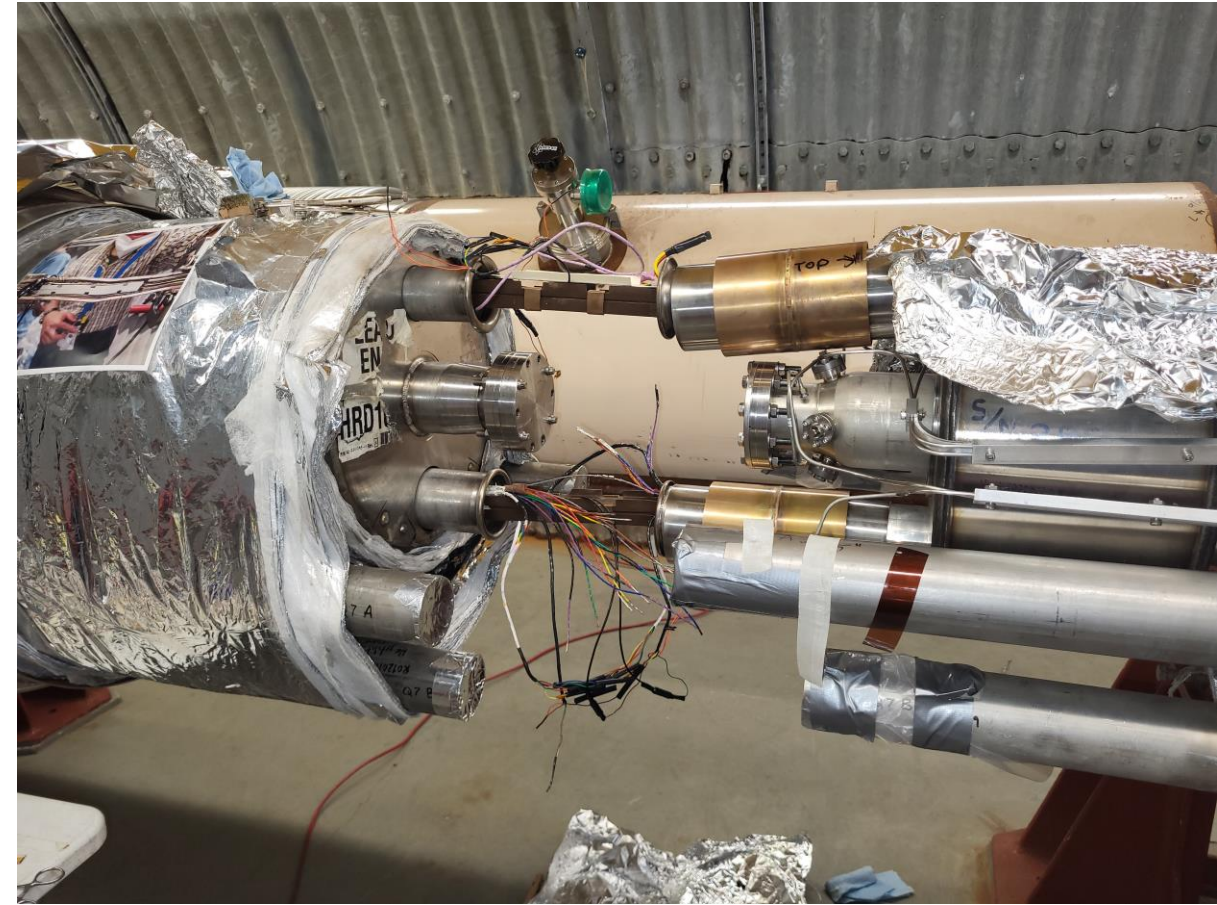
Arc Magnet Interconnect Comparison

Typical Magnet to Magnet Bus Interconnect

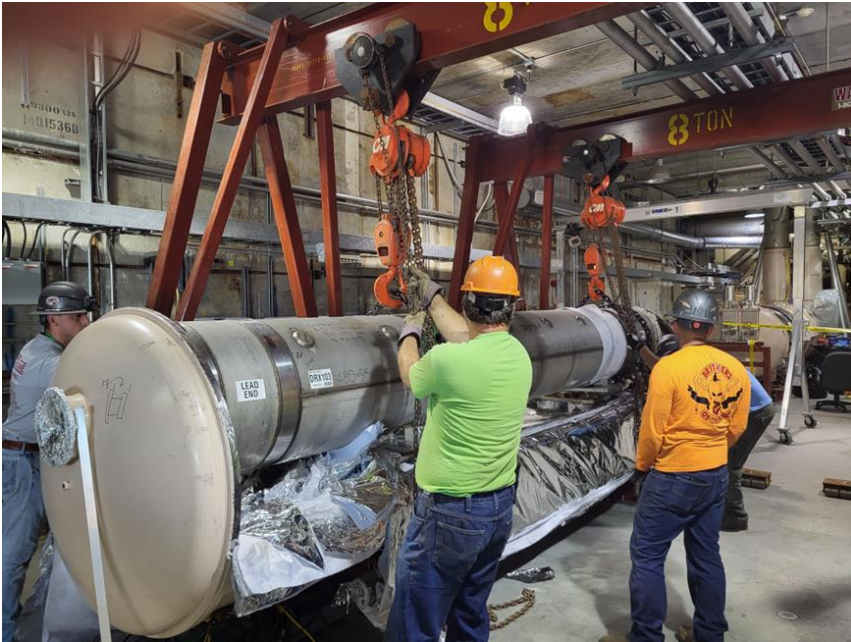
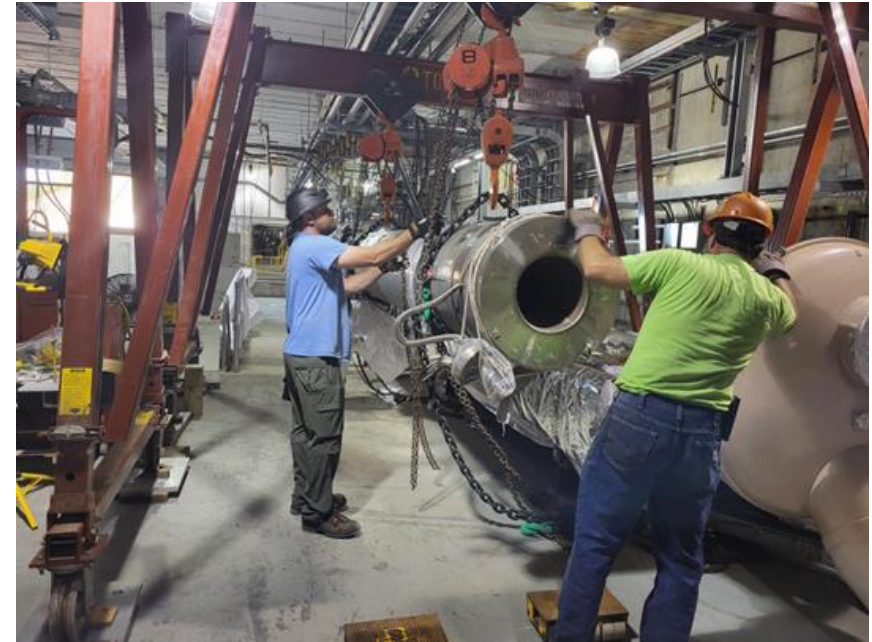
Removal

- Magnet Cold Mass Assembly Surveyed
- Center Beam Tube Removed
- Rigging A Frames Installed, DRX103 Moved to 912
- End Volumes Removed
- Spare DRX114 Located and Moved to 912

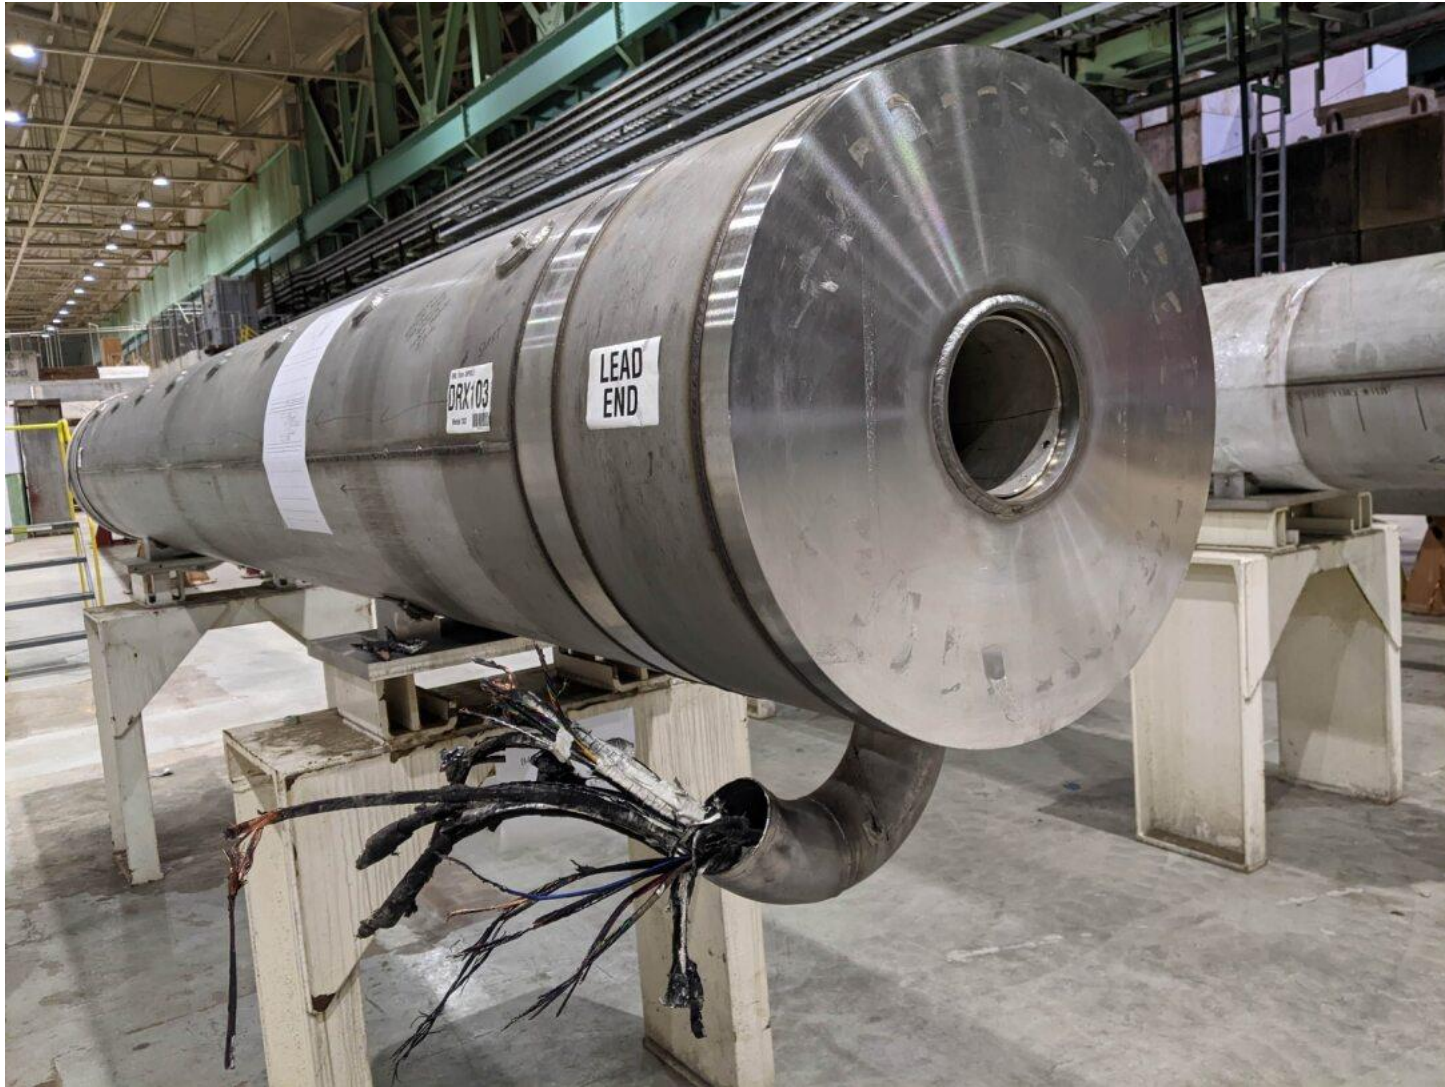
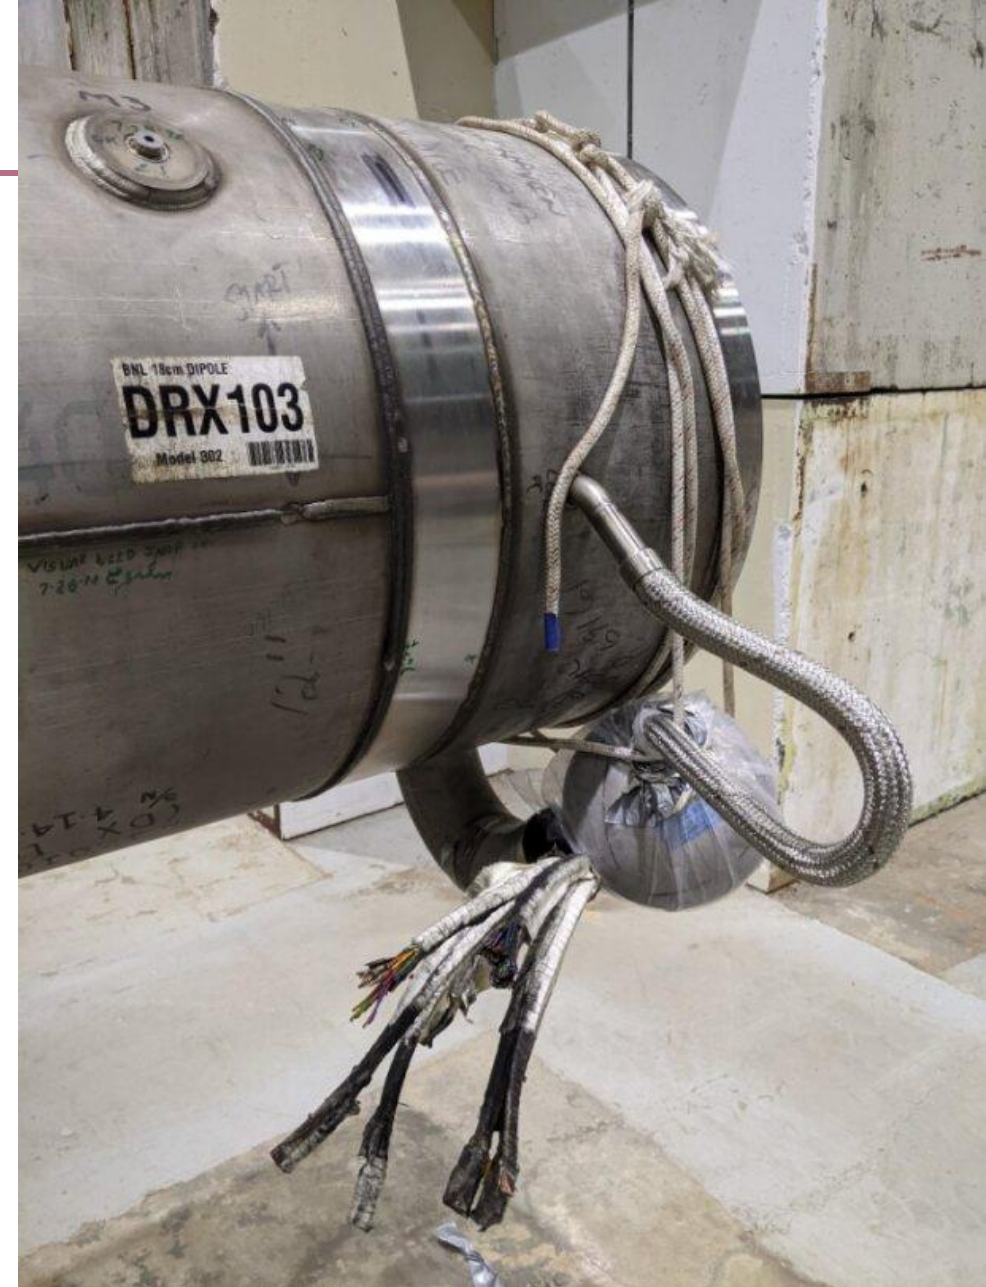
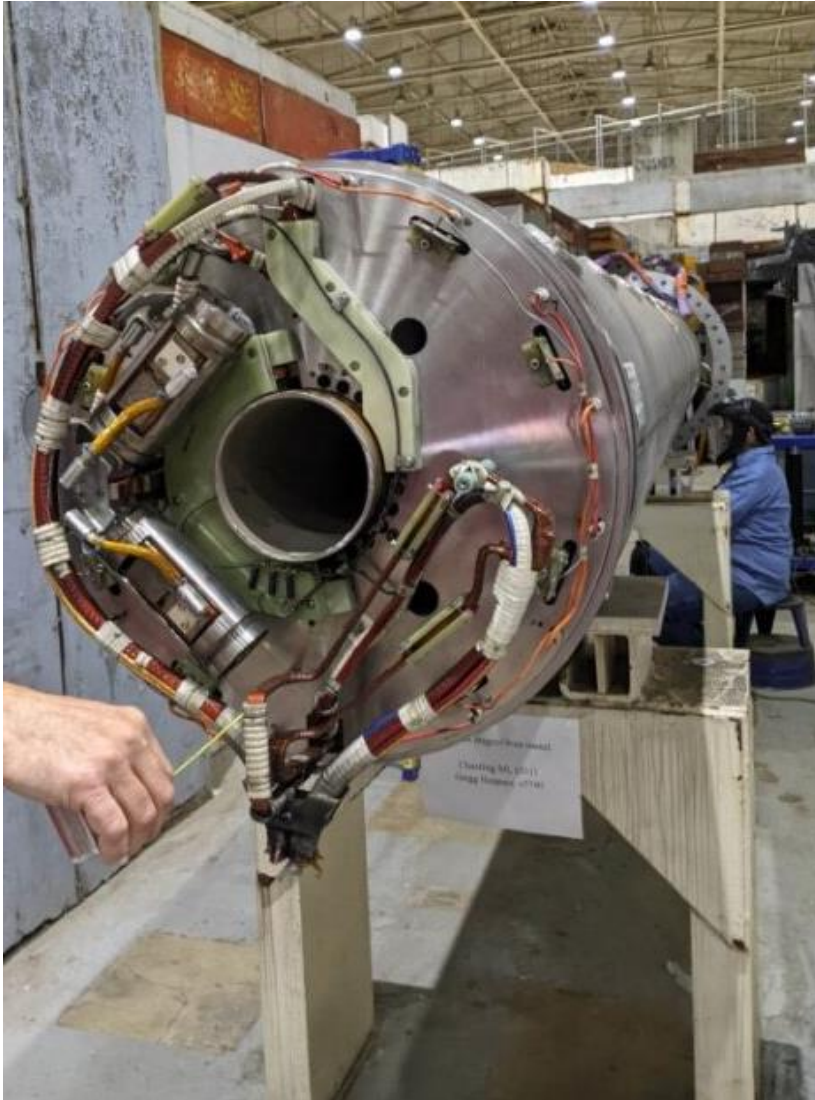
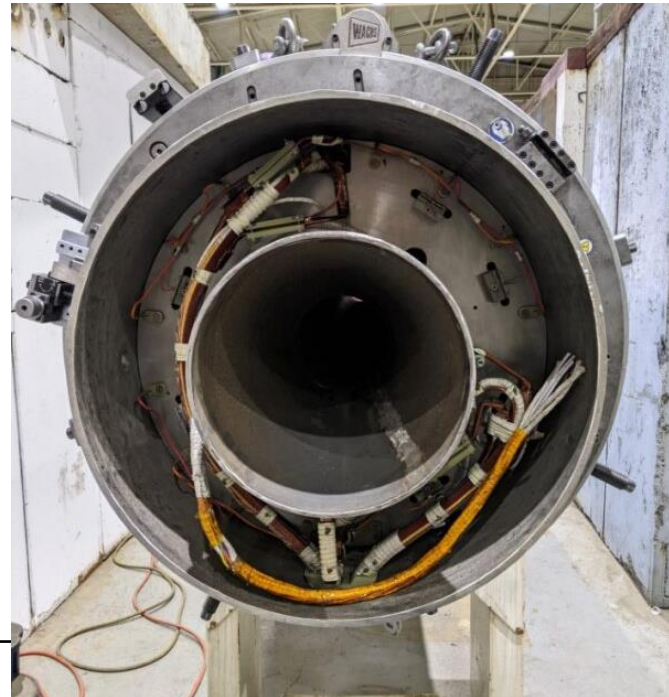
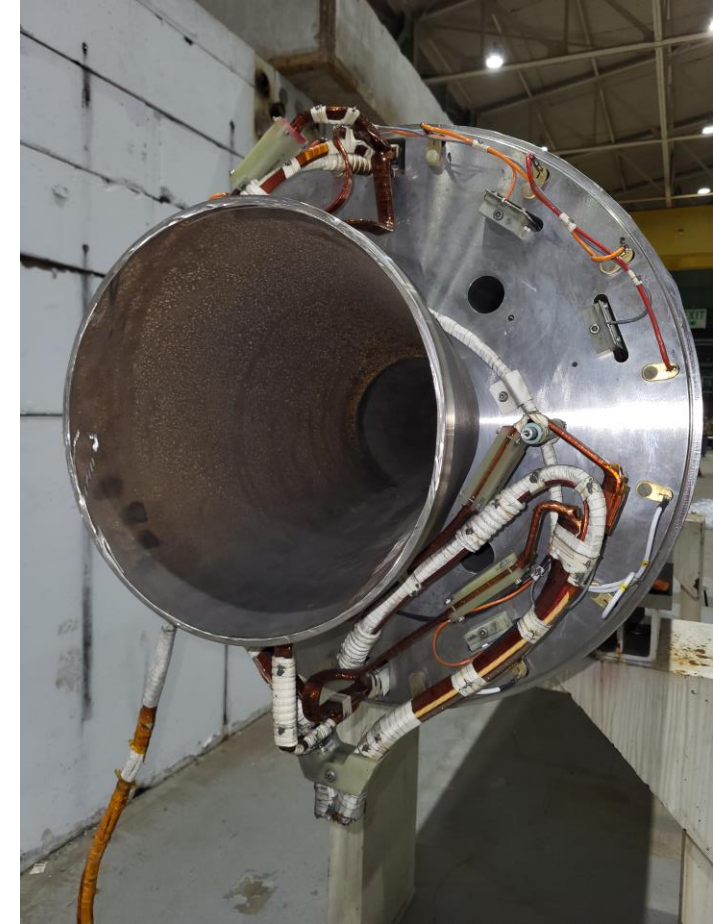
DRX003 End Volumes Removed

- < Lead End (End closest to the IR)
NonLead End (Closest to D0) >
- Ends removed for inspection
- No obvious or additional damage.
 - Guide to prepare the spare.
 - For more detailed testing.
 - Rebuild as a spare.

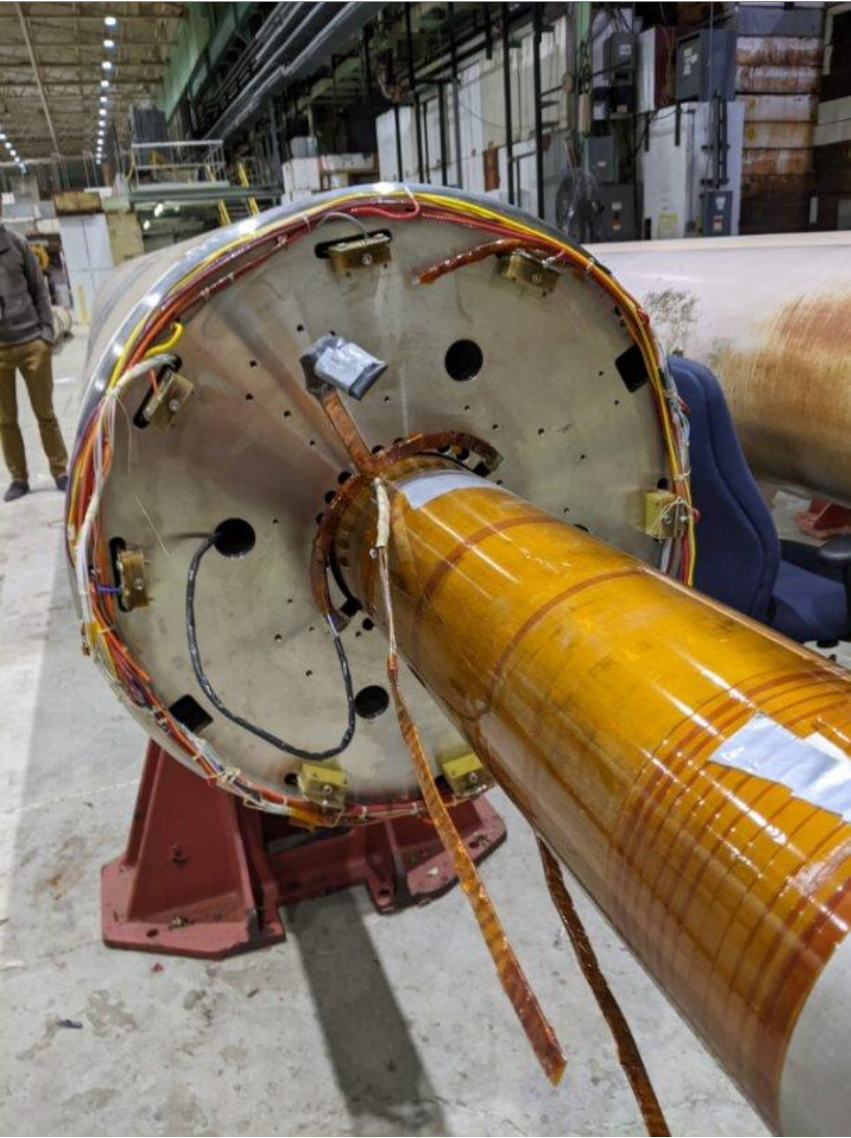
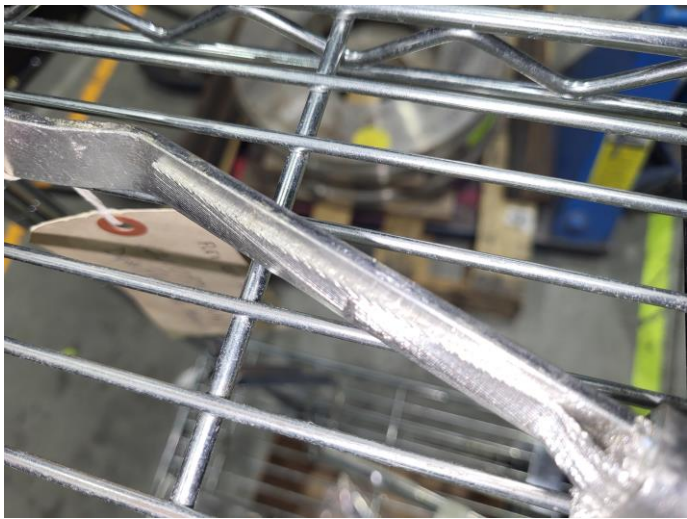
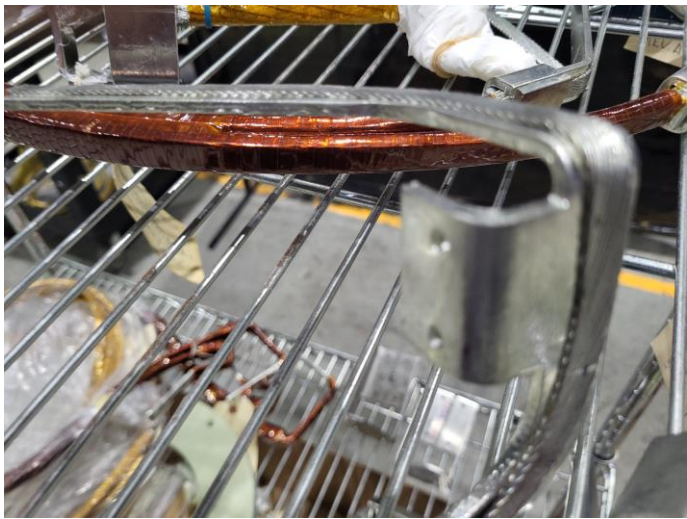
DRX114 Wired and Electrically Tested

- Central Interconnect Bus Installed (spare assemblies)
- Both end volumes wired (spare parts)
- All cables electrically tested and marked for final interconnect
- Ready for End Volume welding

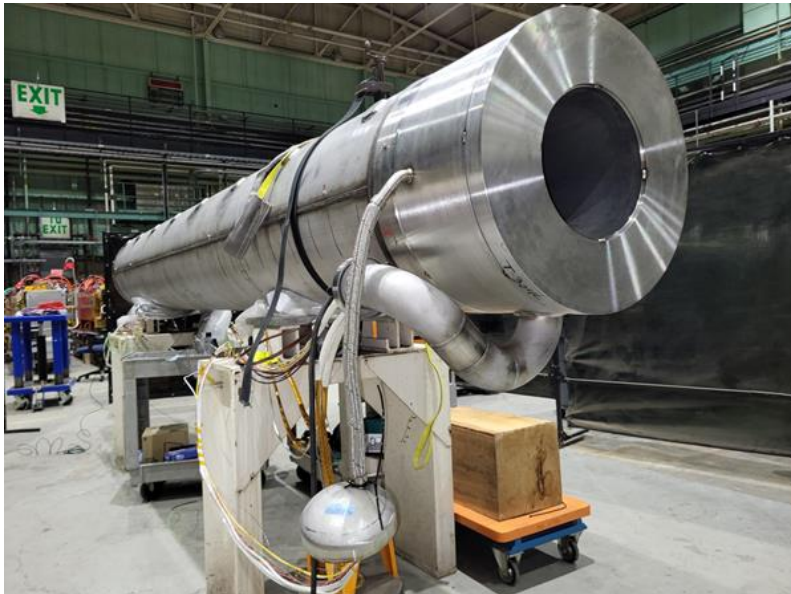
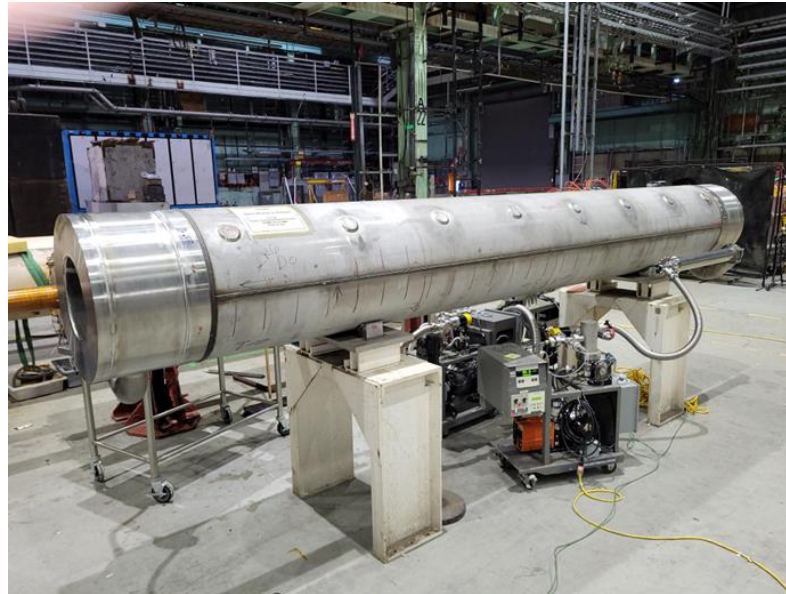
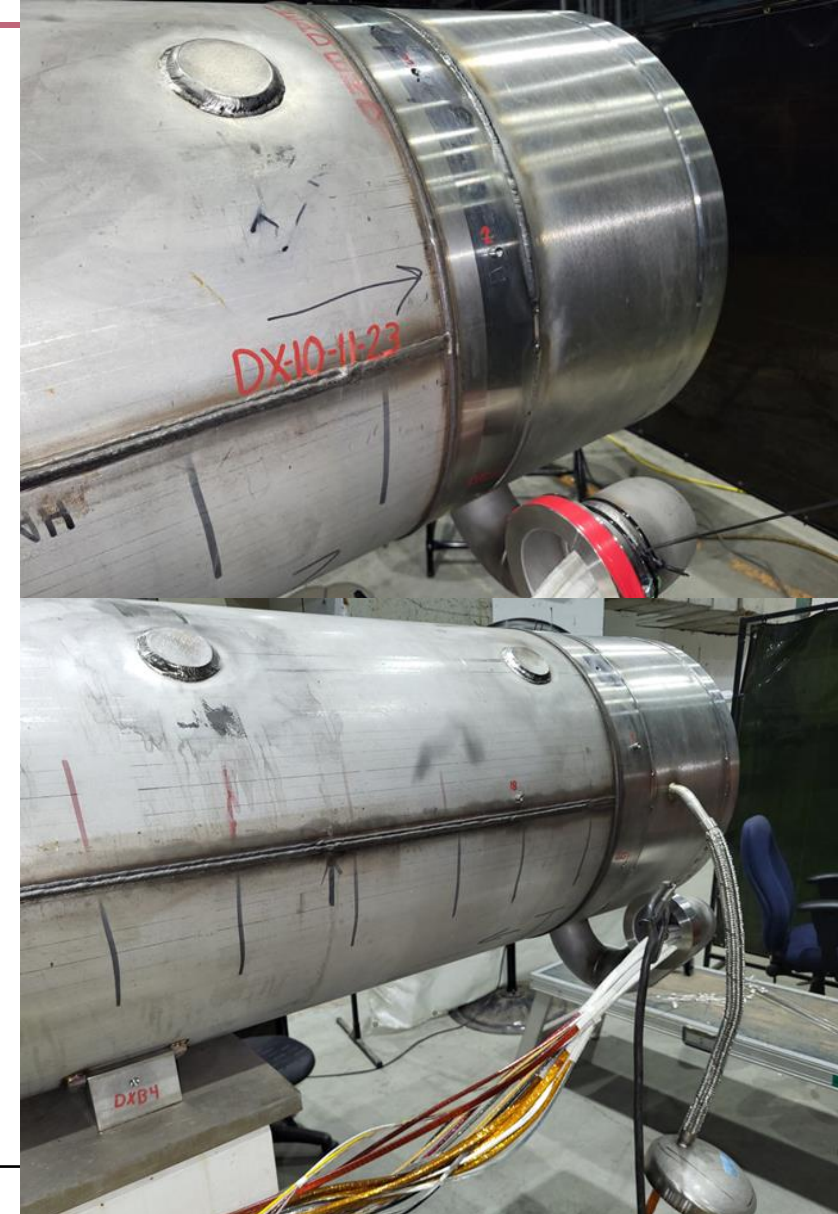
DRX114 Wired and Electrically Tested

- Magnet Pre-Surveyed and Fiducials Added
- End Volumes Welded On and Vacuum Leak Checked
- Electrically Tested Again
- Moved for Magnetic Measurement for Vertical Field
- Final Pressure Test When DRX114 is Installed in RHIC

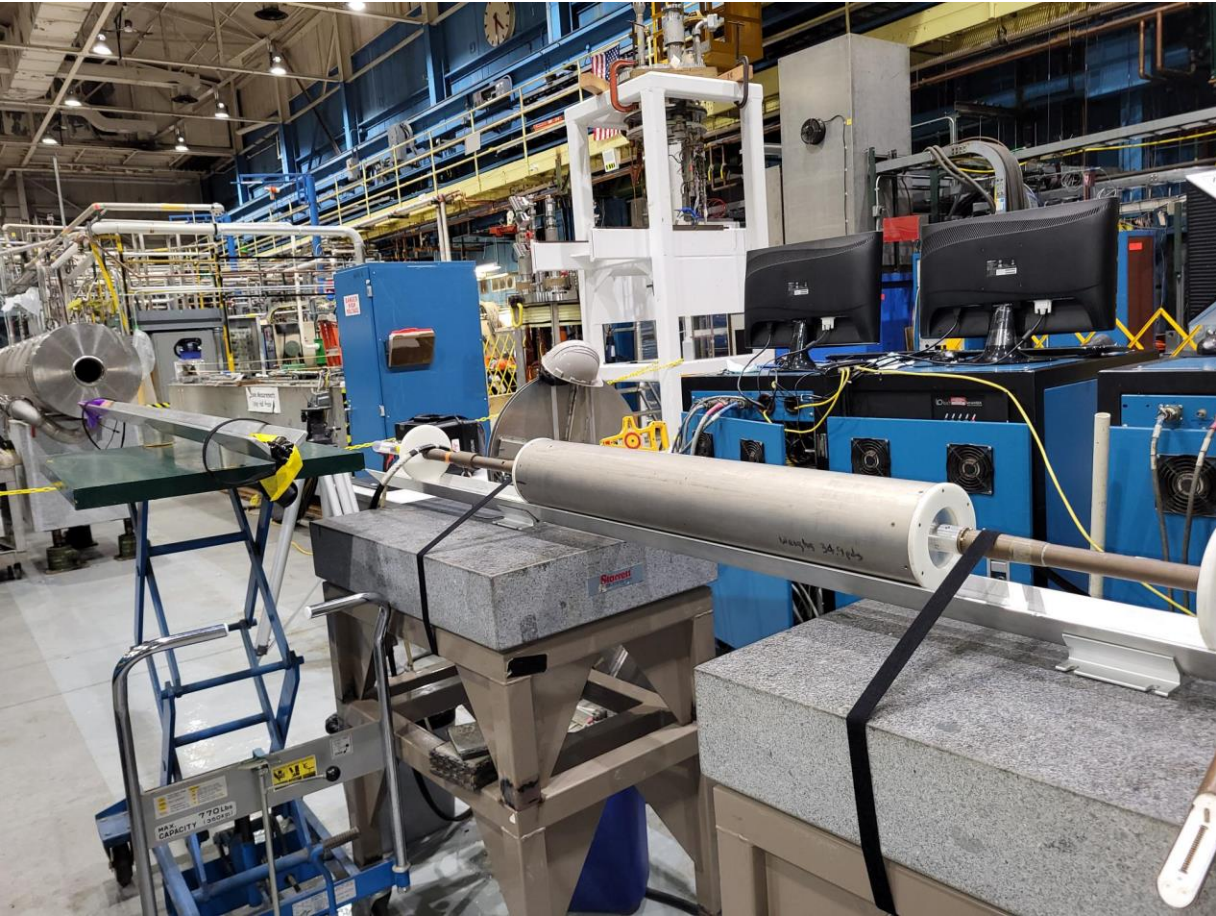
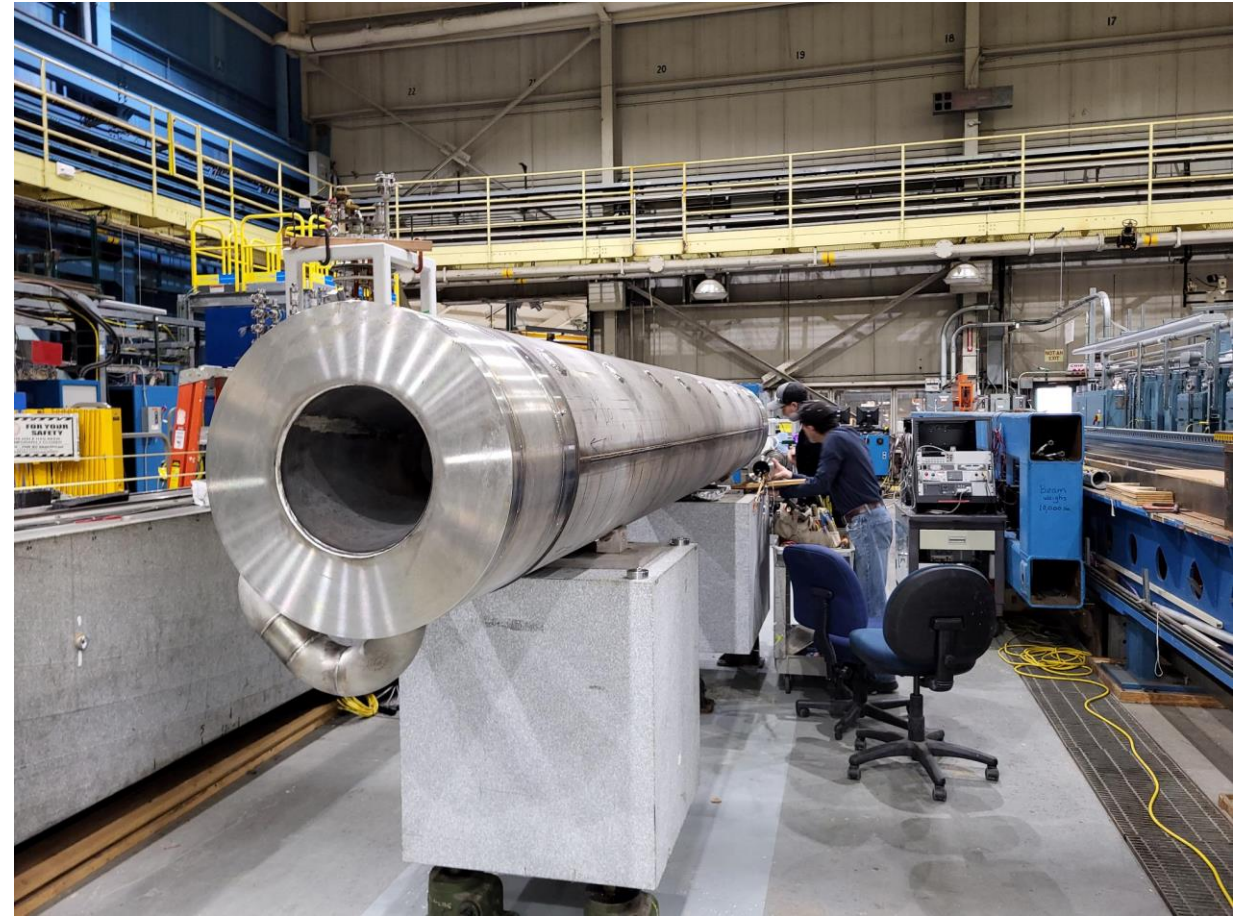
DX Magnet Measurement Set-up

Final Electrical Test and then Magnetic Measurement

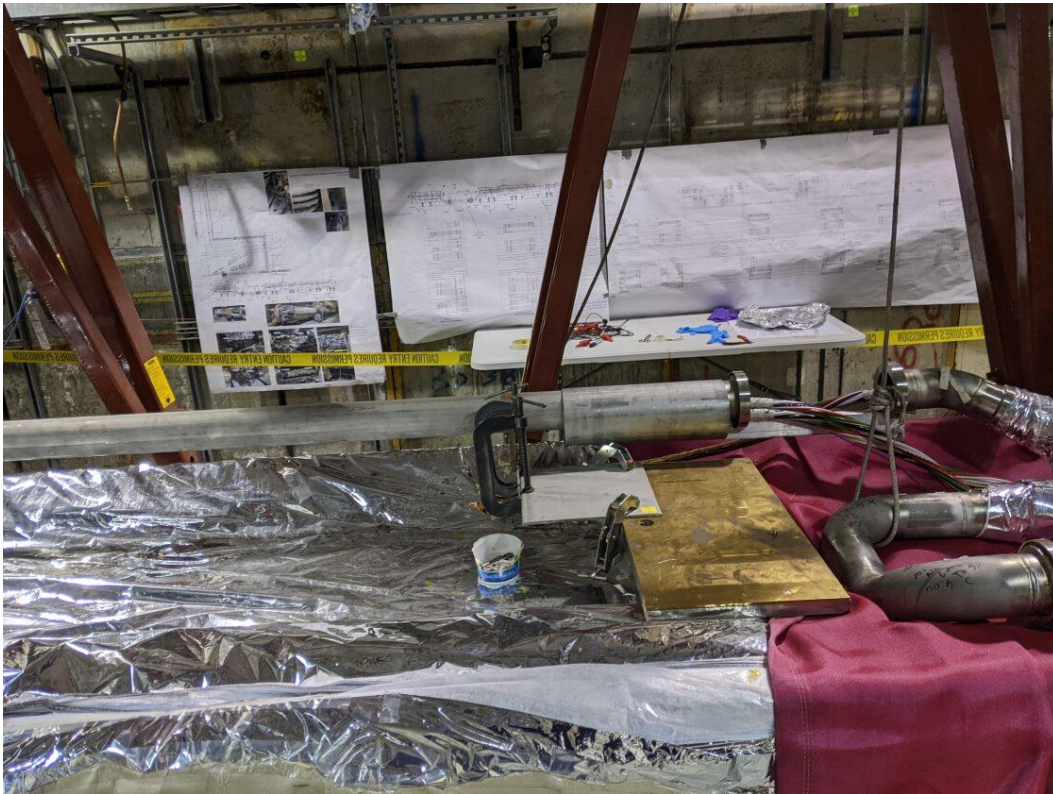
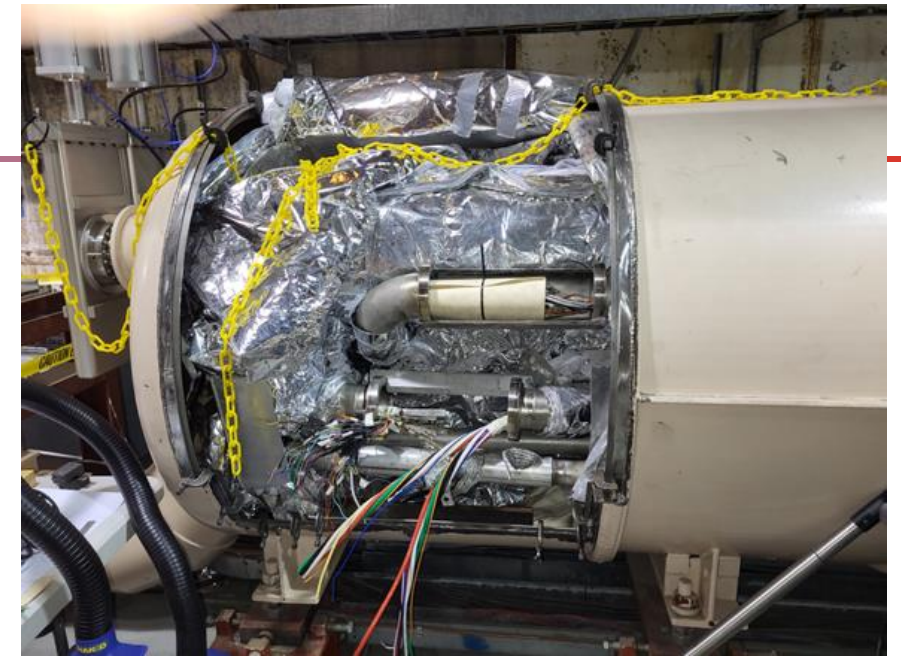
Tunnel Preparation

Replace damaged CCB DX to D0 and splice.

Cut CCB on lead end – Splice at new splice can.
