# Fiber Attenuation Measurement Test

ePIC BIC Meeting  
12. 12. 2023

# Fiber Attenuation Measurement

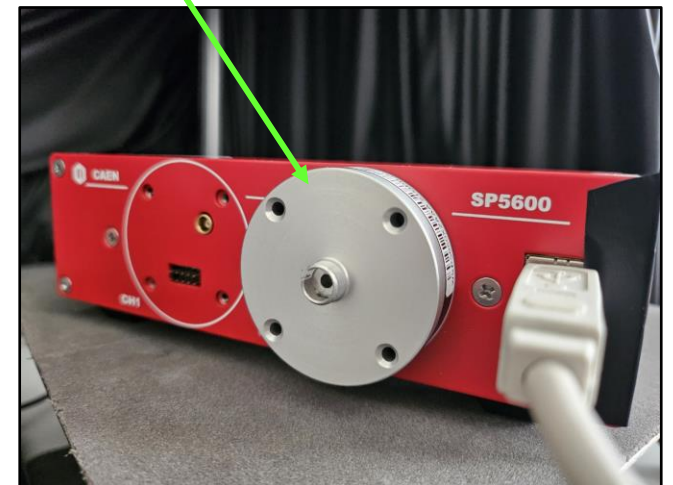
### Photon detection efficiency vs. wavelength

Fiber emission spectra [LINK](#)

SiPM detection efficiency

- Used SiPM as detector, Hamamatsu S14160-1310PS. (Spec. [LINK](#))
- Peak wavelength of fiber's emission & peak of SiPM's detection efficiency is almost same.
- Attached SiPM on PCB board, mounted it on SP5600.

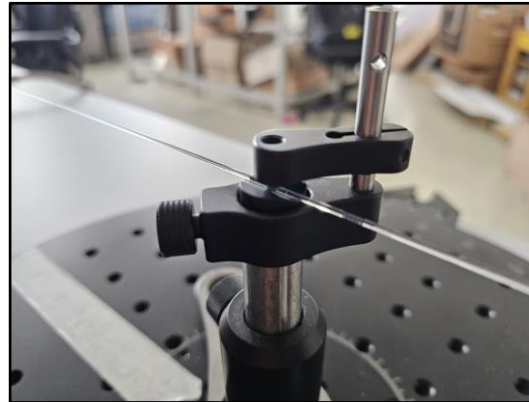
Thorlabs Compact V-mount ([LINK](#))

- Aligned setup & fiber with laser guide, draw measure points on table.
- Used V-shape optical mounts to hold fibers on air.
- Covered whole setup with blackout curtain (Performance on [backup](#))
