COMPASS RICH-1 radiator gas system

Main elements and operation modes

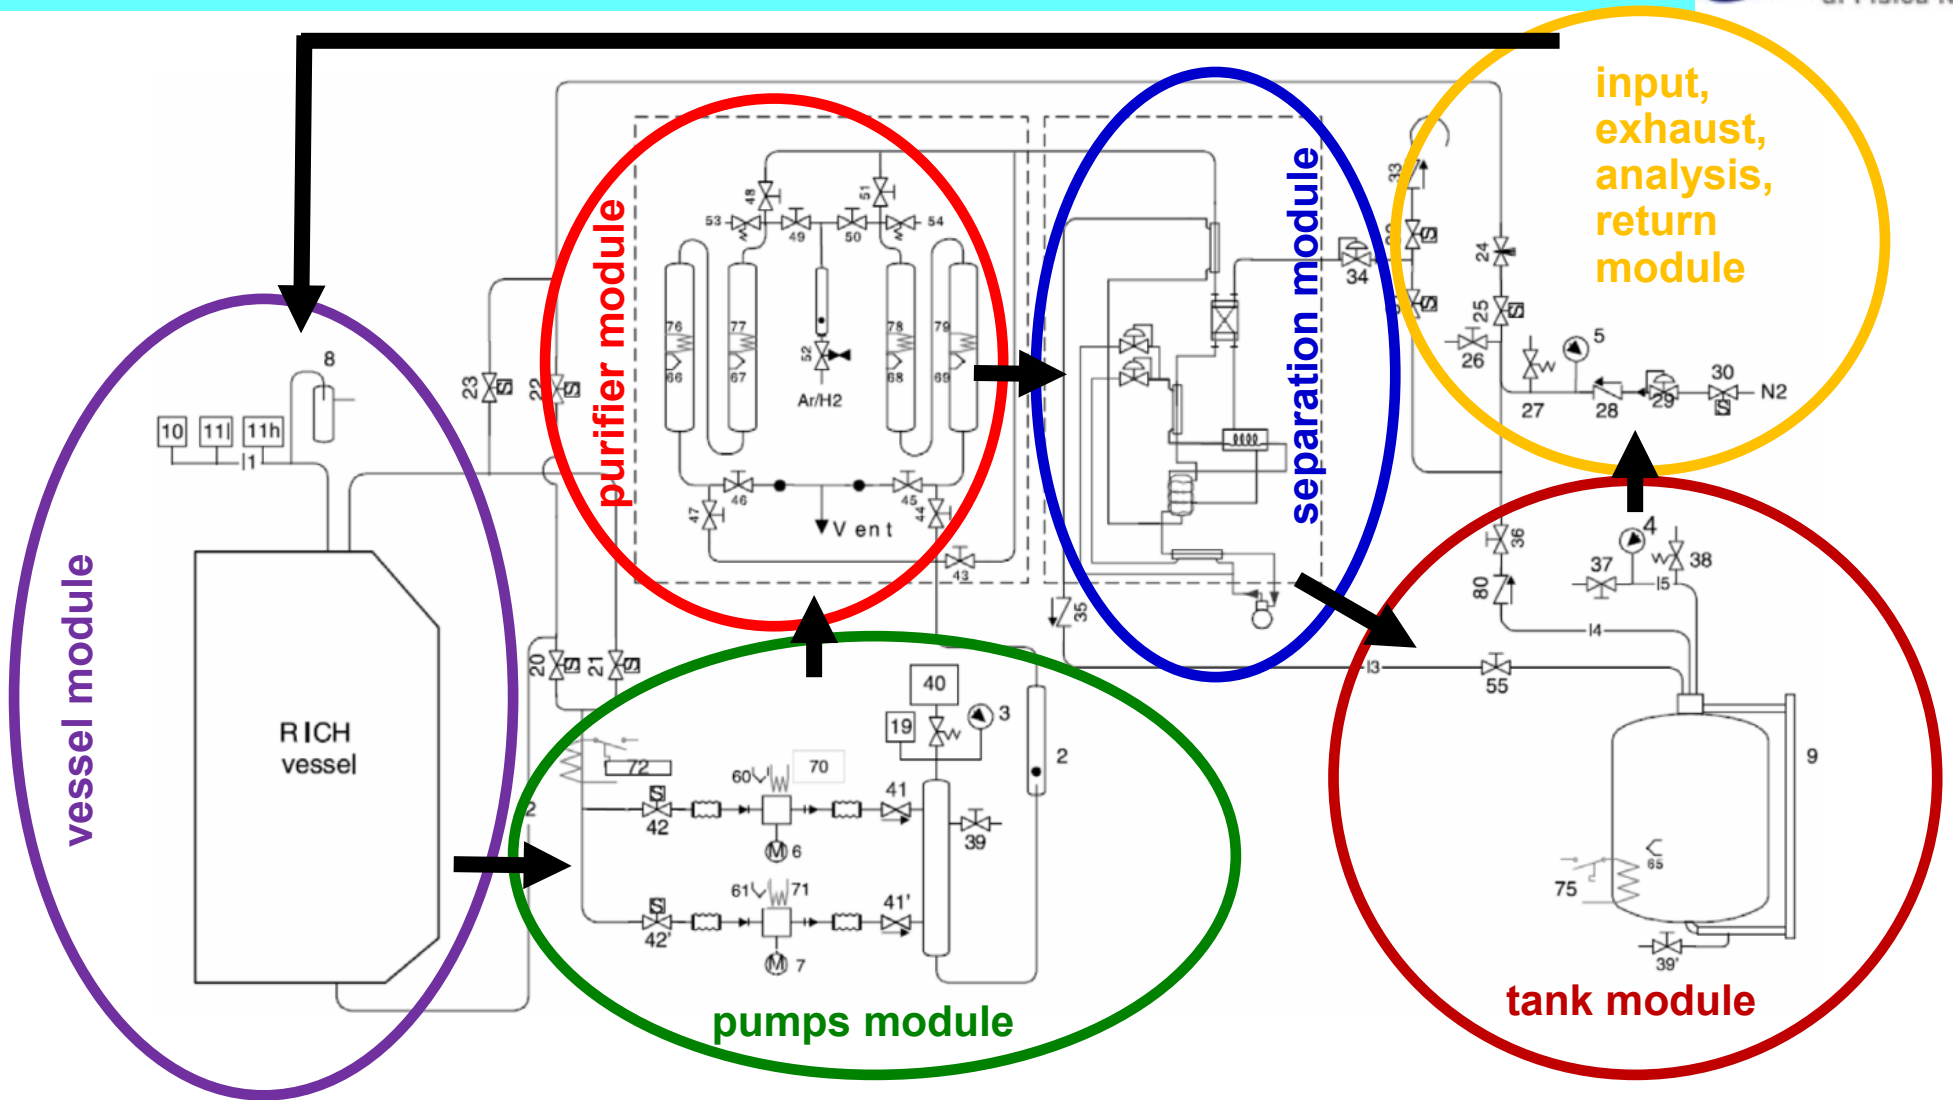
the COMPASS gas system

2 oil-free compressors Haug SOGX 50-D4 running in parallel (typically at 2.5 m³/h), heated at 50°C

A pressure sensor on the RICH

A pneumatic valve regulated according to the pressure sensor

A PLC to control the system

A separation system

A storage tank

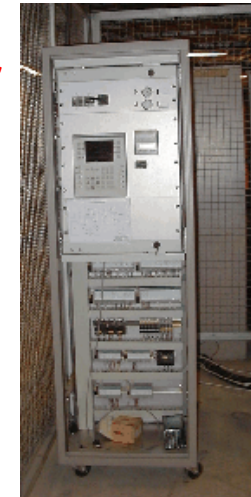
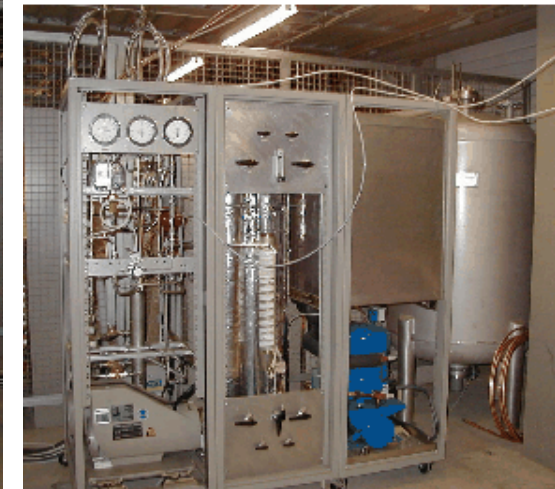
Main elements:

Main operation modes:

- 1) Purge mode: flushing N₂
- 2) Filling mode: inserting C₄F₁₀, separating N₂ and C₄F₁₀, purging N₂ with residual C₄F₁₀
- 3) Run mode: circulating C₄F₁₀, no input, no purge
- 4) Recovery mode: inserting N₂, separating N₂ and C₄F₁₀, purging N₂ with residual C₄F₁₀
- 5) Stop mode (in case of emergency): compressors off, all electrovalves closed

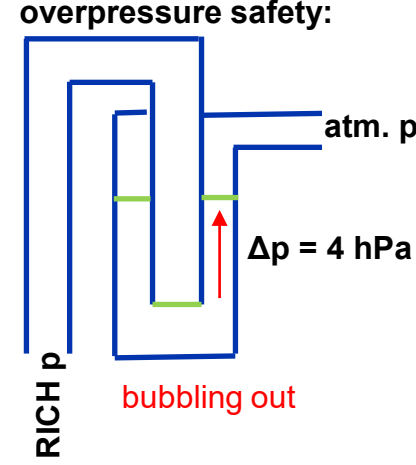
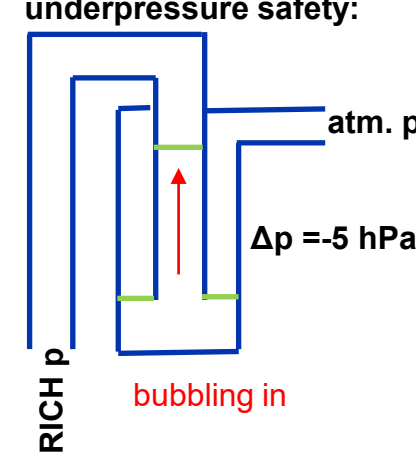
The safety bubbler

passive pressure safety system

pressure gauges and hardware alarms

The safety Δp levels are defined by the inner/outer section surface ratio and the oil level

Large stainless-steel bubbler built for COMPASS RICH1 after choosing the safety levels

Protection of the fused silica windows, which are expected to be in danger for $P > 30$ hPa

Pressure set at atmospheric pressure + 1.00 hPa at the top of RICH volume (

Feedback cycle tolerance < 0.1 mbar

High p alarms at + 2.0 hPa
 Low p alarm at 0.0 hPa

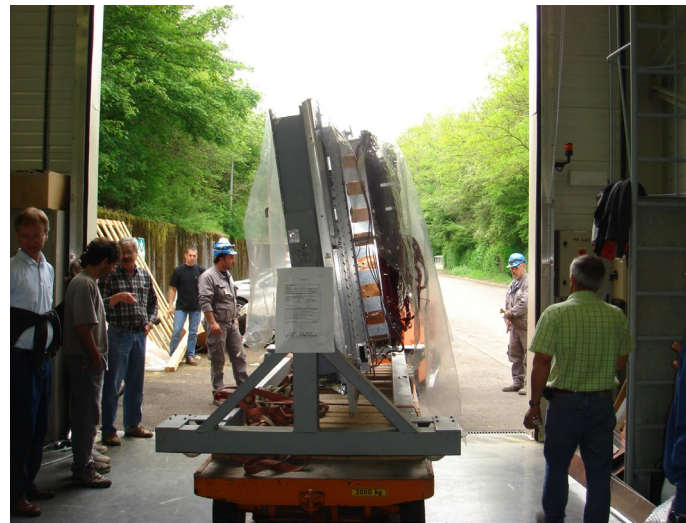
" Δp accident" during transport 18.05.2006

One COMPASS Photon Detector

Transport: gas lines connected in series

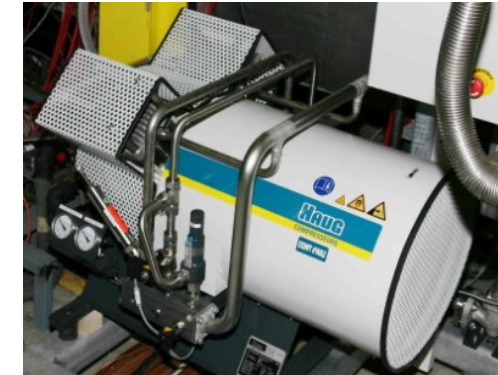
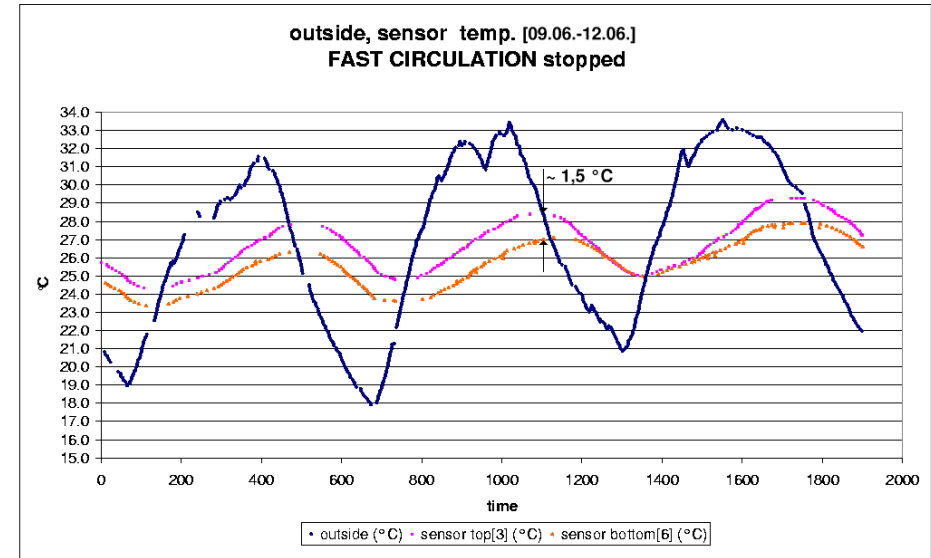
Thermalization of COMPASS RICH: proposal for a standalone RICH (“RICH tent”) studied. Impossible to implement due to accumulation of other detectors around the RICH

Risk of thermal stratification studied by simulations: not fully conclusive but clearly suggesting a significant risk reduction in presence of a 10 times faster gas circulation.

→ Compressor ordered to HAUG and installed in 2003: flow = 20 m³/h

Evidence for increase of thermal uniformity when the fast circulation is on.

Thermal gradients problem: → new fast circulation (20 m³/h) implemented in 2009

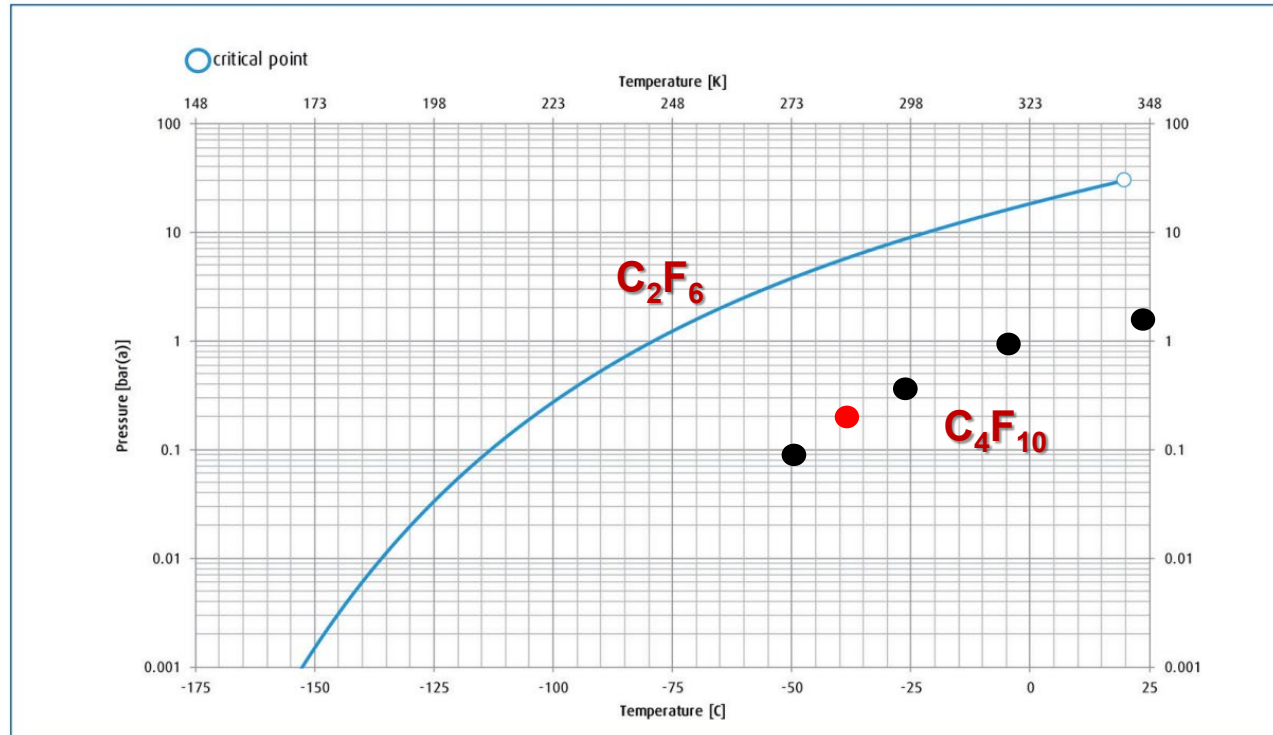
C₂F₆ separation

The partial pressures of C₂F₆ and C₄F₁₀ are very different

At -36°C C₄F₁₀ has 200 hPa vapor pressure. A separator working at 7 bars will purge 97% N₂ and 3% C₄F₁₀

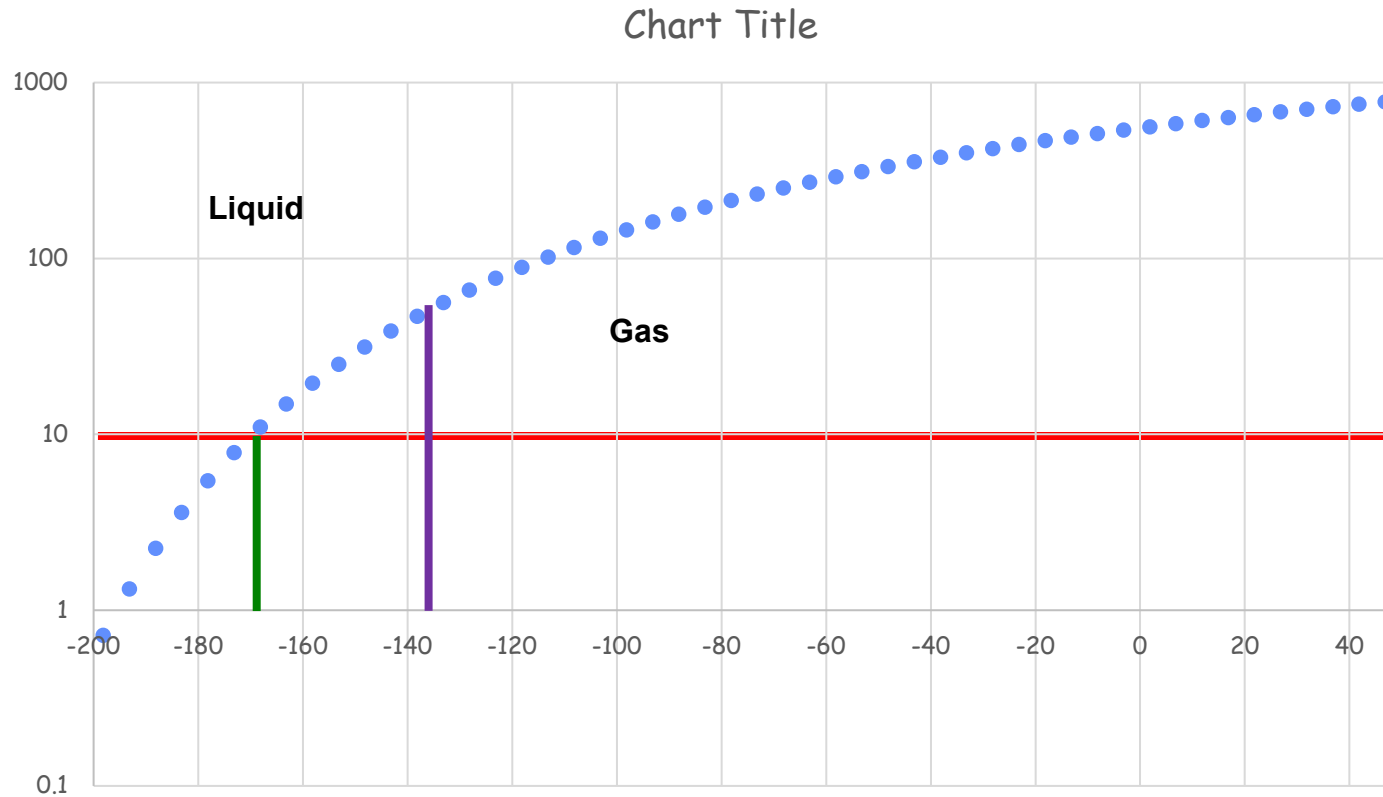
N₂ Partial pressure

At 10 bar(a) N₂ is in liquid phase for T > -170°C

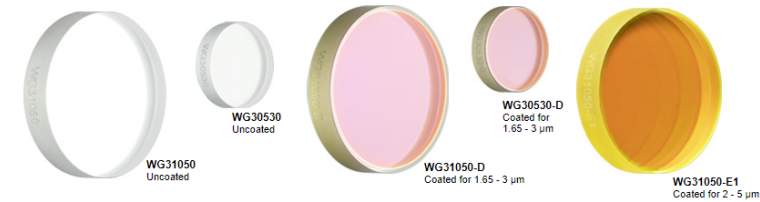
Sapphire Windows

Sapphire	Mechanical Properties
Modulus of Rupture	65,000-100,000 psi ~ 448-689 MPa

- ▶ Uncoated Windows for 200 nm - 4.5 μm
- ▶ AR-Coated Windows for 1.65 μm - 3.0 μm or 2.0 μm - 5.0 μm
- ▶ Ø1/2" and Ø1" Sizes Available

- t = window thickness $t = 5 \text{ mm}$
- r = unsupported window radius $r = 10 \text{ mm}$
- M = Modulus of Rupture, $M = 448 \text{ MPa}$
- SF = Safety Factor, $SF = 4$
- P = pressure differential $P = 37 \text{ MPa}$
