# Diameter uniformity along the z-direction (up to 1 inch) and $\phi$

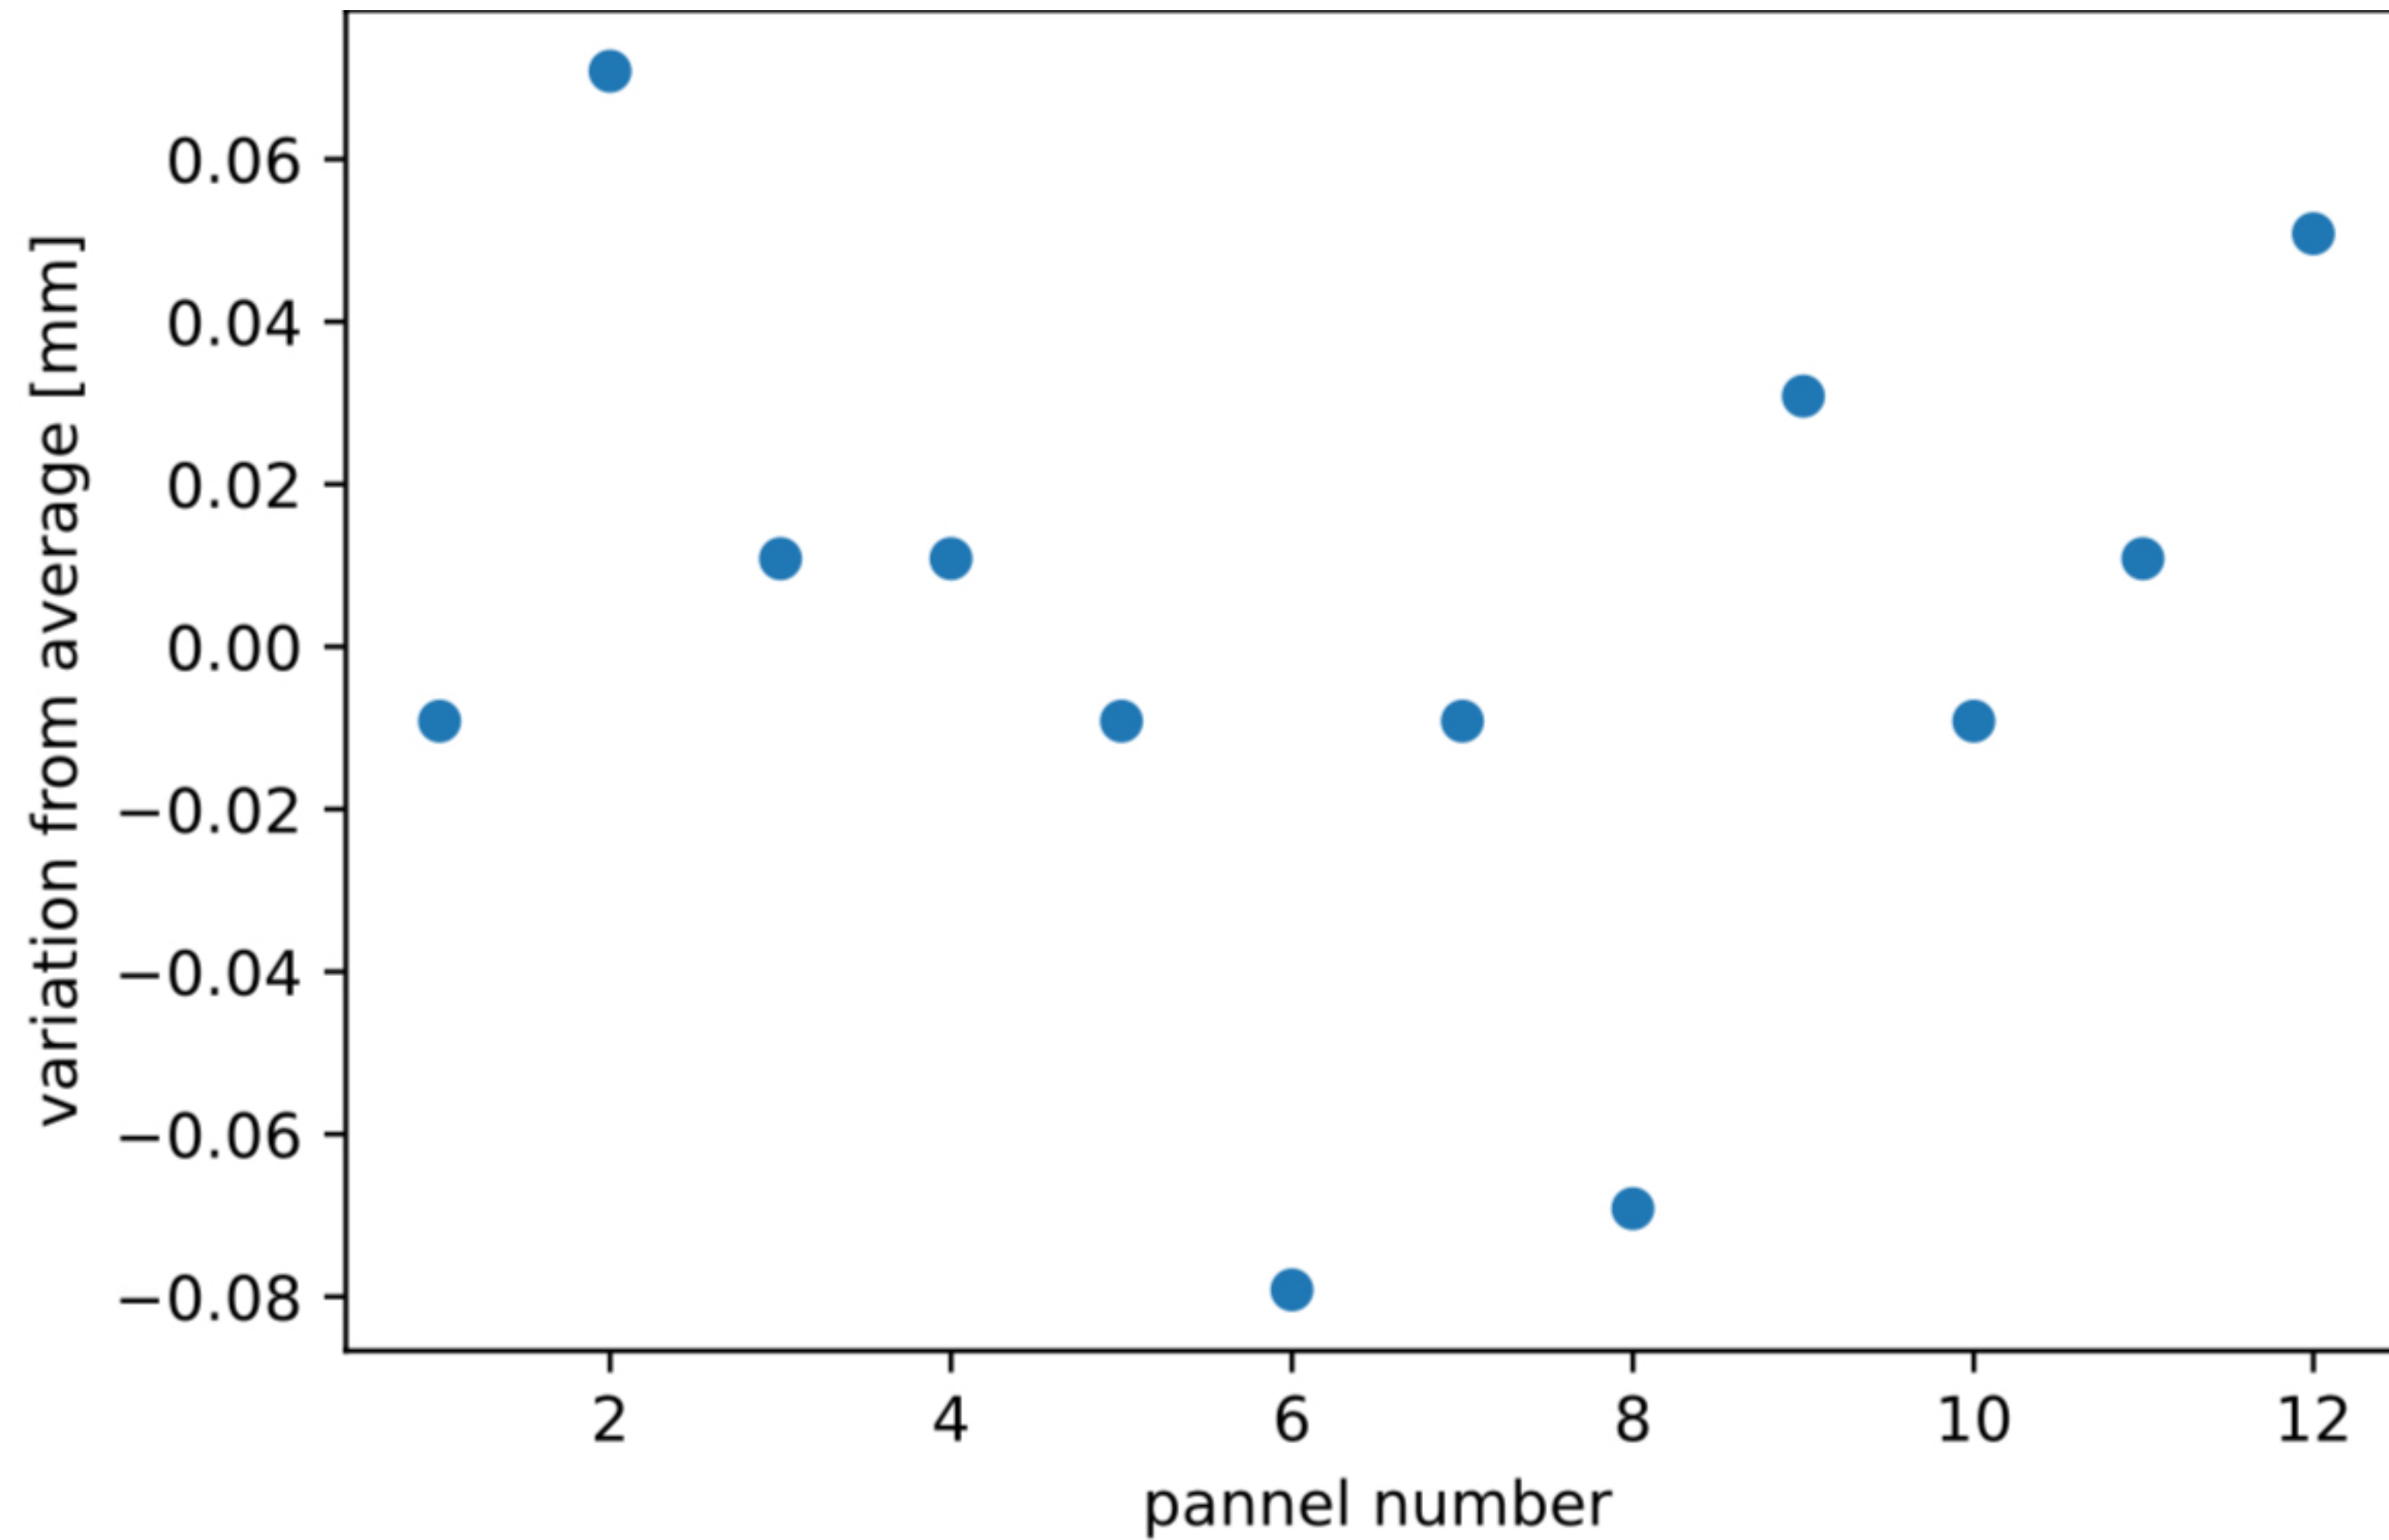
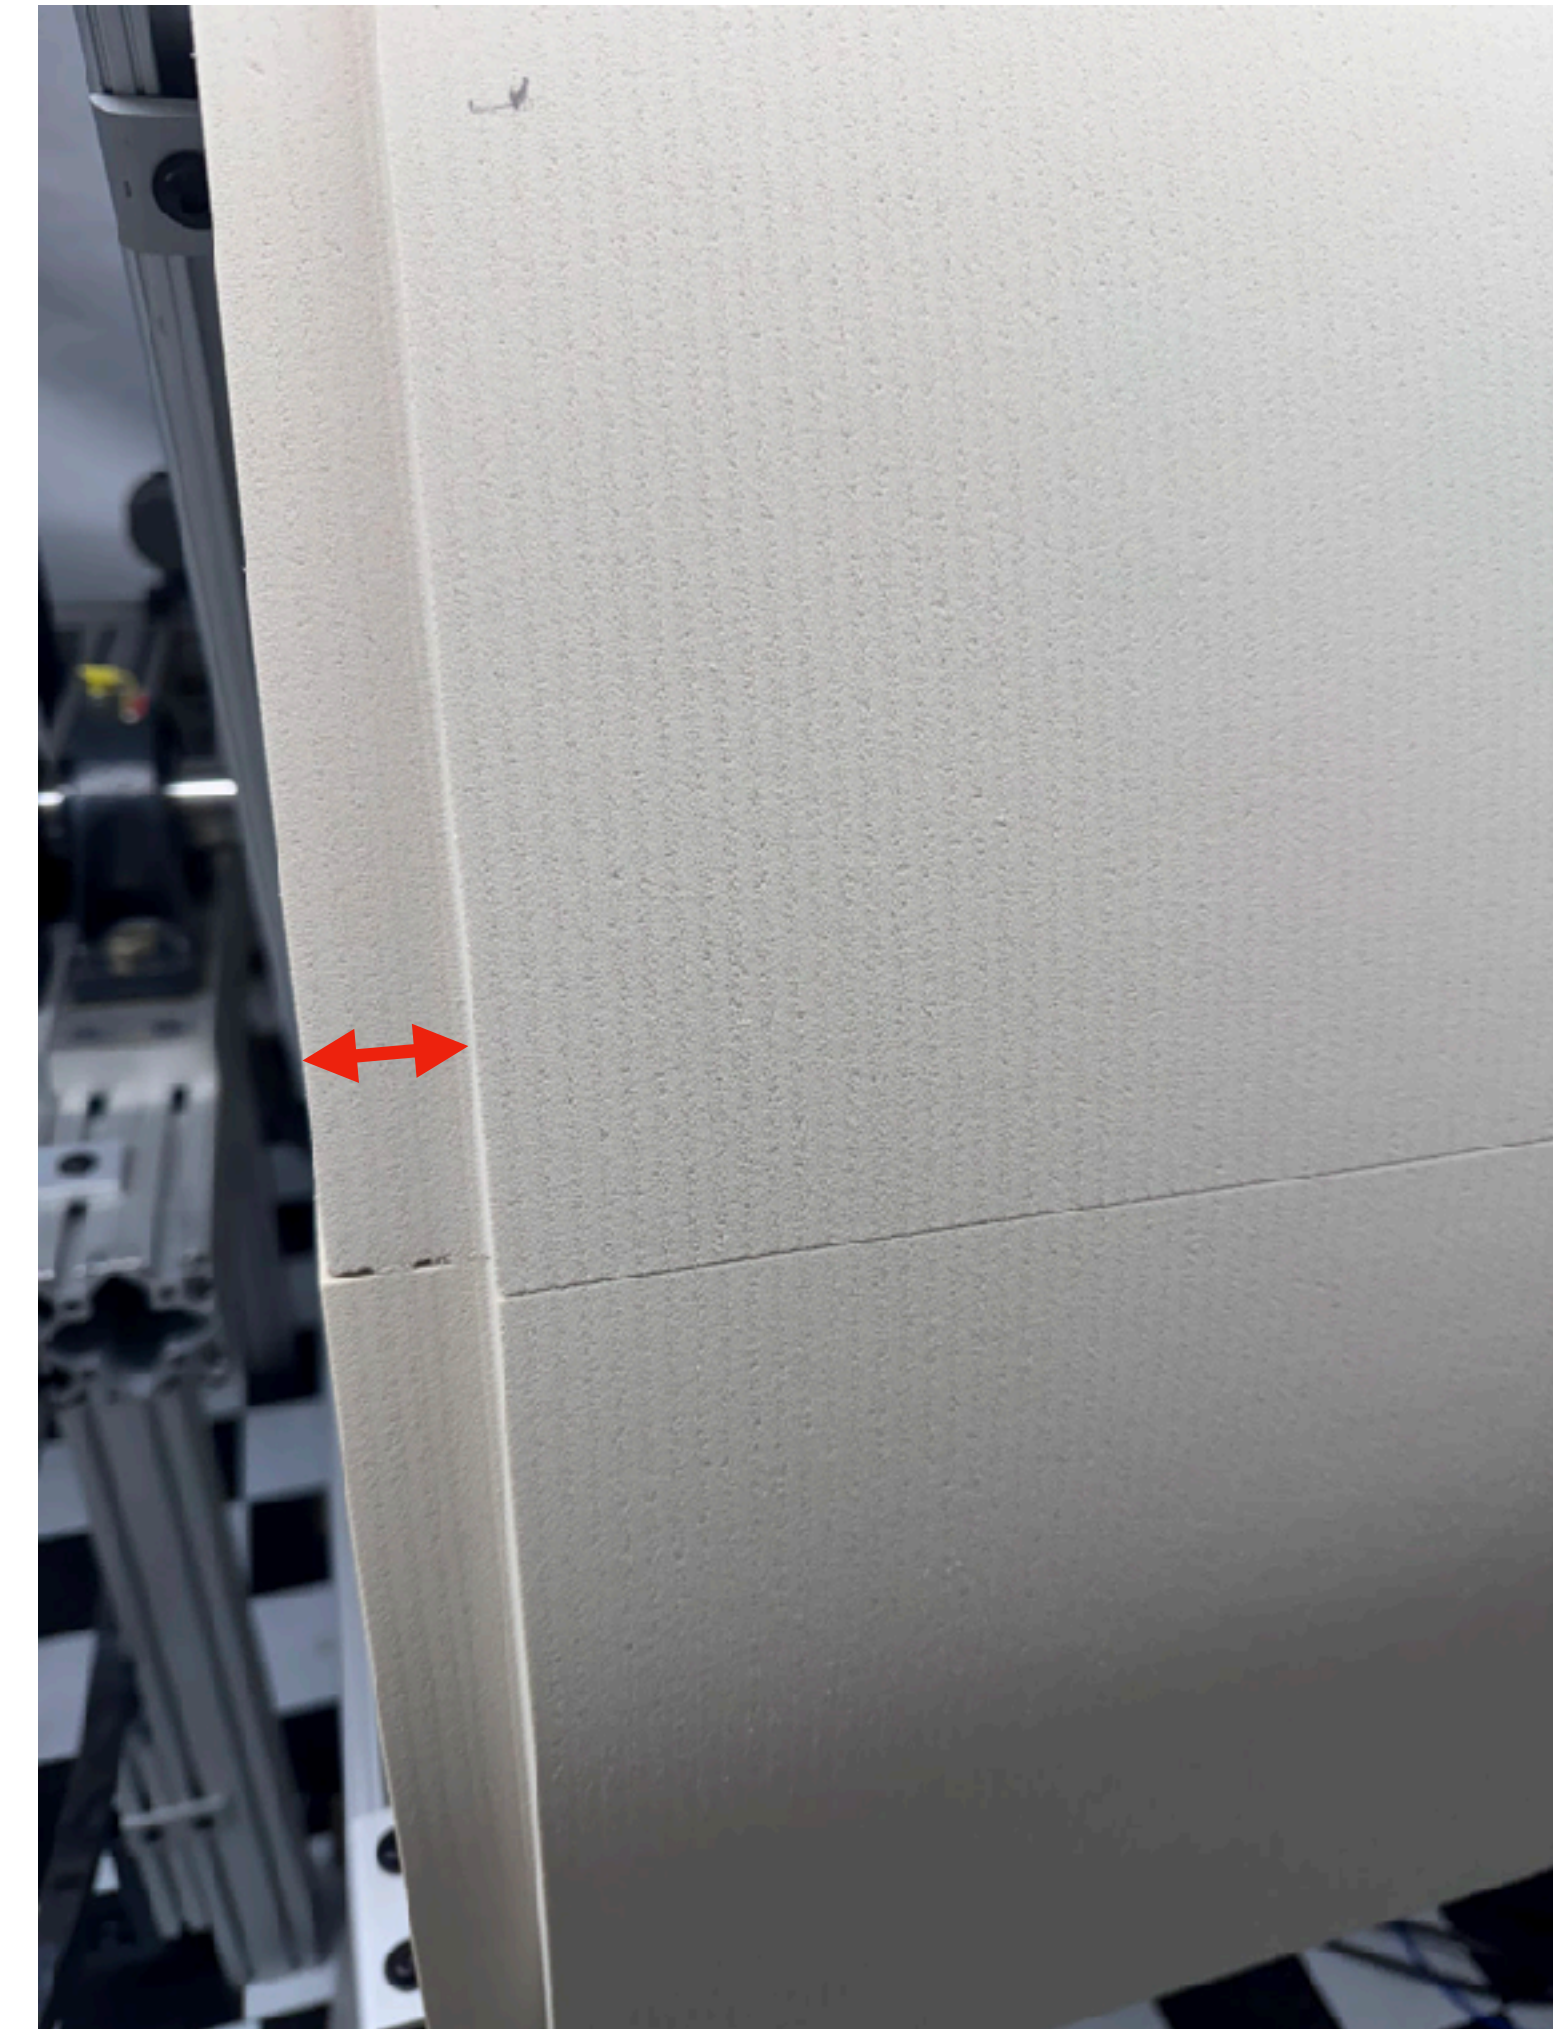
**The variation is negligible**

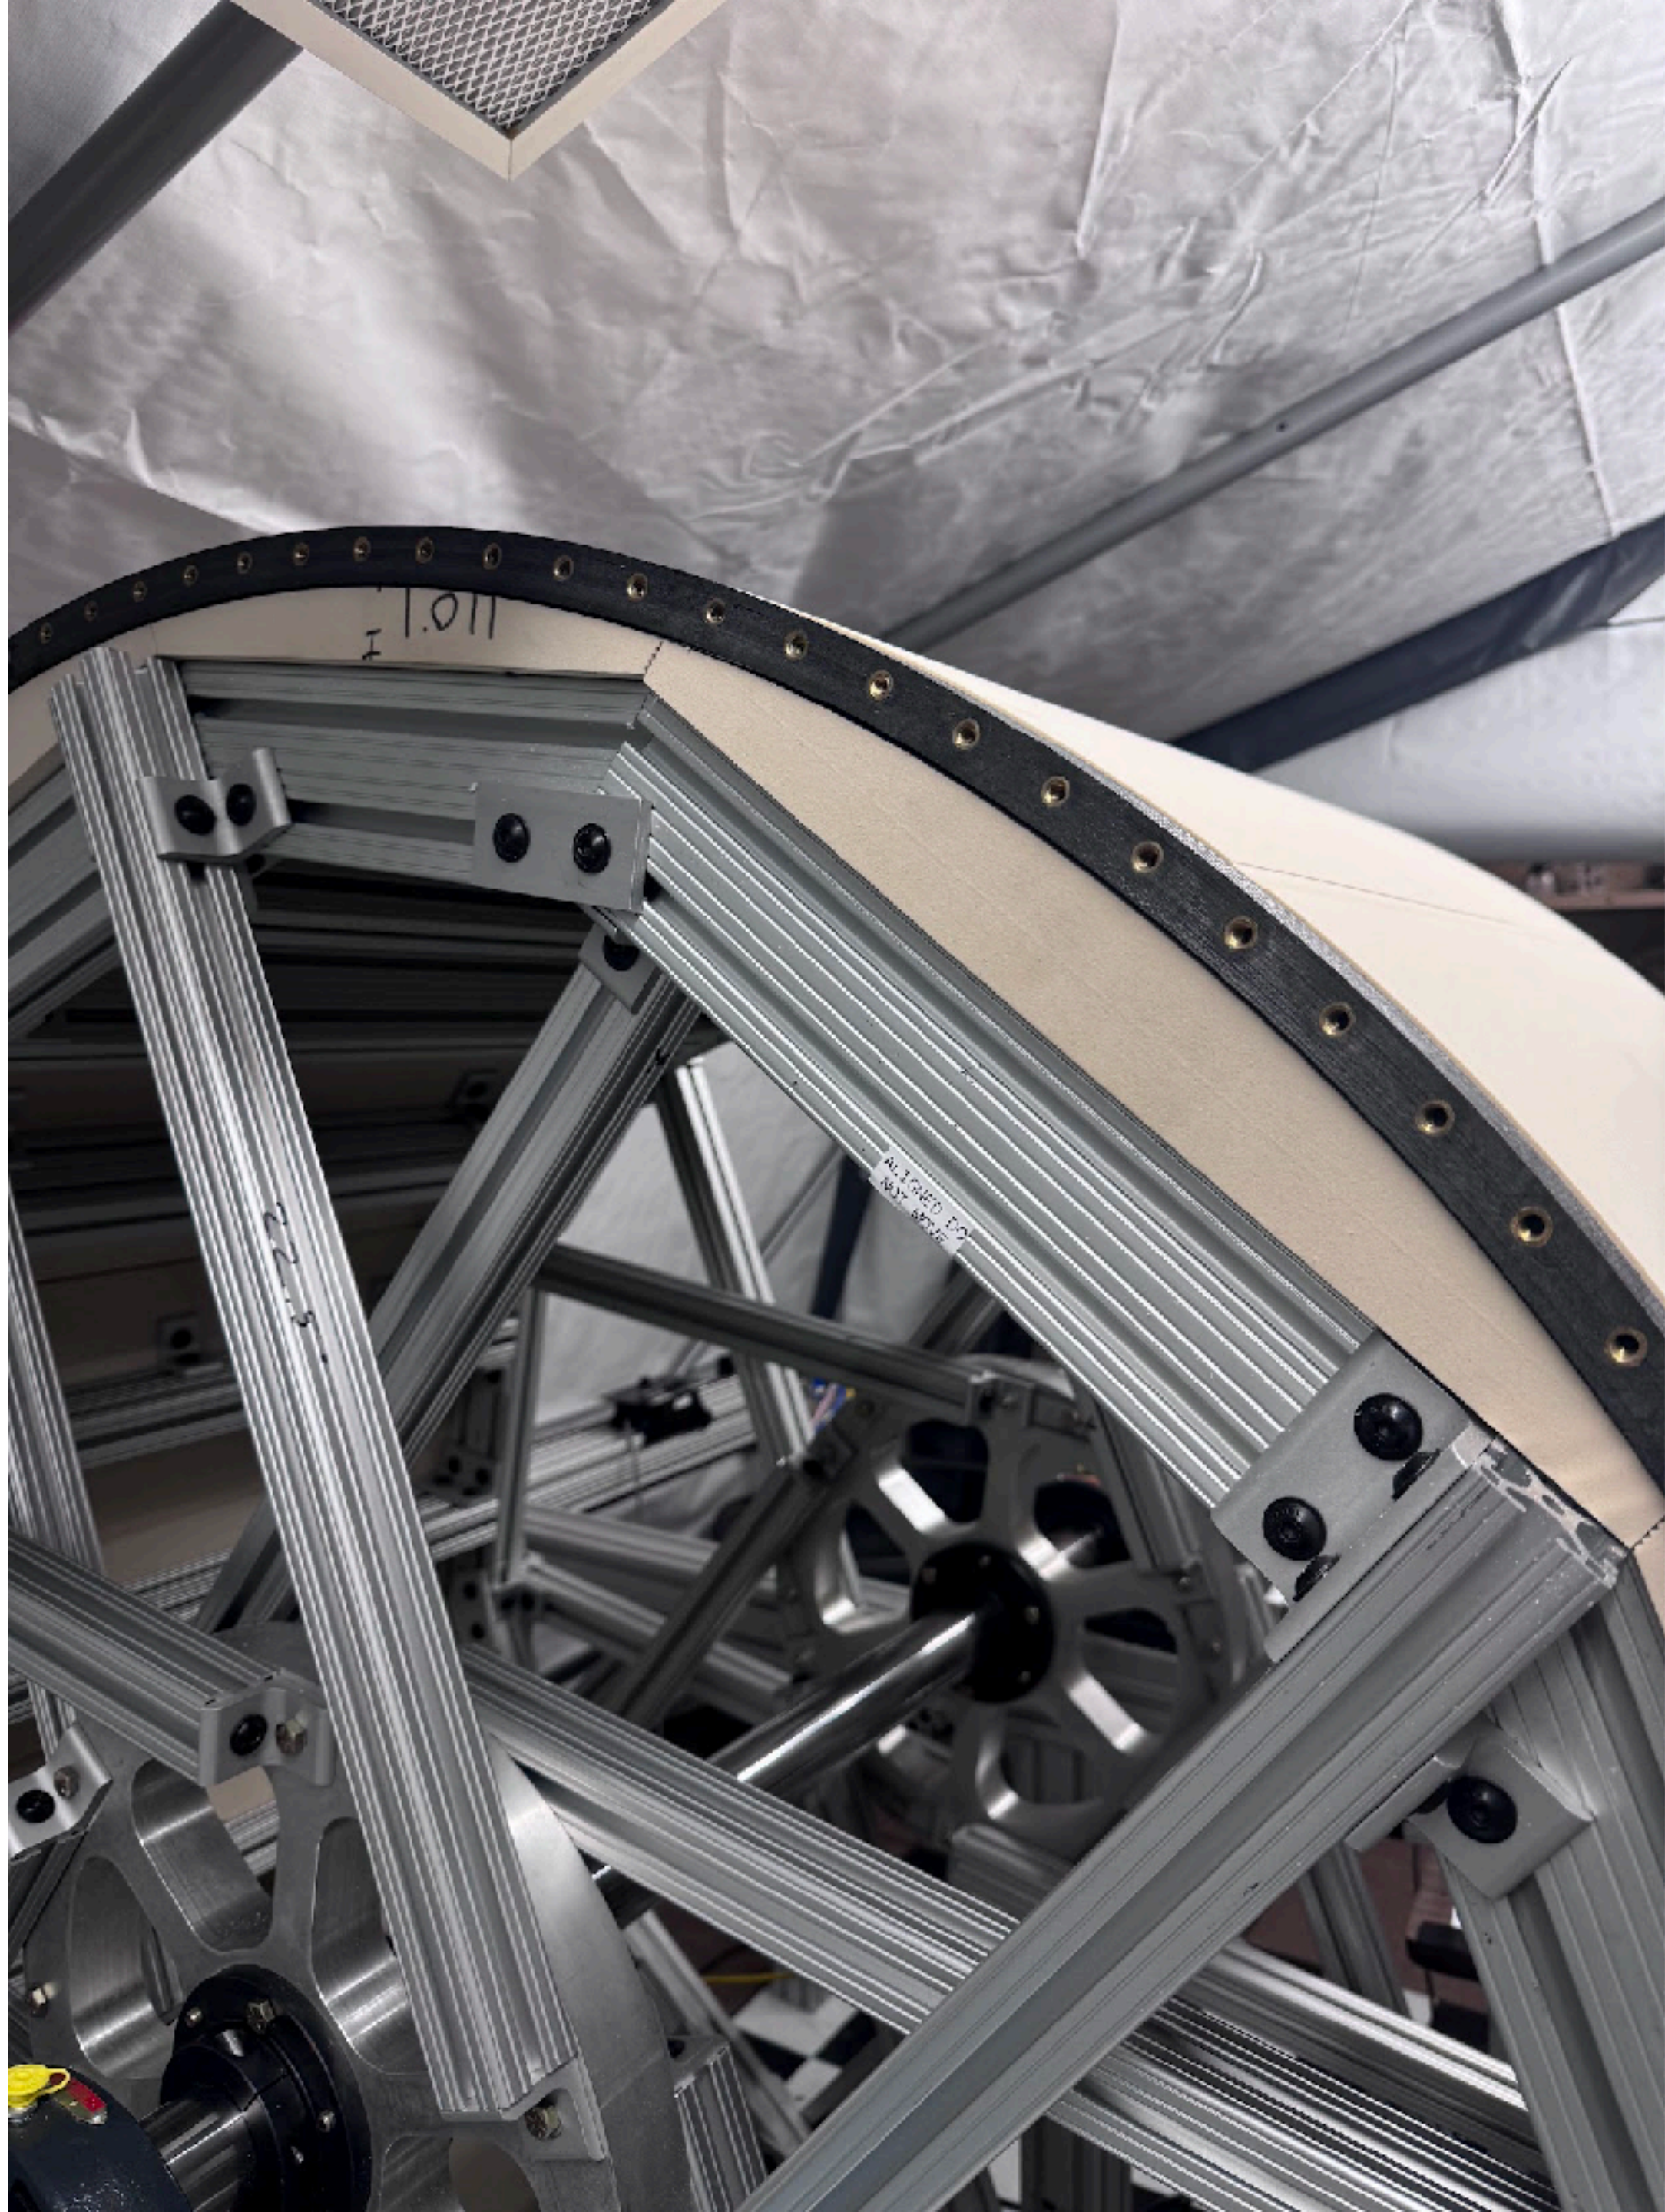
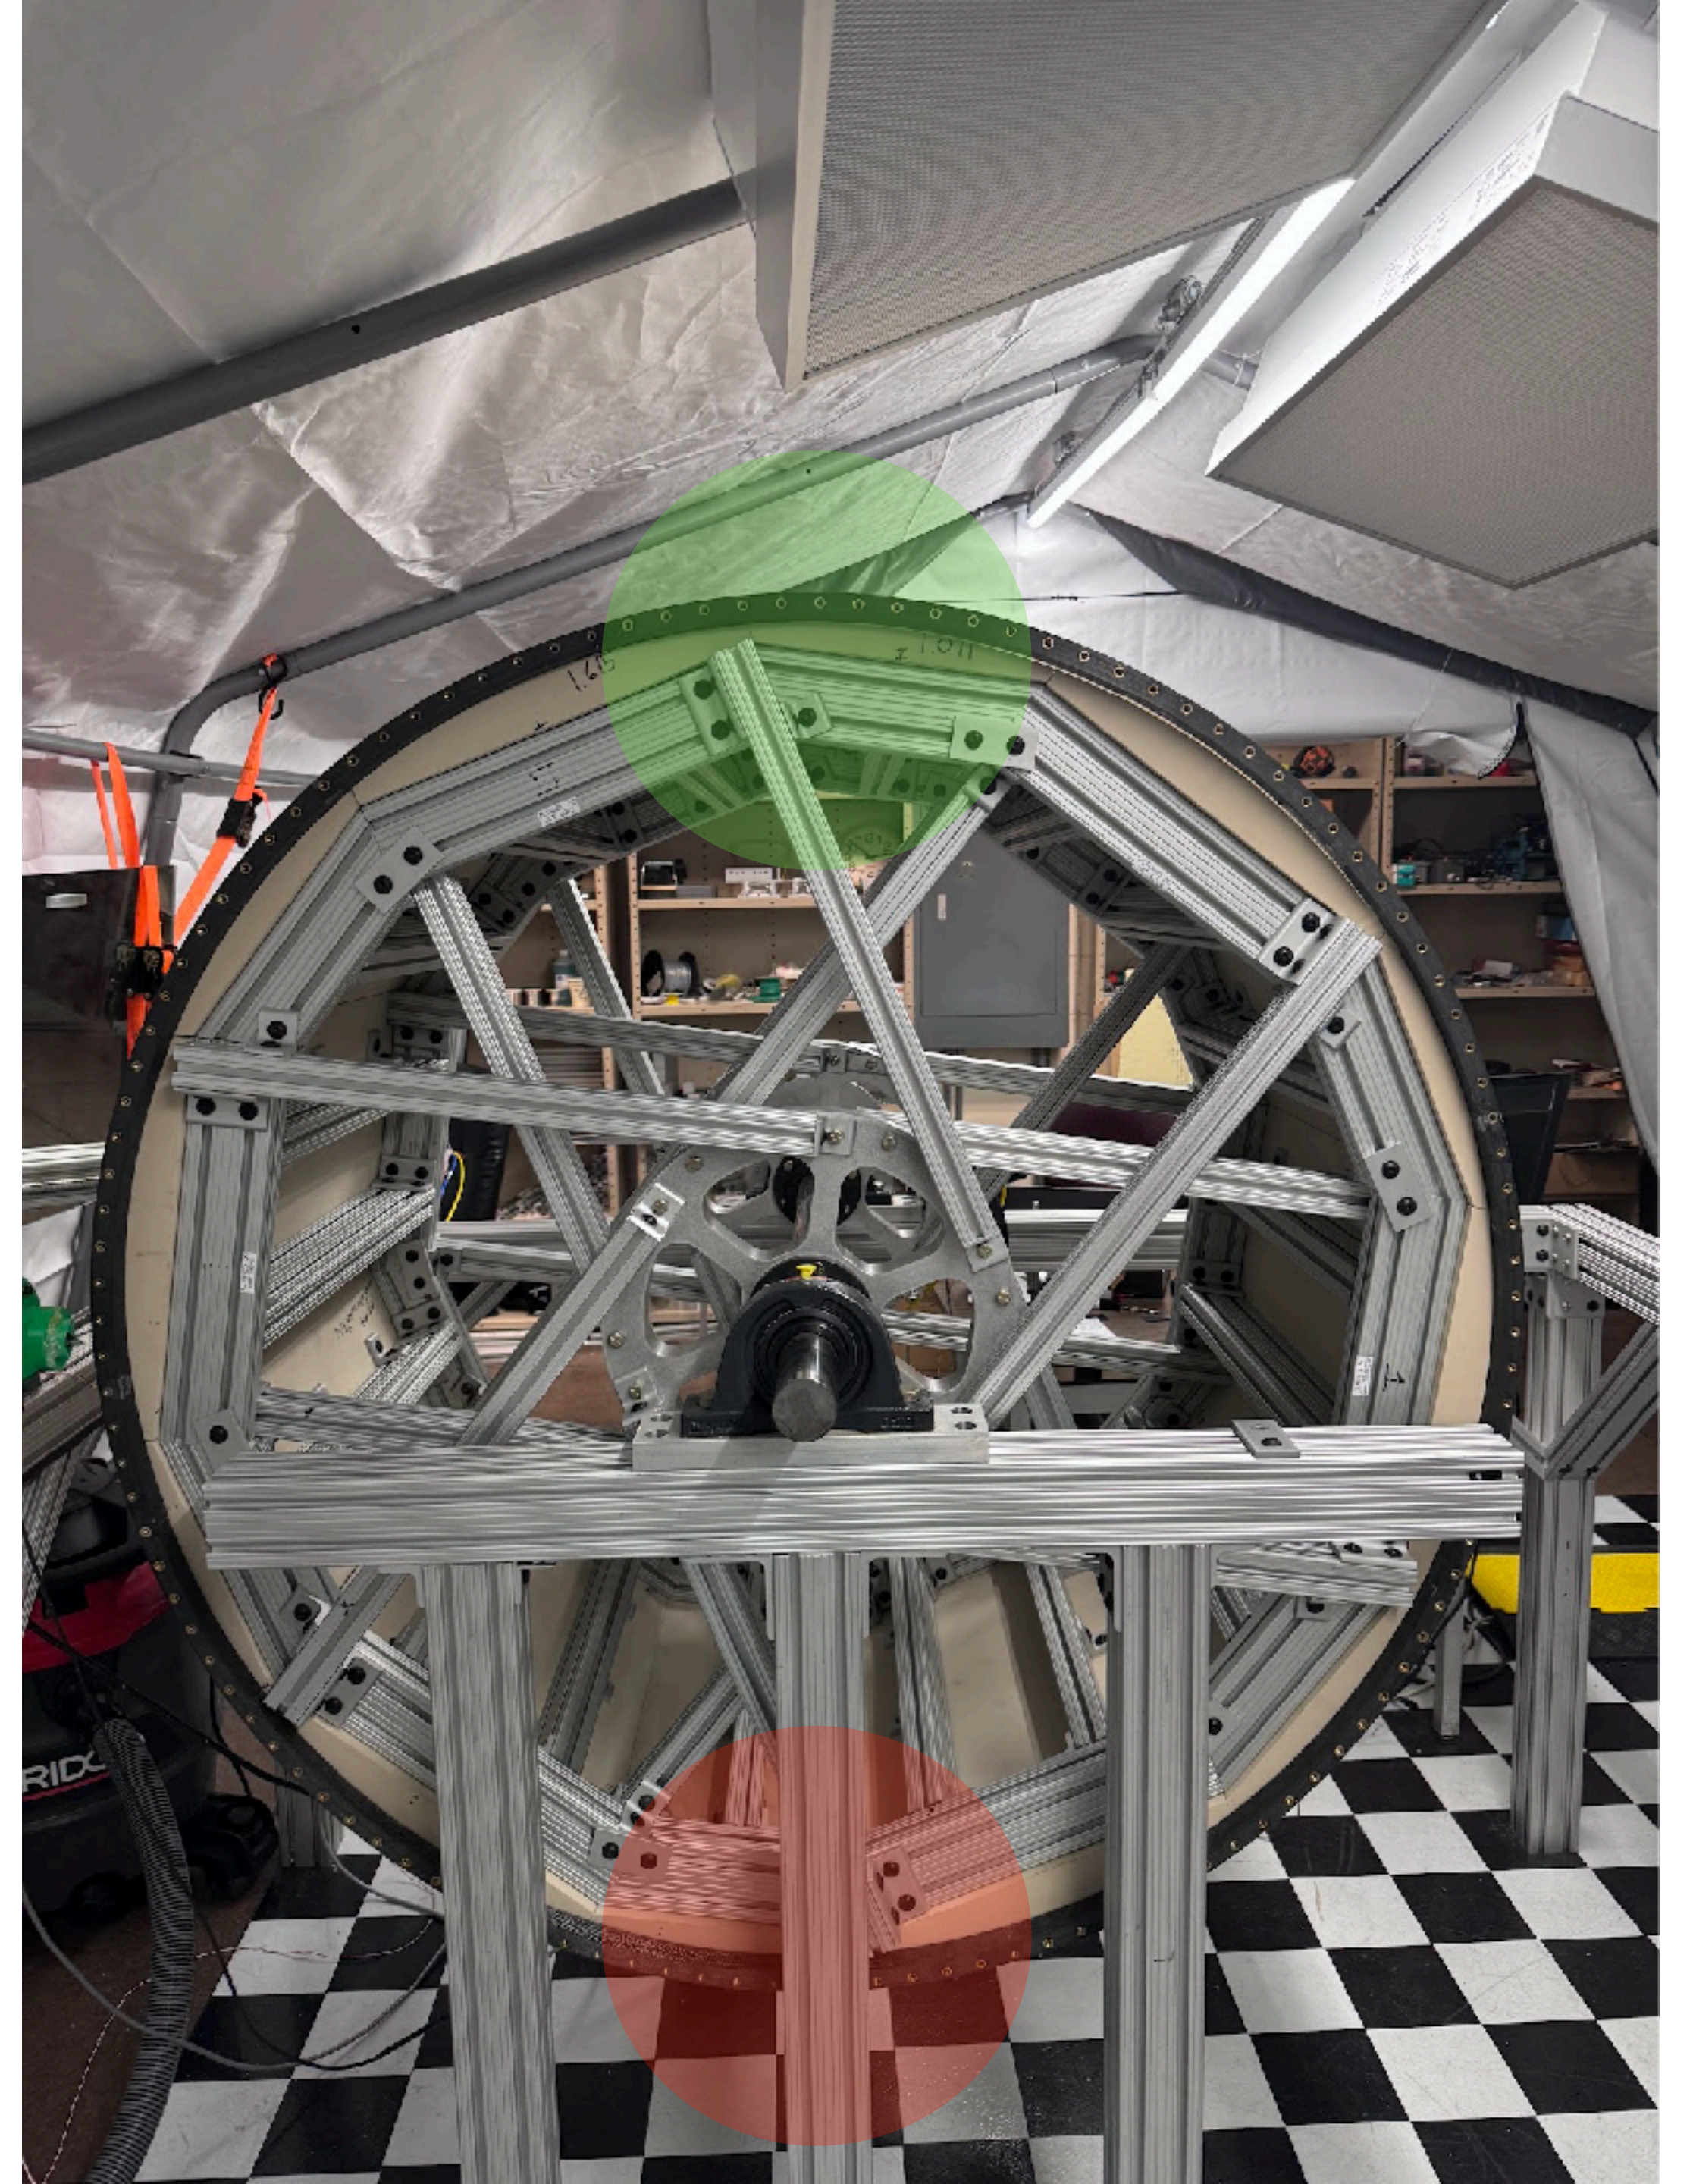
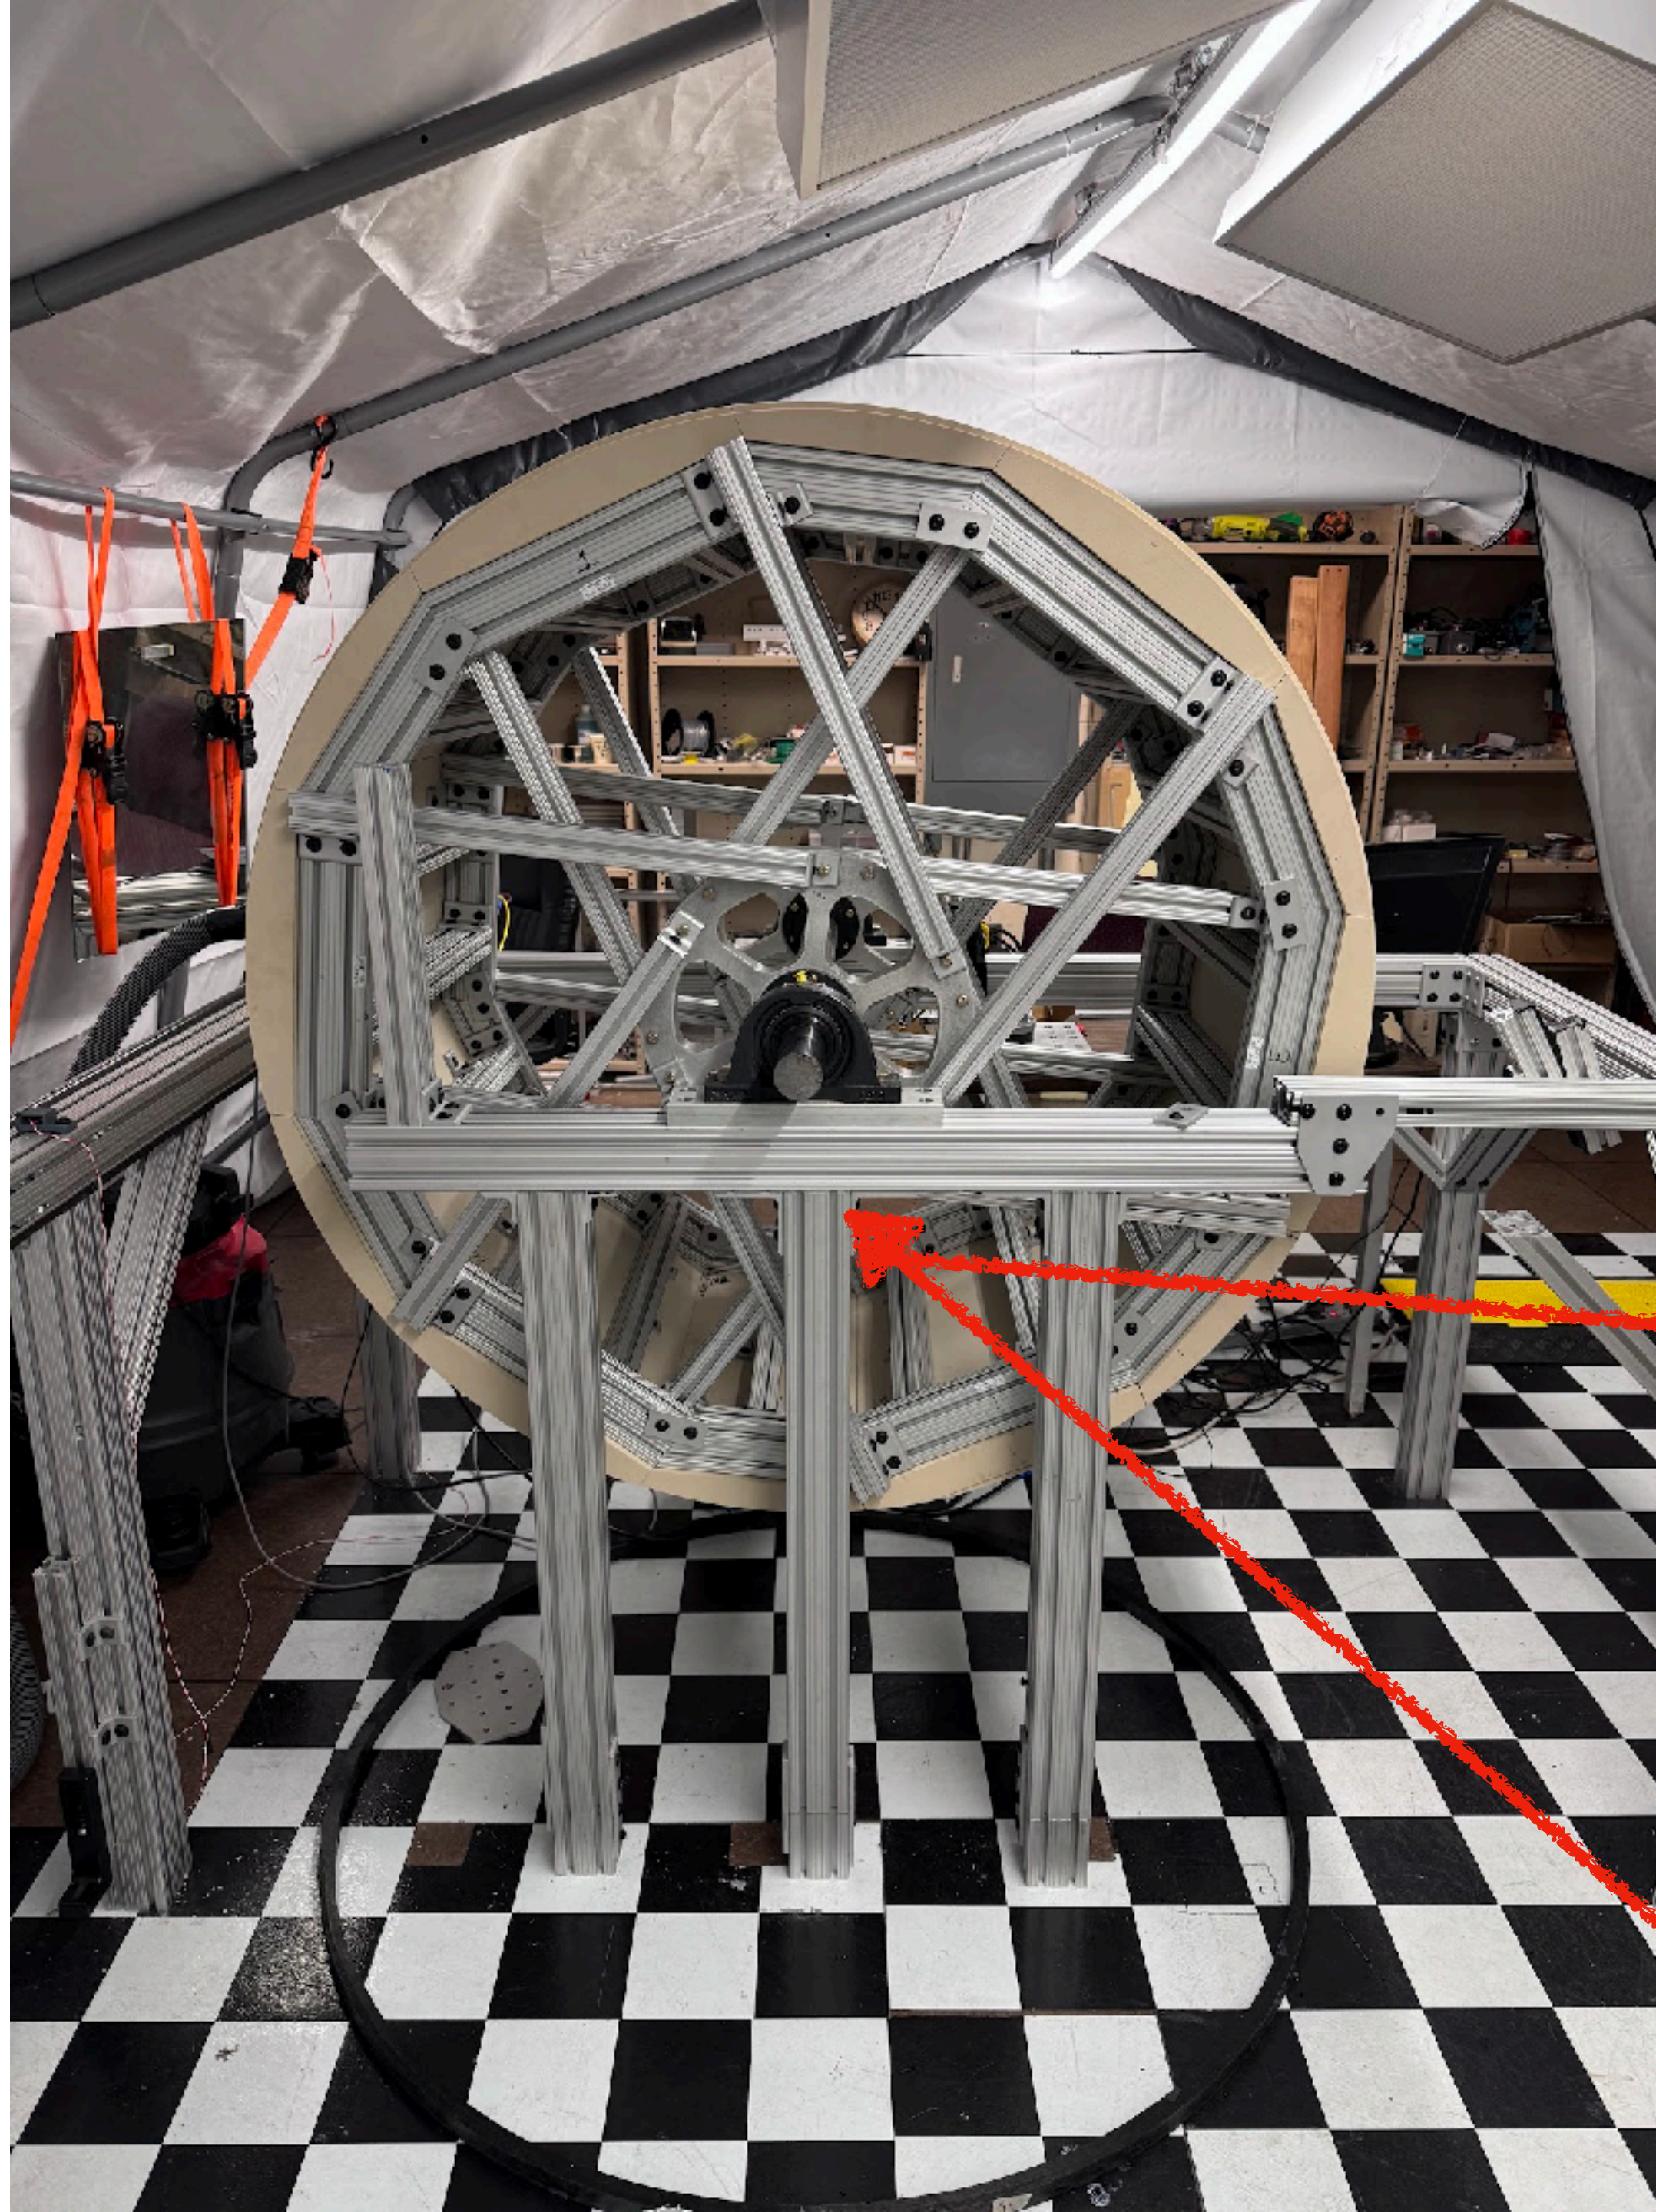
**We modified the 8020 setup to install the end rings**

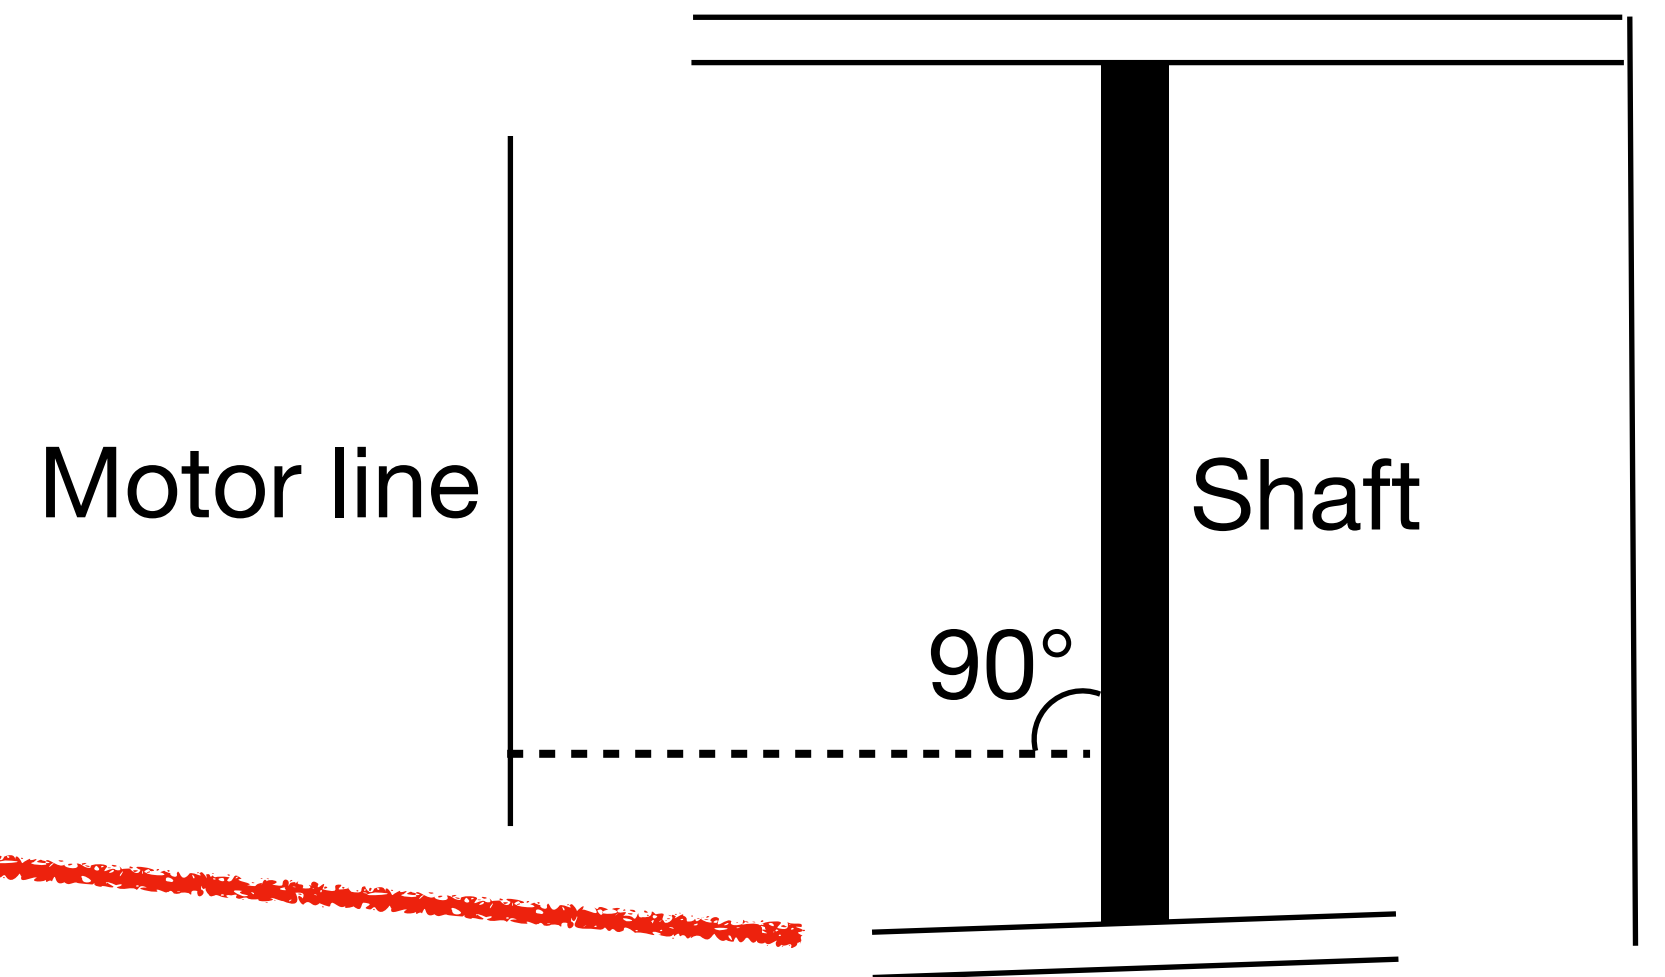
**The shaft is aligned with the motor line**

**The 3 front legs need to be better aligned**
