# Er1 High Speed test-chip Irradiation tests.

# Aims + Overview

To irradiate a test chip to evaluate the breaking point by taking current measurements, eye-diagrams for signal /data communication analysis.

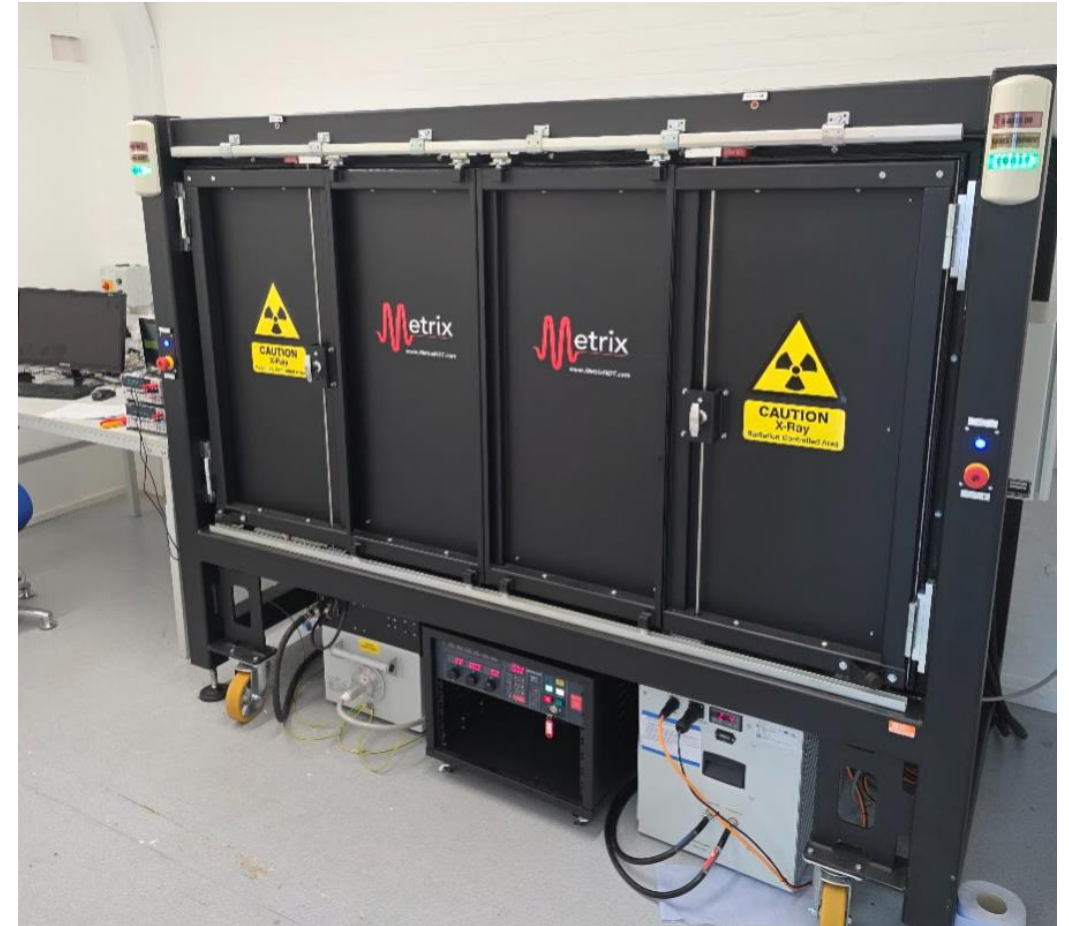
**The test chip was wire-bonded onto a test board and loaded into the x-ray chamber, aligned and set to a height of 33mm**

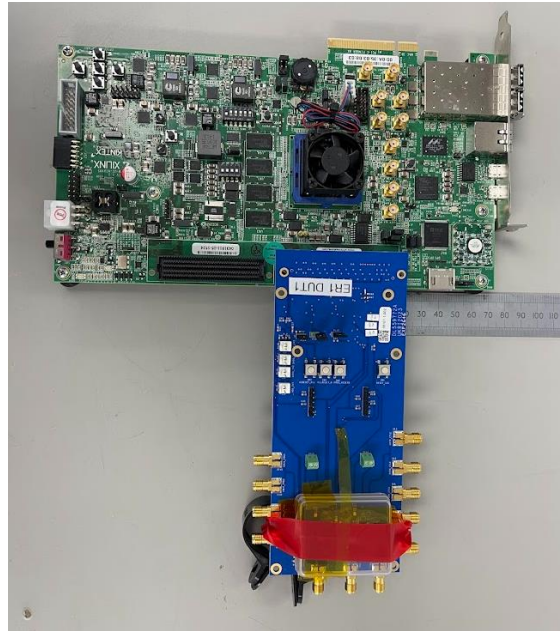
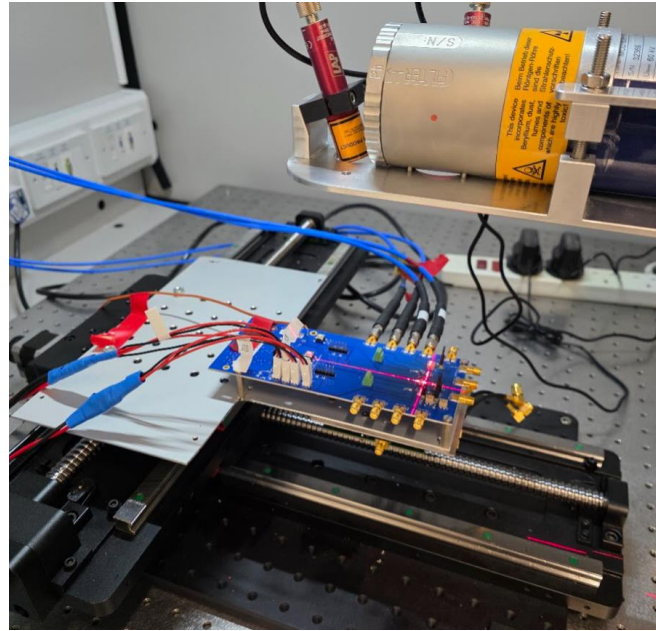
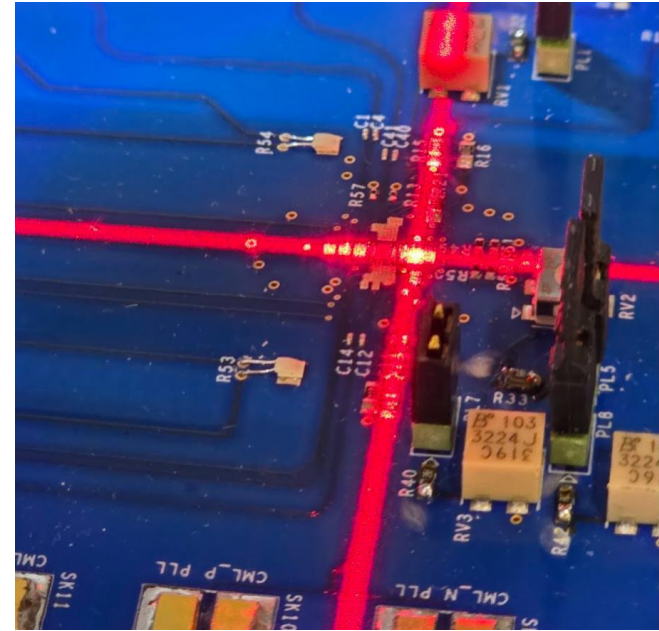
# Set up for manual irradiations

4GBits/s 2GHz signal was inputted into the CTLE provided by the KCU105 via SMA cables. Programmed through Vivado.

This signal was measured using the oscilloscope and eye diagrams were generated after each irradiation step.

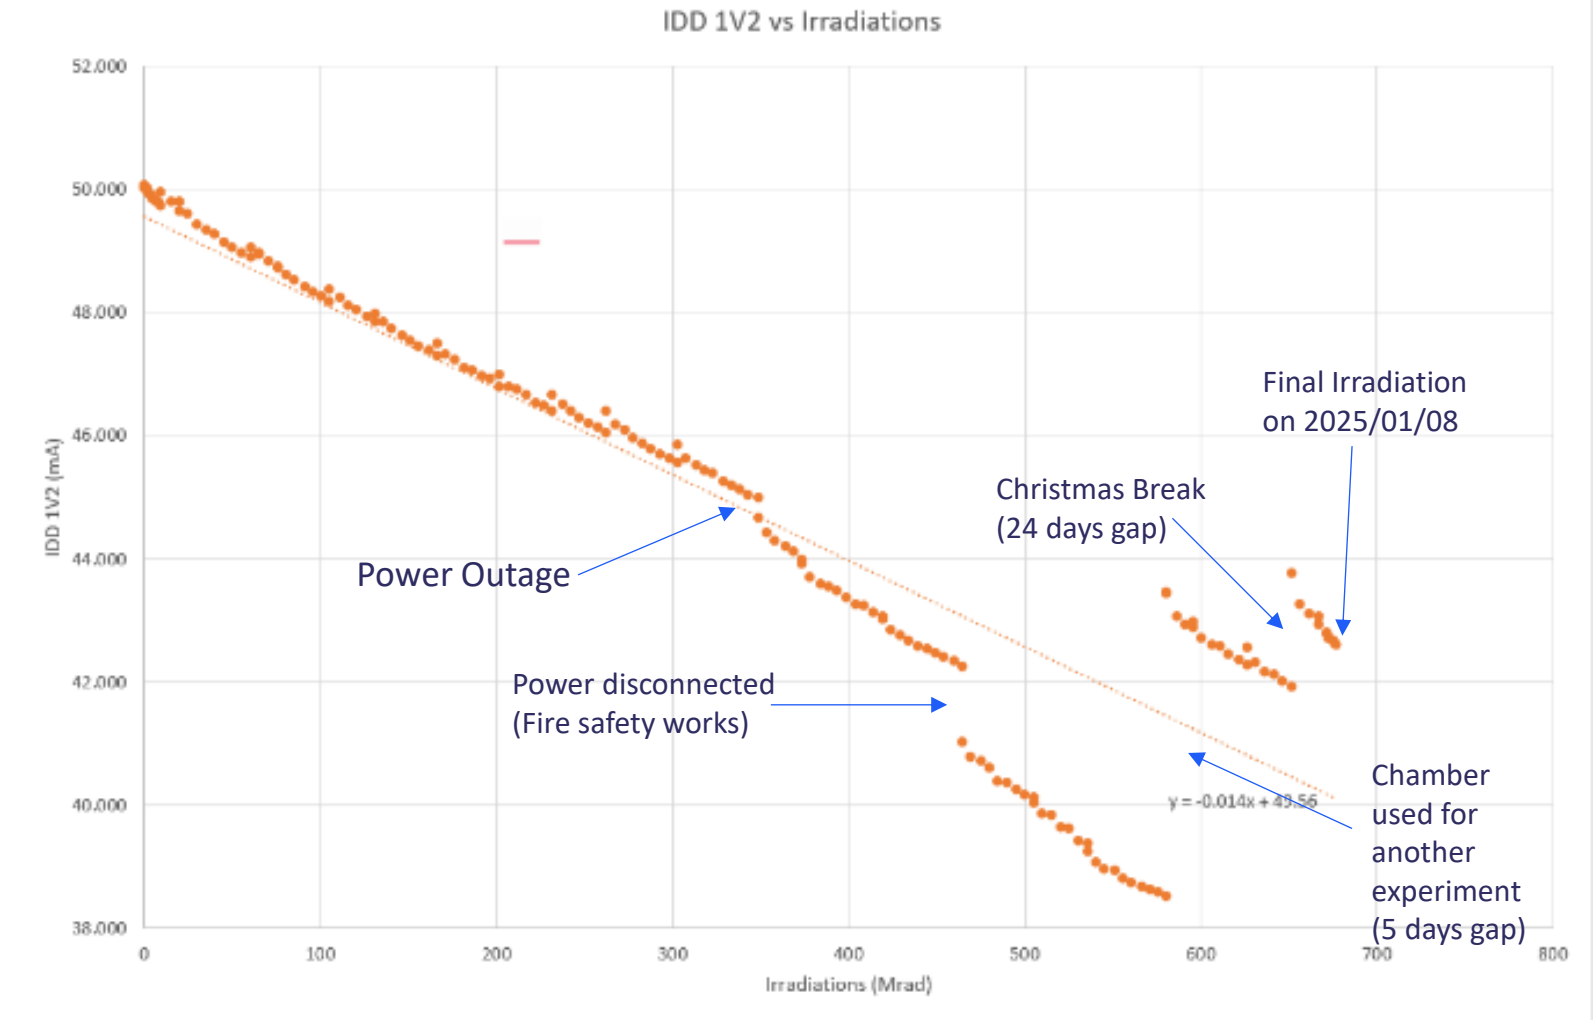
# Manual Irradiations Current measurements

- A linear decrease was seen for the 1V2 rail.
- Between days a small increase was seen due to annealing.
- Discontinuity of measurements due to manual use.

**Overall the chip was irradiated to a TID of 667 Mrad.**

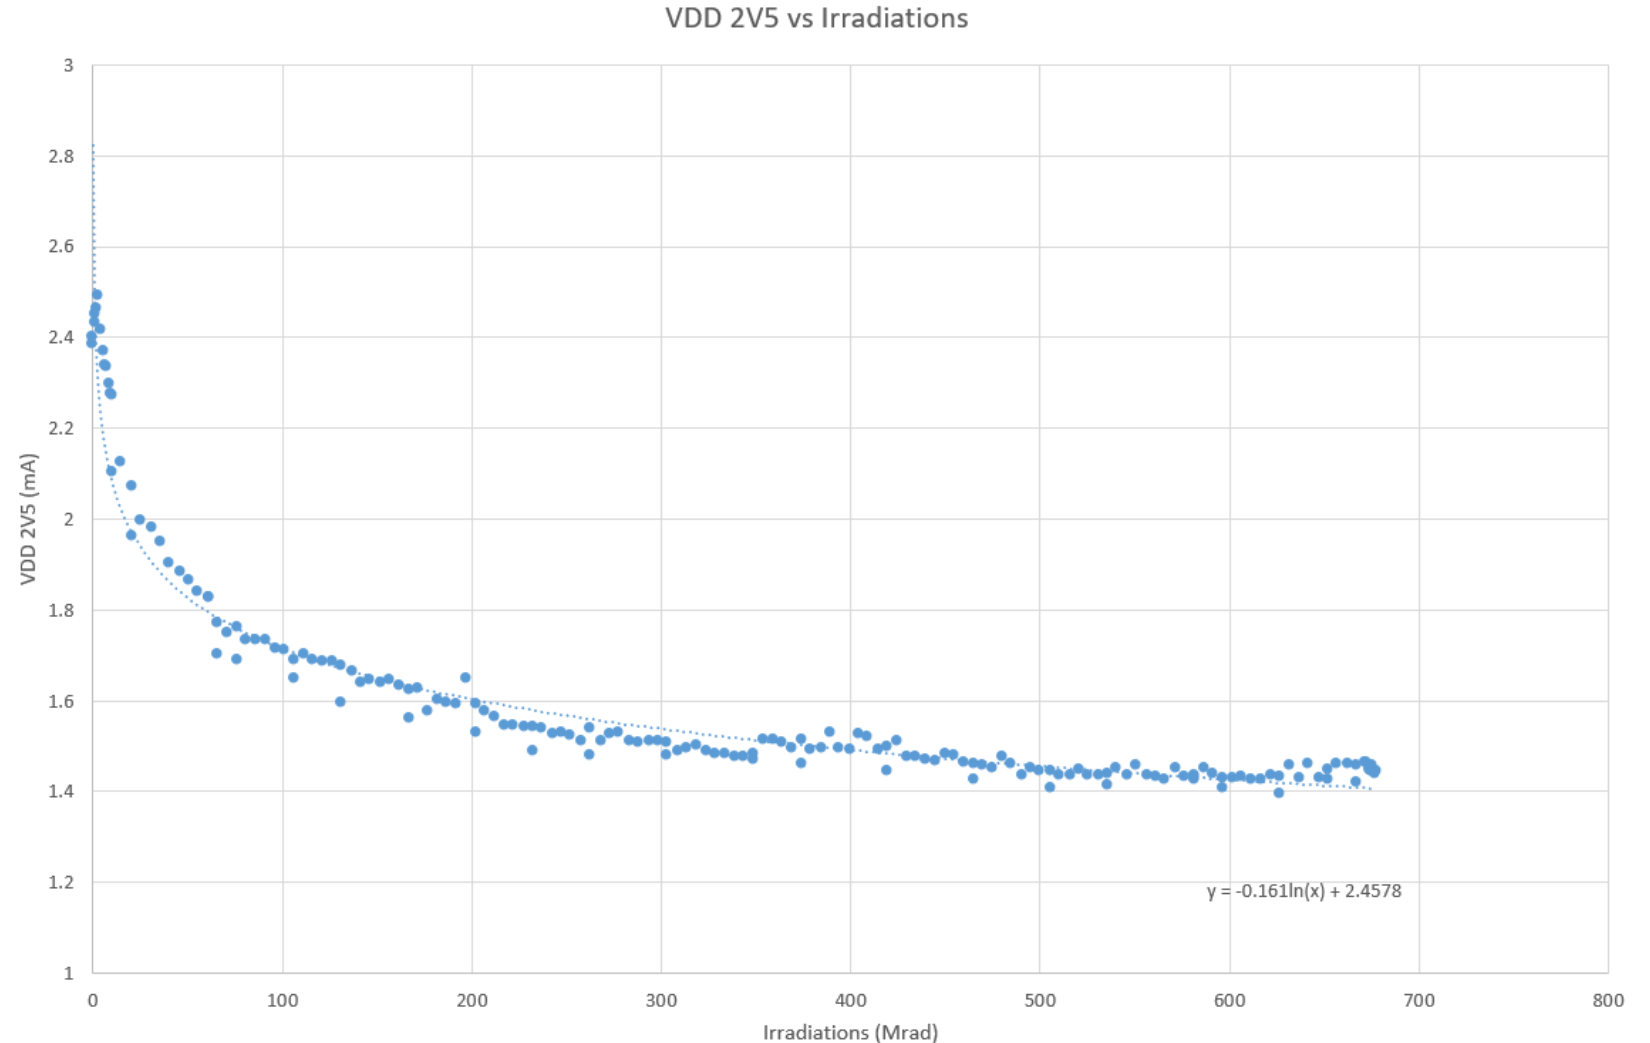
# Manual Irradiations current measurements

- 2V5 rail
- The measured current decreased at a decreasing rate before 'averaging' at ~1.5mA

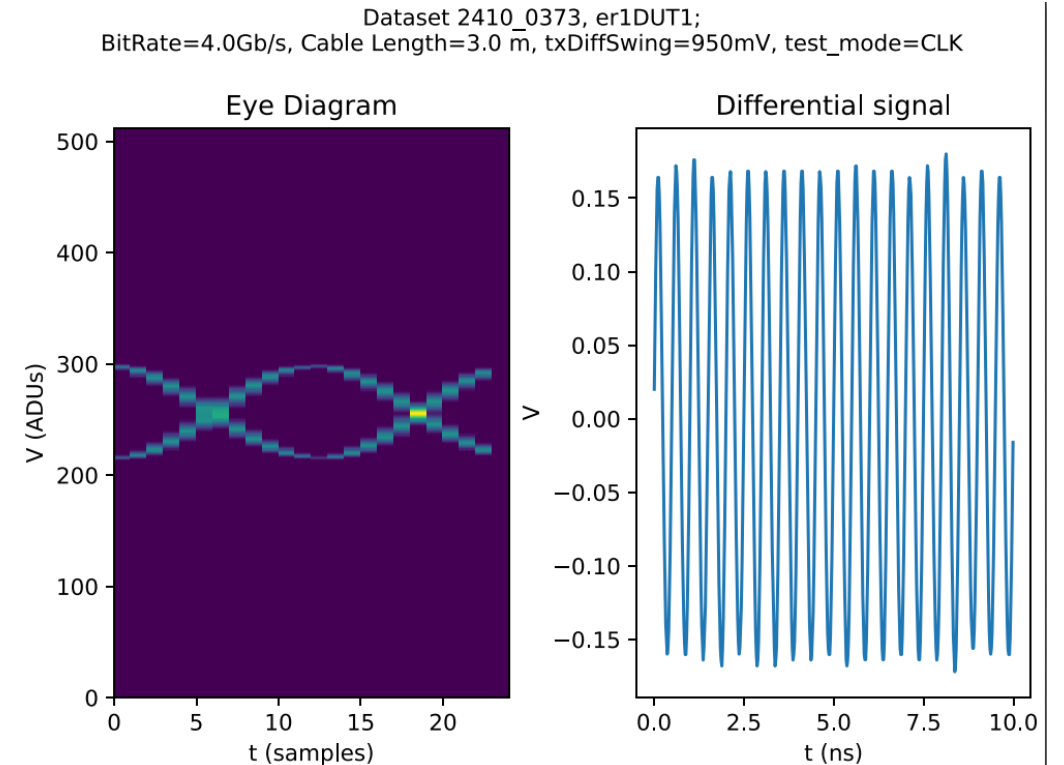
## After 667 Mrad of TID Final data (date)

Amplitudes of the signal expectedly decayed over applied TID.  
Amplitude started at 0.4V and decreased to slightly more than 0.3V.

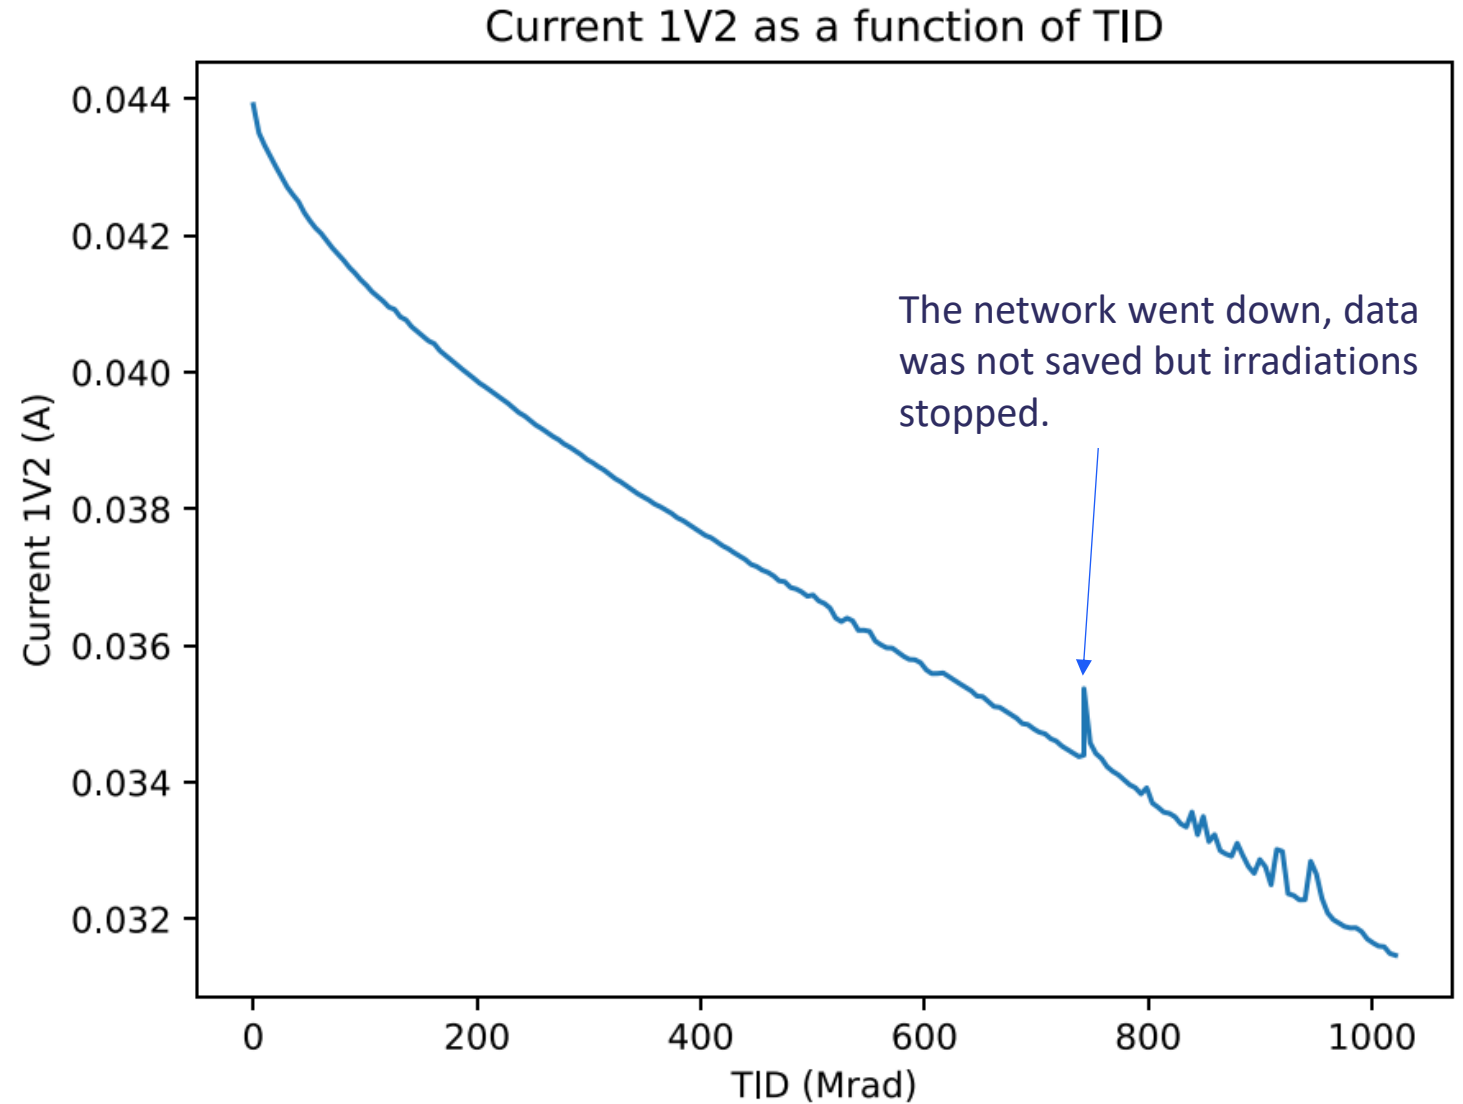
# Results from Auto-Irradiations

- Follows the same trend as before.
- Chip has not been allowed to anneal.

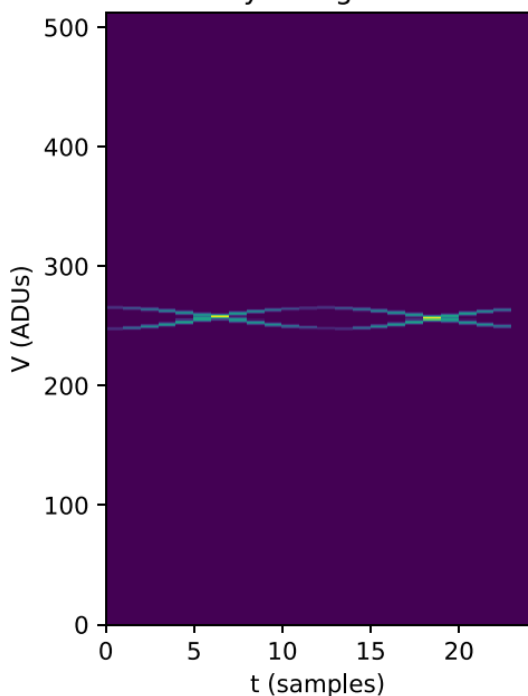
Eye Diagram

Dataset 2501\_205, er1DUT1;  
BitRate=4.0Gb/s, Cable Length=3.0 m, txDiffSwing=950mV, test\_mode=CLK
