LAr R&D Progress Updates

Yichen

9/2/25

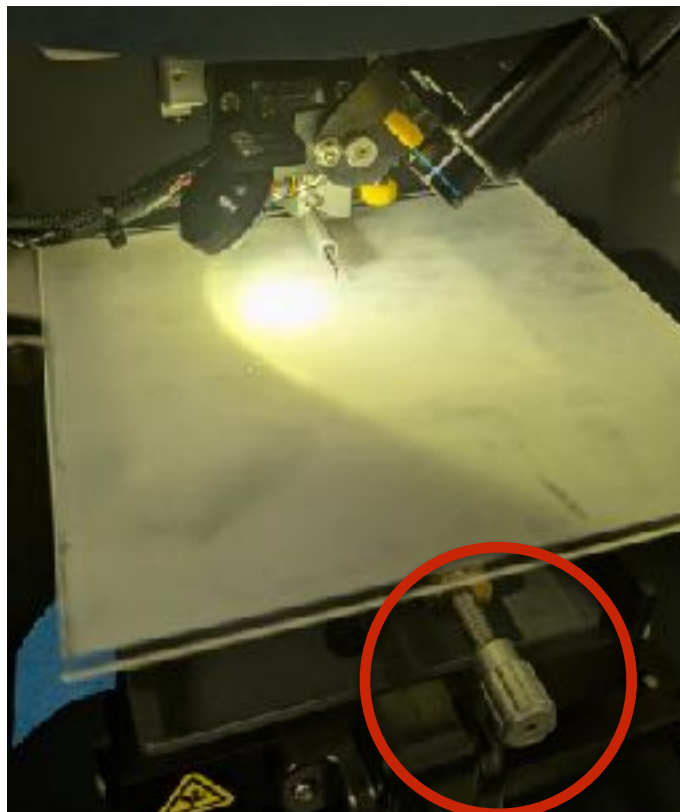
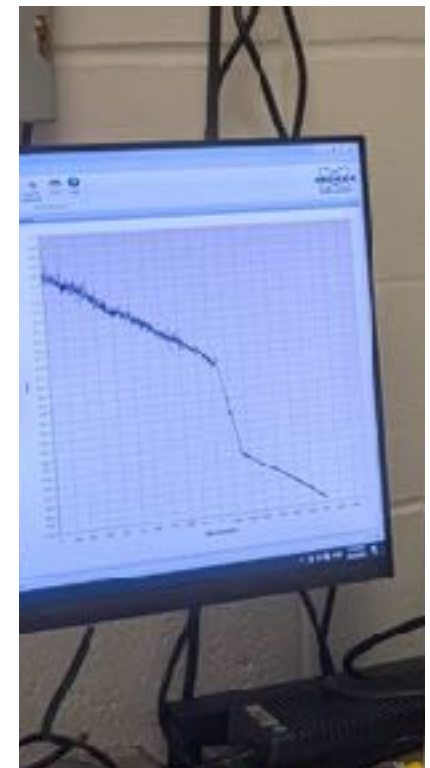
Thickness measurement

- **Improvement on the profilometer thickness measurement**
 - I was suspecting the moving stage is not leveled up
 - Learned from Abdul about the way of adjustment, 1-D adjustment
 - Ensuring the raw data is flat before software correction, down to 6.5 um range
 - The flatness of the holder platform
 - Cleaned up the platform carefully with compressed air and alcohol
 - Clean the back of the substrate

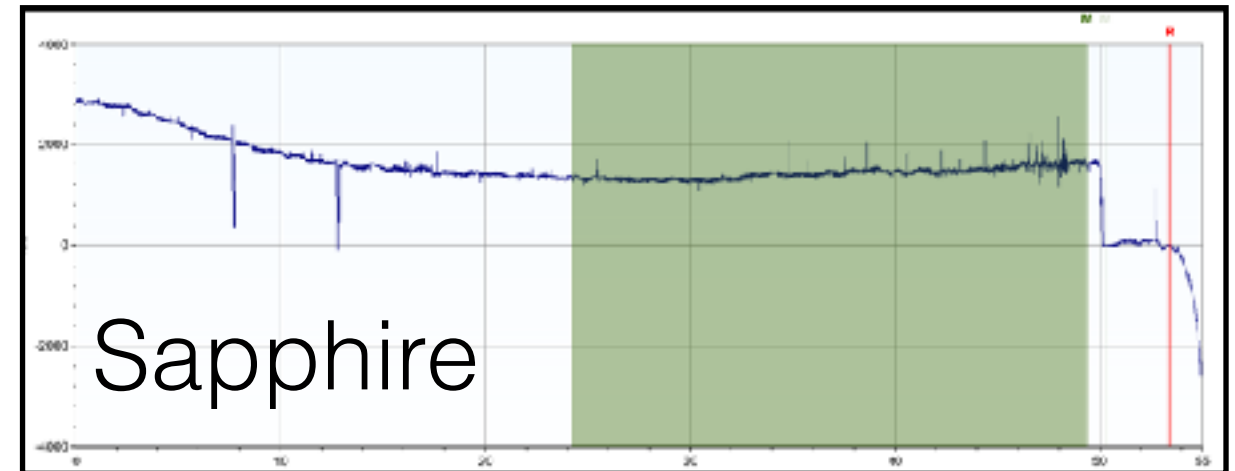
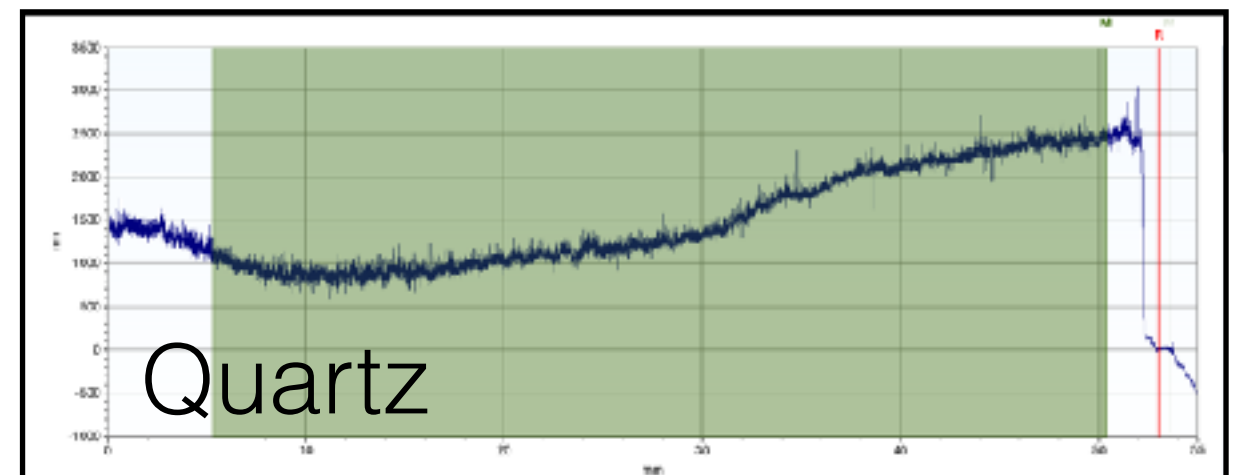
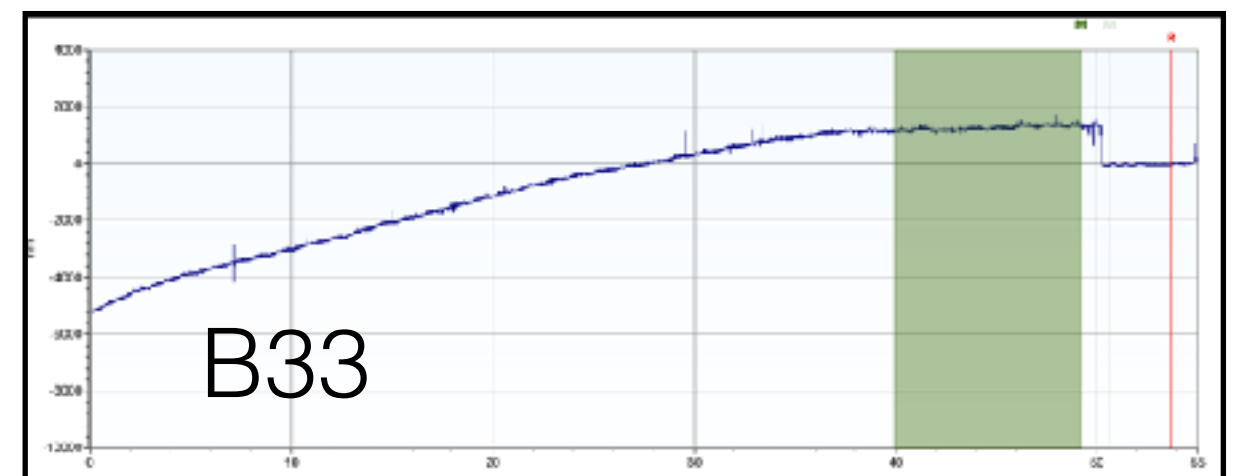
Thickness measurement

► Results after adjustment

- The general ramping feature does not change with the attempted adjustment
- The feature observed is the indication of the flatness of the substrates
 - Quite different flatness
 - No way to further improve with the profilometer
 - The profilometer method only works for short range from the step

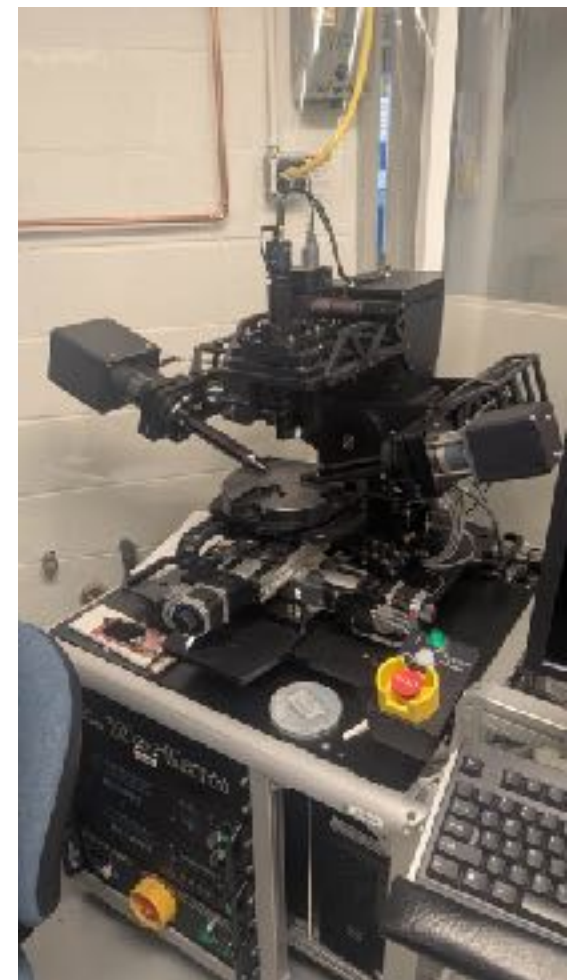
Thickness measurement

► Future thickness measurement plan

- The ellipsometer is the way to go
 - Pros:
 - Full surface coverage
 - Multiple points on the surface
 - Cons:
 - Need to properly modeling
- Abdul made attempted with the parameters of pTP
 - There is a converge issue with the model due to surface quality
- I'm going to work with Abdul tomorrow to learn the operation of the ecllipsometer
 - I've went thru the manual over the weekend
- Abdul also mentioned a microscope method we will discuss tomorrow

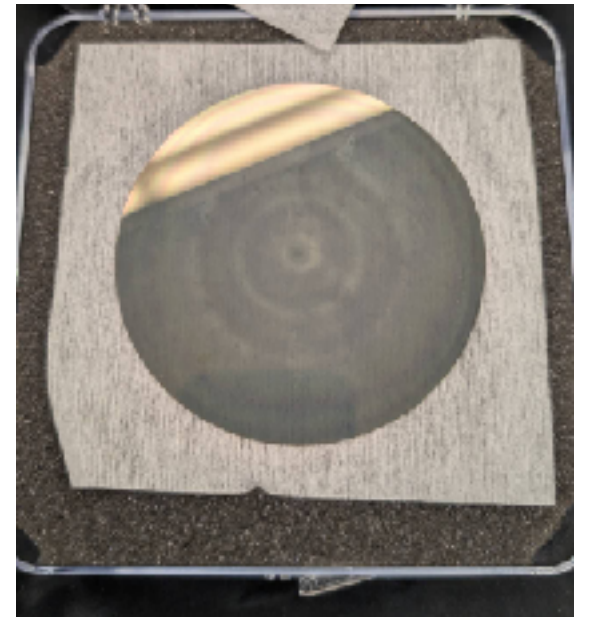
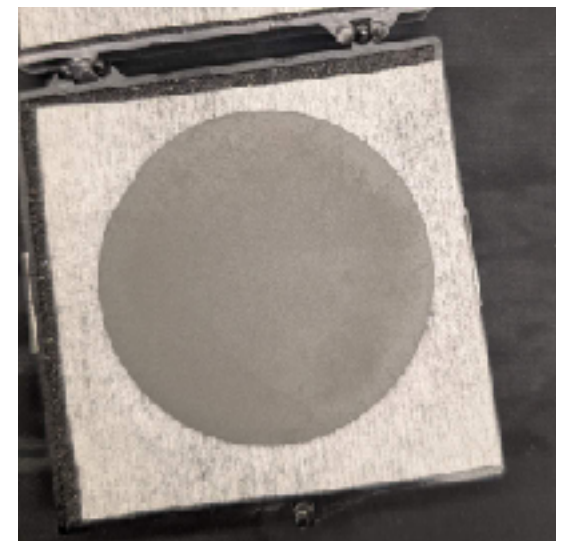
Diamond substrate measurement

▸ Alpha source excitation measurement

- Erik at IO tried with the diamond powder coated samples with alpha source excitation
- No expected emission was observed
- Most likely, the coating is not crystalized enough
- Working with the German company for improvement
