# LAr R&D Progress Updates

# pTP filter cryogenic test in 260L system

# pTP coating comparison

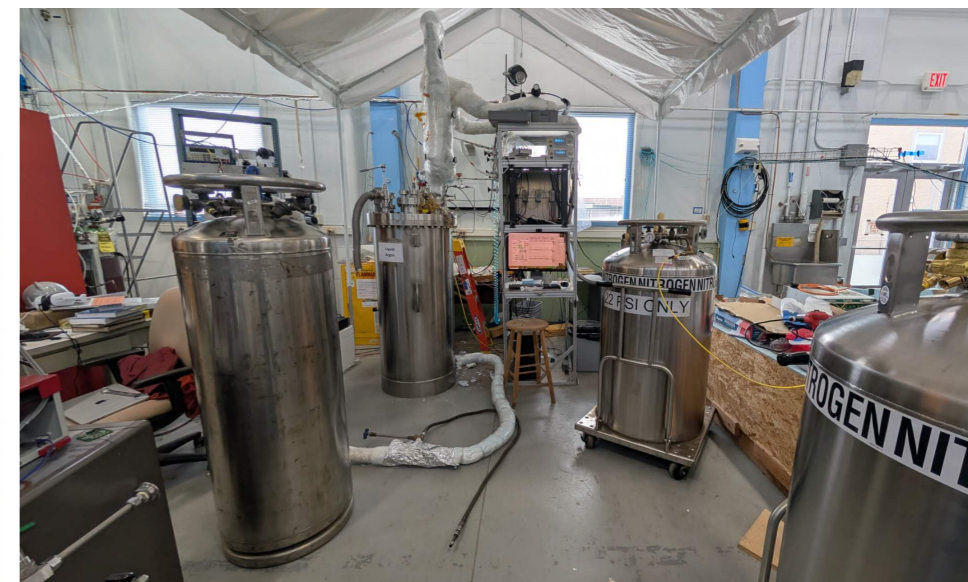
## ▸ pTP Cryogenic Test with LAr immersion

- Similar immersion time like the previous cryogenic test in open mouth dewar ~20 hrs
- The moisture is eliminated with closed system+pump and purge
- Closed loop filling used this time to save LAr
  - Filling directly without using inline filter
  - A large portion of LAr will be boiled off in the previous filling procedure
  - No venting to the air during the filling process with condensing on
  - All LAr being filled into the 260L with the samples immersed
  - The new LN2 dewar was used for the operation
  - Replaced the LN2 three times during the cryogenic operation as a practise
  - Overall process is smooth

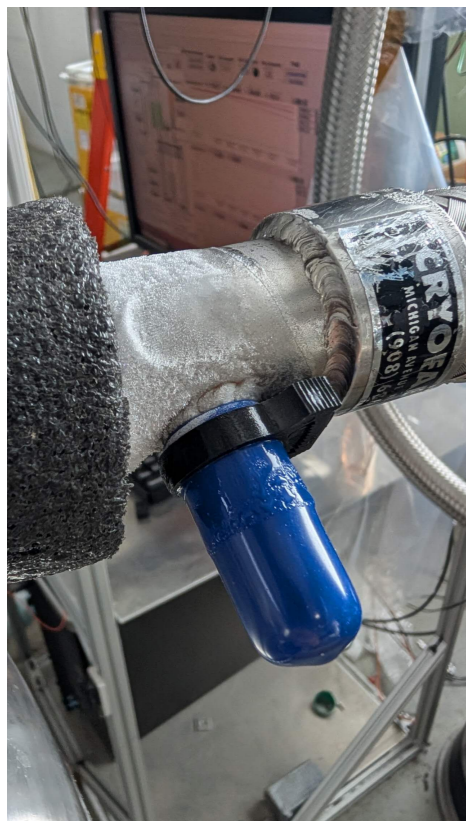
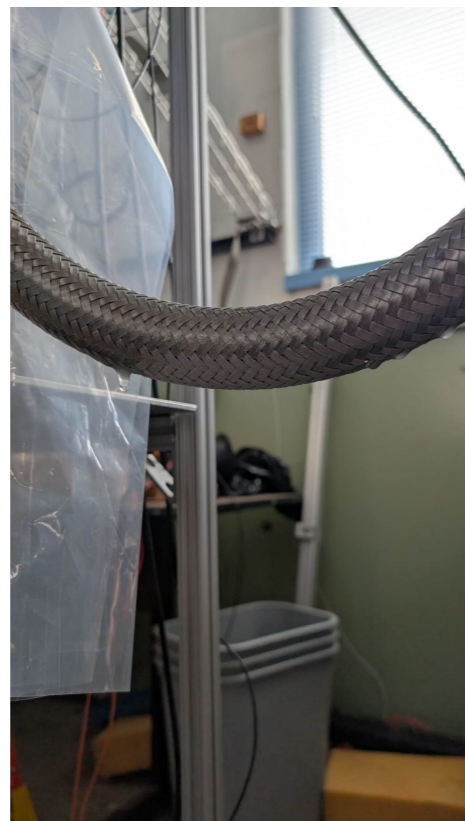
- The system was opened up today
- Some twisting of the support rods observed
- The mounting screws turned to be extremely tight after cryogenic cycle, will add spring washer in the future
- The LN2 supply hose lost vacuum, need re-evacuation before next run

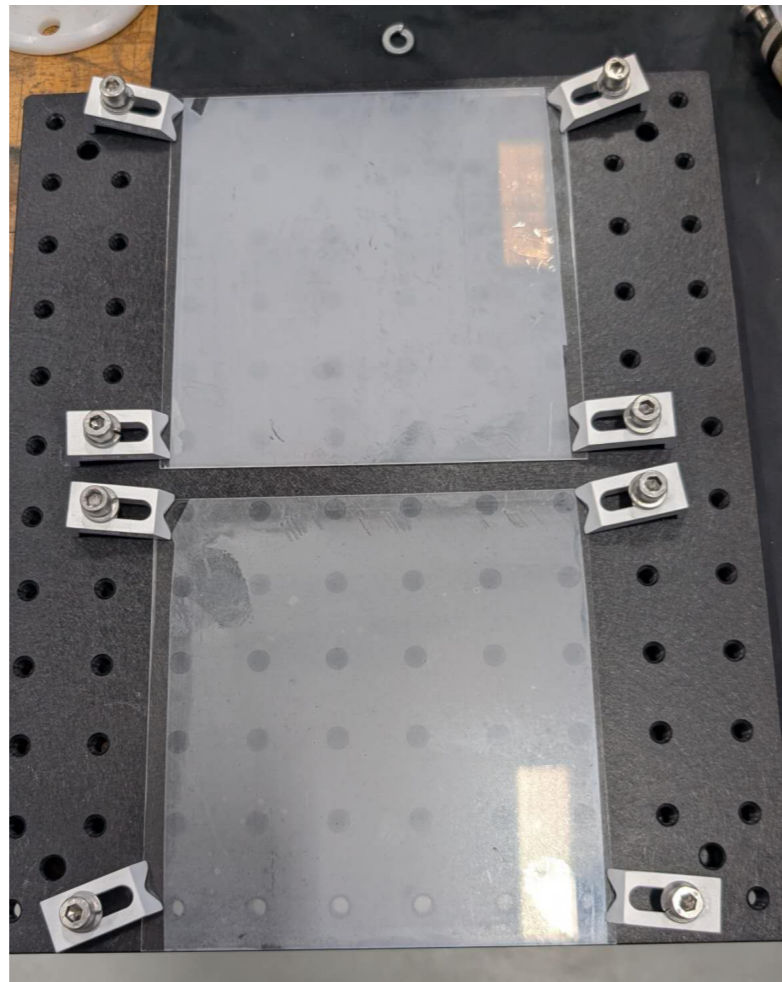
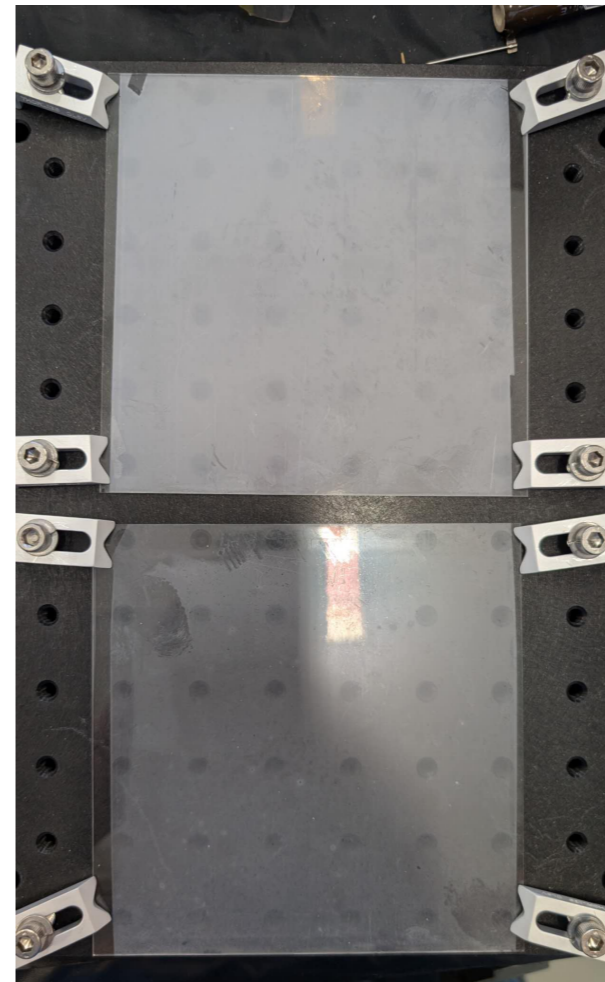
- Previous observation after the cryogenic cycle in open mouth LN2 dewar shows serious degradation on the surface conditions, most likely due to moisture in the warming up stage
- With no moisture, there is no visible change on the coating before and after the cryogenic cycle, just some tiny dust on the surface
- Will repeat the spectrum measurement once the spectrometer is returned to us

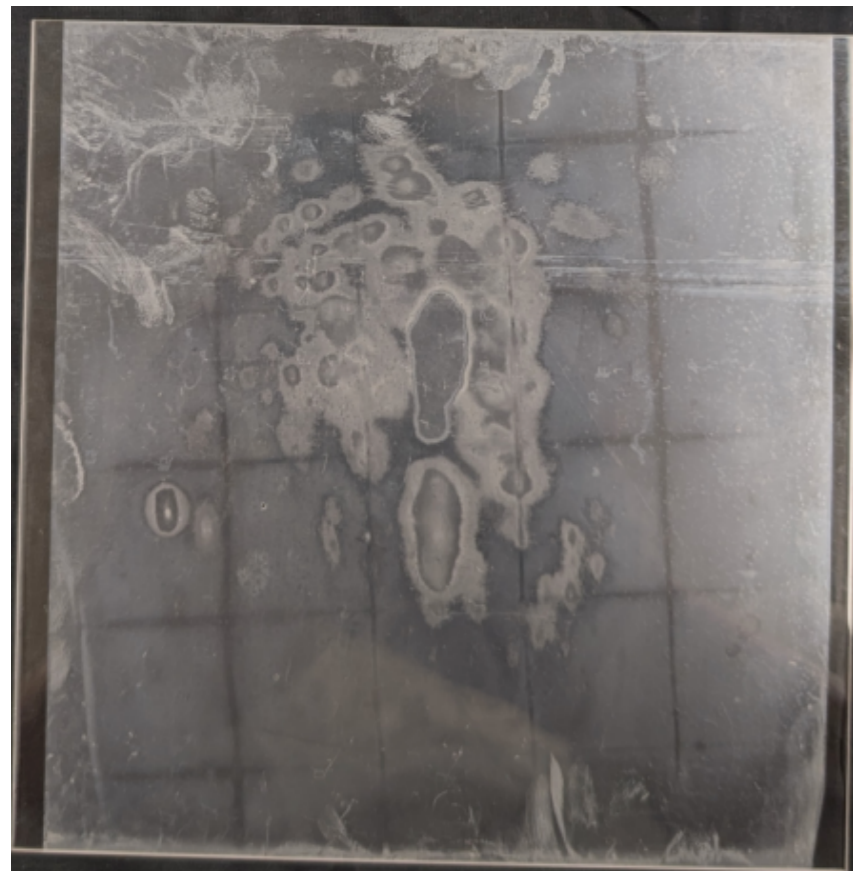
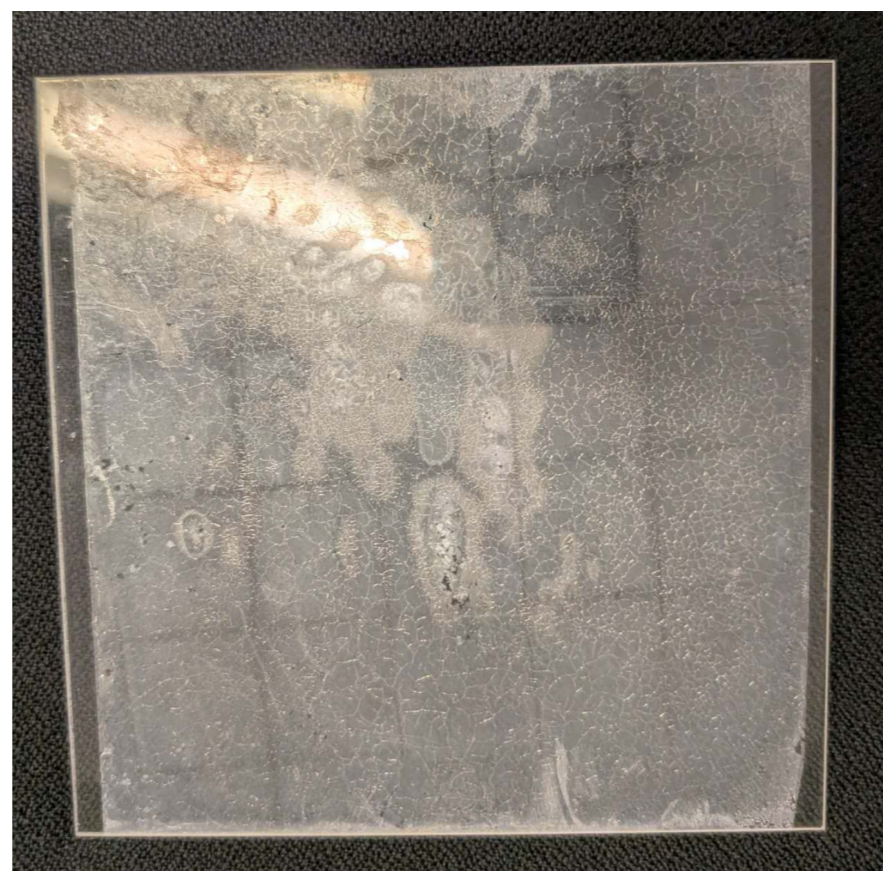
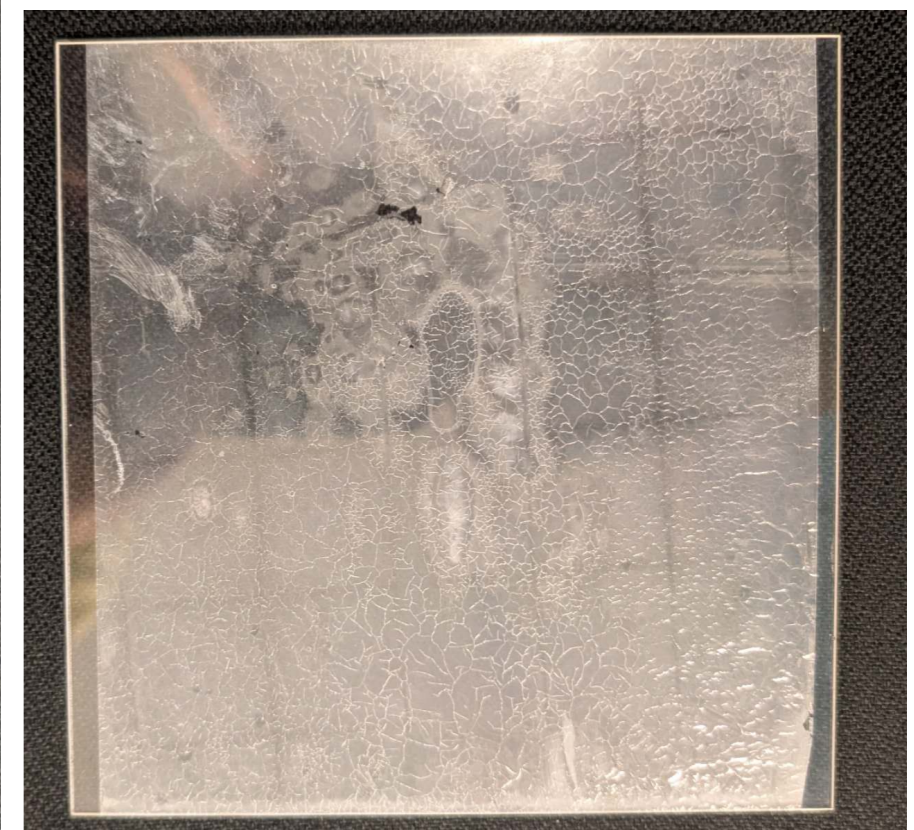
## **S4 Sapphire**

- All substrates survived the thermal stress test with the controlled slow cooling process, no visible damages
- Significant changes on the coating after the cryogenic cycle
  - Most significant on Sapphire, least impact on B33
- Water gets under the coating during warming up
