# AstroPix BIC wafer/module/stave meeting, June 2<sup>nd</sup> (2026), C. Kim (PNU)

## Adapter Features

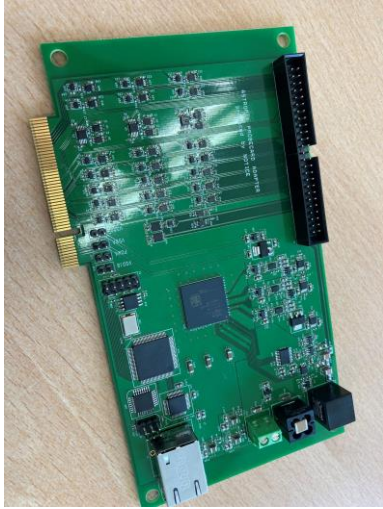
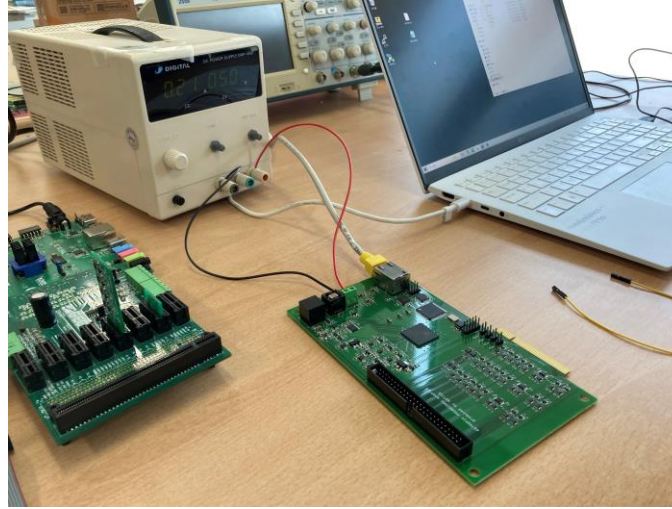
- Interconnect between the Gecco and the probe card
  - a. Connection to control: via TCP/IP (ethernet)
  - b. Connection to Gecco: via PICe
  - c. Connection to probe card: via 50 pin cable
- Can test electrical contact (between the pads on the chip and the probe card's needle)
  - \* Not all v3 pins can be checked for now due to current probe card design (next page)
- Includes its own power module
  - a. Can provide POW4, POW6 (1.8 V), VDD18 (1.8 V), and VSSA (1.2 V), **but NOT VDD33 (2.7 V)**
  - b. Can provide negative bias max. -500 V

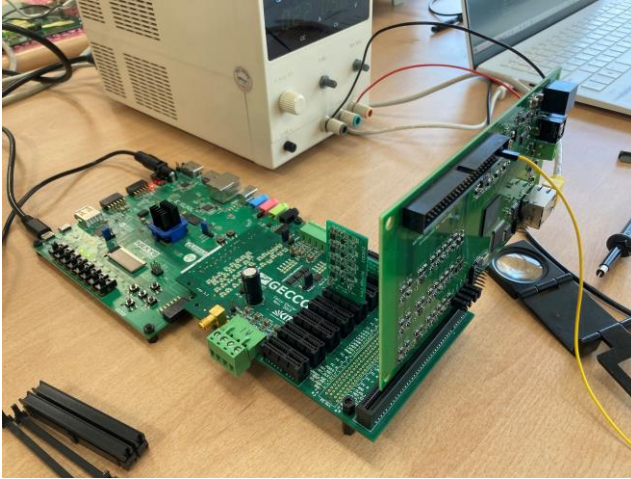
Single pin contact

# Adapter Dry run – mimic electrical contact established

- a. Confirmed electrical contact can be tested, at least under mimic environment
  - \* both “a pin is contacted” and “all pins are contacted” cases are checked
- b. Confirmed the adapter can provide power and bias
  - b-1. The chip sends and receives info (e.g., interrupt and clock) (\* checked by multimeter and scope)
  - b-2. DAC – bias calibrated: “  $DAC \approx 7.54434 * |V\_bias| - 57.68$  ”
- c. I-V scan is now available (in the manner of functionality)

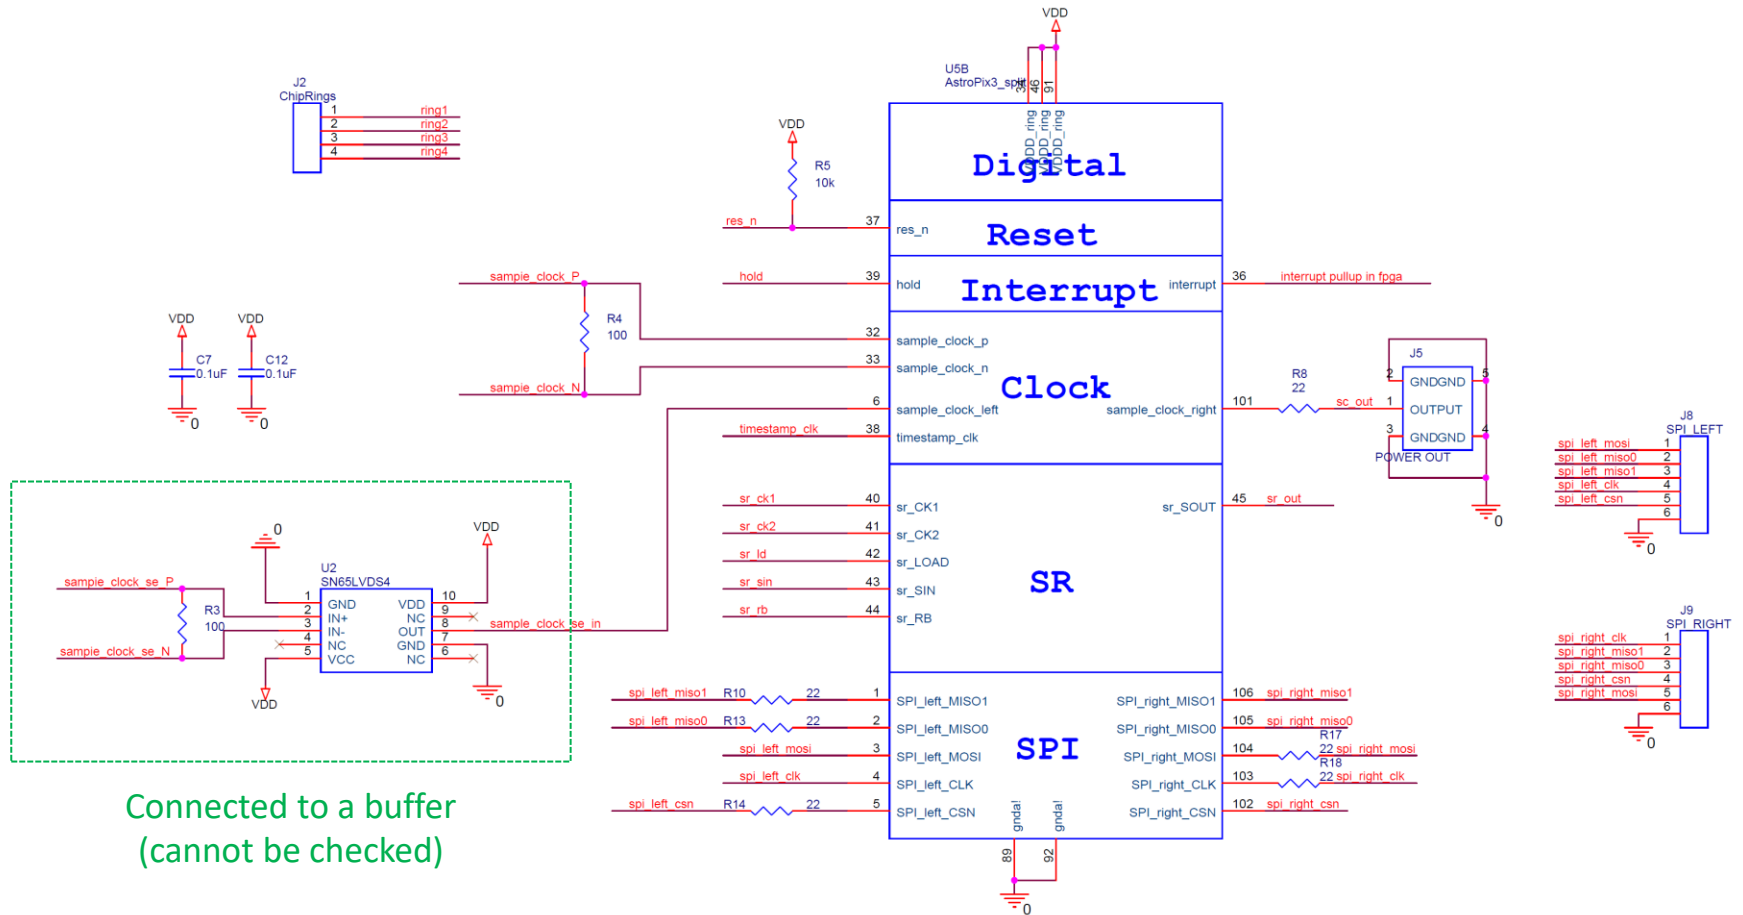
## AstroPix-v3

# Adapter Pins that electrical contact CANNOT be checked
