# Noise filter revisit summary

# Coherent noise removal: +3 shift

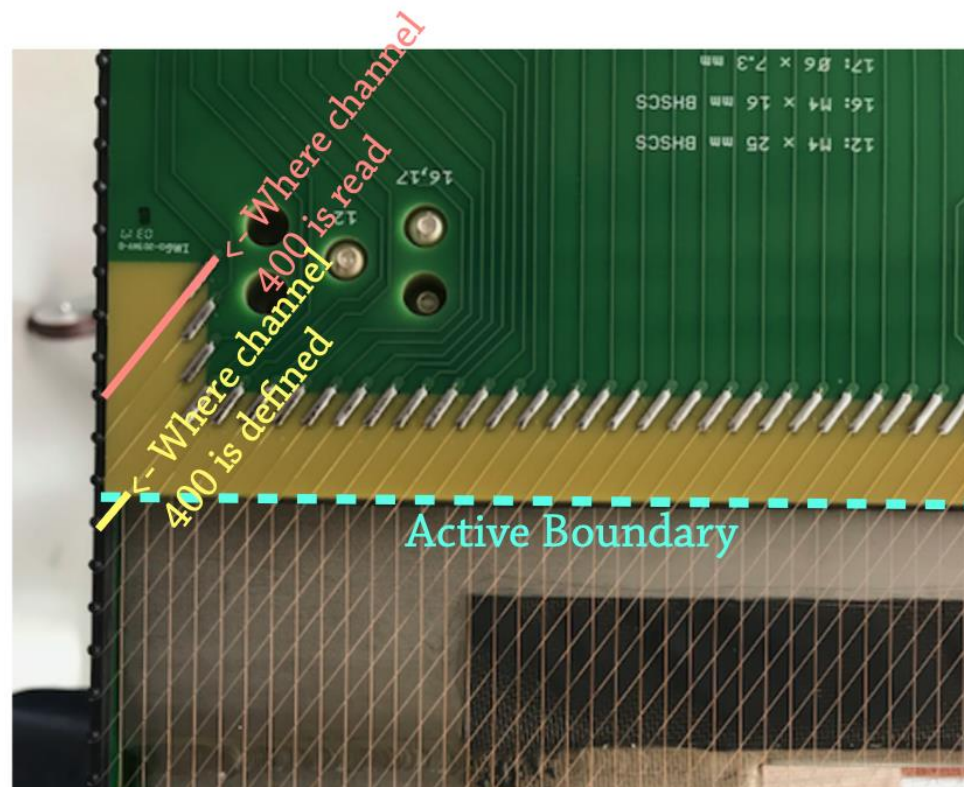
Let's focus on the top side of the APA, where the wires are soldered to the electronics (i.e APA 1&2 for ProtoDUNE-HD, we'll discuss APA3&4 later)

In LArSoft, the wire segment are defined up to the active boundary at the board end : there is a mismatch between the real location of these wires and where it is defined in the reconstruction
